Application for Certificate of Appropriateness

Address of Subject Property: 1859 Ridgewood Drive Atlanta, GA 30307

1859 Ridgewood Dr NE
Atlanta, GA 30307
Project No: 22267

Residential Inspection and Construction Evaluation

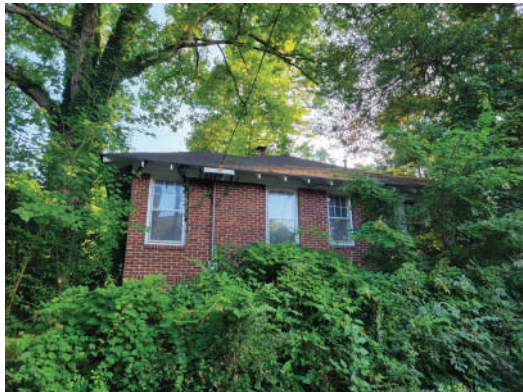
Photo 3

- Tree Roots: One of the larger trees on the entire property is within a few feet of the front wall of the house on the right side (see Photo 3). The roots of this tree are likely infringing upon the front wall foundation. The roots will continue to undermine and apply pressure to the front brick piers until structural failure.

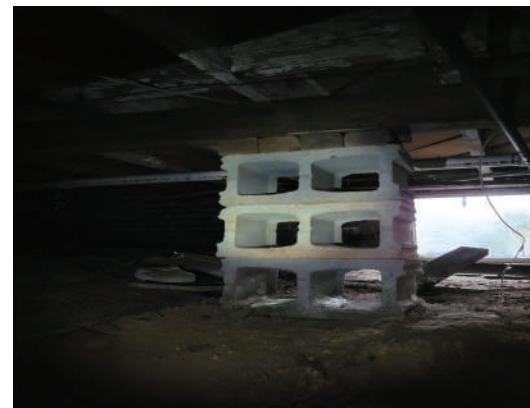
Photo 4

- Stacked CMU Supports: Throughout the crawl space, CMU blocks were stacked to serve as structural piers (see Photos 4 & 5). The blocks are oriented the wrong way and are simply bearing on dirt instead of a proper footing. These are not structurally adequate as installed. Settling will continue until structural failure.

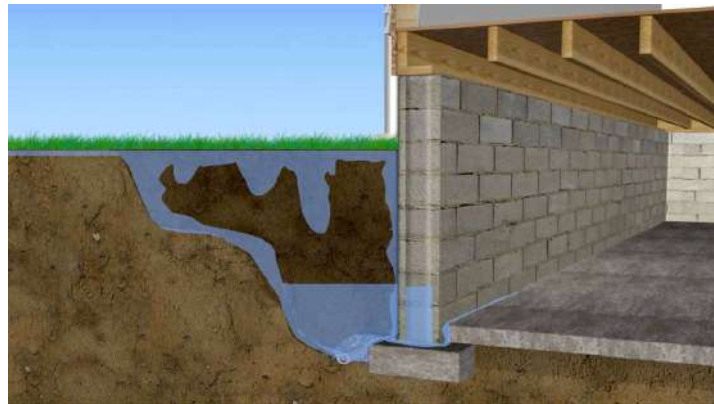
- Portions of the perimeter soil lack sufficient pitch/slope away from the house. This results in large amounts of water being absorbed into the soil adjacent to the foundation walls, and traveling through or under the foundation wall, into the cellar/crawlspace. (Note: Water leakage is very common with all brick foundation walls and they are very difficult to effectively waterproof.) This condition has contributed to the elevated moisture readings and water intrusion into the cellar and crawlspace. Excessively high moisture levels have resulted in conditions that encouraged the growth of microbes such as mold fungi. This condition may also affect the bearing capacity of the soil beneath the footings/foundation. Wet, poorly compacted soil simply cannot support the same loads as dry, properly compacted soil.

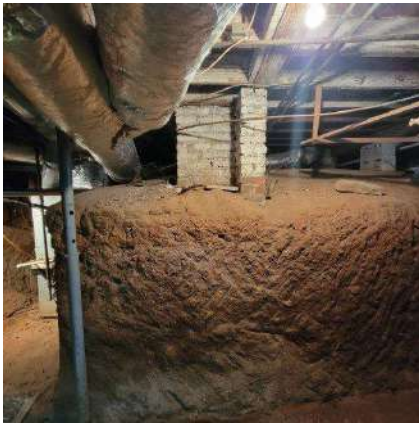
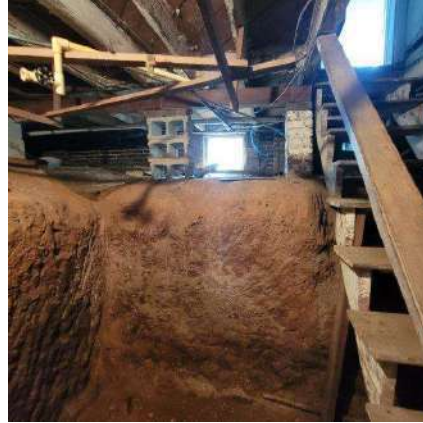
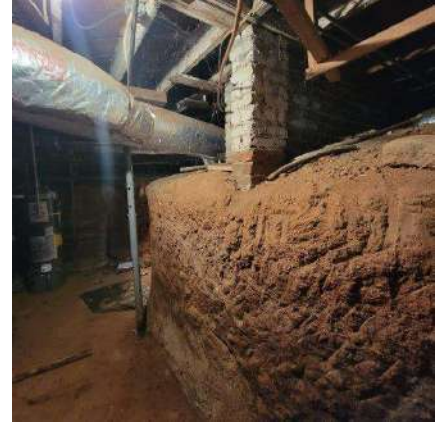
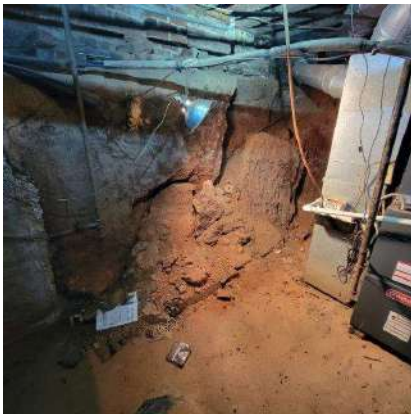
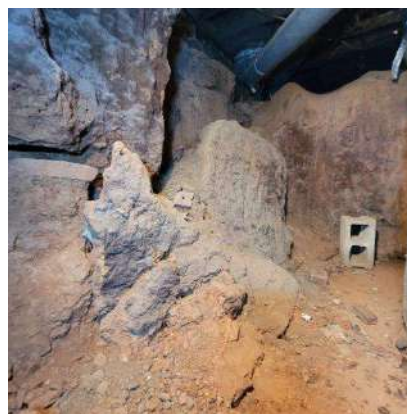
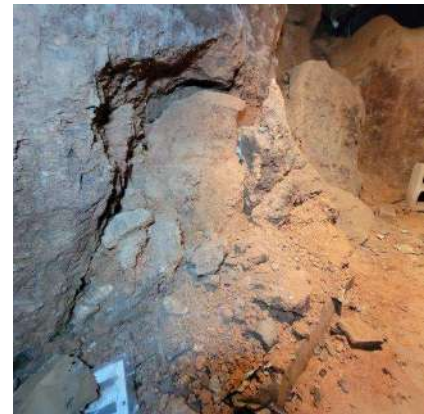
- A portion of the crawlspace was excavated to create a cellar at some point in the past. Digging too close to portions of the foundation and central support footings, combined with the documented long-term water intrusion, has compromised the cone of compression/angle of repose. The profile of the weight-bearing soil beneath the foundation is roughly cone-shaped, sloping down and out from the bottom corners of the foundation footing at an angle of approximately 45° . As of today's inspection, the soil adjacent to two areas of the front foundation has visibly collapsed, further compromising the structural integrity of the house, and contributing to some of the structural movement identified during the inspection. The over excavation combined with the documented long-term water intrusion may have contribute to some of the structural movement identified in the home. From a structural perspective, the footing has failed, and could result in a collapse of that section of foundation wall.

This type of construction frequently lasts for over 100 years, but not when the soil outside the foundation was improperly graded properly resulting in water intrusion AND when structural significant soil within the angle of repose has been removed.

The below included photos show the excavation and collapse of the soil adjacent to the foundation.

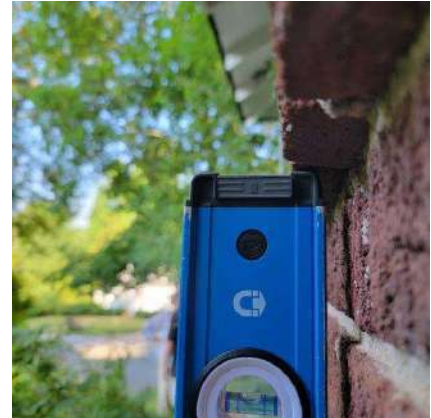
- The brick veneer on the right side of the structure has bowed/bulged outward in at least one area. This movement may appear minor but represents evidence of the failed condition of the foundation below.

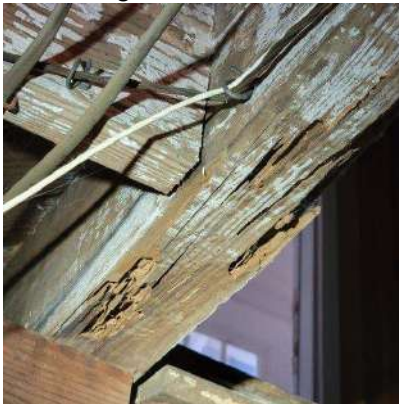
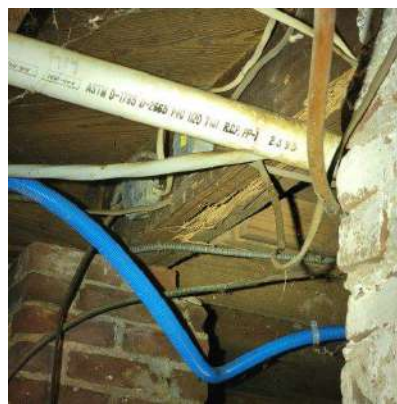
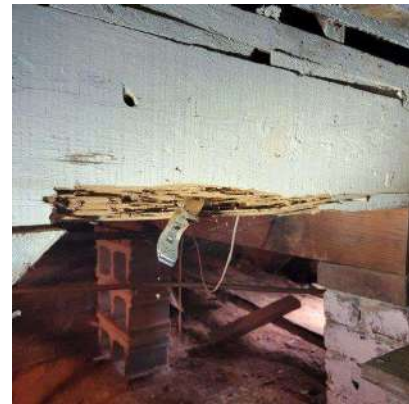
- Termites have damaged structurally significant framing visible in the cellar/crawlspace. The extent of damage remains unknown as I was unable to access all of the crawlspace areas or evaluate each piece of wooden framing. Statistically, when a termite infestation is discovered, there are an average of 2 more colonies already attacking the home's structure. Further, I am unsure if this damage is related to an active infestation, nor am I all that concerned with that component. Treating for termites is not a difficult process if the termites are active. The structural damage and substandard repairs represent a much larger concern.

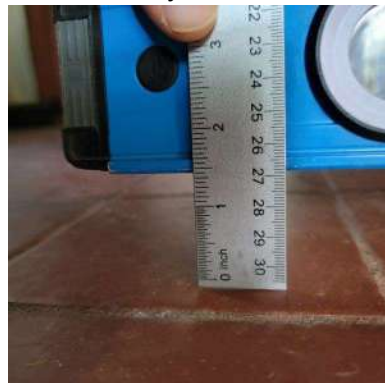
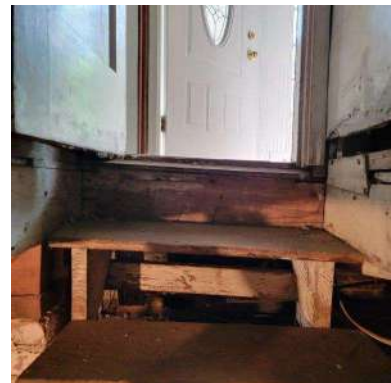
- Elevation measurements were taken inside the home. The front and right sides of the home have settled more than 2 inches in areas. This is the result of the conditions listed above. Some areas (pictured below) have subsided 1-1/2" in only 4'.

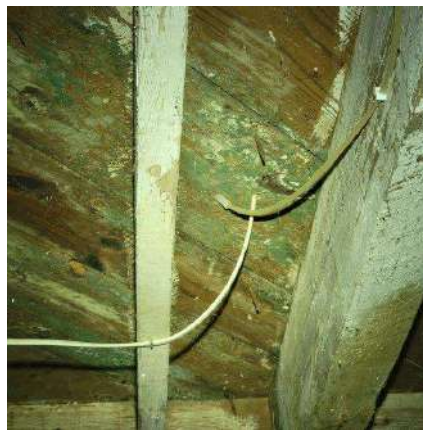
- There is visible mold growth in several places visible in the cellar/crawlspace. If left uncorrected or not fully remediated, mold in a home can lead to health problems. The effect of the occupants health varies from person to person, but can be severe. Exposed or accessible mold can often be easily remediated. (Easy should not be confused with inexpensive) The EPA warns however, that if the moisture sources are not eliminated, the mold will recur in short order. To reduce the water entering the cellar and crawlspace, it will be necessary to ensure that the exterior perimeter soil is properly compacted and pitched away from the structure. In most cases, if visible mold growth is present, sampling is unnecessary. Since no EPA or other federal limits have been set for mold or mold spores, sampling cannot be used to check a building's compliance with federal mold standards. Surface sampling may be useful to determine if an area has been adequately cleaned or remediated.

Some companies will suggest that fogging or spraying the mold with chemicals to "kill" it is sufficient for correcting your mold problem. Complicating matters further, these bids will seem attractive as they are usually significantly lower than a complete remediation estimate. This is understandable as often these bids do not include actual mold removal or air quality tests or guarantees upon completion of the work. Complete and effective mold remediation includes the removal of mold laden porous materials such as drywall, insulation, and/or other porous materials. Mold is resilient and when deep in porous materials, surface treatment may not be effective solution. Further, covering up the mold is not a solution.

Caution: Fogging is NOT and should NOT be considered to be an accepted or effective method of mold removal. According to the IICRC (The Institute of Inspection, Cleaning and Restoration), killing mold without removing it is not considered a complete solution to your mold problem. In their newly published guidelines (2015 Guidelines), the IICRC states "Remediators should not mist or fog disinfectants or sanitizers in an attempt to kill mold in lieu of source removal".
