Application for Certificate of Appropriateness

Address of Subject Property: 1859 Ridgewood Drive Atlanta, GA 30307

1859 Ridgewood Dr NE
Atlanta, GA 30307
Project No: 22267

Residential Inspection and Construction Evaluation

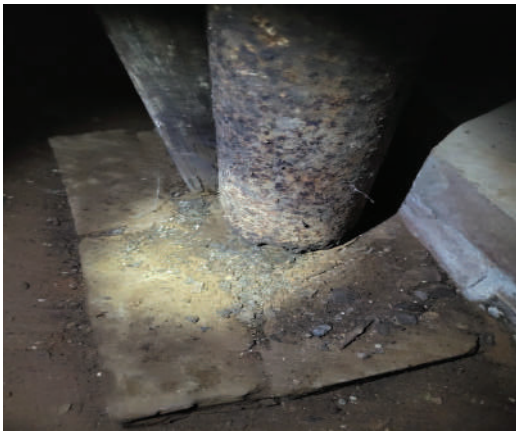
Photo 1

- Steel Posts: At least (5) steel posts in the dug-out basement have significantly rusted at the base due to prolonged exposure to moisture and are no longer structurally adequate (see Photo 1). There is also at least (1) adjustable screw jack post installed in the dug-out basement. These are intended for temporary shoring and are not structurally adequate for permanent use.

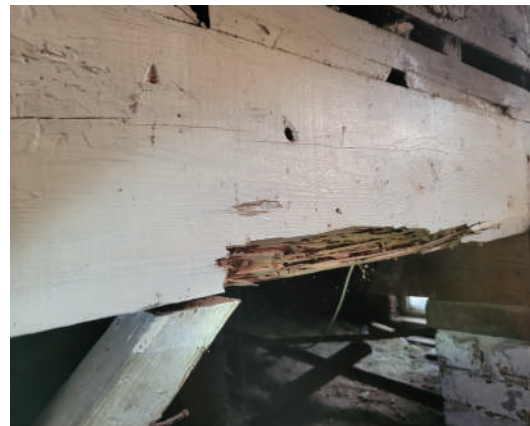
Photo 2

- Termite Damage: At least (1) main girder was found to have significant termite damage (see Photo 2), and is structurally inadequate in its current state. A thorough termite inspection is required to determine the threat level of active infestation (p7 inspection report).

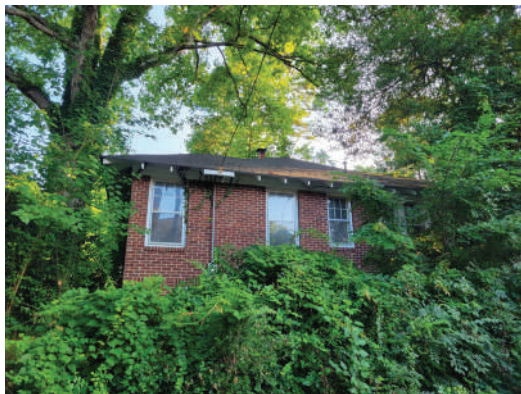
Photo 3

- Tree Roots: One of the larger trees on the entire property is within a few feet of the front wall of the house on the right side (see Photo 3). The roots of this tree are likely infringing upon the front wall foundation. The roots will continue to undermine and apply pressure to the front brick piers until structural failure.

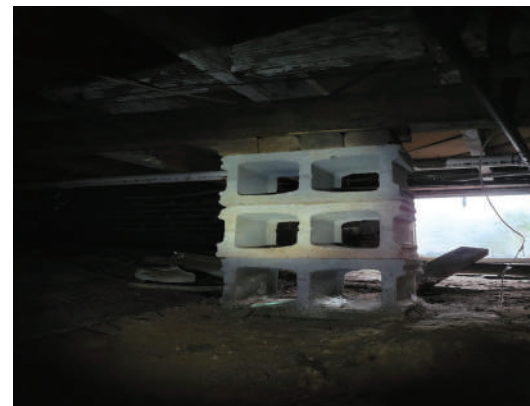
Photo 4

- Stacked CMU Supports: Throughout the crawl space, CMU blocks were stacked to serve as structural piers (see Photos 4 & 5). The blocks are oriented the wrong way and are simply bearing on dirt instead of a proper footing. These are not structurally adequate as installed. Settling will continue until structural failure.

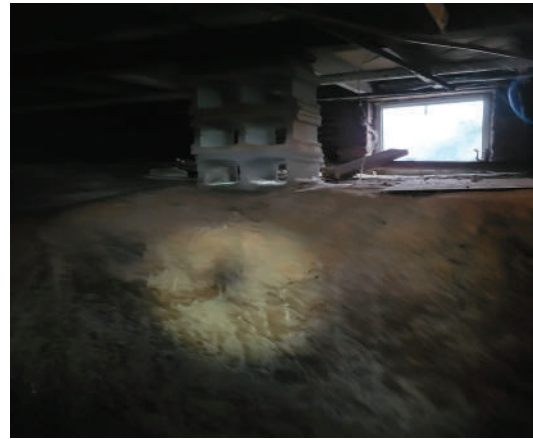
Photo 6

- Undermined Foundations: This is the most serious and immediate threat to the home. When the full height basement was dug out at some point after the original construction, the dirt supporting the crawl space piers was cut too close to the bottom of the brick piers (p5 inspection report). This is undermining at least (2) stacked CMU piers (see Photo 6), the fireplace foundation, and (3) piers along the front wall of the home (see Photo 7). This affects all the structural framing above these areas, as well as the front porch slab. Structural failure will occur.

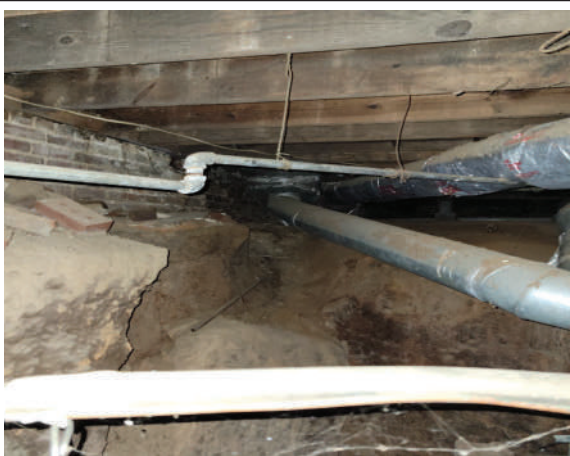
Photo 7

Upon further inspection, the main reason that rehabilitation is not possible is the long-term water intrusion caused by improper exterior grading has led to undermined foundation and reduced bearing capacity. With the existing unreinforced brick foundation without proper cast-in-place concrete footings to bear on, the soil has eroded and weakened underneath due to the constant, repeated flow of water. This will continue to cause the sloping floors to worsen, walls to be more out-of-plumb and differential settlement to accelerate. The front foundation wall already has evidence of this (see Photo 7) with collapsing dirt and the other walls are in danger of similar failure as well.

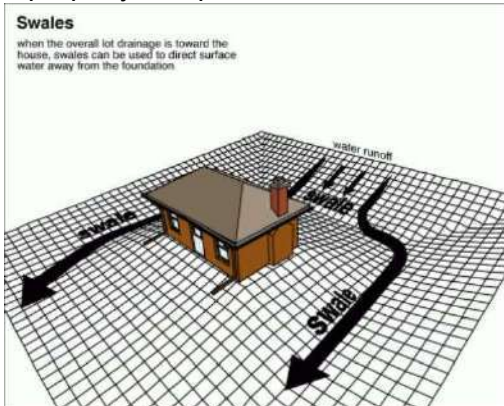
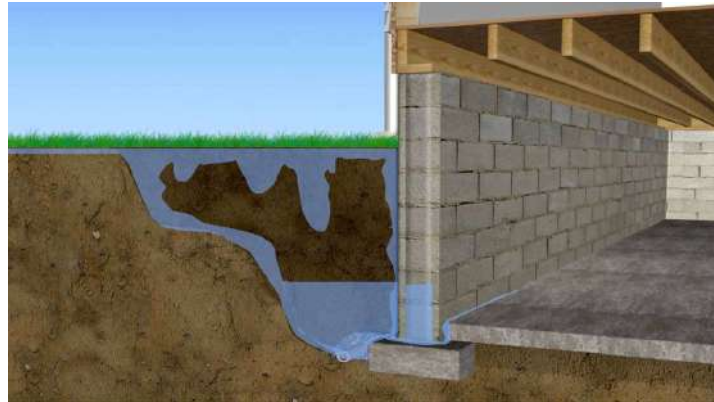
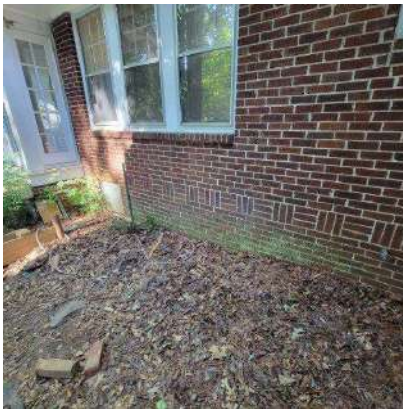
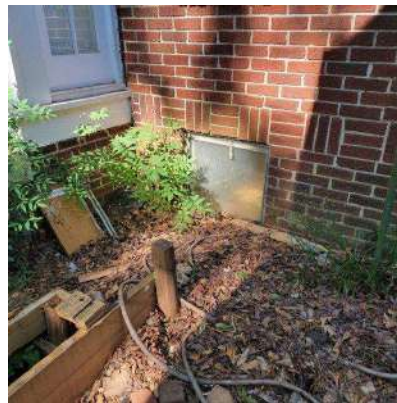
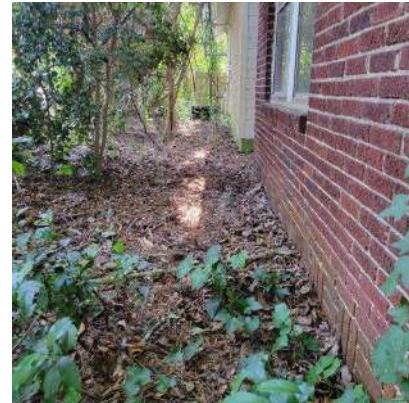
- Portions of the perimeter soil lack sufficient pitch/slope away from the house. This results in large amounts of water being absorbed into the soil adjacent to the foundation walls, and traveling through or under the foundation wall, into the cellar/crawlspace. (Note: Water leakage is very common with all brick foundation walls and they are very difficult to effectively waterproof.) This condition has contributed to the elevated moisture readings and water intrusion into the cellar and crawlspace. Excessively high moisture levels have resulted in conditions that encouraged the growth of microbes such as mold fungi. This condition may also affect the bearing capacity of the soil beneath the footings/foundation. Wet, poorly compacted soil simply cannot support the same loads as dry, properly compacted soil.

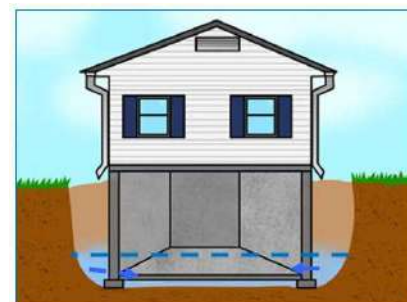
- Because the floor of the cellar is completely below grade, as opposed to a “walkout” type basement where one or more sides of the basement are ABOVE the adjacent grade, properly waterproofing this basement becomes exceptionally challenging, if it’s even possible. This soil slope allows water that collects in the soil outside the foundation to drain to the lowest accessible exterior elevation. (Left diagram below) Water can accumulate several feet high outside the foundation and hydrostatic pressure will attempt to “drive” the water through the wall until equilibrium is reached with water both inside and outside the foundation.

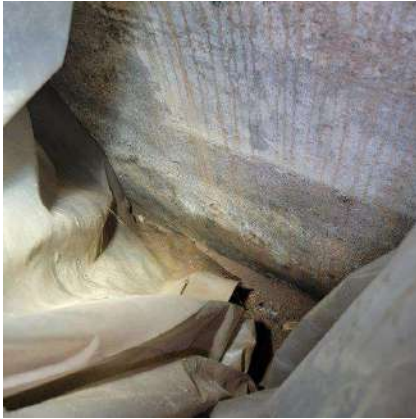
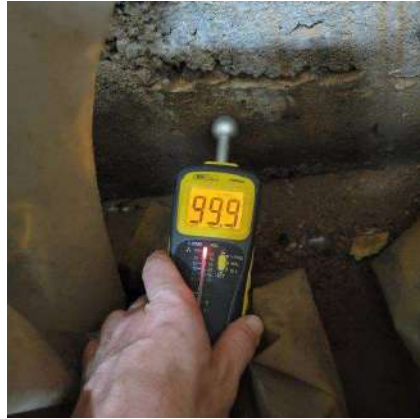
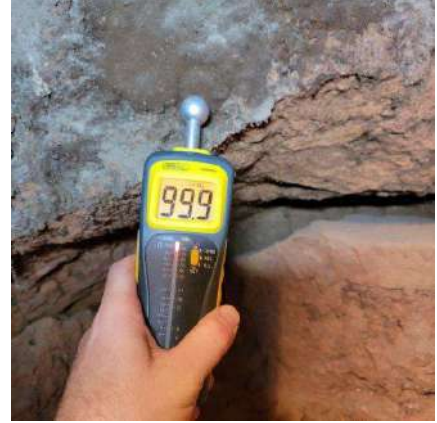
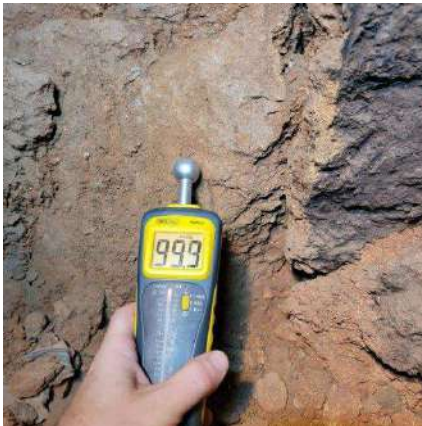
- Evidence of long-term and ongoing water intrusion into the cellar and crawlspace. When this water evaporates it increases the relative humidity, contributing to the mold growth identified during the inspection. Please note, it is not likely that you will be able to correct this condition when previous owners have not been able to correct it for almost 100 years. The installation of a poured concrete wall in the cellar was likely an attempt to prevent additional water intrusion that was clearly ineffective.

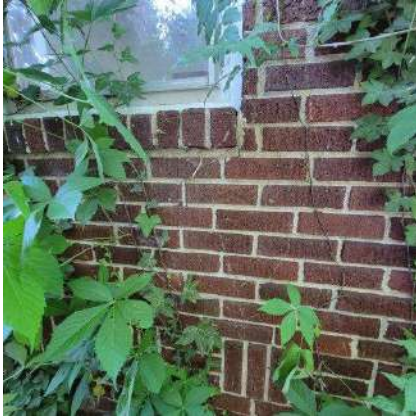
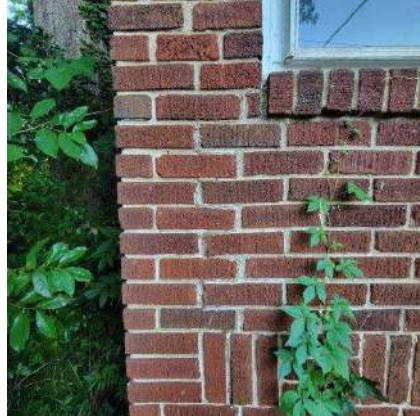
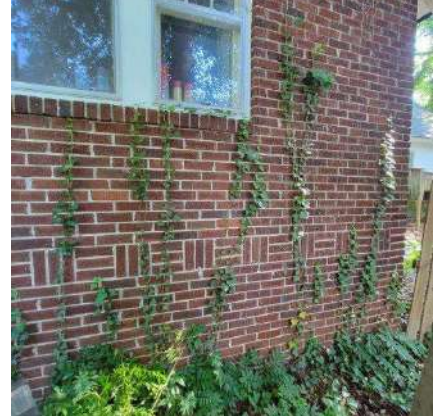
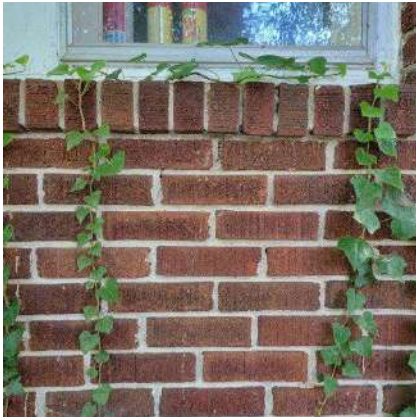
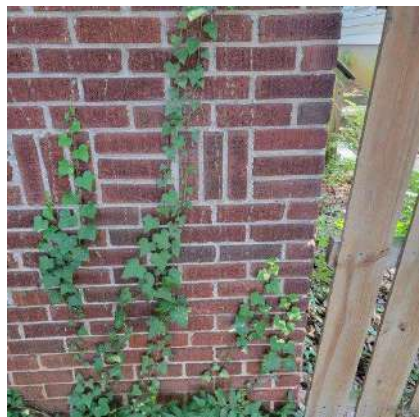
- Cracking in brick veneer walls appeared to be consistent with differential settlement. Differential settlement is caused by differences in settling rates of soil beneath adjacent parts of a foundation wall. This condition appears to be a result of changes in moisture content of the soil due to poor rain watershed management.

NOTE: The brick veneer is not a structural element, and it contributes nothing to the support of the house components. The decision to repair or not to repair the veneer will in no way affect the structure. It does provide evidence of the above-mentioned structural movement.

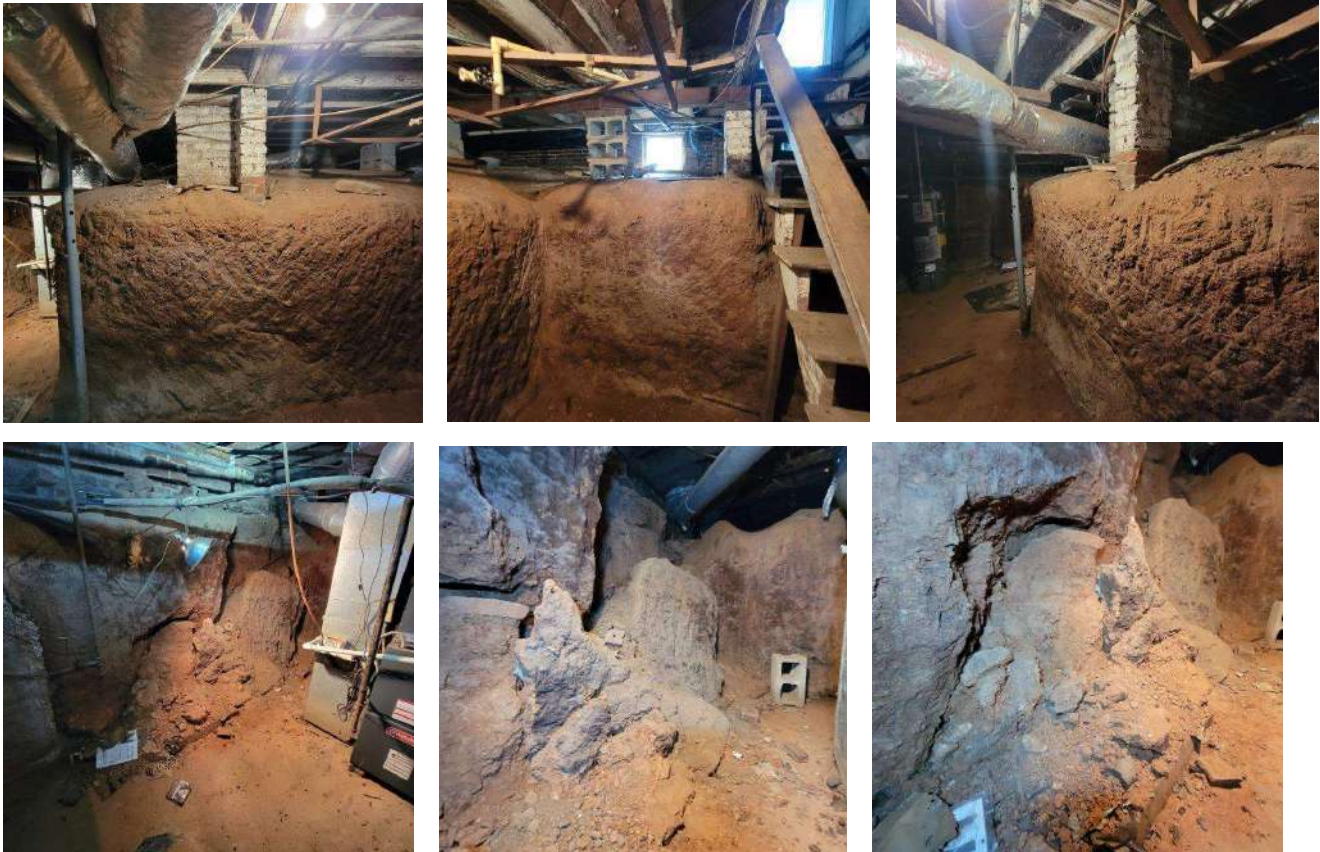
- A portion of the crawlspace was excavated to create a cellar at some point in the past. Digging too close to portions of the foundation and central support footings, combined with the documented long-term water intrusion, has compromised the cone of compression/angle of repose. The profile of the weight-bearing soil beneath the foundation is roughly cone-shaped, sloping down and out from the bottom corners of the foundation footing at an angle of approximately 45°. As of today's inspection, the soil adjacent to two areas of the front foundation has visibly collapsed, further compromising the structural integrity of the house, and contributing to some of the structural movement identified during the inspection. The over excavation combined with the documented long-term water intrusion may have contribute to some of the structural movement identified in the home. From a structural perspective, the footing has failed, and could result in a collapse of that section of foundation wall. This type of construction frequently lasts for over 100 years, but not when the soil outside the foundation was improperly graded properly resulting in water intrusion AND when structural significant soil within the angle of repose has been removed.

The below included photos show the excavation and collapse of the soil adjacent to the foundation.

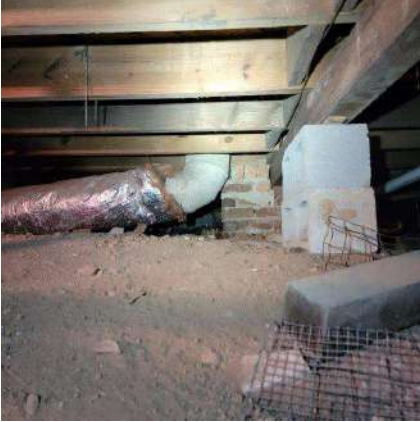
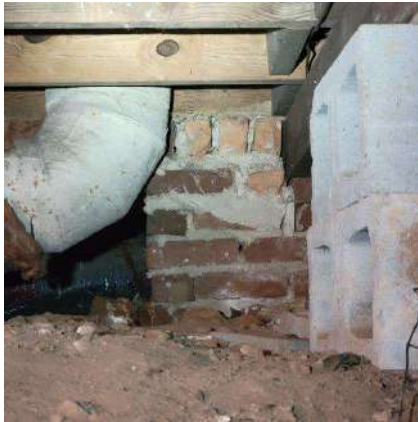
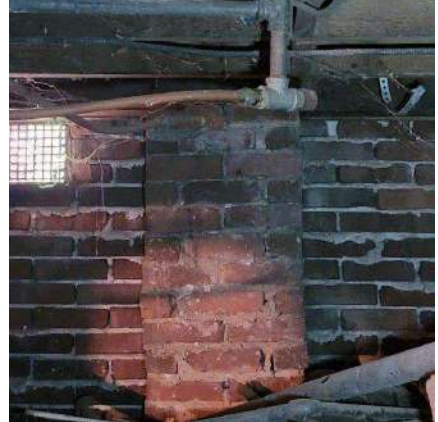
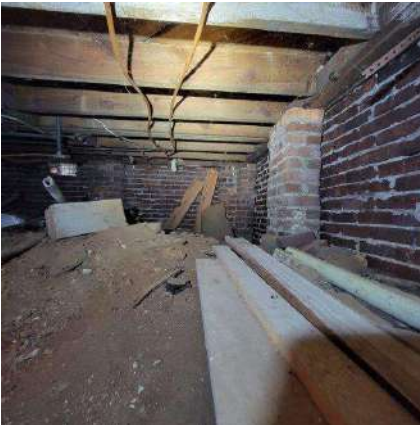
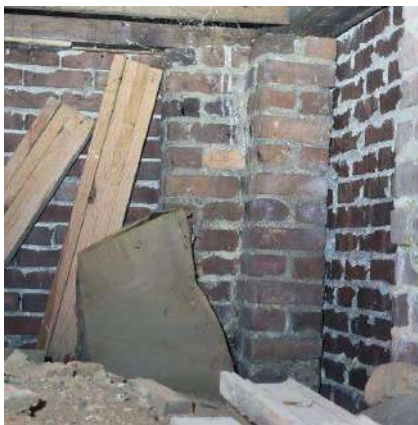
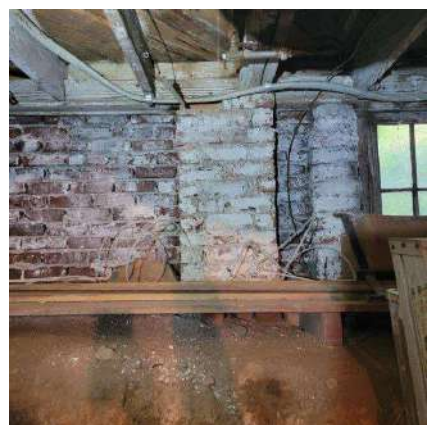
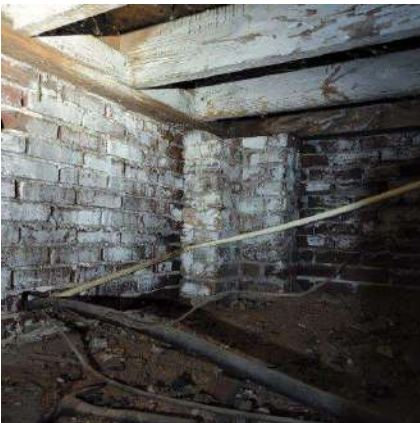
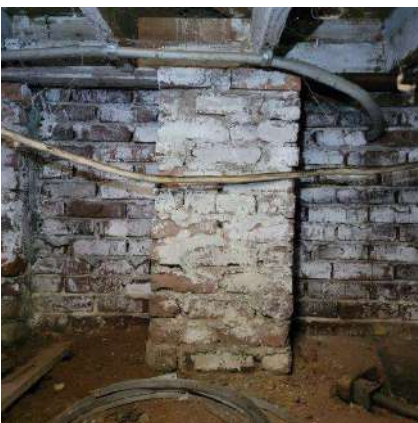
- Several brick foundation piers have settled and are leaned out of plumb. This condition is likely the result of long-term poor watershed management.

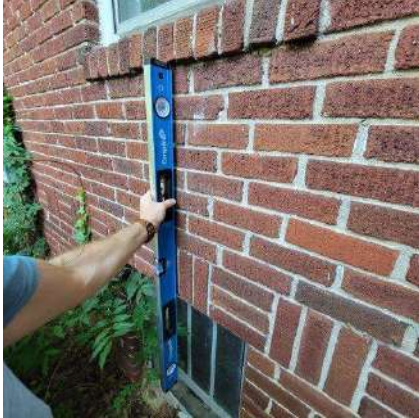
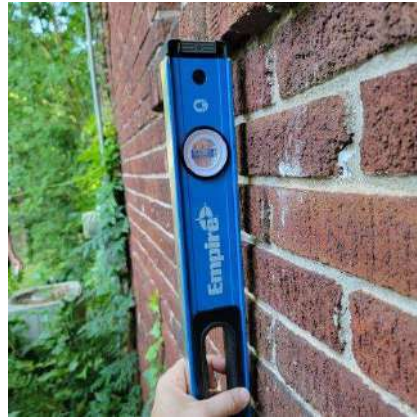
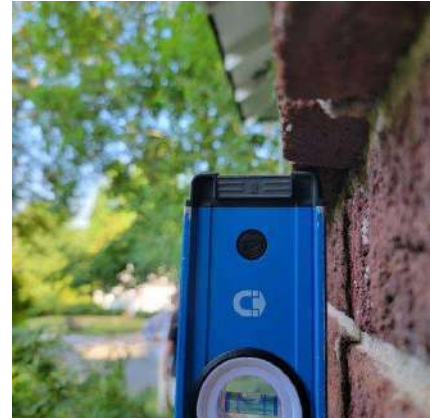
- The brick veneer on the right side of the structure has bowed/bulged outward in at least one area. This movement may appear minor but represents evidence of the failed condition of the foundation below.

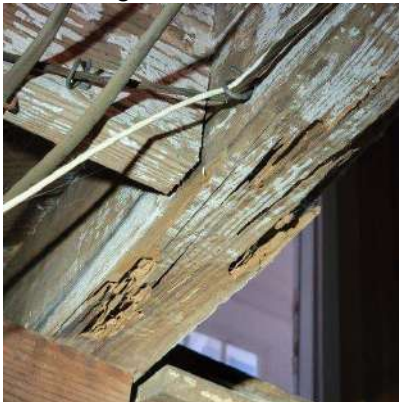
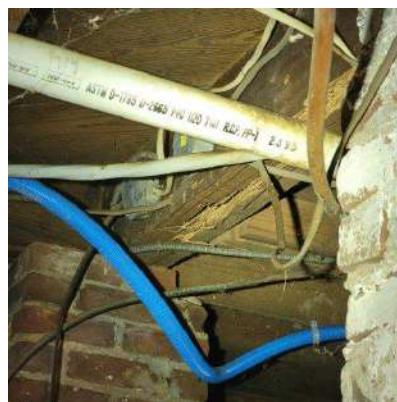
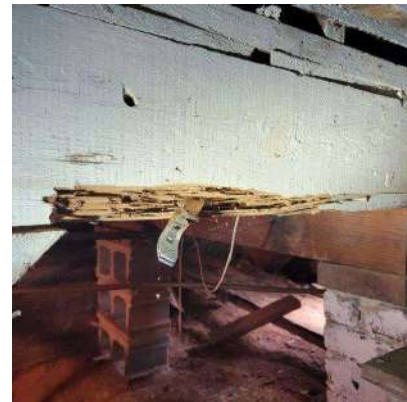
- Termites have damaged structurally significant framing visible in the cellar/crawlspace. The extent of damage remains unknown as I was unable to access all of the crawlspace areas or evaluate each piece of wooden framing. Statistically, when a termite infestation is discovered, there are an average of 2 more colonies already attacking the home's structure. Further, I am unsure if this damage is related to an active infestation, nor am I all that concerned with that component. Treating for termites is not a difficult process if the termites are active. The structural damage and substandard repairs represent a much larger concern.

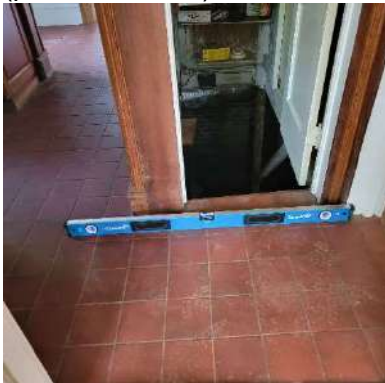
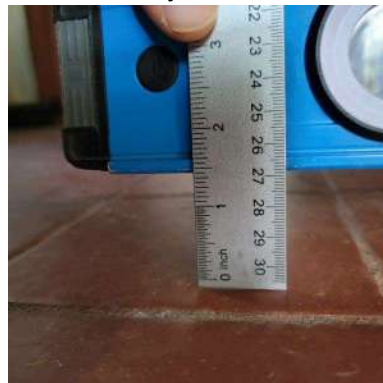
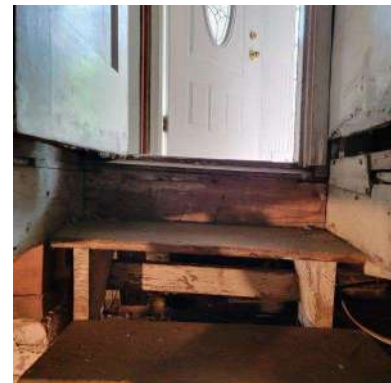
- Elevation measurements were taken inside the home. The front and right sides of the home have settled more than 2 inches in areas. This is the result of the conditions listed above. Some areas (pictured below) have subsided 1-1/2" in only 4'.

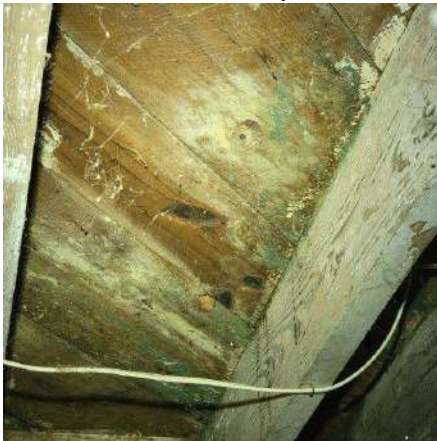
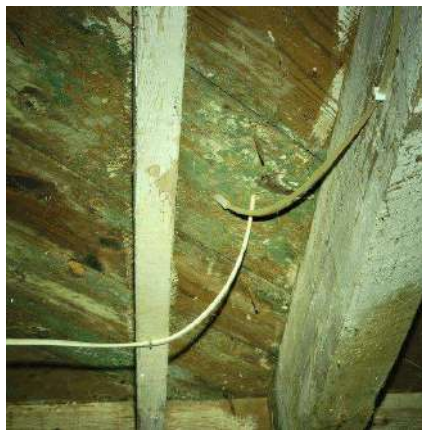
- There is visible mold growth in several places visible in the cellar/crawlspace. If left uncorrected or not fully remediated, mold in a home can lead to health problems. The effect of the occupants health varies from person to person, but can be severe. Exposed or accessible mold can often be easily remediated. (Easy should not be confused with inexpensive) The EPA warns however, that if the moisture sources are not eliminated, the mold will recur in short order. To reduce the water entering the cellar and crawlspace, it will be necessary to ensure that the exterior perimeter soil is properly compacted and pitched away from the structure. In most cases, if visible mold growth is present, sampling is unnecessary. Since no EPA or other federal limits have been set for mold or mold spores, sampling cannot be used to check a building's compliance with federal mold standards. Surface sampling may be useful to determine if an area has been adequately cleaned or remediated.

Some companies will suggest that fogging or spraying the mold with chemicals to "kill" it is sufficient for correcting your mold problem. Complicating matters further, these bids will seem attractive as they are usually significantly lower than a complete remediation estimate. This is understandable as often these bids do not include actual mold removal or air quality tests or guarantees upon completion of the work. Complete and effective mold remediation includes the removal of mold laden porous materials such as drywall, insulation, and/or other porous materials. Mold is resilient and when deep in porous materials, surface treatment may not be effective solution. Further, covering up the mold is not a solution.

Caution: Fogging is NOT and should NOT be considered to be an accepted or effective method of mold removal. According to the IICRC (The Institute of Inspection, Cleaning and Restoration), killing mold without removing it is not considered a complete solution to your mold problem. In their newly published guidelines (2015 Guidelines), the IICRC states "Remediators should not mist or fog disinfectants or sanitizers in an attempt to kill mold in lieu of source removal".

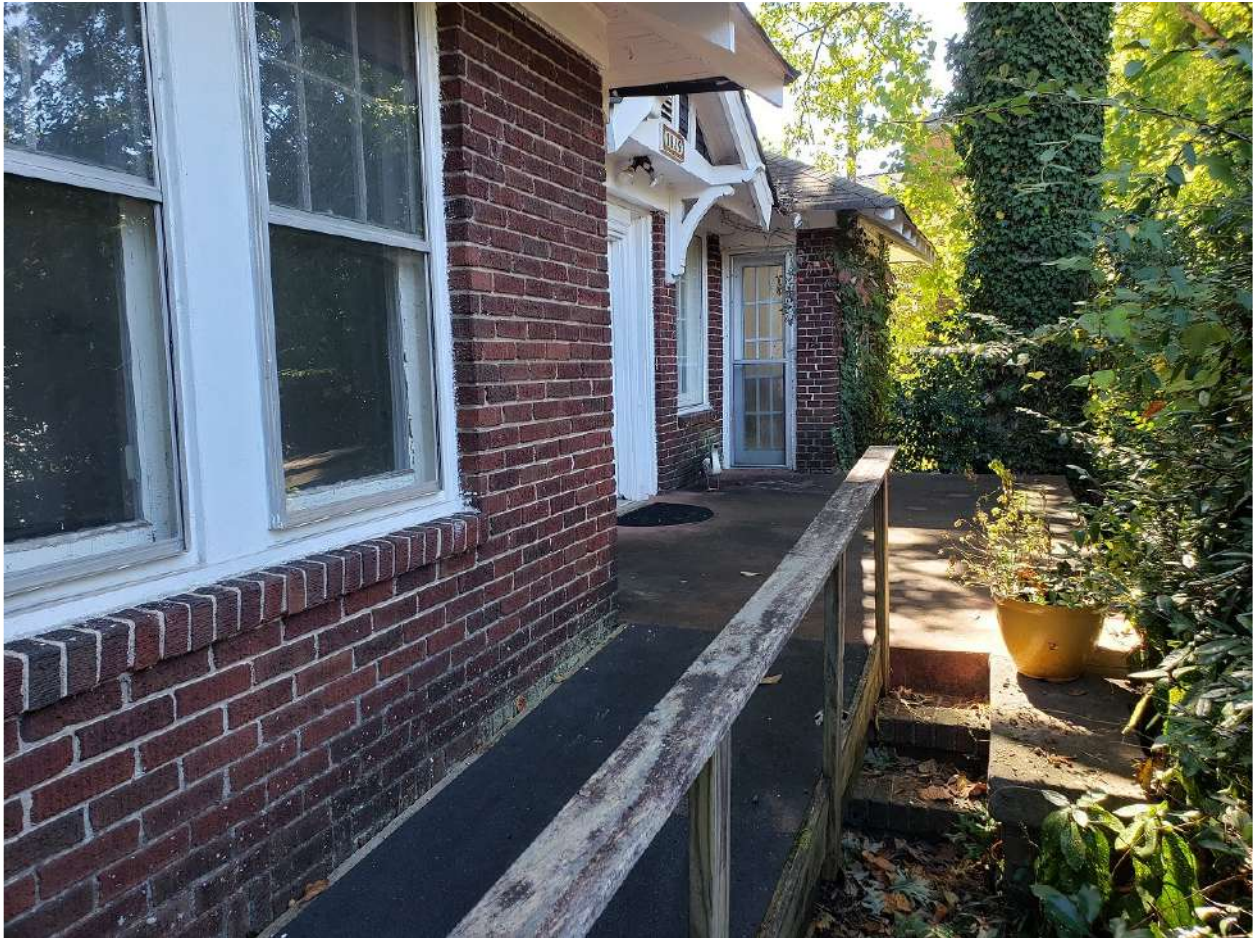
The front steps and terrace, showing the specimen tree slowly destroying the house in the background.

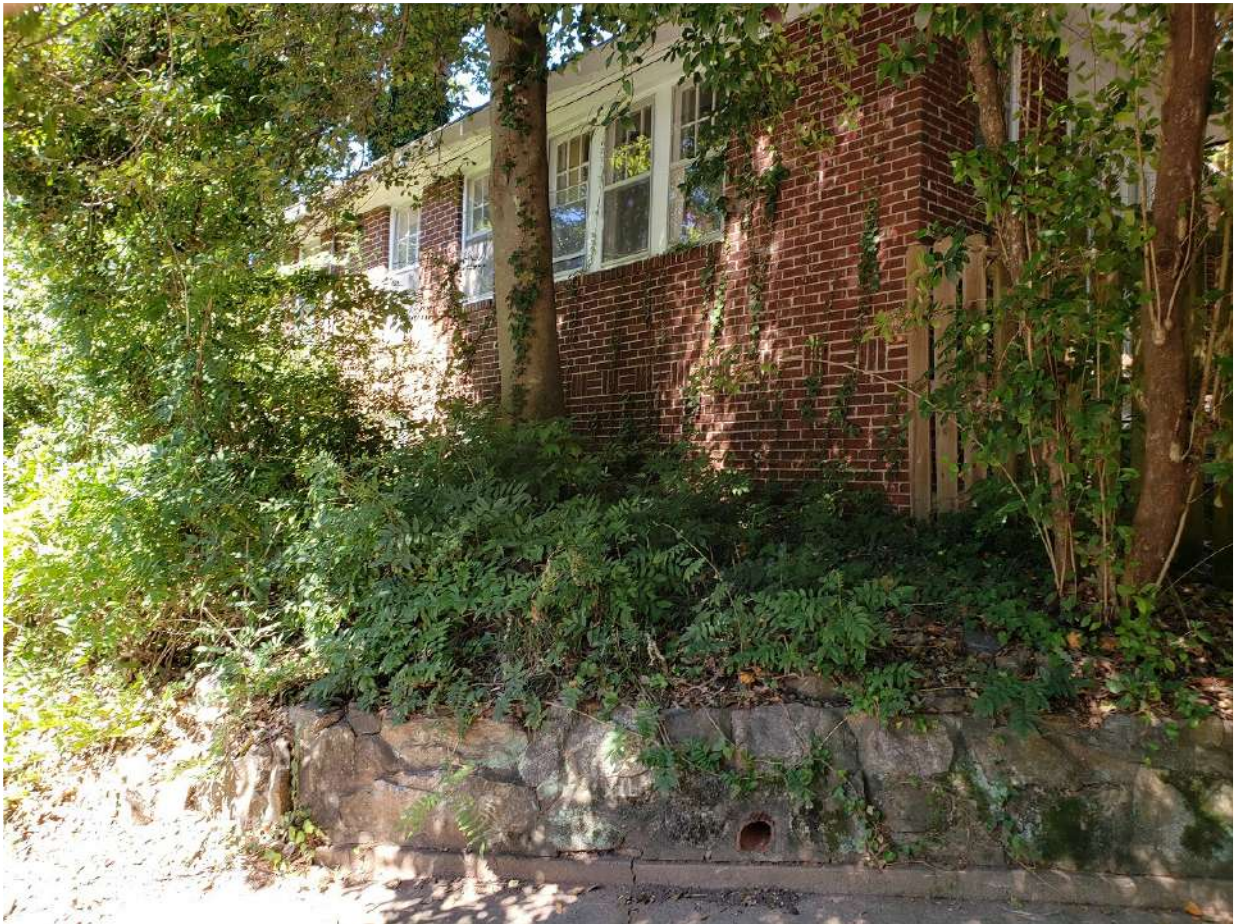
Rear corner of right side of home with damaging tree

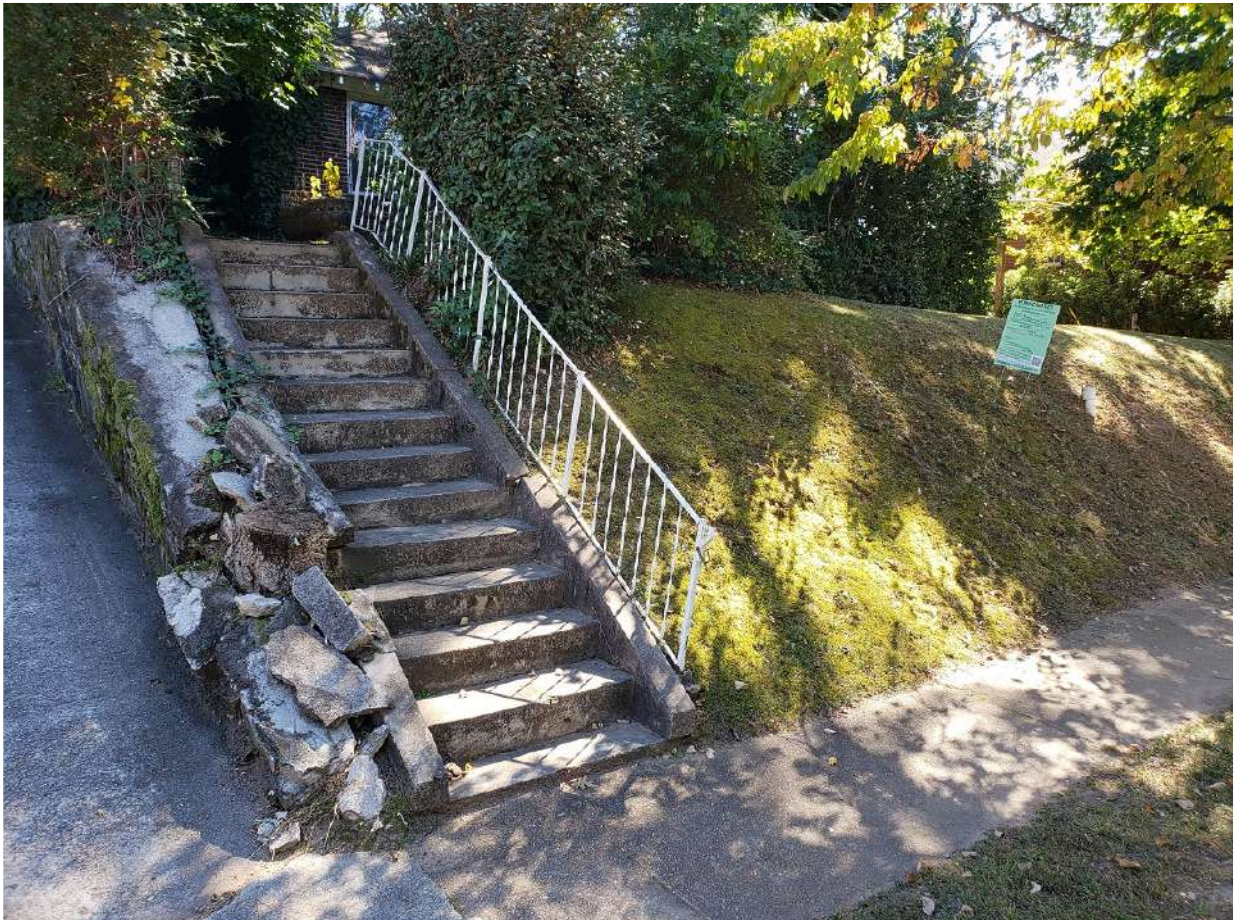
Front concrete stairs (repairs needed)

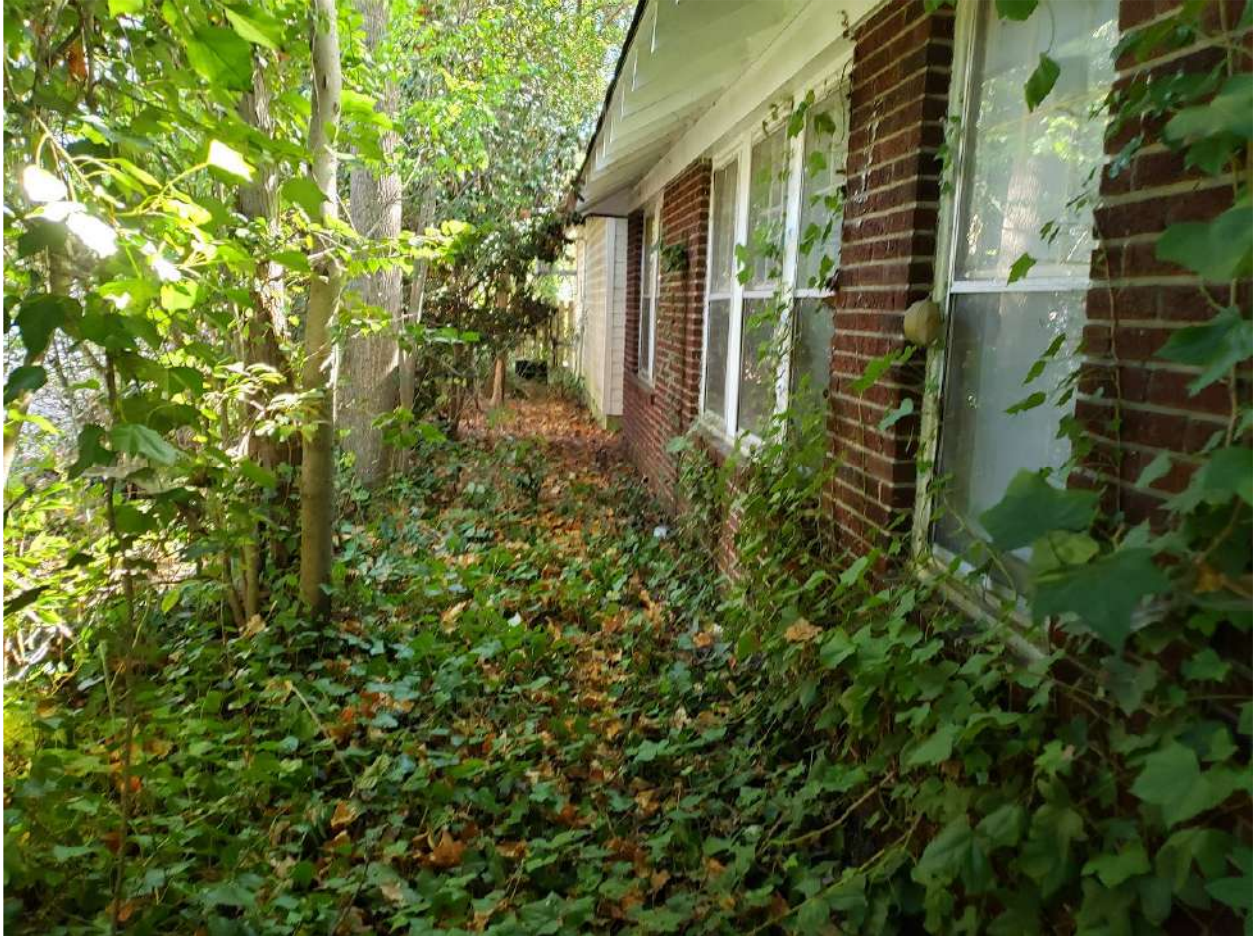
View from front of northern side yard – there is no water management

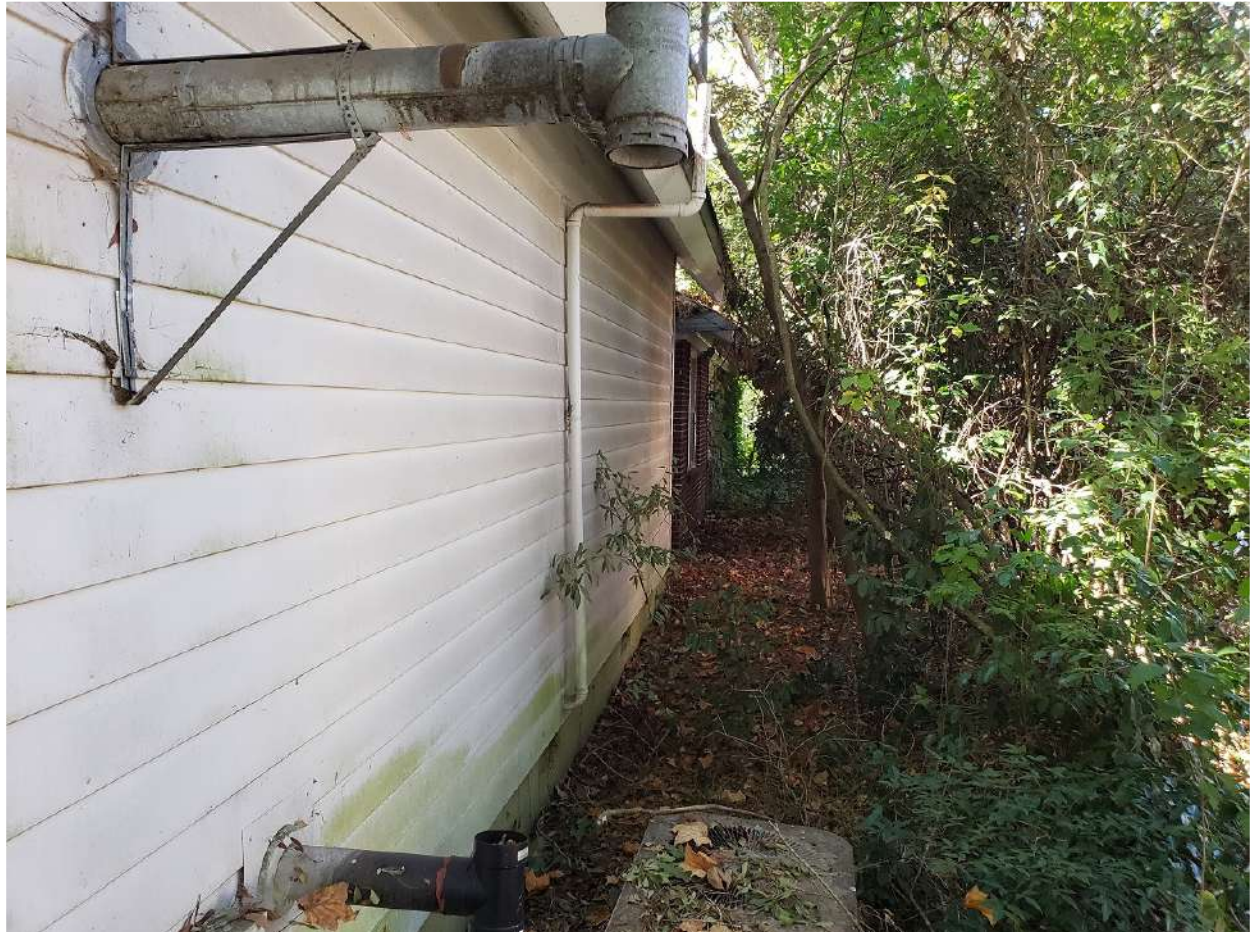
View from rear of northern side – construction of the addition may have prevented drainage from yard
