Andrew A. Baker, AICP **Application for Certificate of Appropriateness**

1853 North Decatur Road

# Request for Certificate of Appropriateness to Demolish Existing Structures

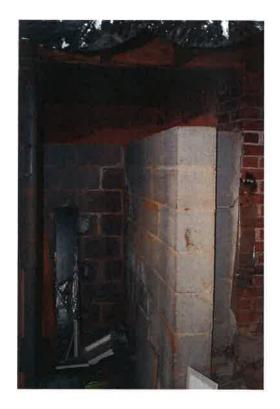
The photo to the right indicates persistent water intrusion under the original cavity stem walls and thru. the new CMU retaining wall

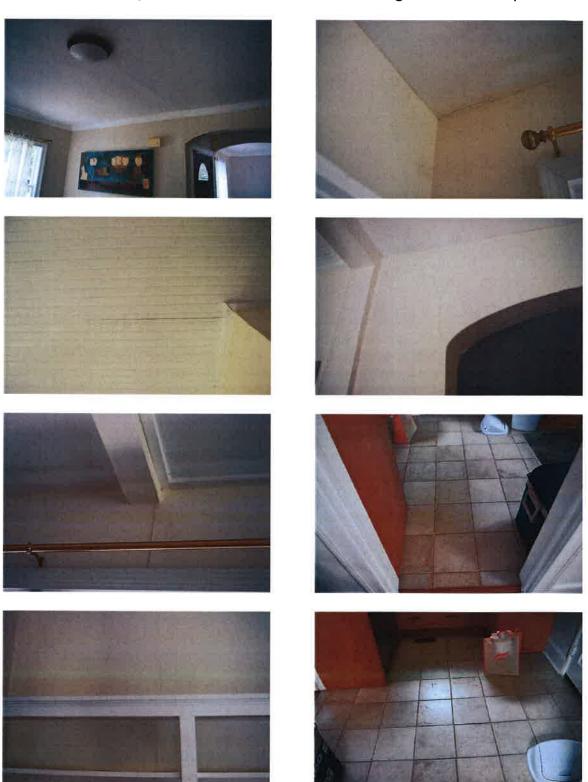
In addition to cracking of drywall/plaster, extensive damage can be seen in the tile flooring of the kitchen, and separation within the hardwood flooring due to structure movement.

Uneven floor joists can be seen and felt throughout the entry level.

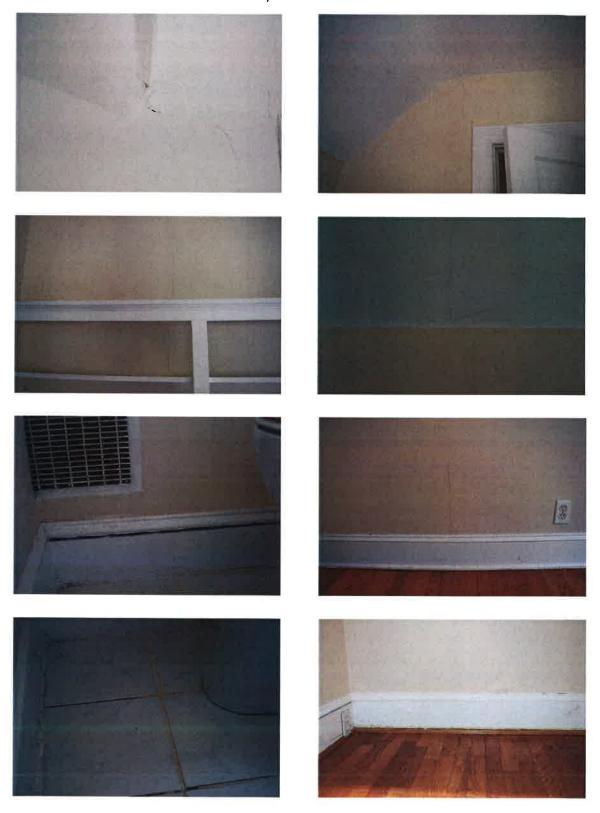
Walls on the upper-level present cracks over doorways, windows, and throughout walls in every room. Baseboard trim illustrates the movement of the floor joists below via gapping. Bathroom floor tiles have separated, unable to withstand the fluctuation of the over spanned floor joists below. Patching measures can be seen throughout that have already separated significantly in 3 years alone.
