Application for Certificate of Appropriateness

Address of Subject Property: 1080 Clifton Road NE, Atlanta, GA 30307

STRUCTURAL ASSESSMENT

1080 Clifton Road, NE

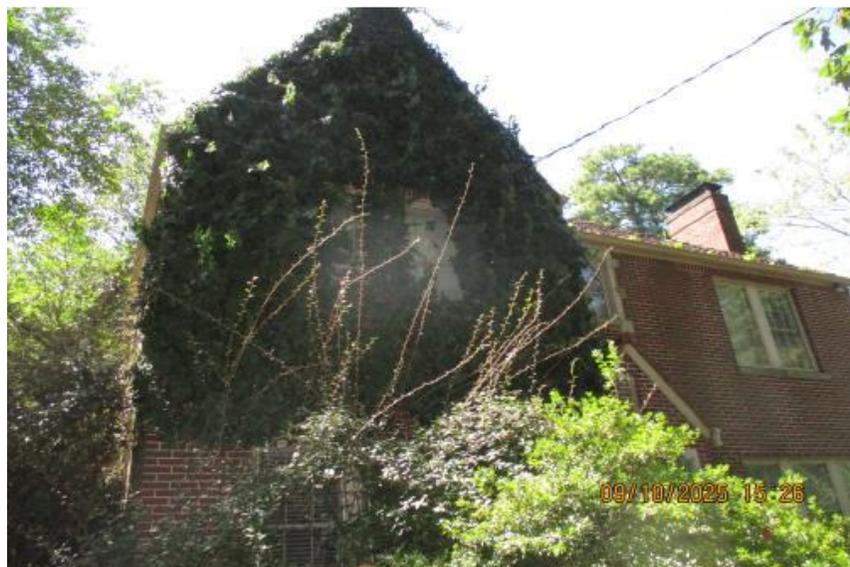
In the instant Application, the dilapidated single-family residence suffers from more than 20-years of acute neglect which occurred prior to the present owner’s acquisition of the Property. The Property is a 1920’s era brick structure in a state of advanced disrepair incapable of rehabilitation in any meaningful economically-viable repair which would cause significant financial hardship to the Property Owner which outweighs preservation, notwithstanding the opinions of the County-engaged engineers. *See* Figure 1 below.

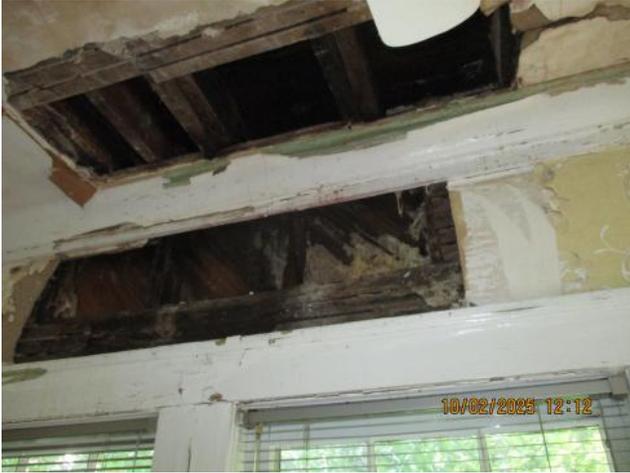
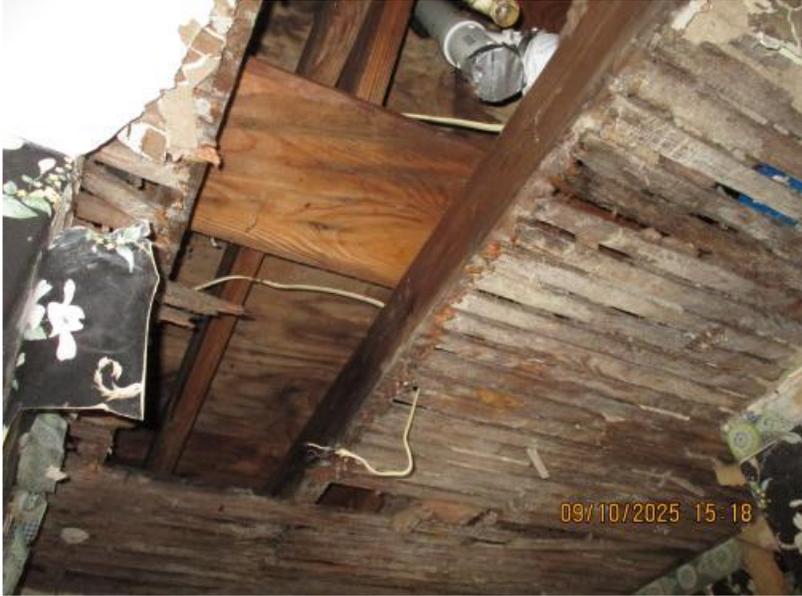
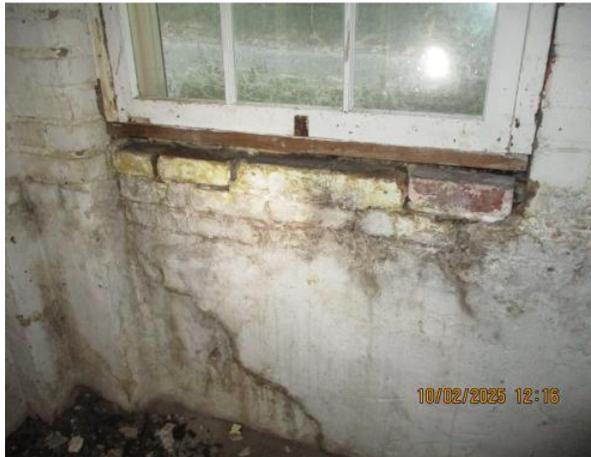
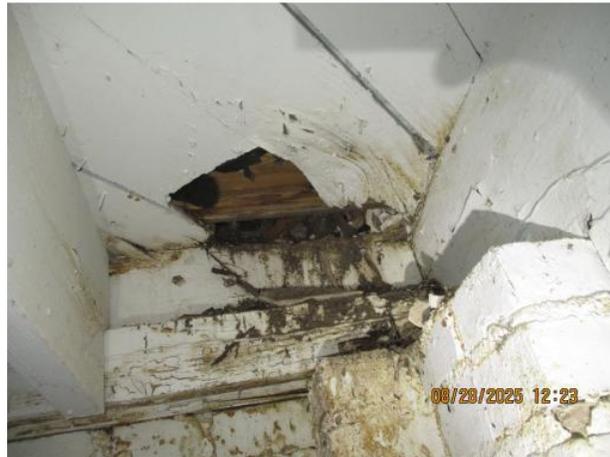
Water intrusion has been observed in the ceiling and exterior walls in the main floor kitchen, breakfast room, living room, dining room, stair landing, side porch, and the upstairs bedrooms. The plaster and lath has been removed in the areas with water stains, and the joists, wall studs, subfloor, wall plates, and sheathing that were exposed have extensive rot and deterioration and mold. Where the sheathing was rotted, no brick ties were observed for the brick. Indications of past termite damage has also been observed. Roof leaks have caused rot and mold in the decking, the exterior and interior walls, the ceiling joists of the upstairs bedrooms and the stair hall. In addition, water has penetrated the roofing material and several areas of the wood is completely destroyed. *See* Figure 2 below depicting various elements of damage to the structure.

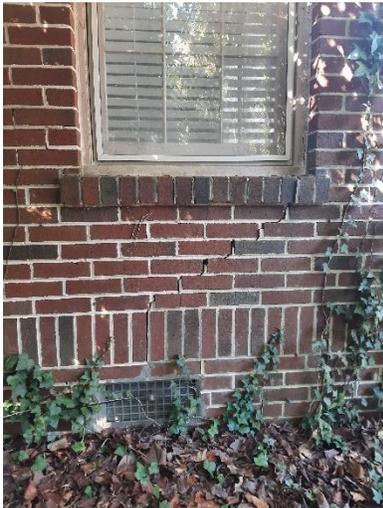
Photo 5
Stair-Step Crack (South Wall)

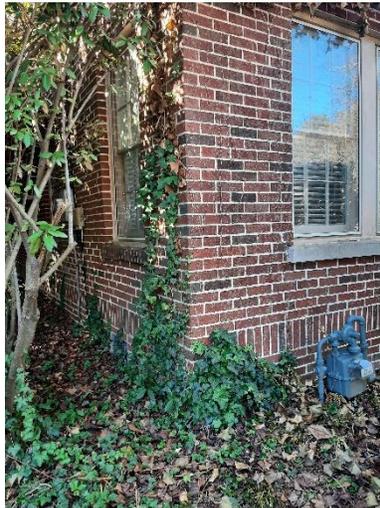
Photo 6
Stair-Step Cracks (SE Corner)

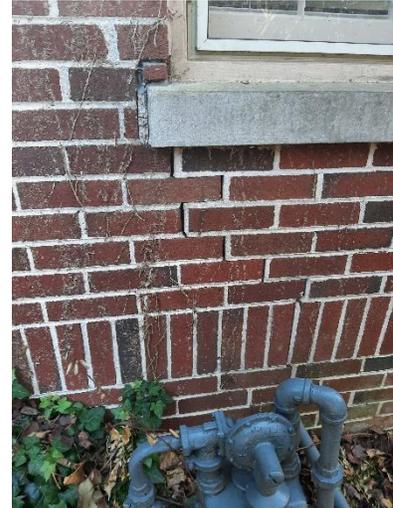
Photo 7
Stair-Step Crack (East Wall)

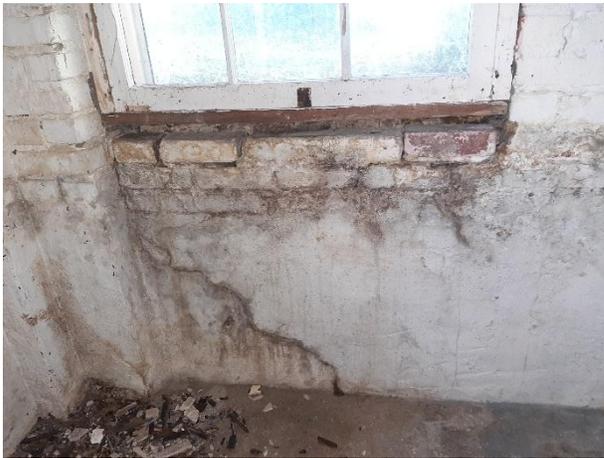
Photo 8
Stair-Step Crack at Basement

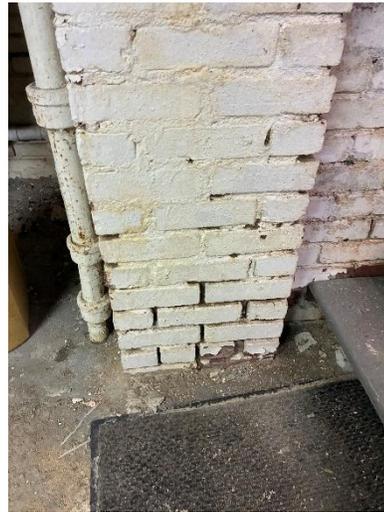
- ii. Loss of mortar / cracked mortar in some locations
 - 1. Ivy / vines growing on the wall can cause damage
- iii. Steel lintels supporting brick above windows show signs of rust, but no significant deflection or damage to adjacent brick
- b. The brick walls below grade appear to be in adequate condition with the following exceptions
 - i. Stair-step crack under window adjacent to driveway. See **Photo 8**.
 - ii. Loss of mortar in some locations. See **Photo 9**.
 - iii. Evidence of water leaks, primarily at windows and piping but some water intrusion / stains at other locations could be due to inadequate exterior waterproofing. See **Photos 10 through 12**.

Photo 9
Loss of Mortar at Brick

- i. Need to verify framing is adequate or if beam reinforcing / replacement is necessary. See **Rehabilitation Feasibility Section 2.a.**
 - d. Clean brick and repoint where necessary

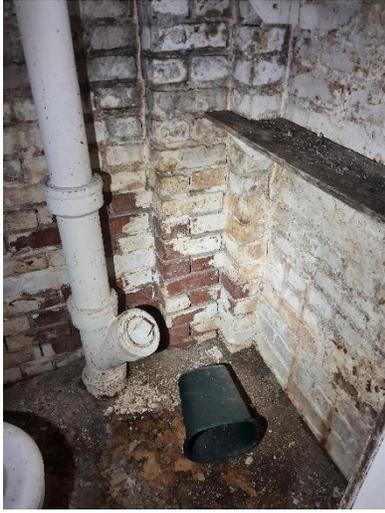
Photo 10
Water Leak Staining / Damage

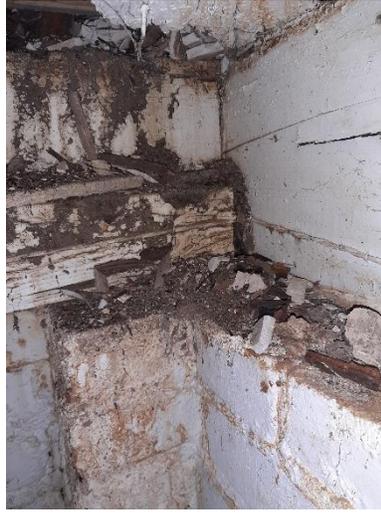
Photo 11
Water Leak Staining / Damage

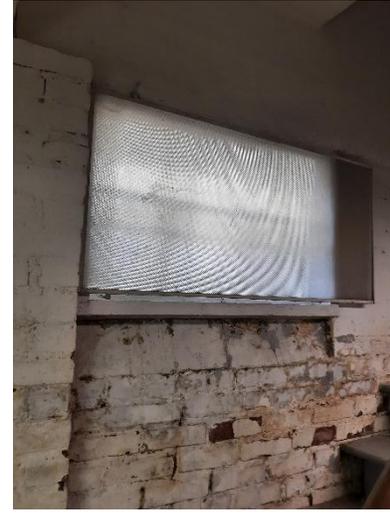
Photo 12
Water Leak Staining / Damage

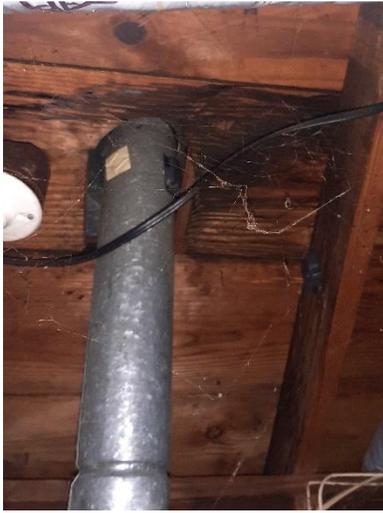
Photo 13
Water Damage at Vent

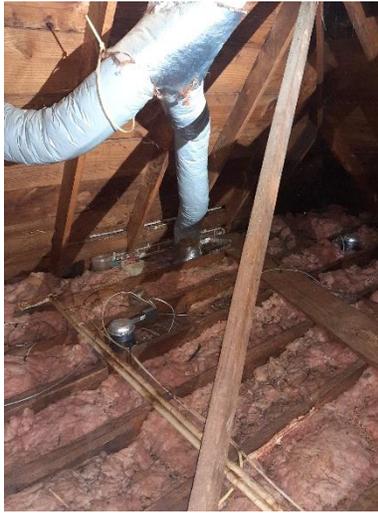
Photo 14
Containers to Collect Water

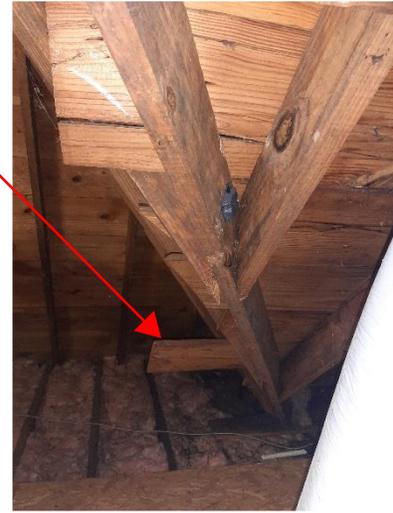
- i. Sykes was only able to observe the top side of the roof from the ground and recommends a specialist be engaged to inspect the existing clay tile roof for missing / damaged tiles and any other deficiencies.
- ii. The roof framing was visible in the attic and water intrusion was observed at the roof specifically around openings, the chimney, the low slope portions, and the perimeter. **See Photo 13.** Containers were placed in some locations presumably to collect water. See **Photo 14.**
- iii. At least one rafter at a valley was dislodged. **See Photo 15.**

Photo 15
Dislodged Roof Rafter

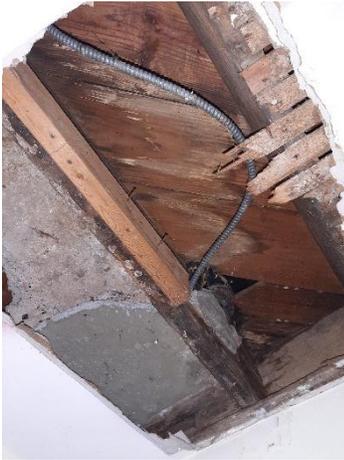
Photo 16
Damage at 2nd Floor Framing

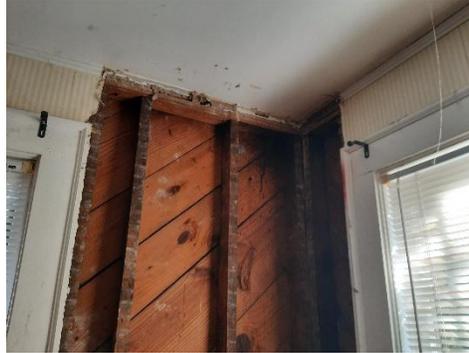
Photo 17
Second Floor Wall

- iv. Second floor wall framing was visible in the southeast bedroom. See **Photos 17 and 18**. The framing appeared to be in good condition; however, Sykes recommends a mold assessment. See **Public Safety Considerations** section.

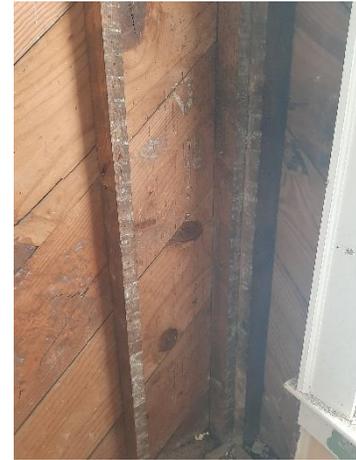
Photo 18
Second Floor Wall

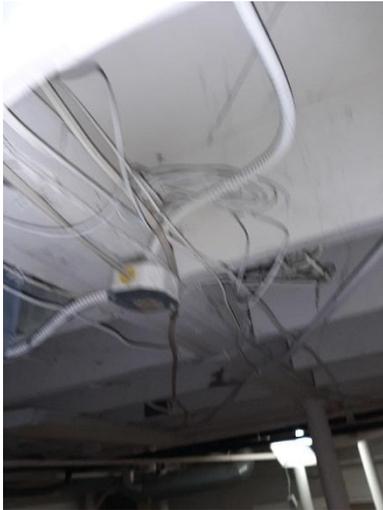
- ii. First floor framing was visible from the basement. See **Photo 25**.
 - 1. Floor joists are supported by wood ledgers. A few joists show cracking at the notch.
 - 2. The ledgers are nailed to beams / rim joists. Some ledgers have slight separation from the support member.
 - 3. There is floor damage directly below the northwest corner of the Breakfast Nook. See **Photo 26**. This damage extends from the roof to the basement in this location.
 - 4. Beams are supported by multiwythe brick or CMU walls, by other beams, or on columns.
 - a. No metal connectors were observed
 - b. The header beam at the stairs has been cut to allow for piping. See **Photo 27**.
 - c. Some beams at the columns show signs of crushing at the column caps. See **Photos 28 and 29**.

Photo 25
First Floor Framing

- i. The basement wall adjacent to the driveway, the rear of house at basement windows, and the exterior basement entry require particular attention
 - c. Updating first floor framing at posts (replace damaged column and add larger column caps), additional attachments at ledgers, repair at overcut joists

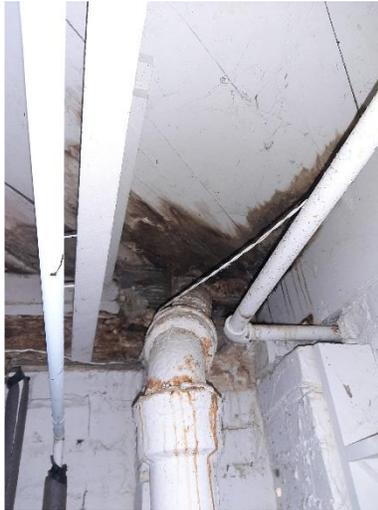
Photo 26
Floor Damage below Breakfast Nook

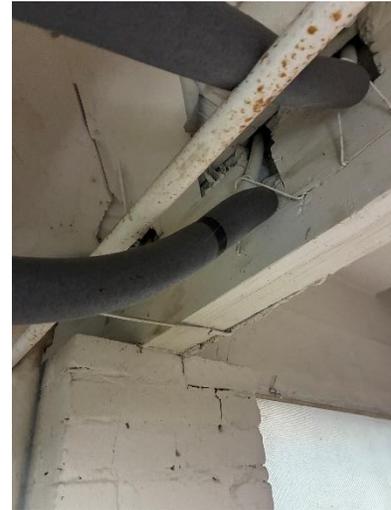
Photo 27
Header Beam at Stair Opening

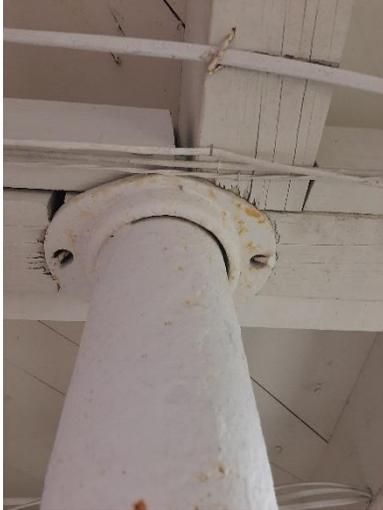
- 1. The top of the pipe columns have separate cast caps with two holes for nails to be fastened to the beams above. See **Photos 28 through 30**.

Photo 28
Top of Pipe Column

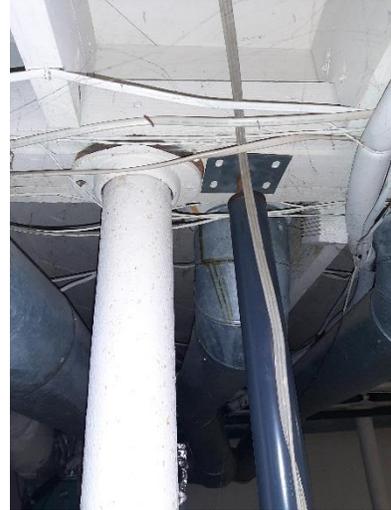
2. One column has an adjacent shoring post. The bottom of the beam is at least 1/2 inch above the column cap, so the column is no longer load bearing. A slight indentation is visible where bearing occurred indicating compression of the wood possibly due to inadequate bearing area. See **Photos 29 and 30**.

Photo 30
Top of Pipe Column
With Adjacent Shoring Post

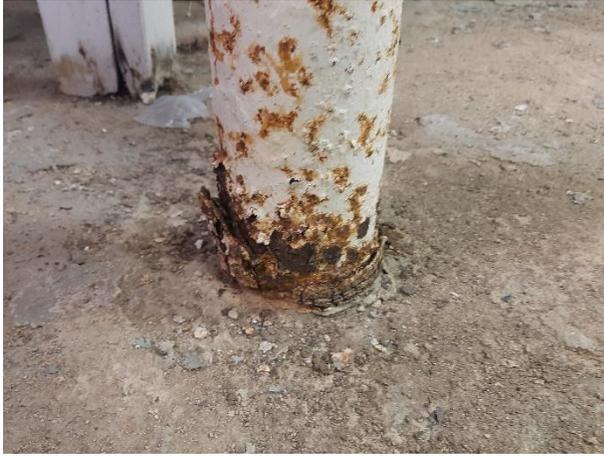
- f. Foundations / Basement / Crawlspace
 - i. Foundations could not be assessed since they are below grade and would require excavation to expose them.
 - ii. See **Structural Assessment Section 2.b** for exterior multiwythe brick walls below grade.
 - iii. Columns
 1. The bottoms of the columns are rusted. Some are in extremely poor condition with significant loss of section. See **Photos 31 and 32**.
 2. The column foundations are unknown.
 3. One column has an adjacent shoring post. See **Photos 30 and 32**.

Photo 31
Rusted Bottom of Column

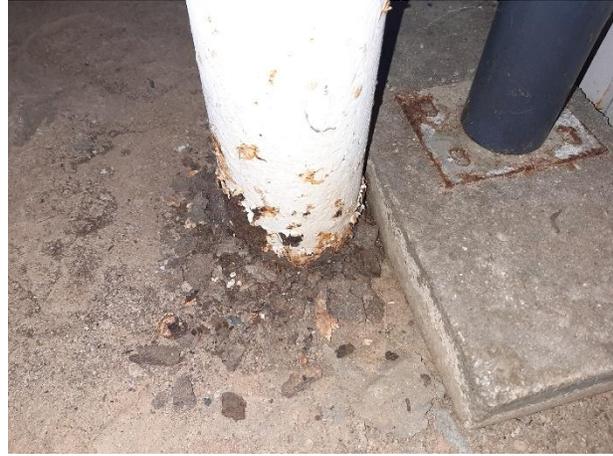
Photo 32
Rusted Bottom of Column at Adjacent Shoring Post

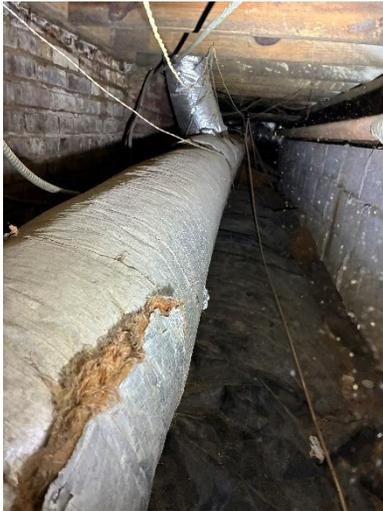
1. The accessible portion of the crawlspace (under the front patio) was dry at the time of Sykes' visit. Some localized water stains were observed on the exterior brick wall and the interior CMU wall. See **Photos 33 through 35**.

Photo 33
Crawlspace

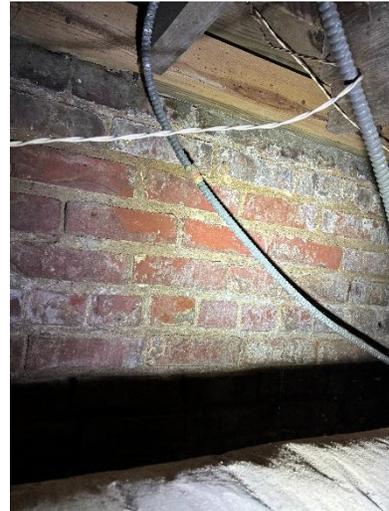
Photo 35
Exterior Wall at Crawlspace

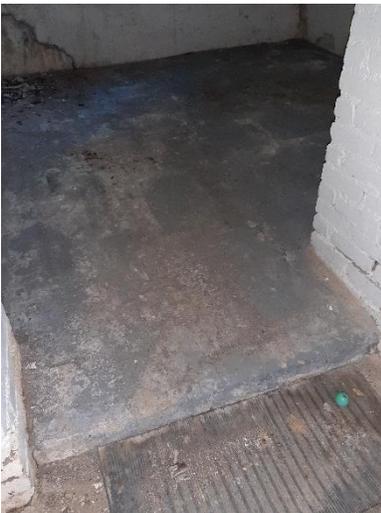
- v. Slab on Grade
 - 1. The thickness of the slab on grade is unknown.
 - 2. No standing water at the time of Sykes' site visit; however, there is damage to the slab on grade due to continuous water intrusion and prior patching. See **Photos 36 and 37**.
- vi. Exterior Entrance
 - 1. There is an exterior entrance to the basement that allows water to enter. See **Photo 38**.
- vii. A mold assessment is recommended. See **Public Safety Considerations** Section

Photo 36
Slab on Grade

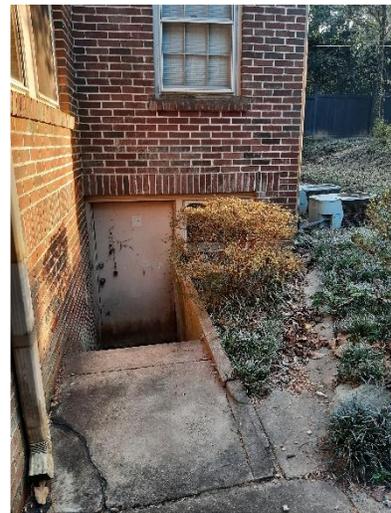
Photo 38
Exterior Basement Entrance

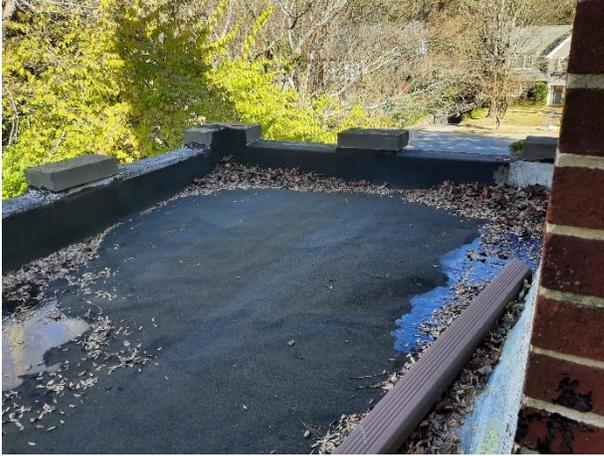
Photo 39

- g. Sunroom / Enclosed Porch
 - i. This area shows the most damage to the structure.
 - ii. The roof over the Sunroom / Enclosed Porch shows extensive signs of water intrusion with damaged and rotten roof joists. The framing over the window on the north side is damaged and rotten with mold growing. See Photos **39 through 42**.

Roof of Sunroom / Enclosed Porch

- i. Roof over sunroom would need to be completely redone. There is significant damage to the wood where the roof has leaked
 - b. Sykes recommends a roof assessment for main building. The corner of the roof over the private bathroom on the second floor and the breakfast nook on the first floor shows signs of significant water leaks. This low slope portion of the high roof does not appear to have the typical clay tile that was observed on the rest of the high roof. Damage to the framing from water leaks was also observed at framing near the chimney.

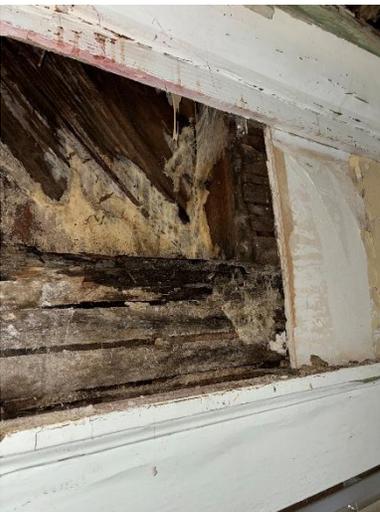
Photo 41

Mold / Rot over North Window at Sunroom / Enclosed Porch

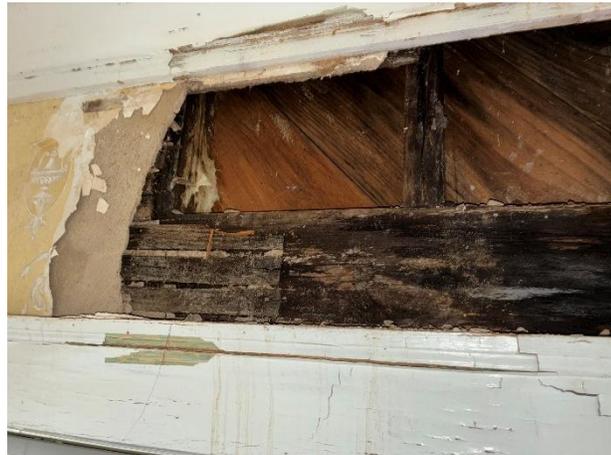
Photo 42

Rotten Framing over North Window at Sunroom / Enclosed Porch

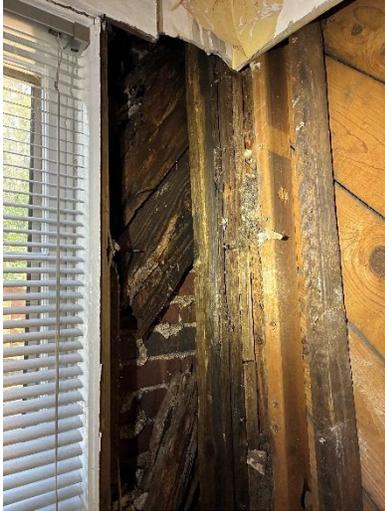
- iii. The wall in the northwest corner has extensive damage and rot. Some of the wall studs and exterior diagonal sheathing have partially rotted away and the exterior brick veneer is visible. See **Photos 43 through 45.**
- iv. The floor shows signs of water damage but most of the framing below appears sound. See **Photos 46 and 47.**

Photo 43
Northwest Corner Framing
At Sunroom / Enclosed Porch

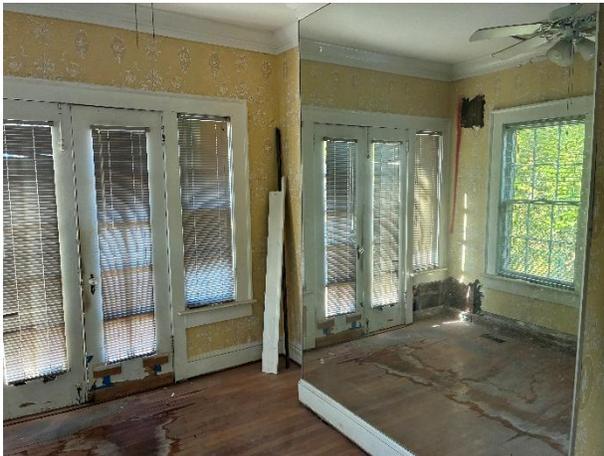
Photo 46
Water Damage at Floor of
Sunroom / Enclosed Porch

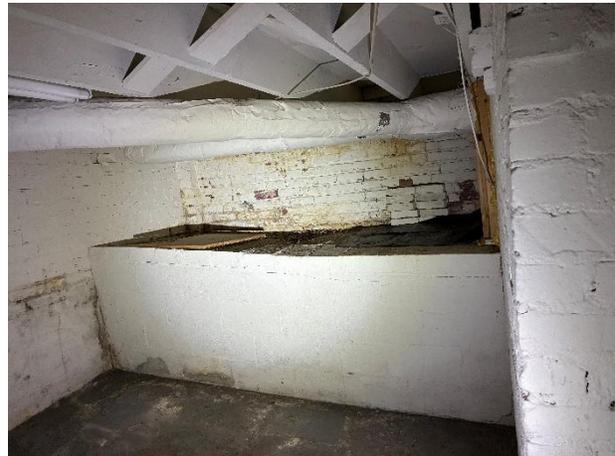
Photo 47
Basement Below Sunroom / Enclosed Porch
Showing Floor Framing
