## EXHIBIT 4 Site Photos

## Appendix –Photos (Existing condition)

<b>Client Name:</b> DeKalb County, Department of Watershed Management	<b>Site Location:</b> Scott Candler WTP Electrical Building # 2	<b>Contact / Task No.</b>
--	--	---------------------------

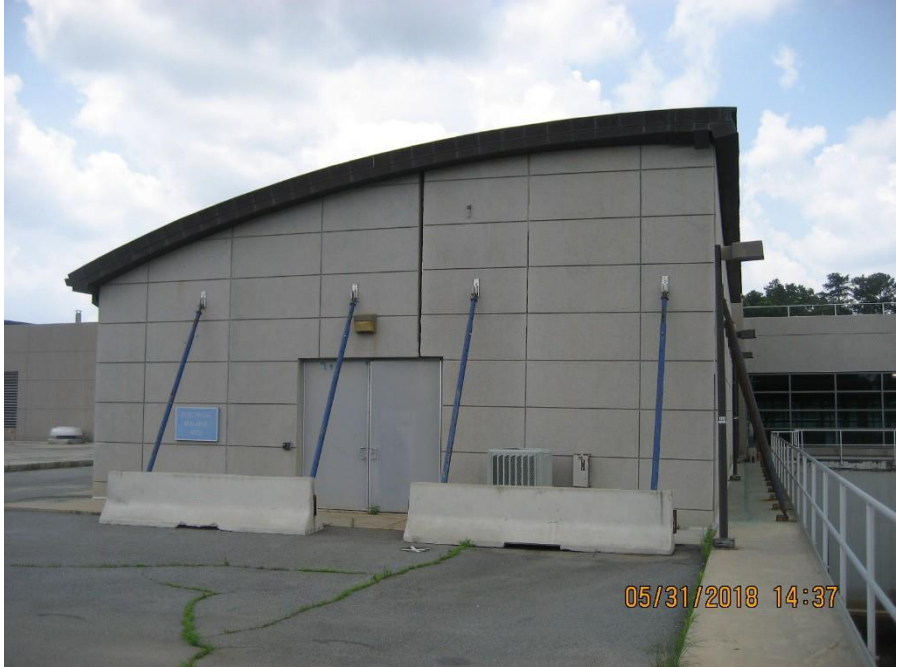
<b>Photo No.</b> 1	<b>Date:</b>

<b>Description:</b> Exterior of South Wall showing Precast Panel Separation at Expansion Joint.

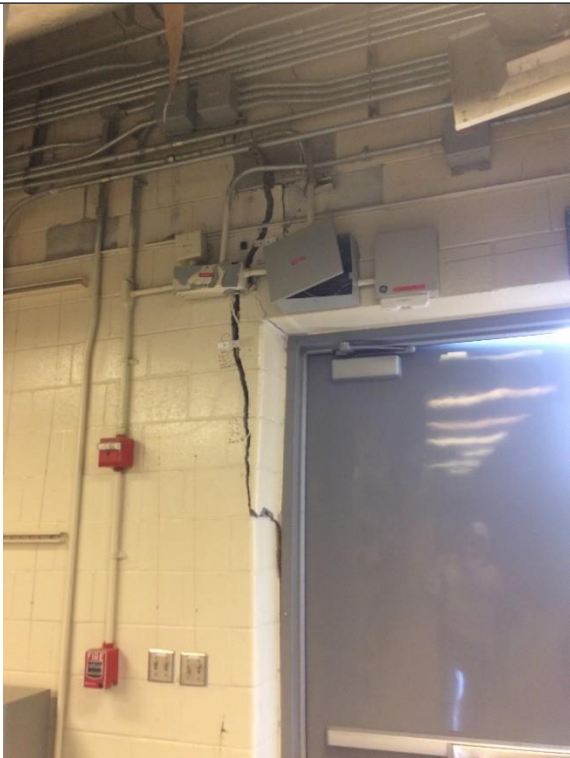
<b>Photo No.</b> 3	<b>Date:</b>
<b>Description:</b> Masonry Door Jamb cracking at double door (South Wall).

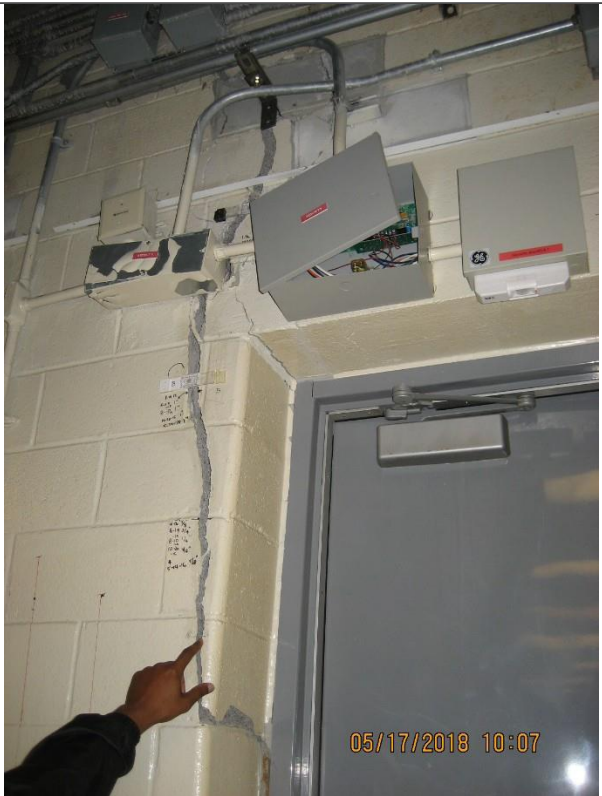
<b>Photo No.</b> 4	<b>Date:</b>
<b>Description:</b> Masonry Door Jamb cracking at double door (South Wall).

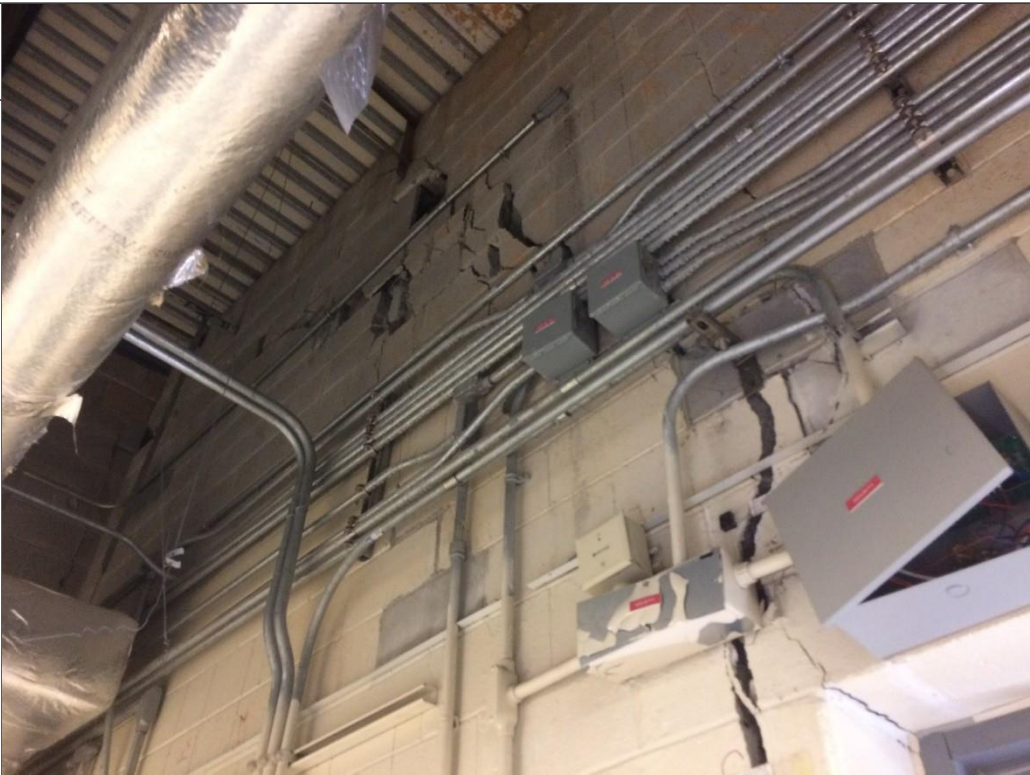
<b>Photo No.</b> 5	<b>Date:</b>
<b>Description:</b> Gable End (South Wall) Masonry cracking.

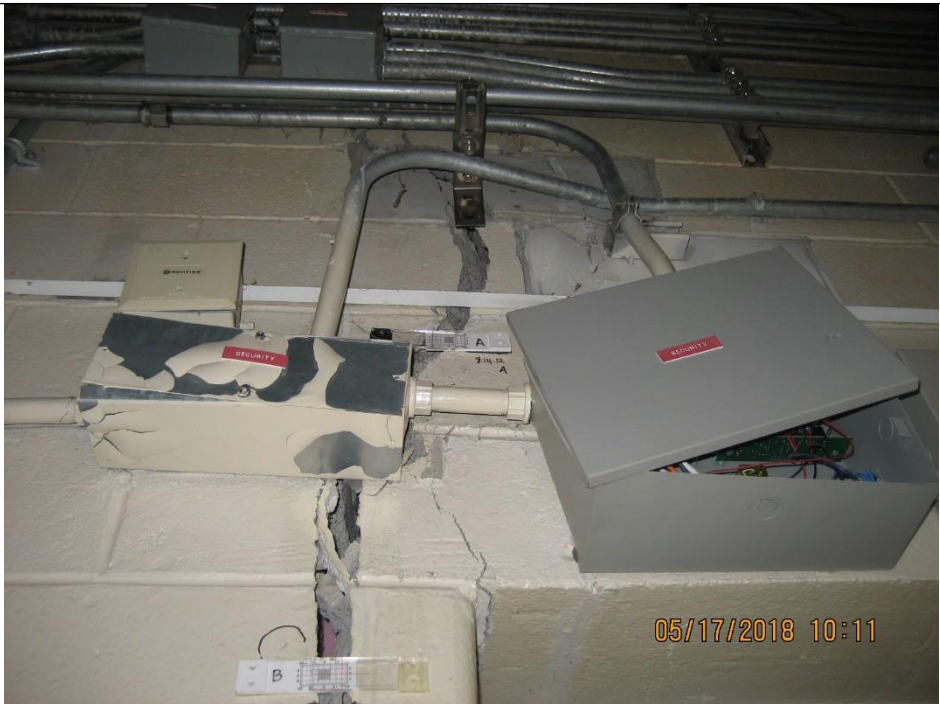
<b>Photo No.</b> 6	<b>Date:</b>
<b>Description:</b> Gable End (South Wall) Masonry cracking.

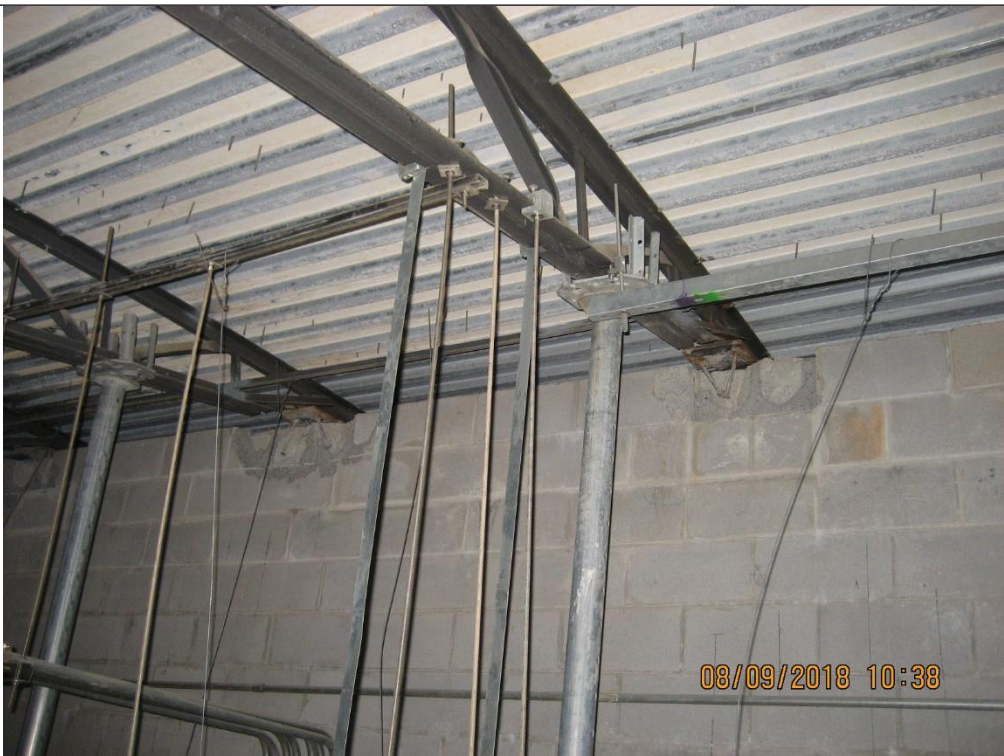
<b>Photo No.</b> 7	<b>Date:</b>
<b>Description:</b> Damaged Truss Bearing at East Wall.

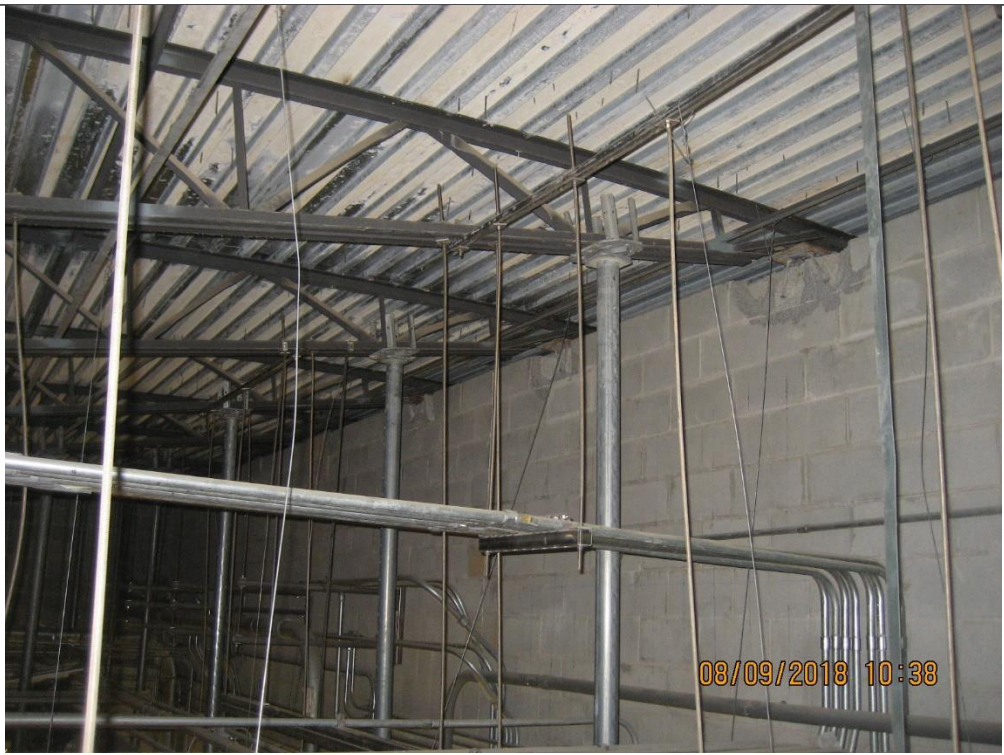
<b>Photo No.</b> 8	<b>Date:</b>
<b>Description:</b> Temporary roof support and Damaged Truss Bearing at East Wall.

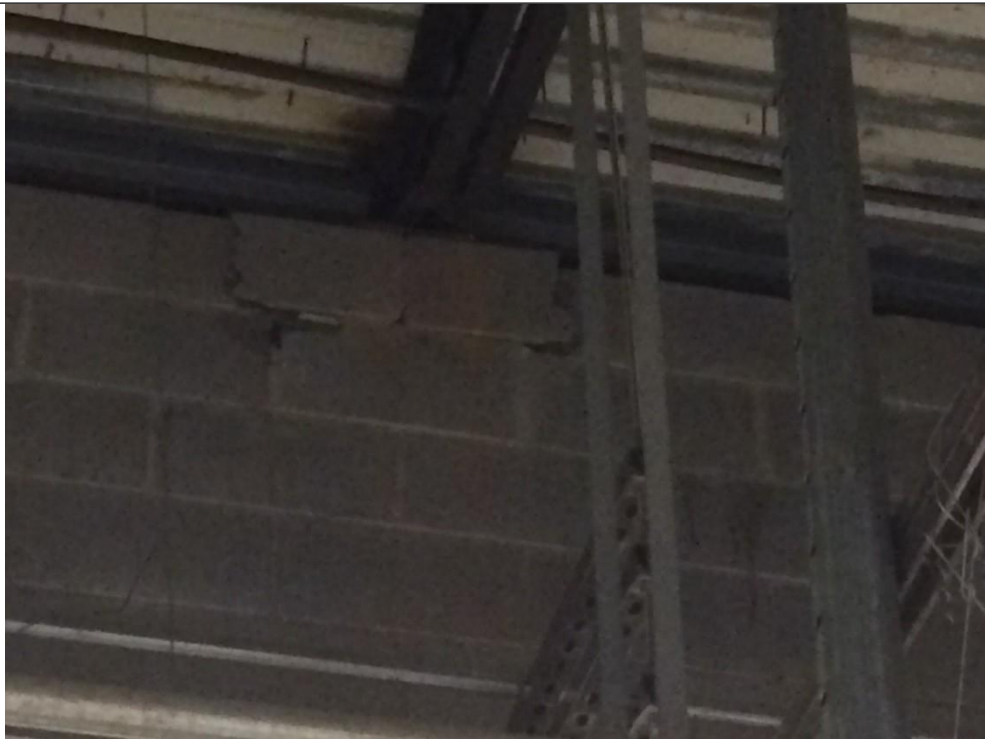
<b>Photo No.</b> 9	<b>Date:</b>
<b>Description:</b> Damaged Truss Bearing at East Wall.

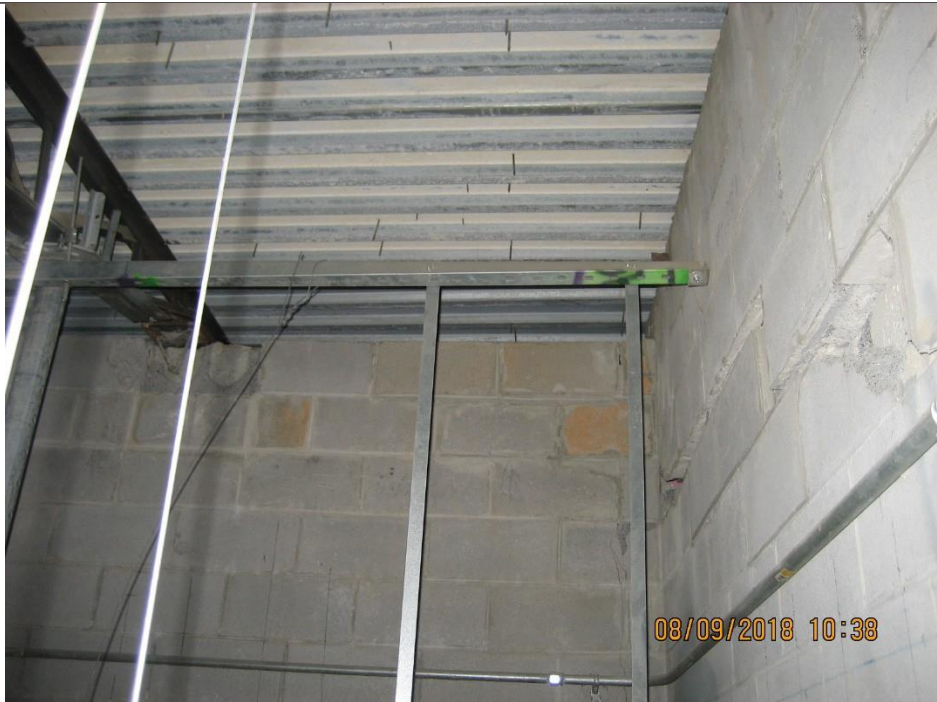
<b>Photo No.</b> 10	<b>Date:</b>
<b>Description:</b> Damaged Truss Bearing at East Wall and damaged interior non-load bearing partition wall.

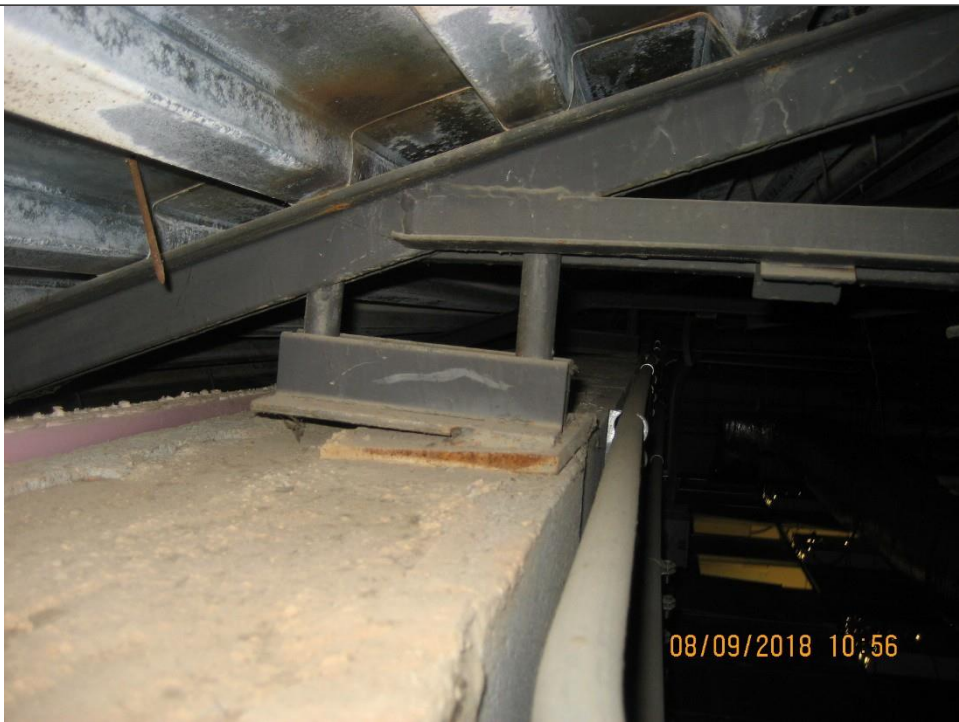
<b>Photo No.</b> 11	<b>Date:</b>
<b>Description:</b> Existing Truss Bearing shows gap at top of masonry wall.

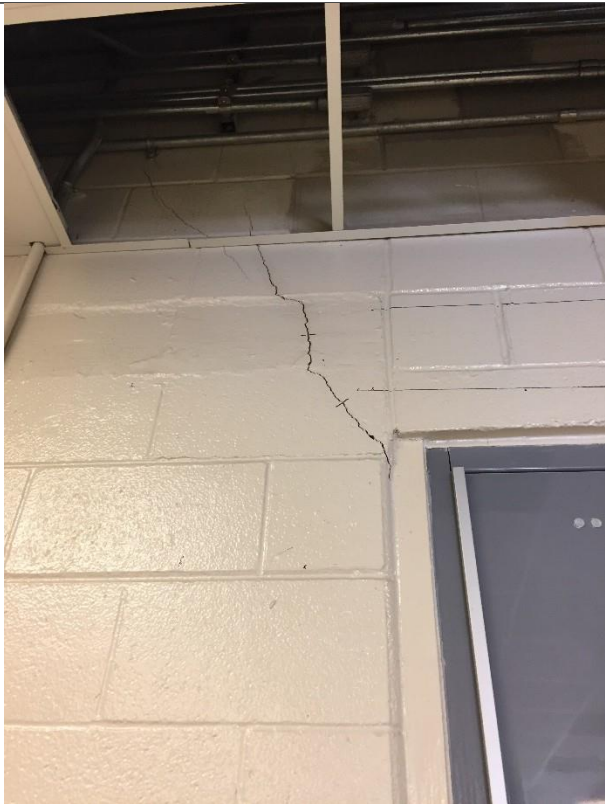
<b>Photo No.</b> 12	<b>Date:</b>
<b>Description:</b> Damaged interior non-load bearing partition wall.

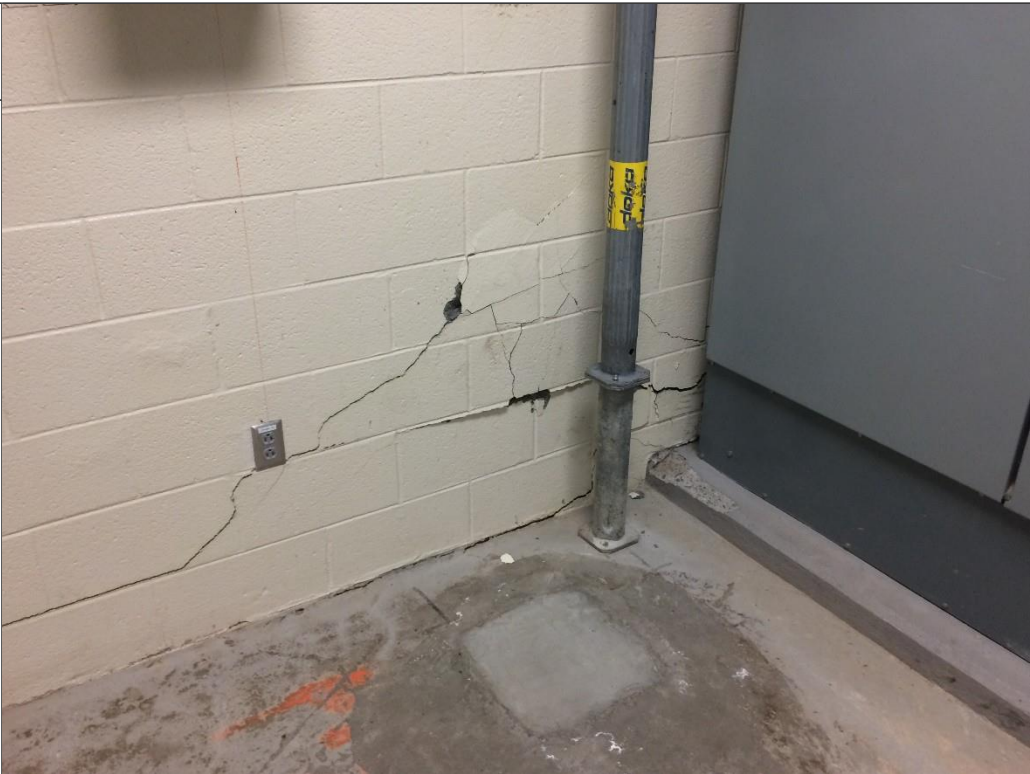
<b>Photo No.</b> 13	<b>Date:</b>

A photograph showing a corner of a room with a light-colored cinder block wall. A significant vertical crack runs down the wall, starting from the top and extending to the floor. A grey metal pipe runs vertically along the wall. To the right, a grey door is partially visible. The floor is concrete and shows some staining.
<b>Description:</b> Damaged interior non-load bearing partition wall.

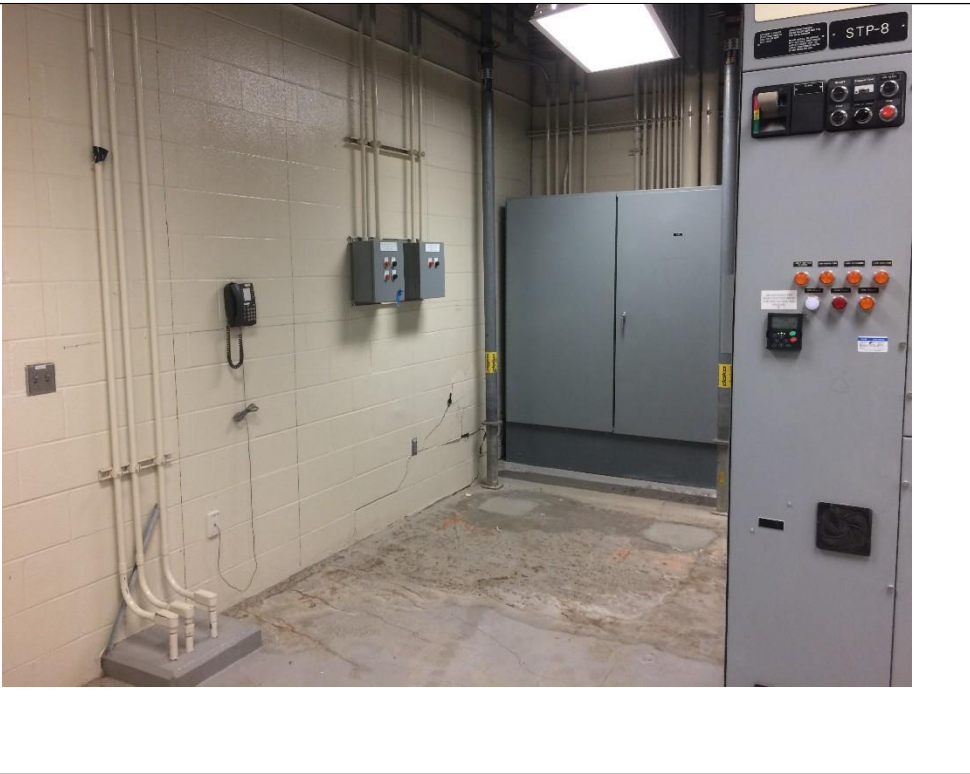
<b>Photo No.</b> 14	<b>Date:</b>

A photograph of an electrical room. The wall is made of light-colored cinder blocks and shows signs of damage, including a crack and a hole. Several white pipes run vertically along the wall. A black telephone is mounted on the wall. In the background, there are large grey electrical cabinets. On the right side of the image, a tall grey electrical panel is visible with various switches and indicators. The floor is concrete and appears worn.
<b>Description:</b> Damaged interior non-load bearing partition wall.

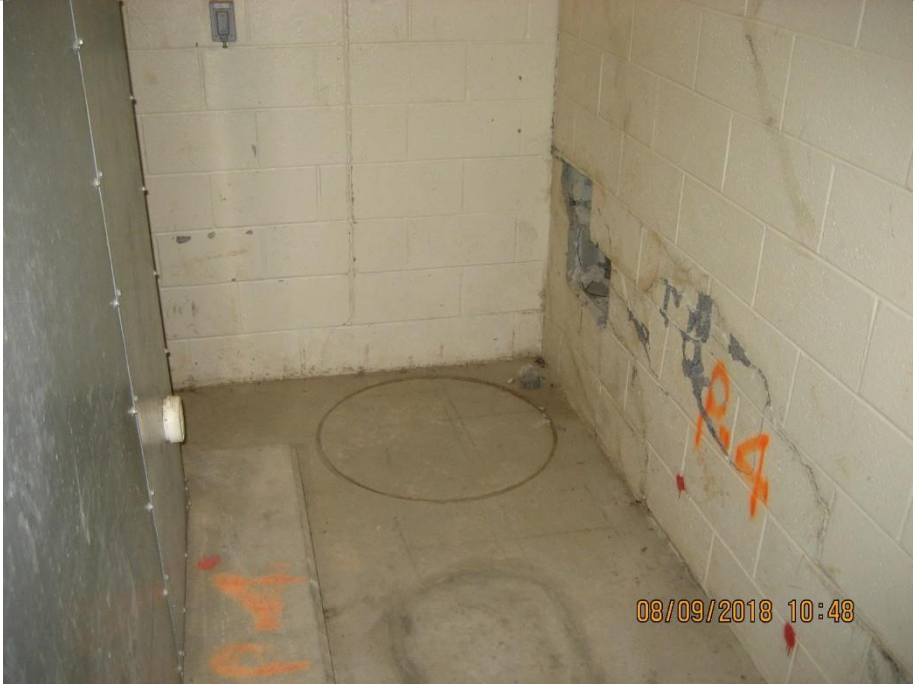
**Photo No.**  
15

**Description:**  
Damaged interior non-load  
bearing partition wall at East Wall  
Junction.
