1750 Hummingbird Lane Existing House

Inspection Report

Property Address:
1750 Hummingbird Ln NE
Atlanta GA 30307

Home Sweet Home Inspections LLC

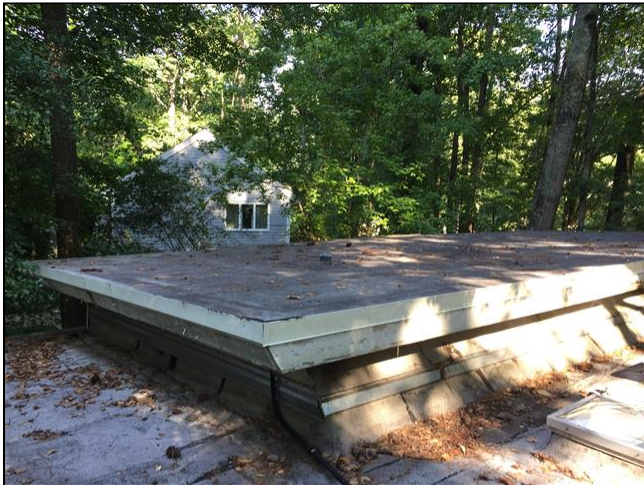
1.0 Item 1(Picture)

1.0 Due to the age and condition of the roof covering, it is recommended that the roof covering be replaced. There are many cracks and bulges in the covering. The average life expectancy of roll roofing is 5-10 years.

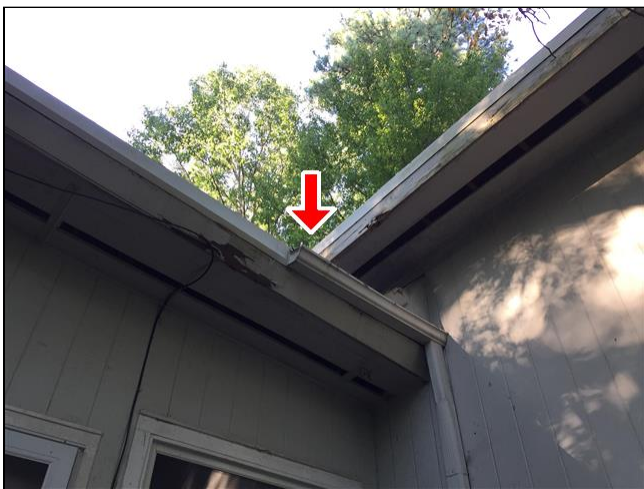
1.3 Item 1(Picture)

1.3 I recommend adding diverter flashing to the areas where the roof meets the siding. These are small metal pieces that help to direct water away from the siding which will lengthen the lifespan of the siding. These can be installed by a qualified roofing or gutter contractor.

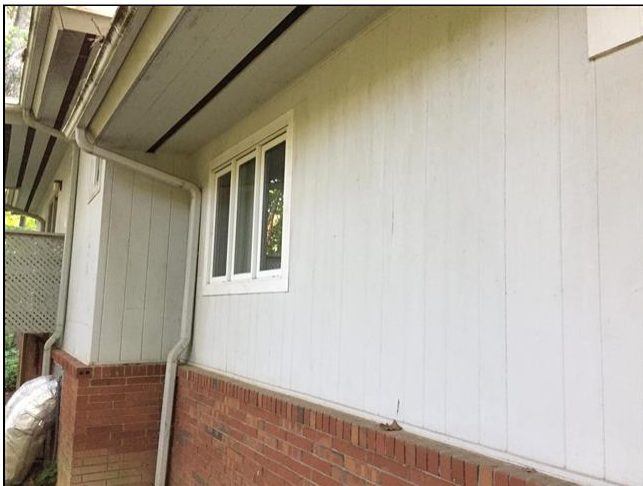
2.0 Item 1(Picture)

2.0 The wood siding appears to be painted with a lead-based paint. Lead-based paint has known health hazards. If the paint is removed it will need to be performed by an EPA certified lead-abatement specialist. In some areas, the siding may be able to be painted over without removal. Replace any water damaged siding and repaint all areas that are missing paint. Further review is recommended by a qualified siding contractor.

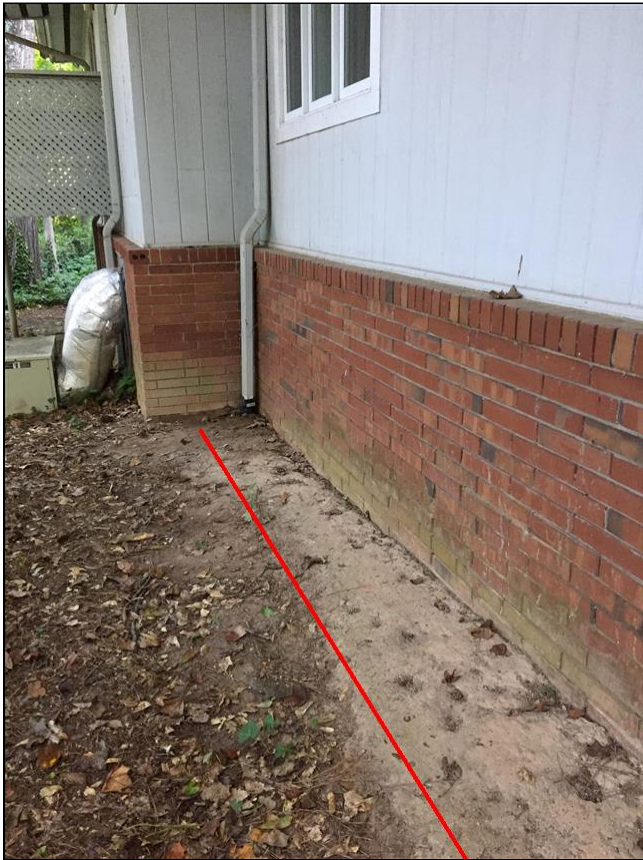
2.3 Item 1(Picture)

2.3 (1) Due to a lack of positive grade away from the foundation of the home, adding a french drain along the perimeter will help to avoid soil erosion and keep the foundation stable over time. This can be done by a qualified handyman or landscaping contractor.

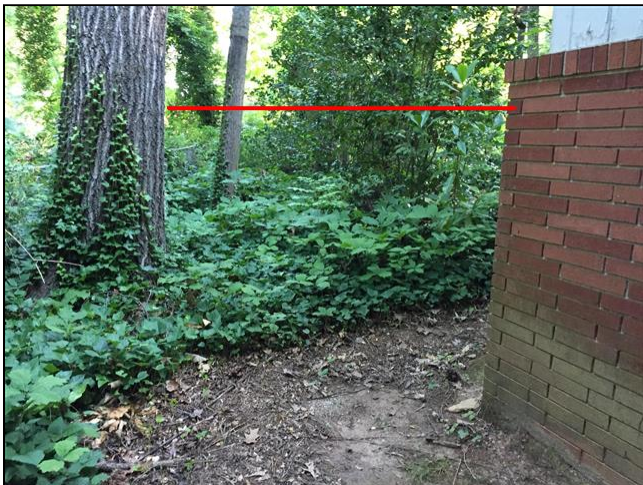
2.3 Item 3(Picture)

(2) Mature trees within 12' of the home can disrupt the foundation of the home. If any signs of structural movement occur in the future (in this area) I recommend further evaluation by a structural contractor. Due to the number and age of trees around the home, it is recommended that a qualified arborist diagnose the health of the trees.

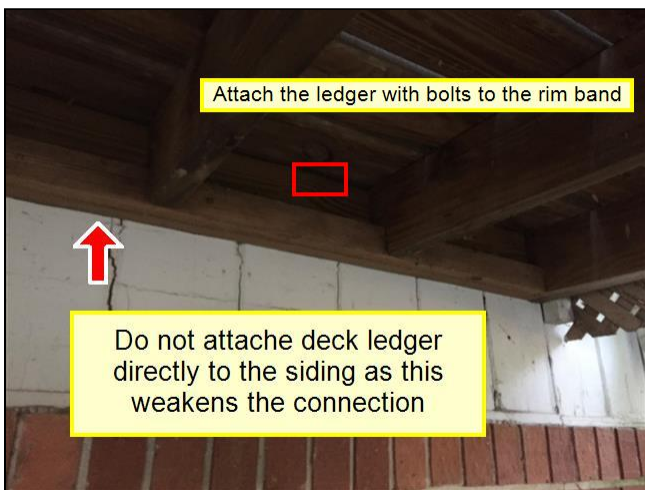
2.4 Item 1(Picture)

2.4 I recommend the following repairs to the deck. These repairs can be made by a qualified decking contractor.

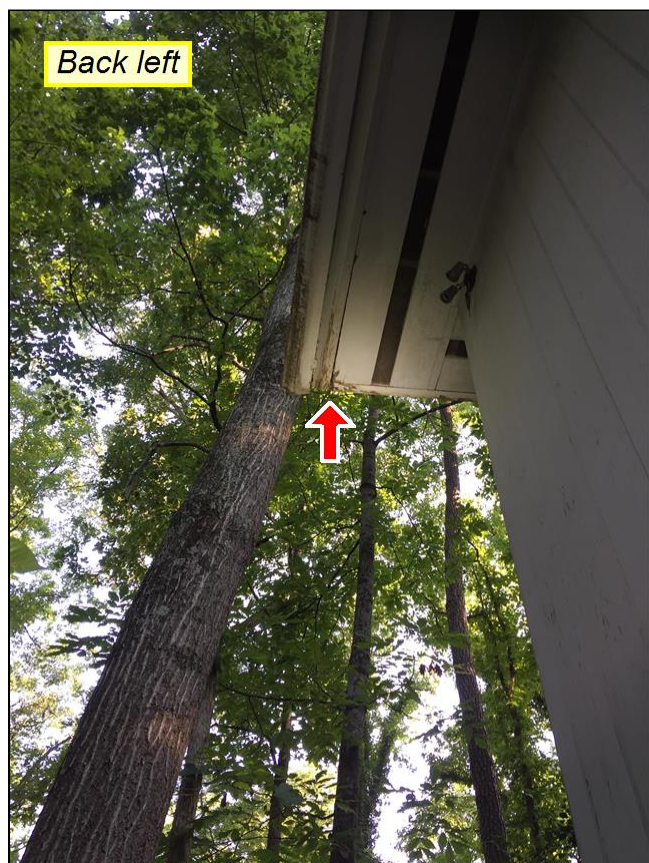
2.5 Item 1(Picture)

2.5 The fascia trim beneath the gutters are damaged from rain water. I recommend repair or replacement and regular cleaning of the gutters to prevent water and debris build up, which can become trapped behind the gutters and damage the trim.

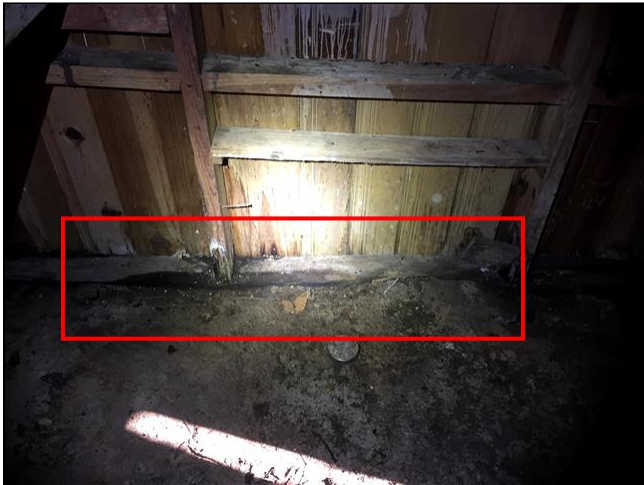
3.0 Item 1(Picture)

3.0 (1) There is significant water damage to the carport shed. To ensure the integrity of the structure over time, it is recommended that the shed be rebuilt by a qualified structural contractor.

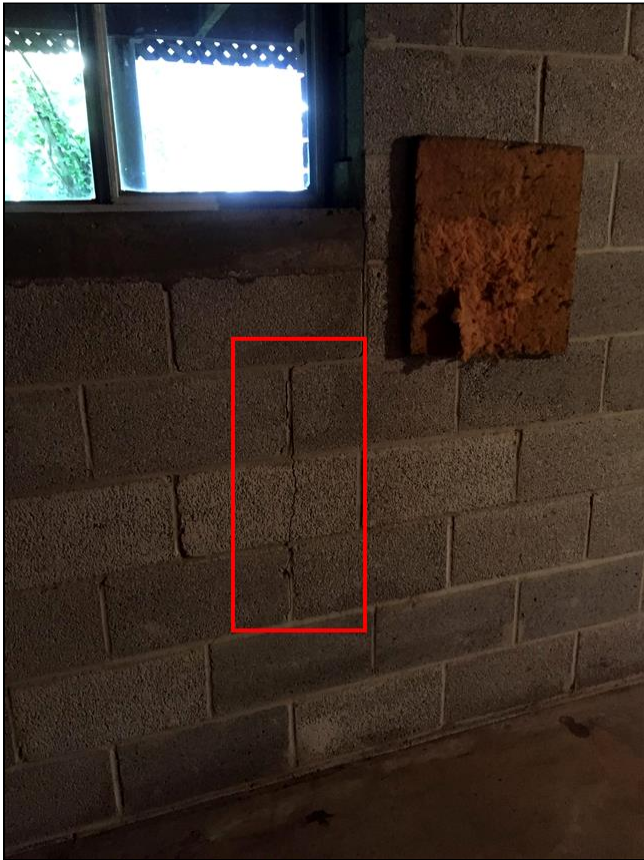
3.0 Item 5(Picture)

(2) Hairline cracks were observed in the foundation of the add-on structure. I recommend regularly observing the areas to look for signs of structural movement. Due to the pattern and number of the cracks, further review by a qualified structural contractor.

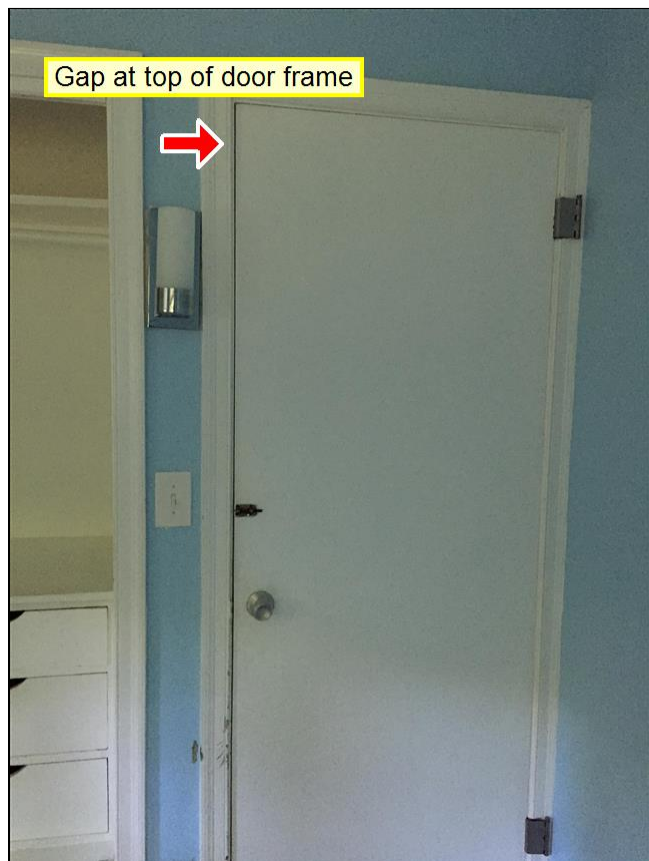
3.3 Item 1(Picture)

3.3 Much of the foundation slab was not visible for inspection due to the presence of floor coverings. The slab in the living room and tile in the front bathroom is sloped. This, in conjunction with the presence of cracks in the walls/ceilings and out of frame interior doors, indicate structural movement. More invasive inspection is needed to determine if there are cracks in the slab and if the movement is active.

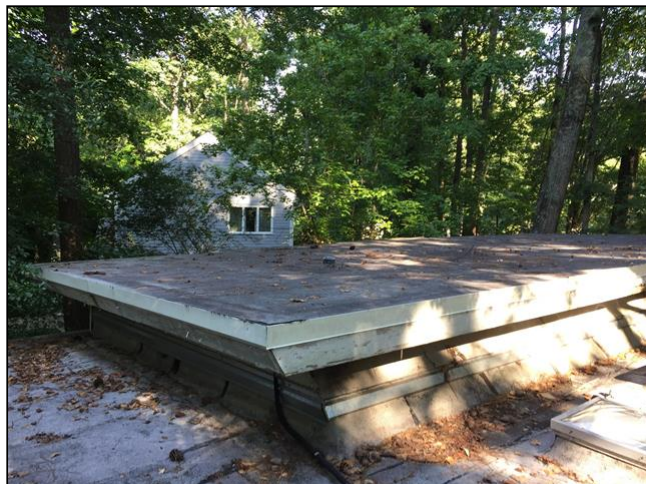
1.0 Item 1(Picture)

Due to the age and condition of the roof covering, it is recommended that the roof covering be replaced. There are many cracks and bulges in the covering. The average life expectancy of roll roofing is 5-10 years.

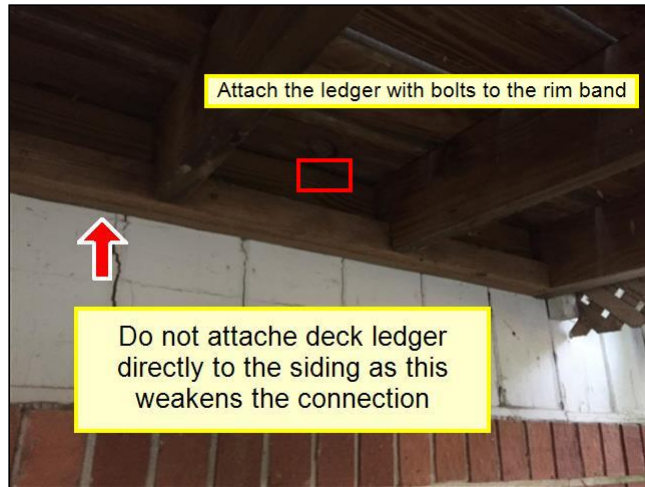
2.4 Item 1(Picture)

I recommend the following repairs to the deck. These repairs can be made by a qualified decking contractor.

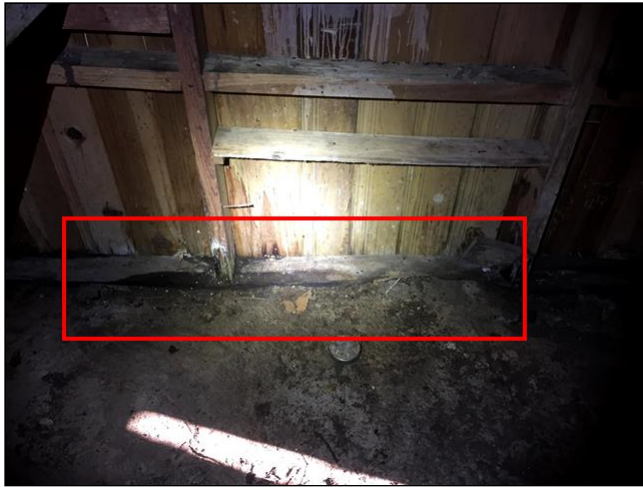
3.0 Item 1(Picture)

(1) There is significant water damage to the carport shed. To ensure the integrity of the structure over time, it is recommended that the shed be rebuilt by a qualified structural contractor.

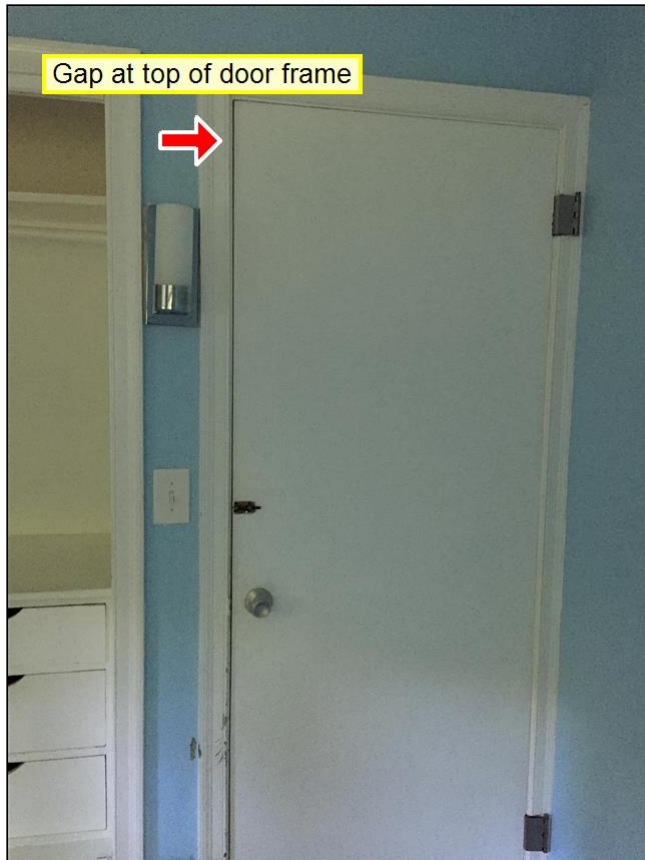
3.3 Item 1(Picture)

Much of the foundation slab was not visible for inspection due to the presence of floor coverings. The slab in the living room and tile in the front bathroom is sloped. This, in conjunction with the presence of cracks in the walls/ceilings and out of frame interior doors, indicate structural movement. More invasive inspection is needed to determine if there are cracks in the slab and if the movement is active.
