Letter from the Owners of 1207 Oakdale RD, Atlanta, GA 30307

03/03/2021

Jerry W. Hopkins, Pres. Construction Consulting Services, Inc. Georgia Licensed Professional Engineer, 13519 Attachments:

March 1st, 2021

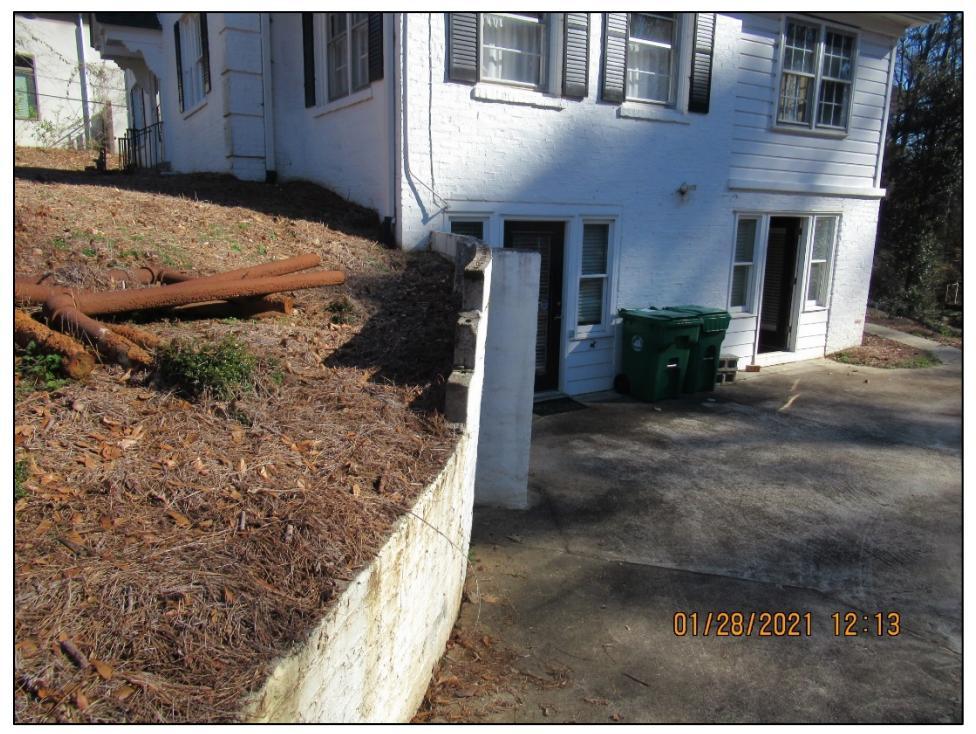
Photo 02: View of the right side of the house. Note the leaning retaining wall.

- 28. The concrete stairs at the kitchen door would require replacement.
- 29. The retaining wall at the right front of the house would require replacement.

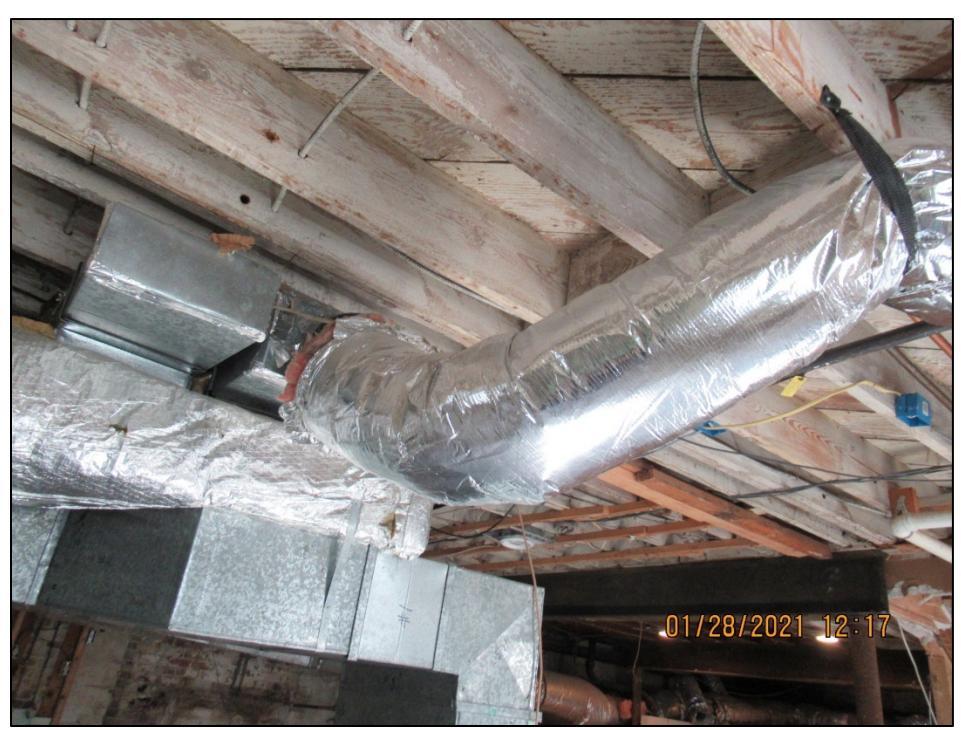
- 16. At many locations, the 2x4 ledge for the support of floor joists had cracked.
- 17. The HVAC ductwork, returns and some supply lines, were not insulated.

Photo 03: HVAC ductwork that was not insulated and in poor condition. Some of the ductwork had been replaced.

- 3. A new HVAC system would be required.
- 4. New foundation walls would be required to replace the 4" CMU sub walls in basement. Compacted backfill would be replaced behind the new walls. A vapor barrier would then be required for the exposed earth portion of the basement.

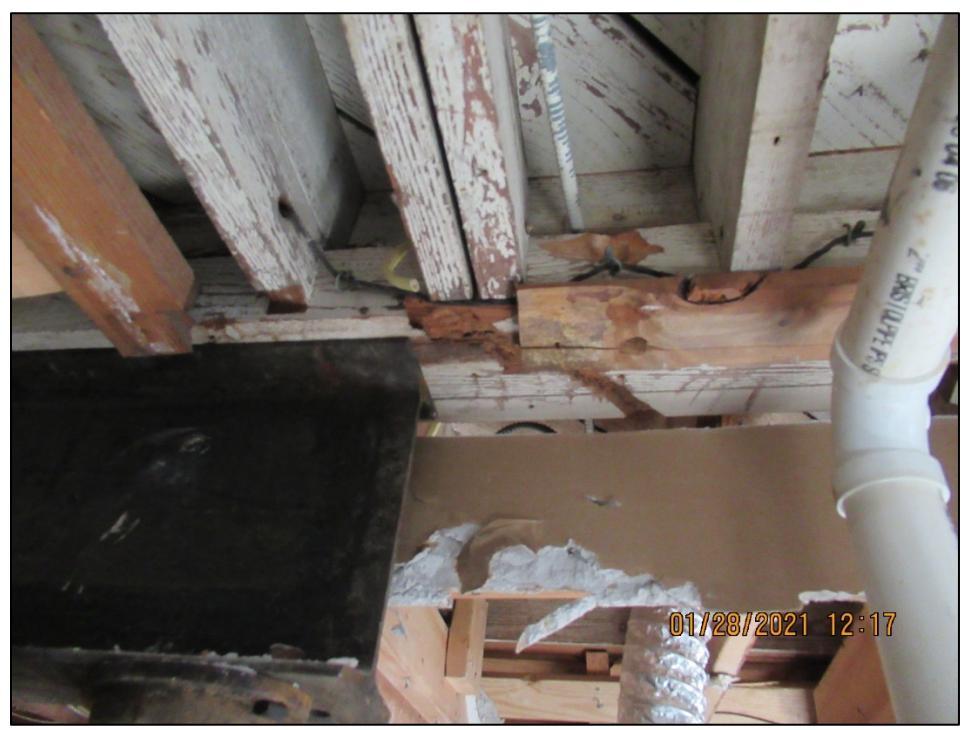
- 3. Decay for the following items was observed.
 - a. Several beams supporting the first floor.
 - b. The exterior band of the house
 - c. More than 40% of the floor joists had decay, splits, termite, or other damage and require repair or preferably replacement.

Photo 04: Typical decay and deterioration of a main beam for the first floor.

- 11. Floor joists and beams for the first floor would require repairs and replacement.
- 12. Decking for the first and second floor would require replacement due to code requirements, damage, and insect damage.

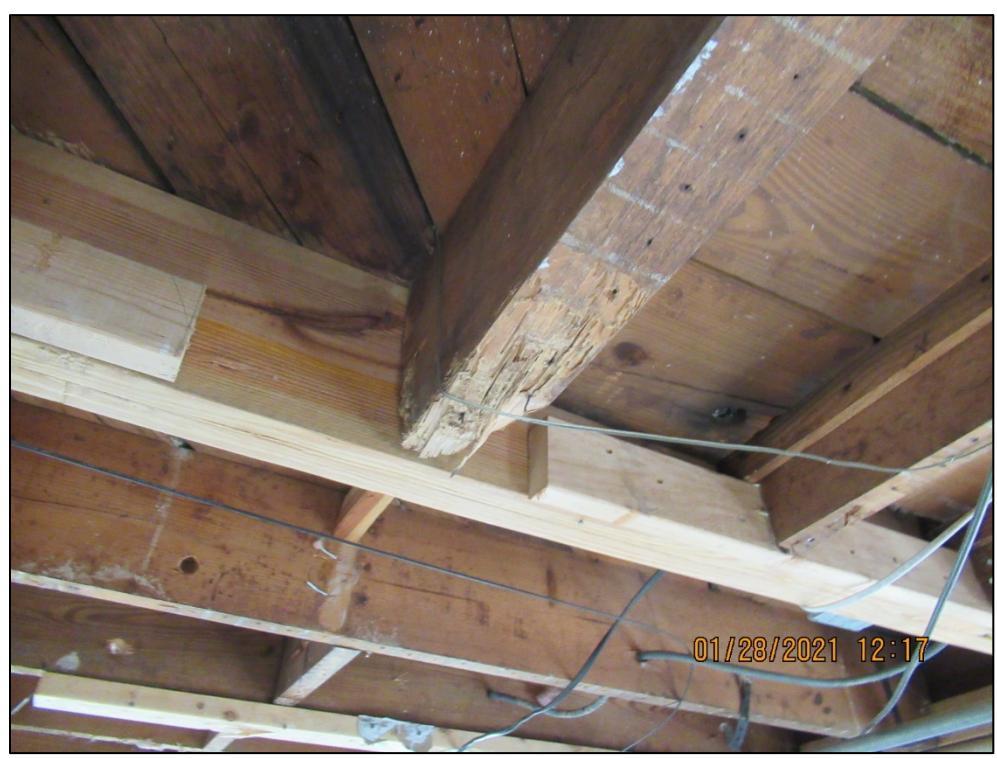
Photo 05: Damage to a main beam for the first floor.

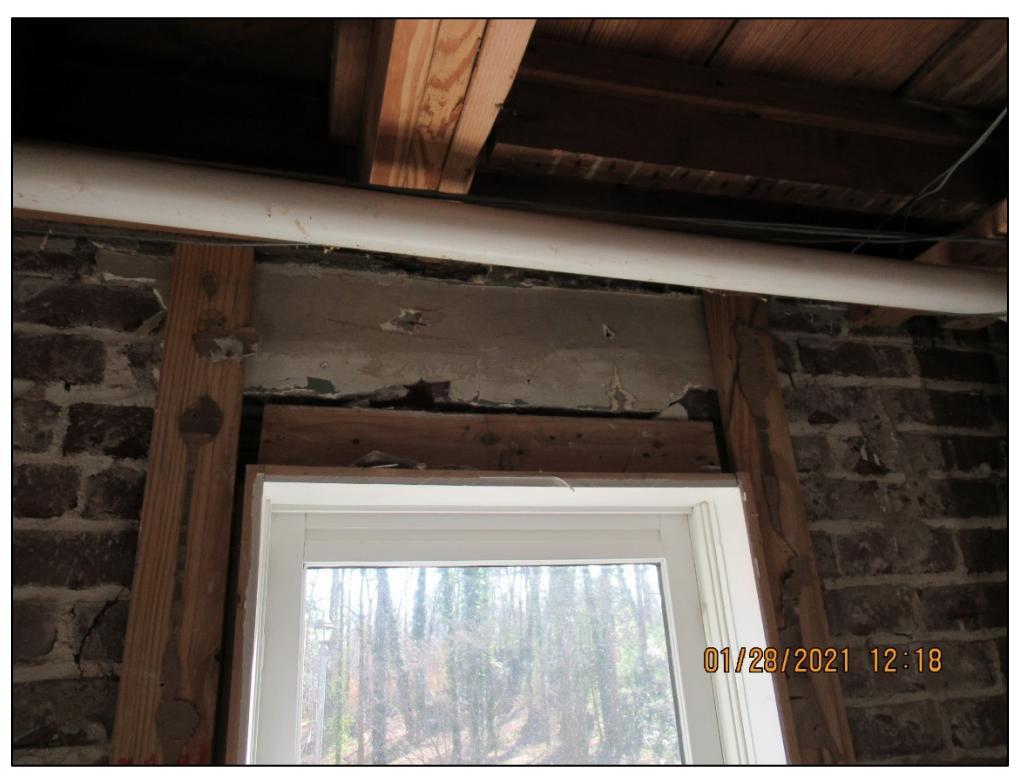
- 11. Interior walls, just inside the foundation walls, had decayed and will require replacement.
- 12. Both concrete and wood headers at the foundation walls had deterioration.

Photo 06: Damaged concrete and wood header at basement window

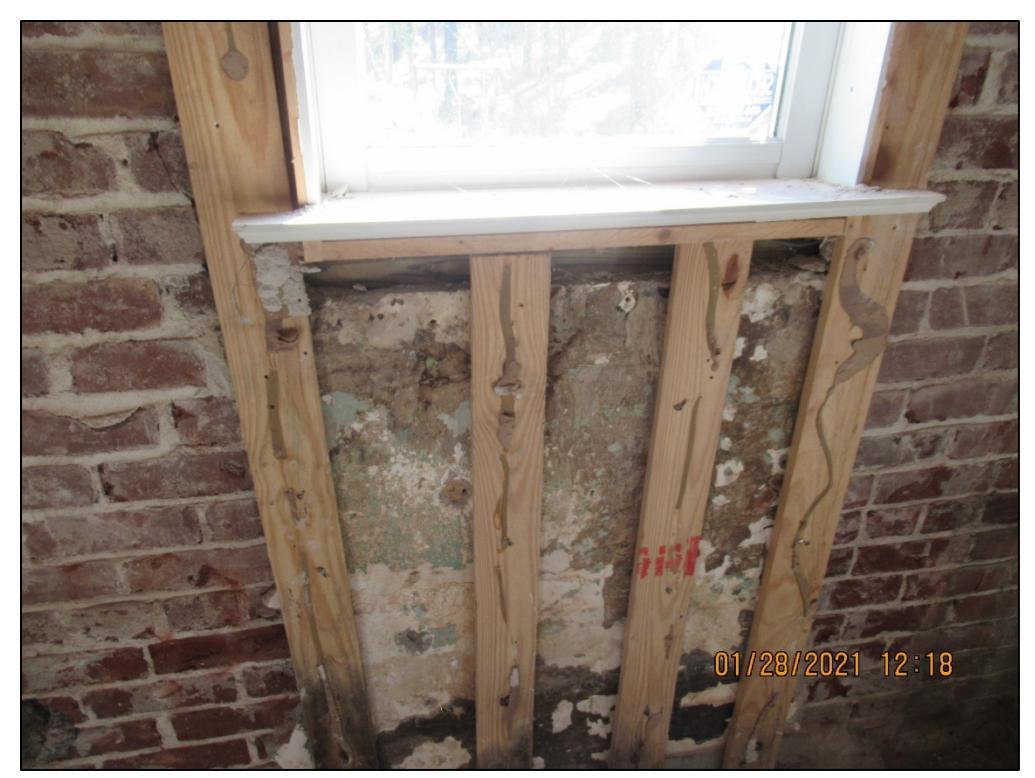
Photo 07: Decayed wood at window.

- 5. All of the basement doors and windows would have to be replaced due to deterioration from water and termites.
- 6. The foundation walls would require repair.

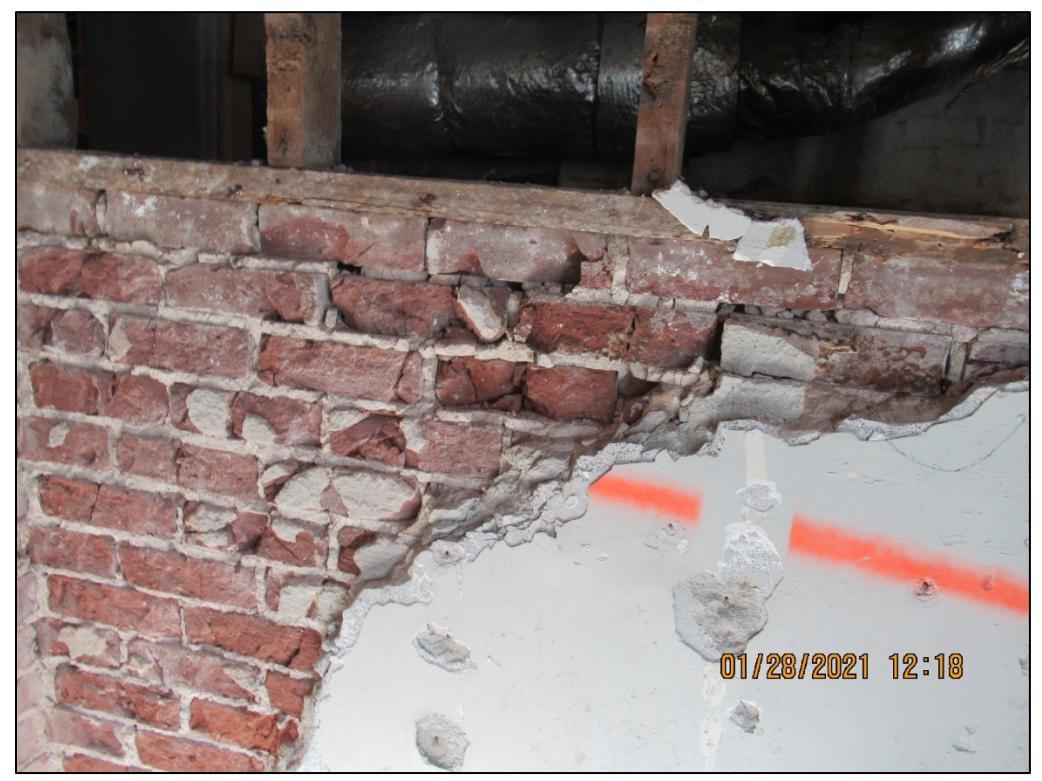
- 13. The masonry foundation had deterioration at many locations. The brick had spalled, eroded, and cracked.
- 14. Brick was missing from the foundation walls at critical corners.

Photo 08: Deterioration of foundation wall that is part of the crawl space. Note the decayed wood plate on top of the wall.

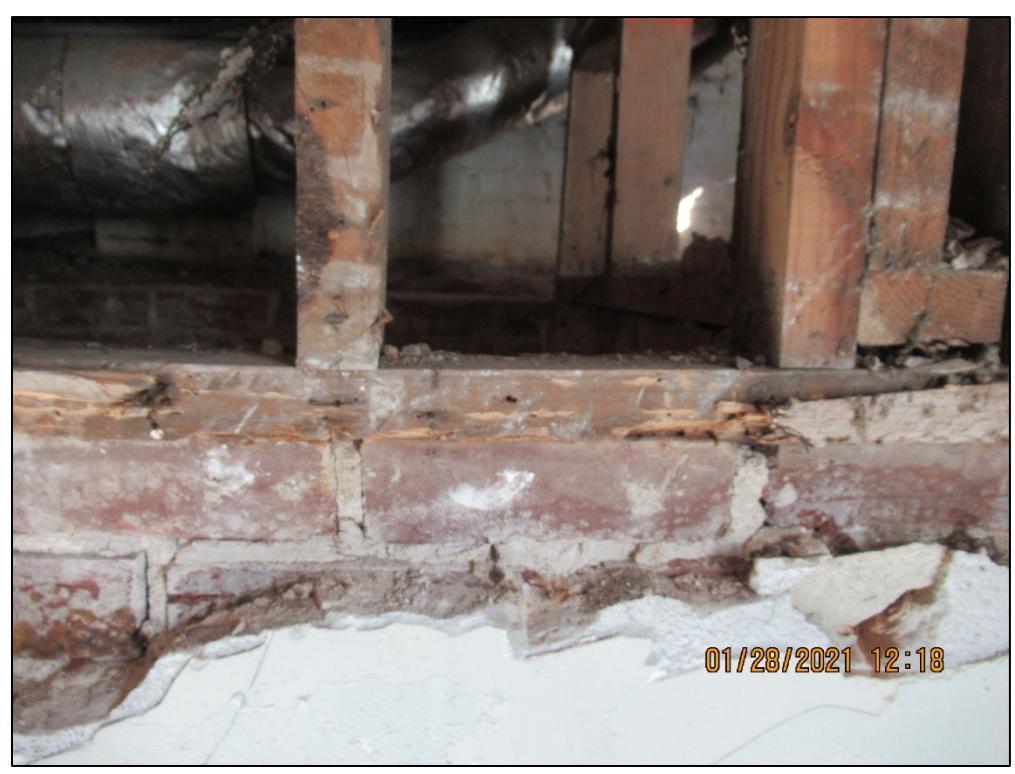
Photo 09: Decayed plate and studs. Typical throughout the basement.

- 13. Bracing and a weather resistant membrane would be required for all exterior walls.
- 14. All damaged, bowed, notched, decayed and damaged wall studs would have to be replaced.

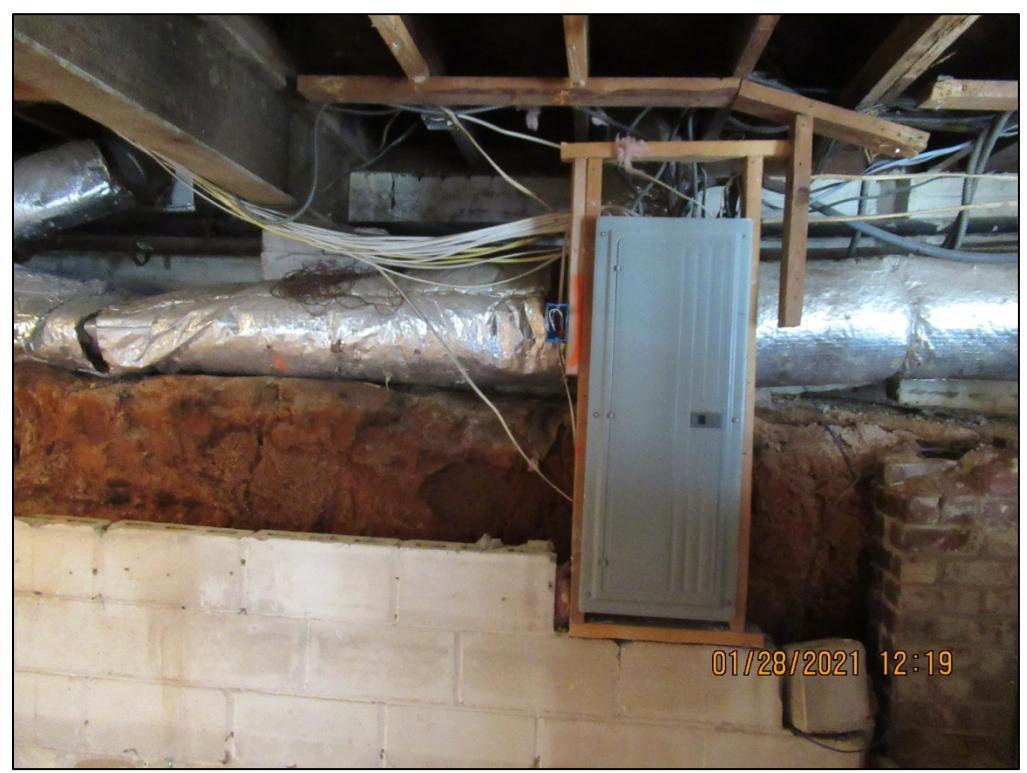
- 23. The foundation walls and floor system lacked any insulation.
- 24. The electrical panel had exposure to soil and moisture.
- 25. The electrical system can be best described as a jumble of wiring. Both recent and what is believed to be original wiring was being used. It is my opinion the electrical system is not safe.

Photo 10: The electrical panel was next to the earth cut, supported by a failing retaining wall and decayed studs.

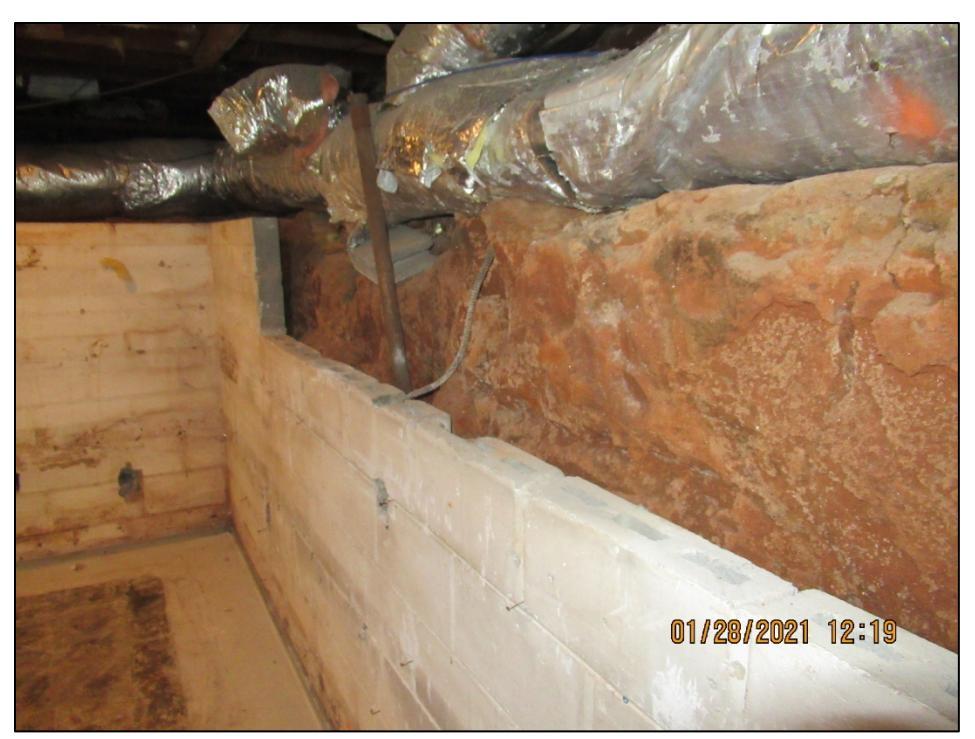
- d. Joists and beams throughout the first-floor framing system
 - e. Exterior wood walls
- 8. A basement was excavated to within three to four feet of the exterior foundation wall. The shear cut was supported by unreinforced 4" CMU (concrete block). The following items were observed.

- a. The 4" CMU wall was failing. The wall had bowed and displaced at several locations.
 - b. The 4" CMU wall was not adequate to support the earth pressure and the pressure from the house footings. The wall did not have sufficient width, grout or reinforcing.

- c. The shear cut had undermined the exterior foundation system and individual column footings.

Photo 11: Retaining wall constructed of unreinforced 4" CMU that is close to the exterior foundation walls.

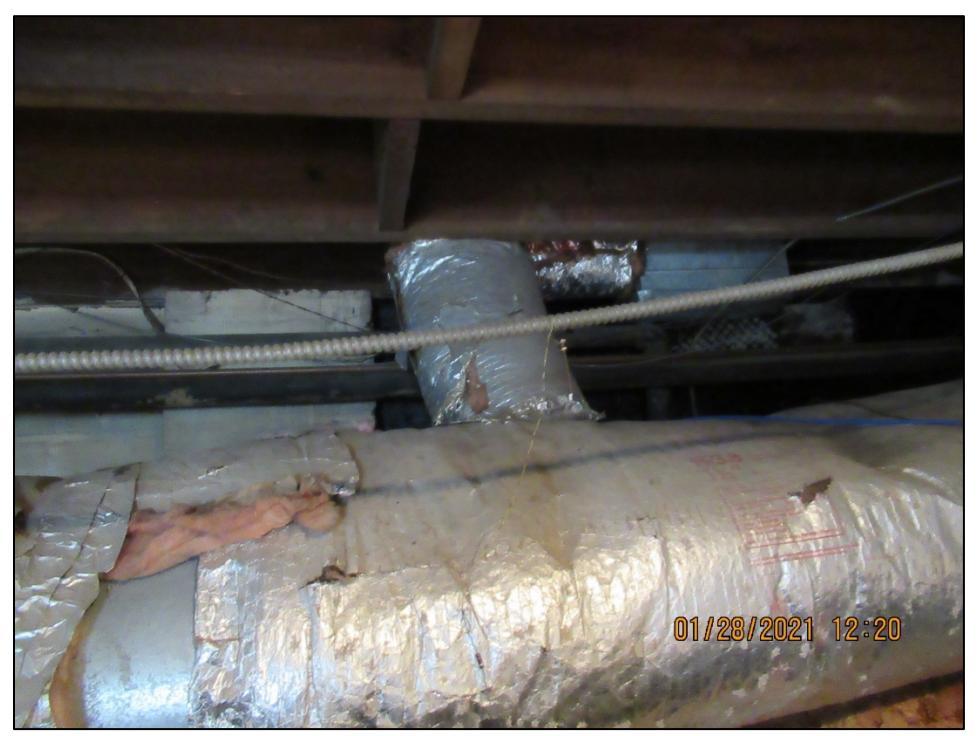
- 18. HVAC ductwork was in contact with the ground.
- 19. The thermostat for the HVAC system had been mounted to a decayed stud that leans against the ductwork.

Photo 12: Poorly maintained HVAC ductwork, and the ducts are resting on the exposed earth.

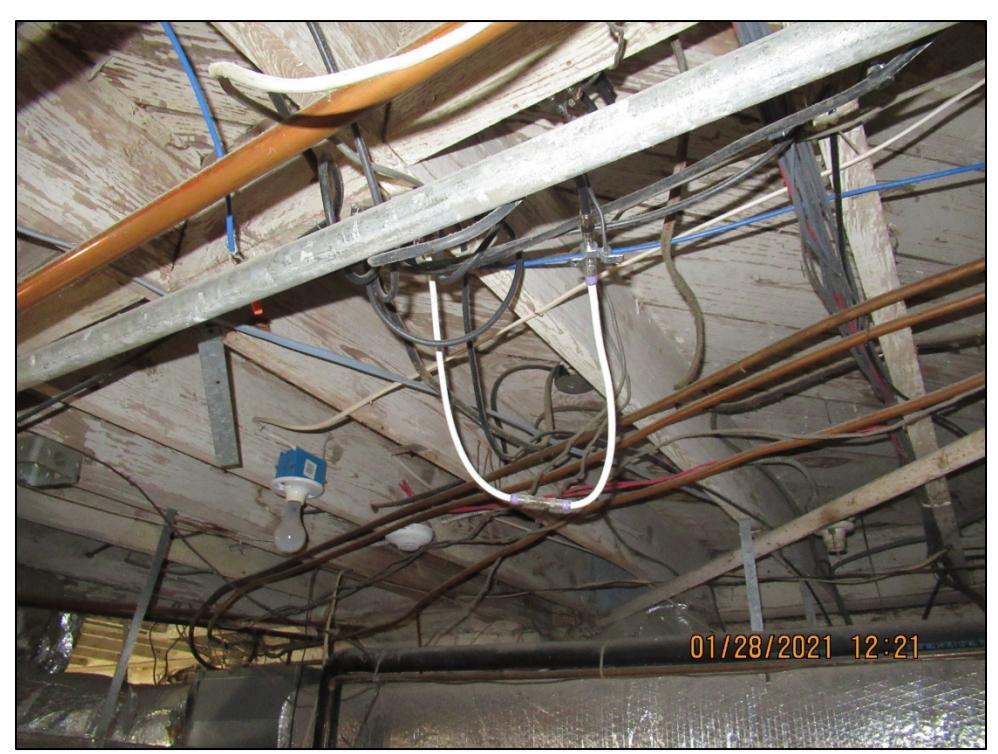
Photo 13: A jumble of electrical wiring.

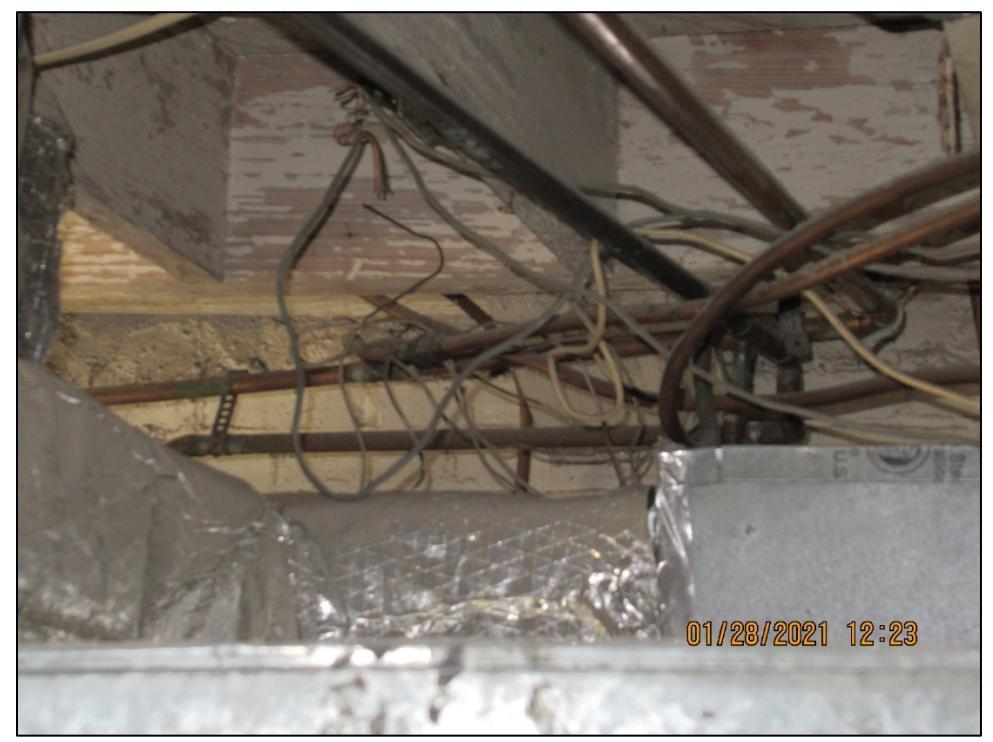
Photo 14: Another jumble of electrical wiring touching the copper plumbing pipes.

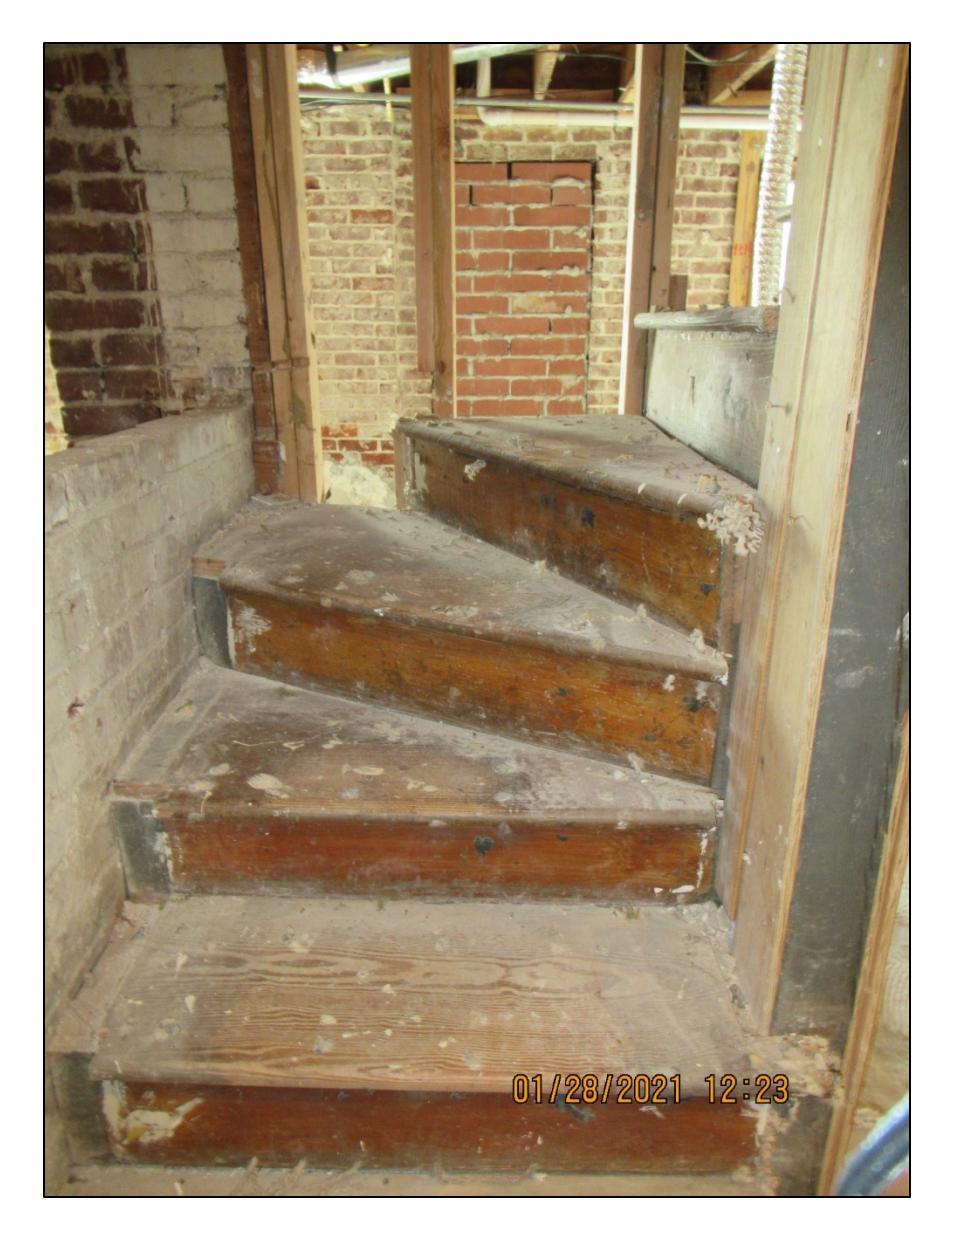
- f. The stair system will have to be replaced. This in turn will require major modifications to the first-floor walls, floor framing and room layout.

Photo 15: The stairs from the basement to the first floor. All of the stair components do not meet the IRC requirements.

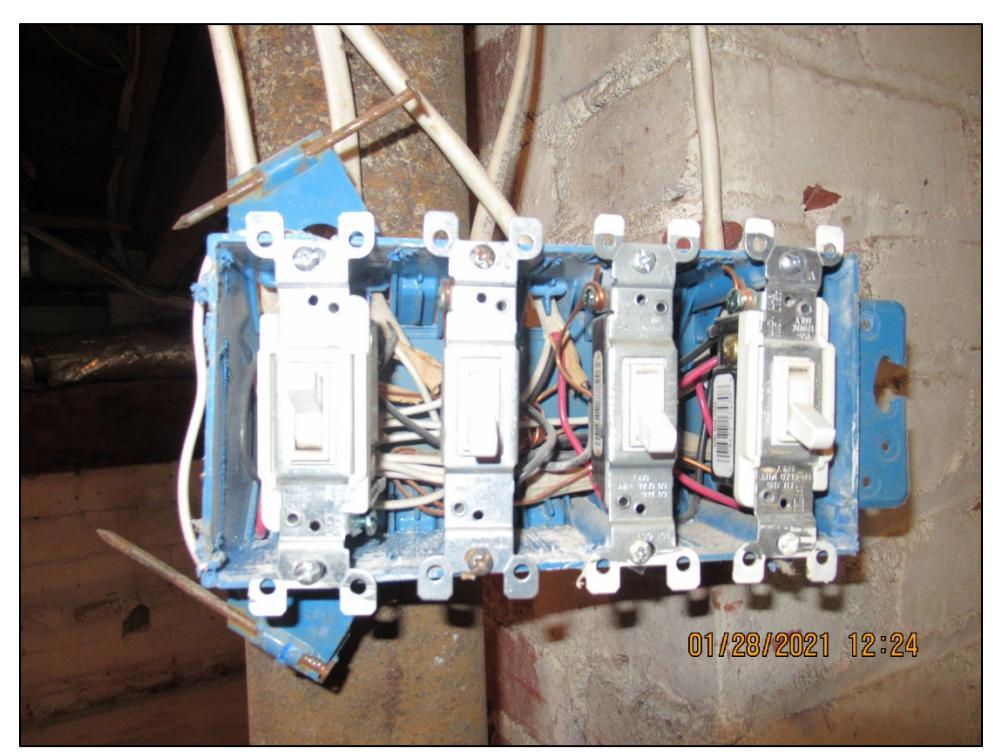
Photo 16: Open switch boxes

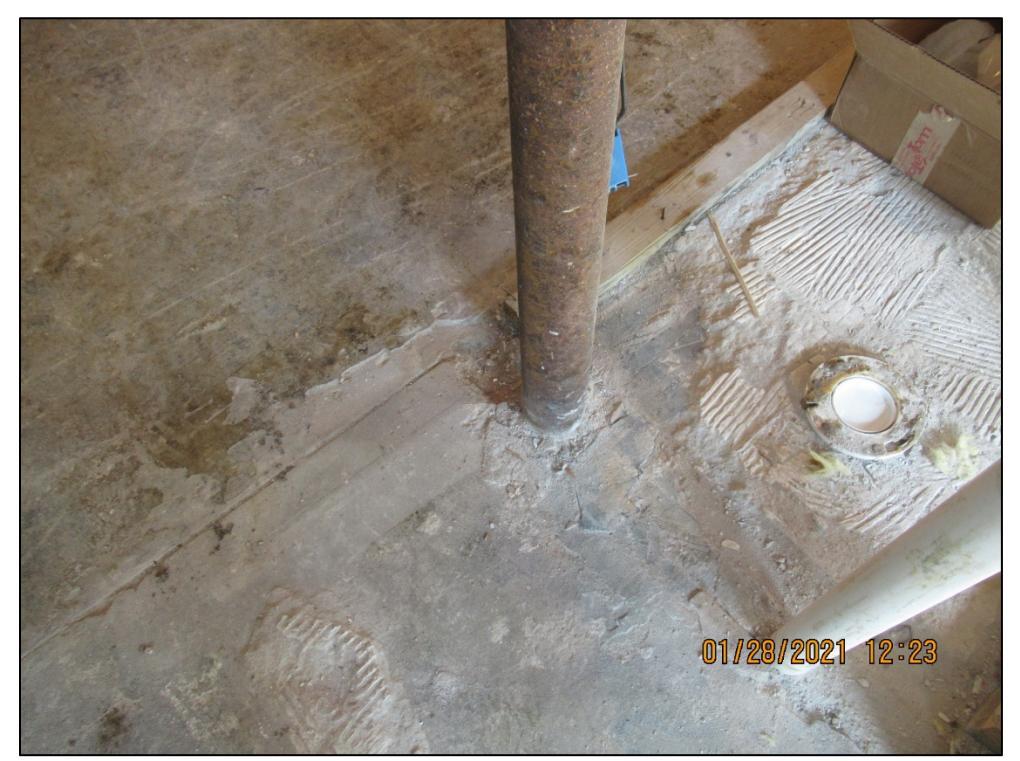
- 5. The steel columns supporting the structure had been supported below the slab. The columns had extensive corrosion at their base.
- 6. At the right side of the house 2x6 floor joists were used to support the first floor. The joists were over span and need to be replaced or upgraded to meet the minimum span requirements of the IRC.

Photo 17: Corroded support posts.

- 7. A waterproofing system along with foundation drains would be required. This would involve removal of landscaping, trees, porches and sidewalks.
- 8. All of the steel posts would require removal and replacement at the basement.

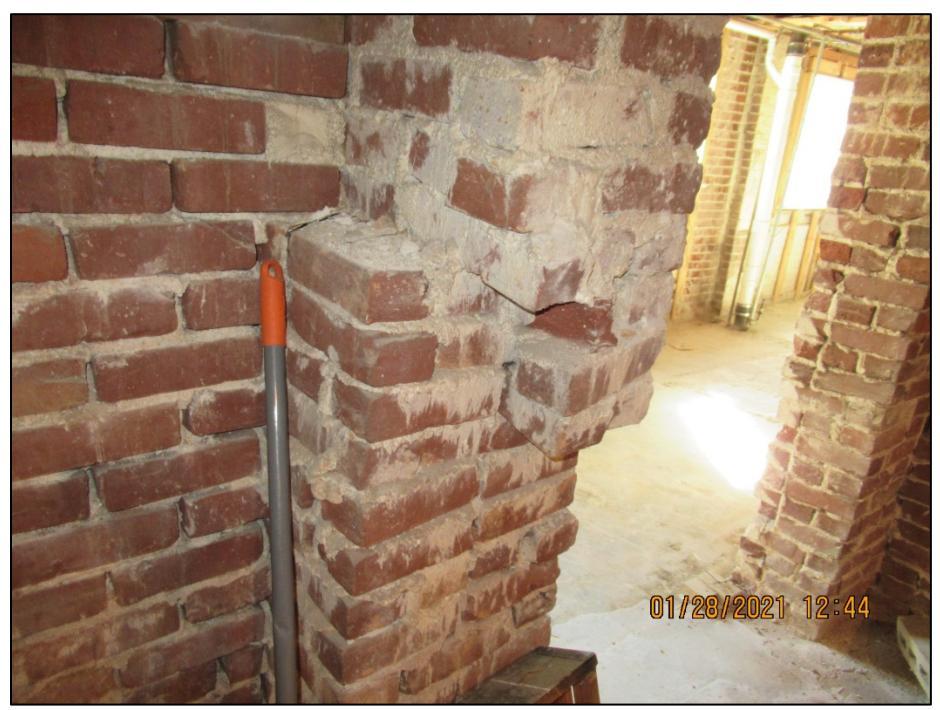
Photo 18: Missing brick for part of the foundation system.

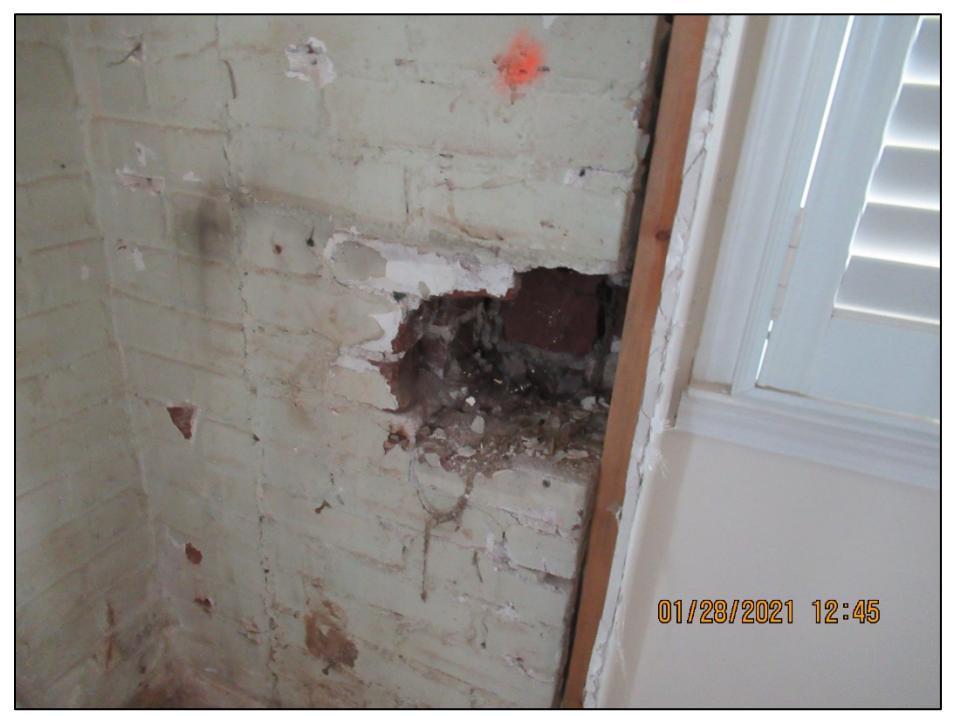
- 9. A portion of the foundation system had been damaged at the right side of the house and requires repair.
- 10. Steel beams and their bearing plates had corroded, which in turn damaged the masonry that they bear on.

Photo 19: Damaged foundation wall.

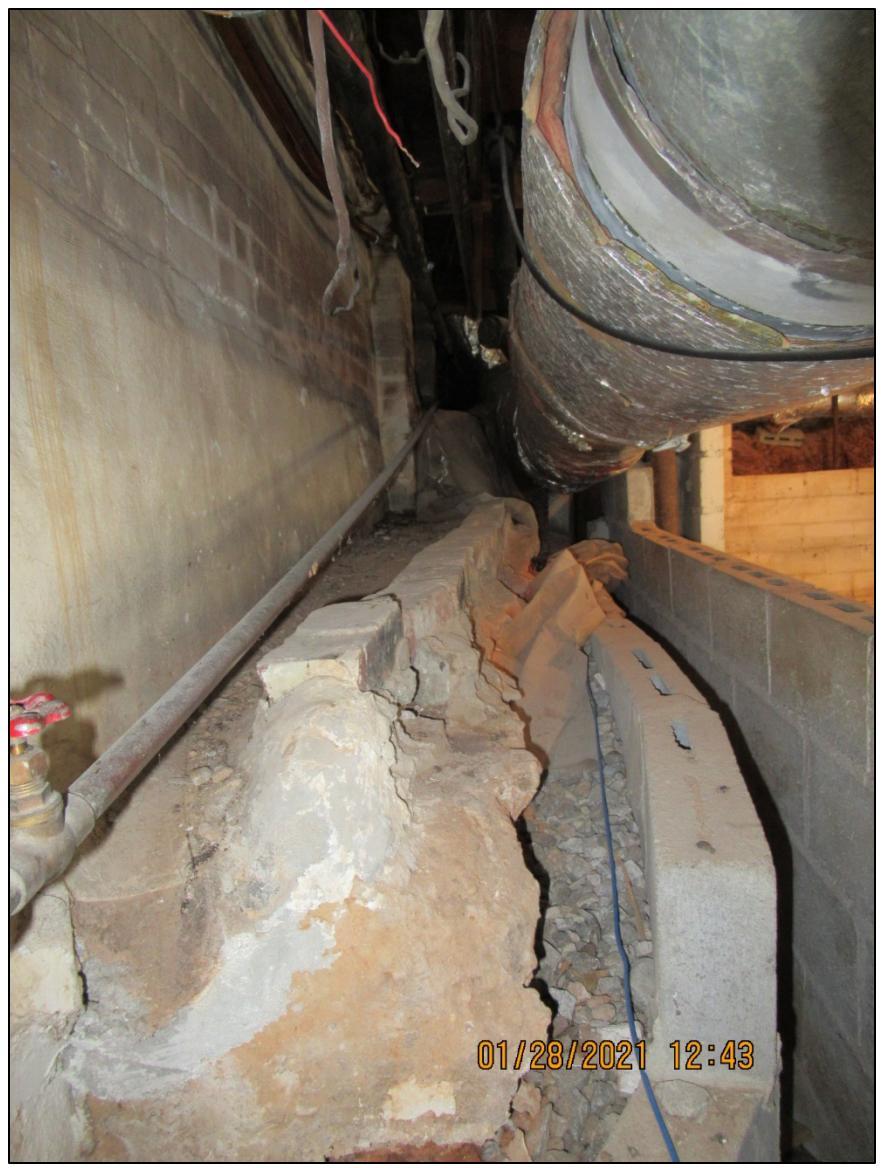
Photo 20: Failing 4" CMU retaining wall near the front foundation wall.

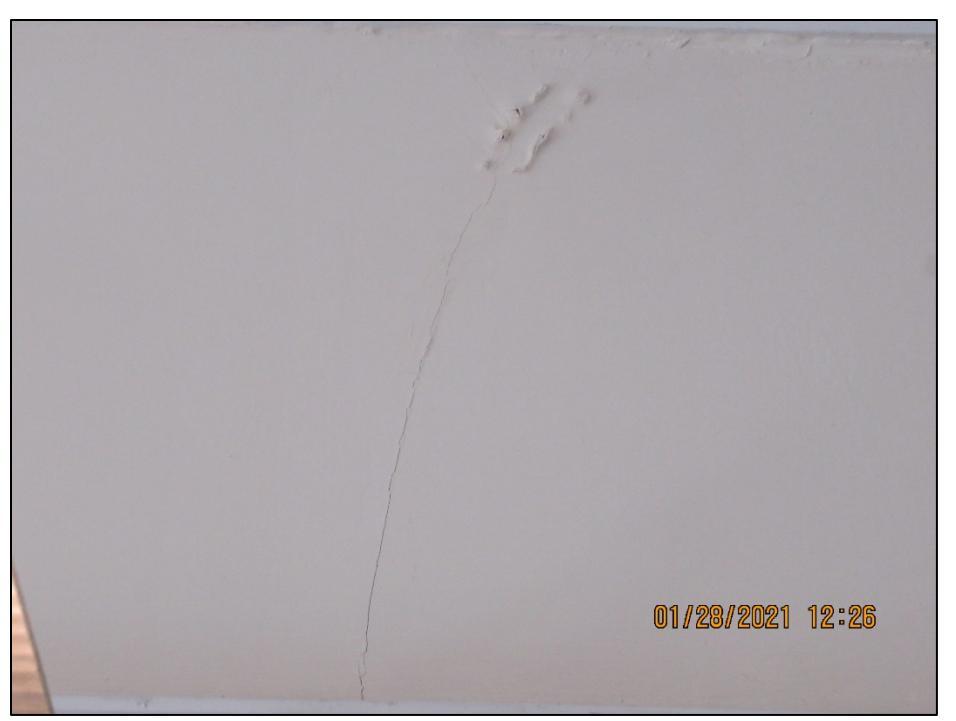
- 34. At the vast majority of the doors (interior and exterior) and windows diagonal cracks were present. This indicates settlement of the foundation system or the wood structure had decay or other damage causing compression of the wood.

Photo 21: Typical Cracking and water damage at all of the first floor windows and door openings.

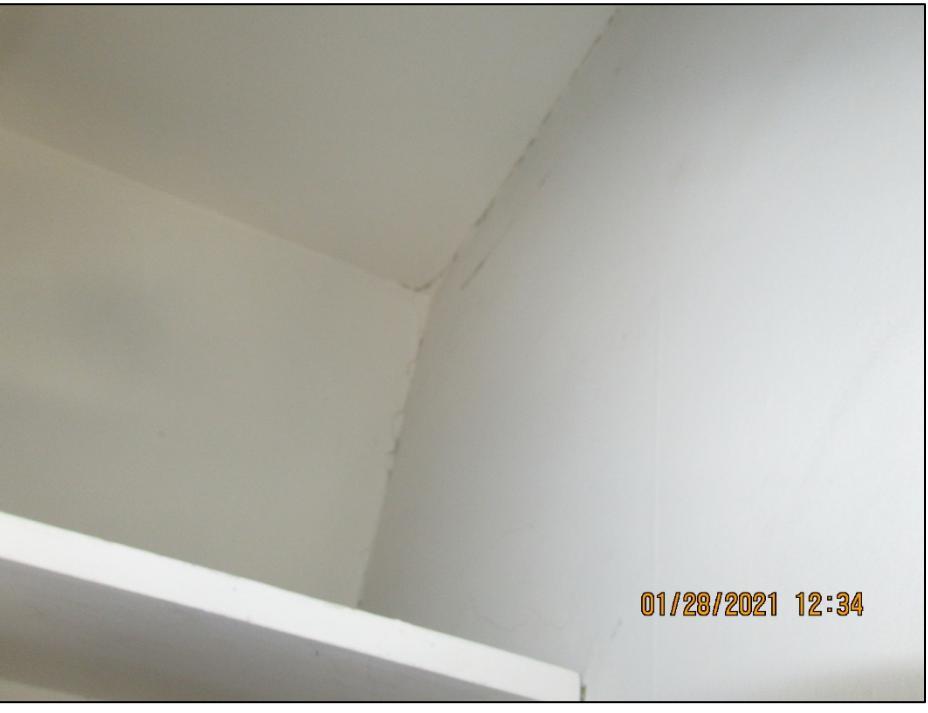
Photo 22: Cracks and water damage in first floor closet.

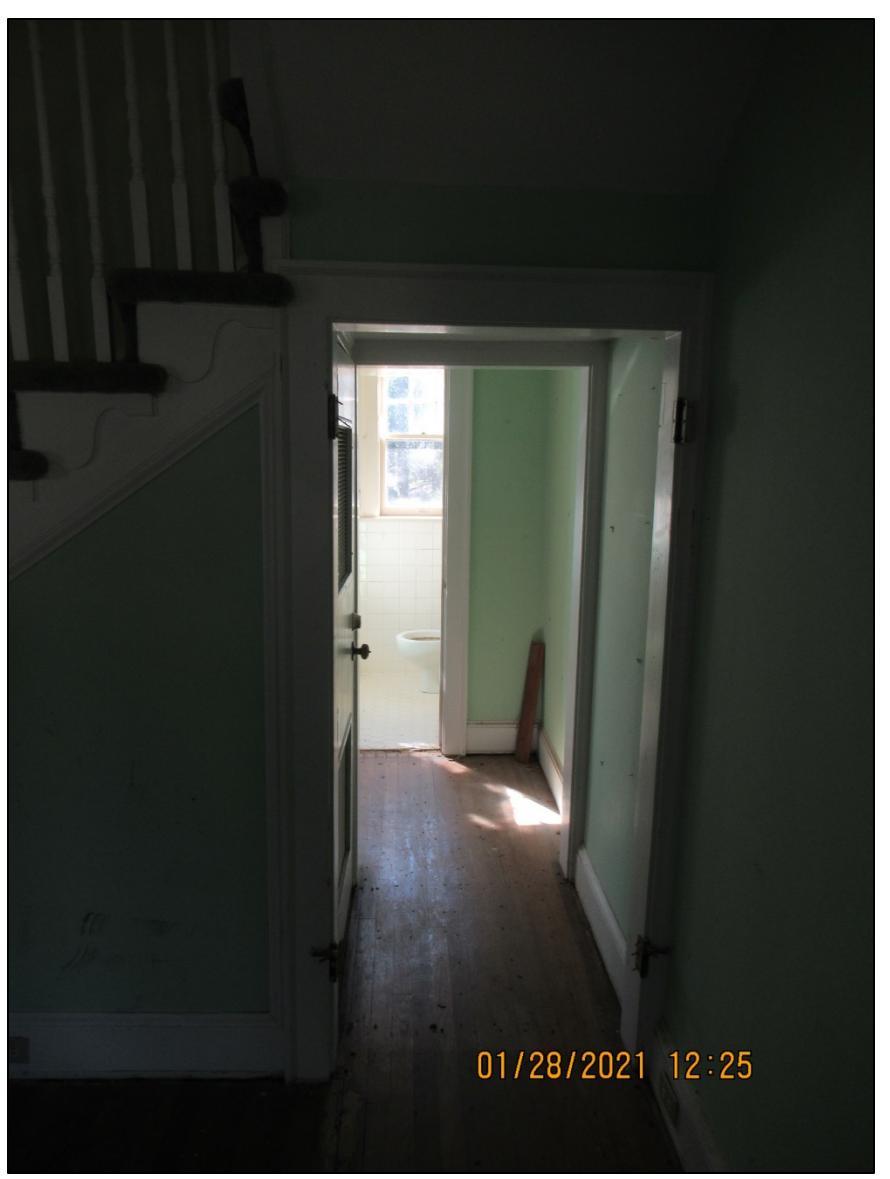
Photo 23: The stairs do not have the required 80" headroom clearance in the hallway from the foyer to the kitchen.

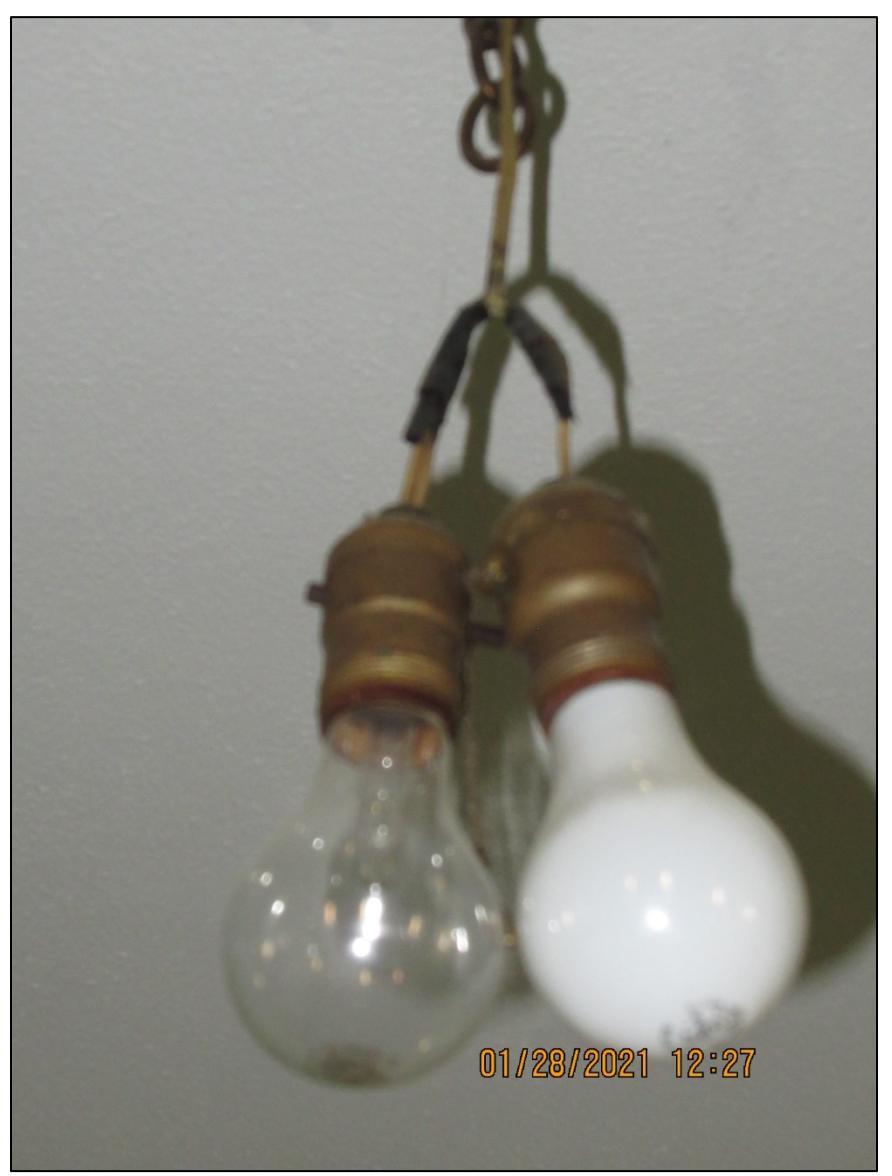
- 35. The floors had the right side of the house had a noticeable deflection.
- 36. Water damage was found at several locations in the walls.
- 37. Electrical fixtures had exposed wiring. The wiring appeared to be original wiring.

Photo 24: Original wiring for the house.

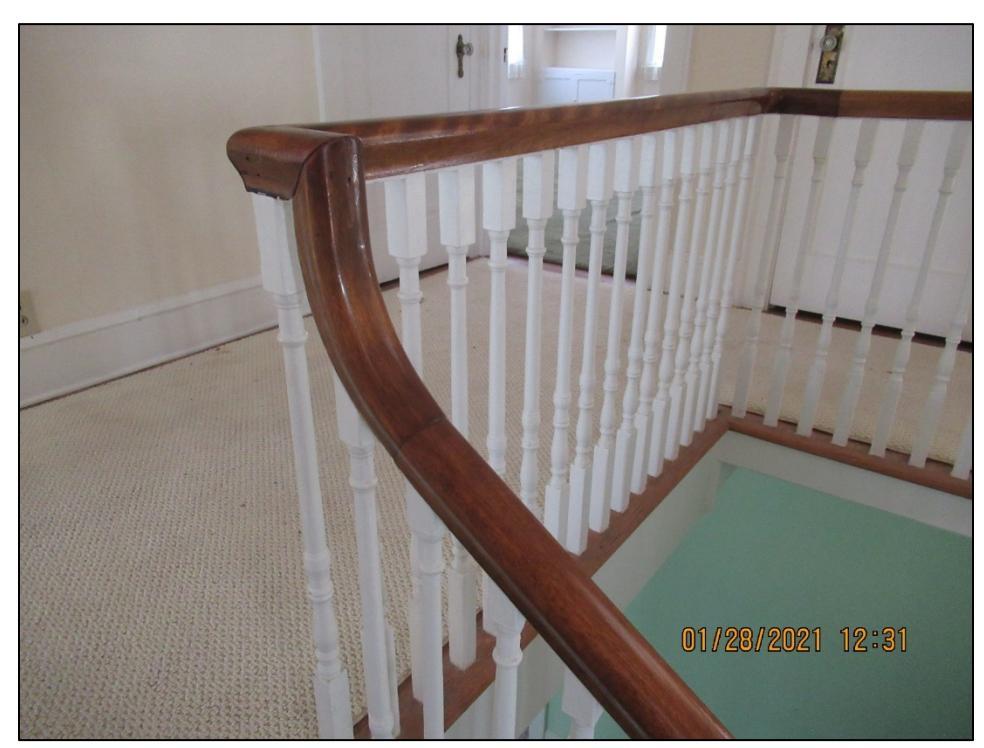
- 42. Similar to the first floor all of the window and door (interior and exterior) openings had diagonal cracks that indicate movement of the structure.
- 43. The guardrails at the upper foyer were less than 36" high and are a danger to the occupants.
- 44. Most likely there are building components in the walls and ceilings, and possibly the floor covering, that have asbestos.
- 45. The floors had noticeable deflections for most of the rooms. This was an indication the structure had issues.

Photo 25: The guardrails do not have the minimum 36" height as required by the code and they are a safety hazard.

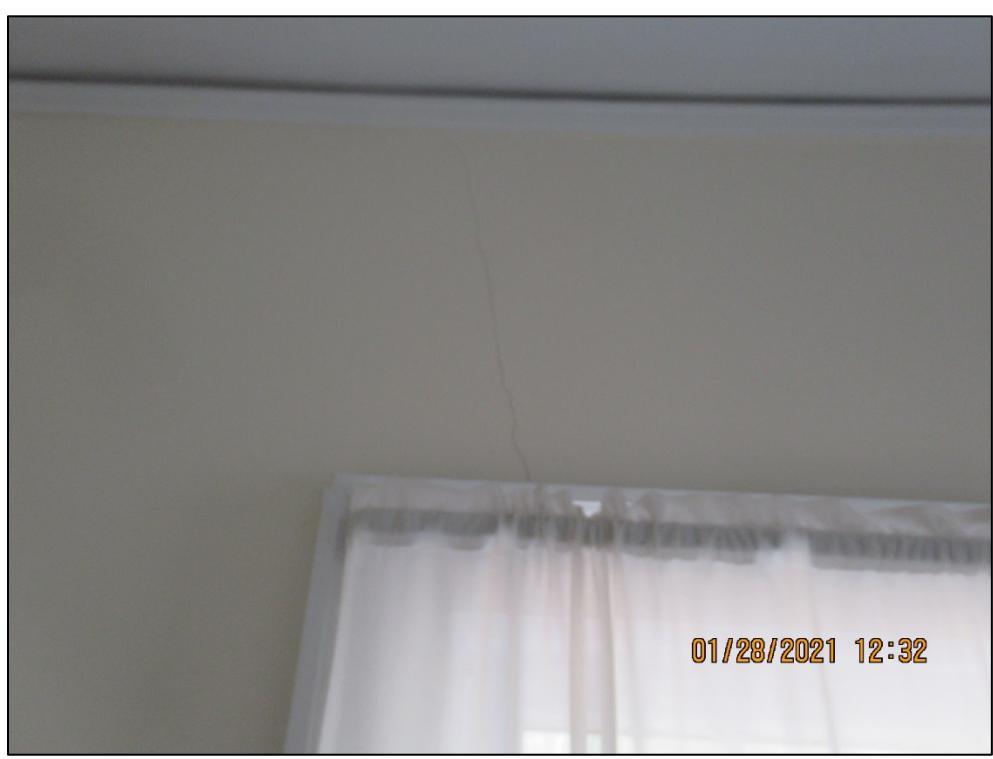
Photo 26: Typical cracks at the windows and doors for the second floor indicating movement of the structure.

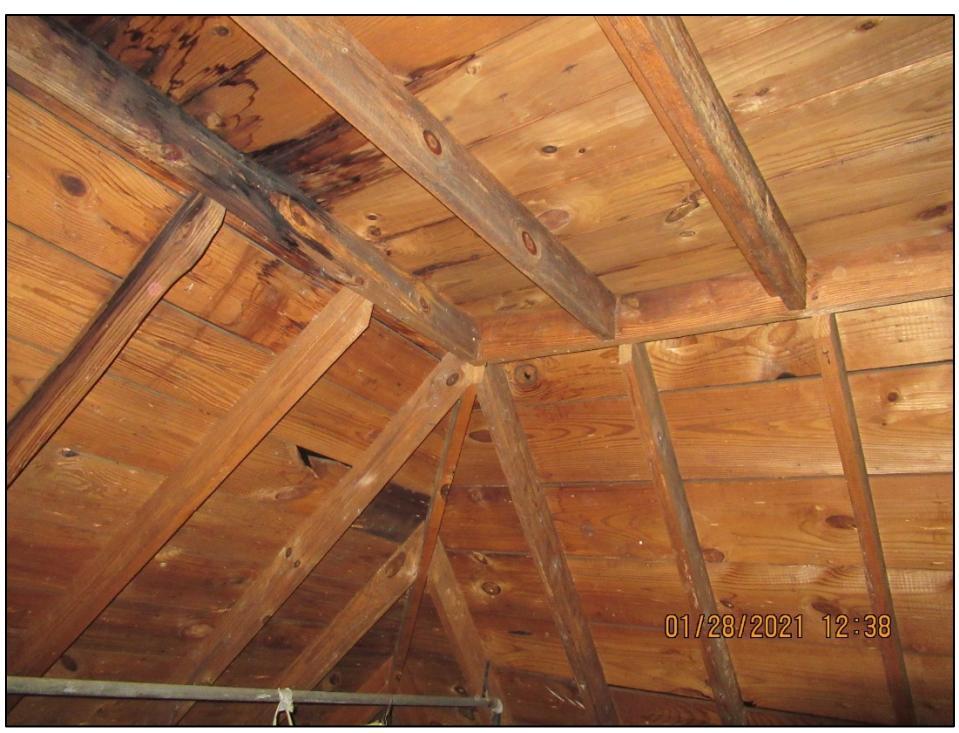
Photo 27: The flat roof is missing posts, adequate perimeter beam, connections for the flat rafters and the sloped rafter end cuts are greater than the ridge.

- 21. Repairs to the second-floor joists and beams may be required.
- 22. The split rafters would have to be replaced or repaired.
- 23. The flat roof requires extensive structural repairs.
