Letter from the Owners of 1207 Oakdale RD, Atlanta, GA 30307

03/03/2021

Jerry W. Hopkins, Pres. Construction Consulting Services, Inc. Georgia Licensed Professional Engineer, 13519 Attachments:

March 1st, 2021

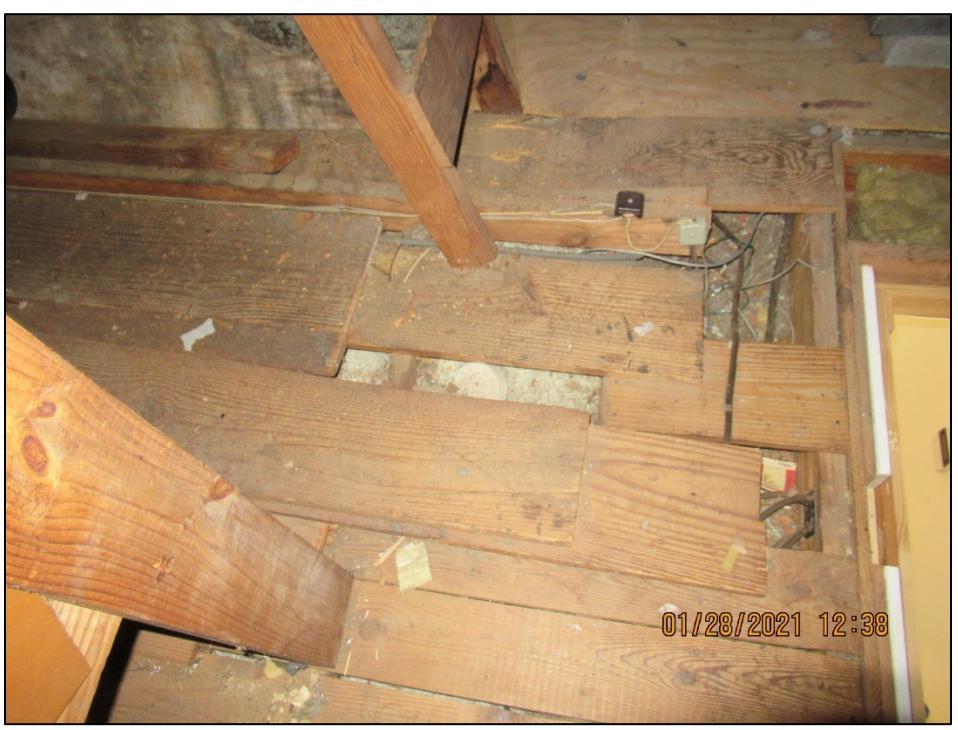
- 49. The attic was not vented.
- 50. The ceiling was not properly insulated.
- 51. There was evidence of rodent activity.
- 52. The floor decking had gaps that created trip and fall hazards.

Photo 28: Missing decking that is a fall hazard.

- 24. The attic decking requires repairs.
- 25. The brick veneer would have to be removed due to the following reasons.
 - a. A weather resistant envelope cannot be installed unless the exterior sides of the wood walls are accessible.

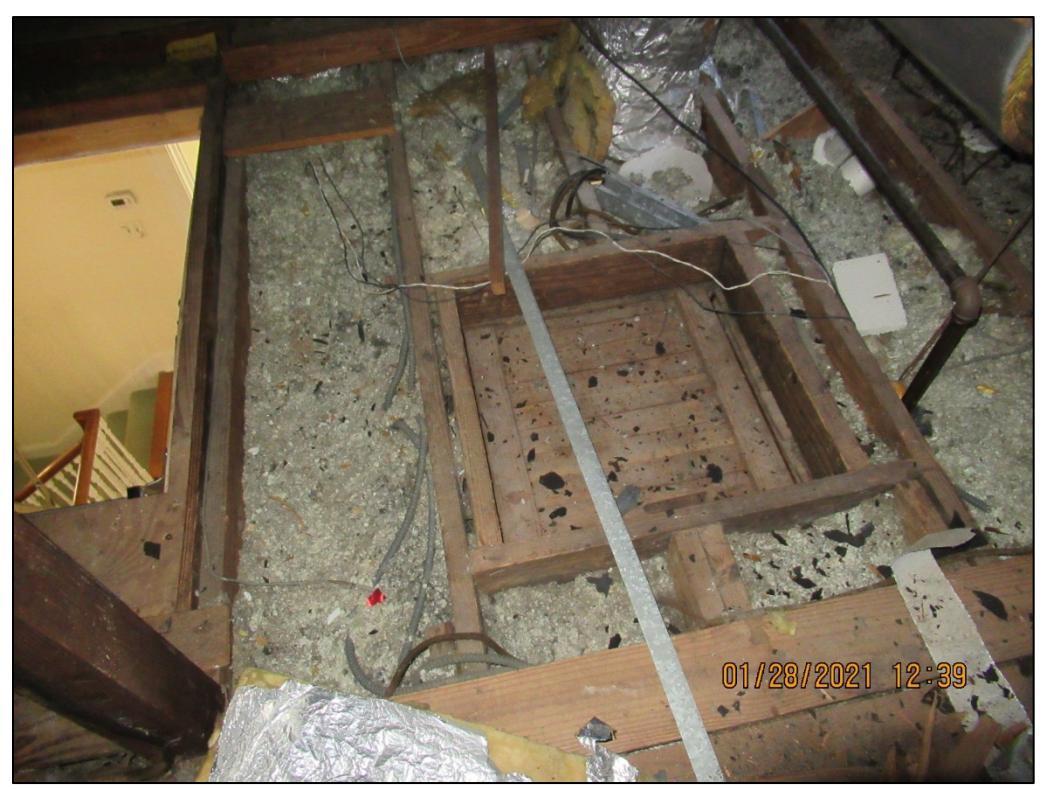
Photo 29: Inadequate ceiling insulation.

- 16. Existing windows do not meet current energy code requirements for the basement, first and second floors.
- 17. Insulation was missing for basement walls and most likely for the, first and second exterior walls. Insulation for the attic was also inadequate.

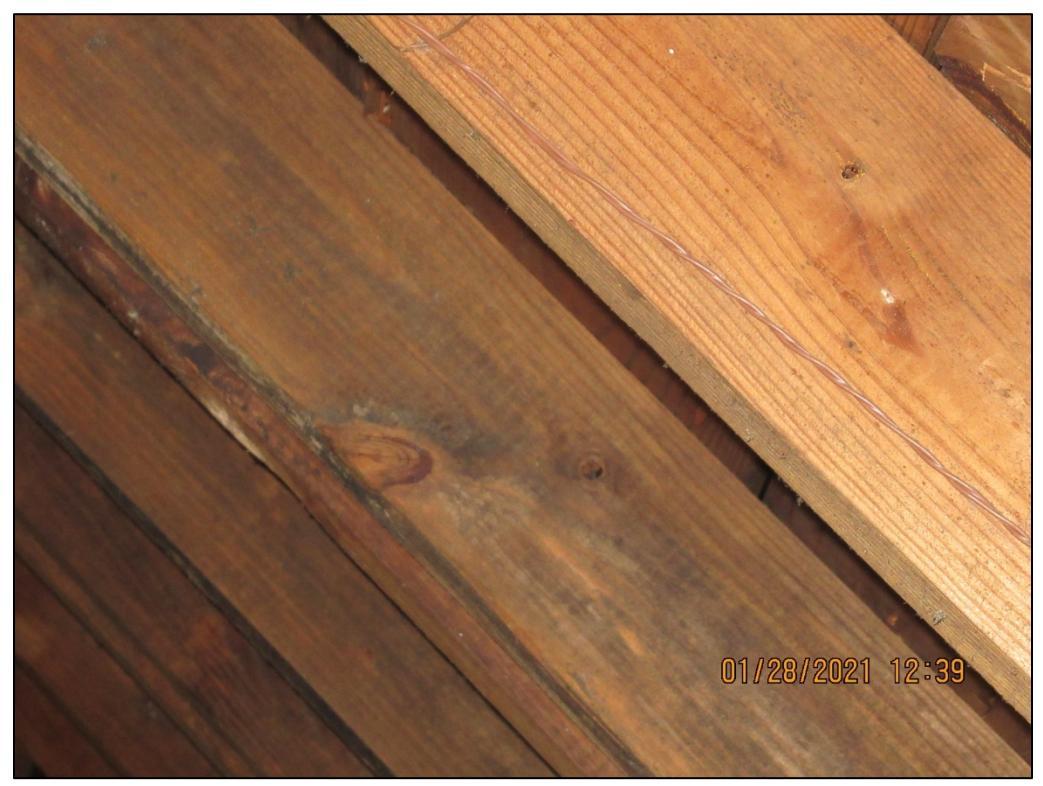
Photo 30: Typical splits in rafters caused by age and heat in the attic.

- 21. Repairs to the second-floor joists and beams may be required.
- 22. The split rafters would have to be replaced or repaired.
- 23. The flat roof requires extensive structural repairs.

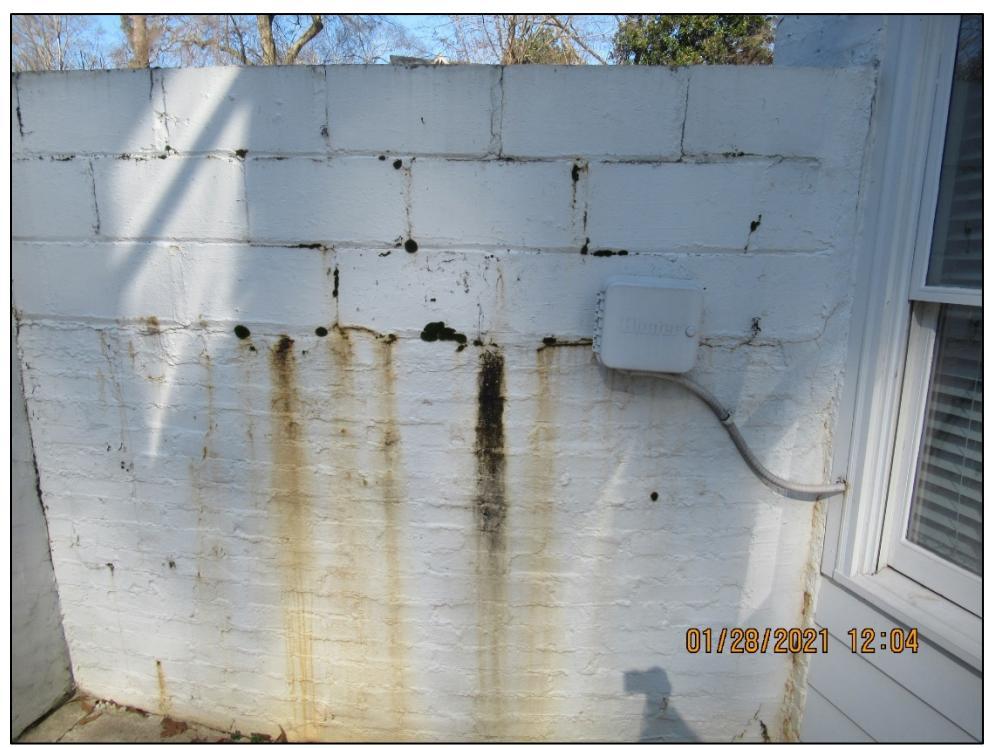
- 55. The retaining wall at the driveway, left side, was failing. The wall had tilted and bowed. The retaining wall will require replacement.
- 56. The driveway did not have the proper clearance from the basement slab to prevent water from entering the basement area.

Photo 31: Failing retaining wall at the right side of the house.

- 28. The concrete stairs at the kitchen door would require replacement.
- 29. The retaining wall at the right front of the house would require replacement.

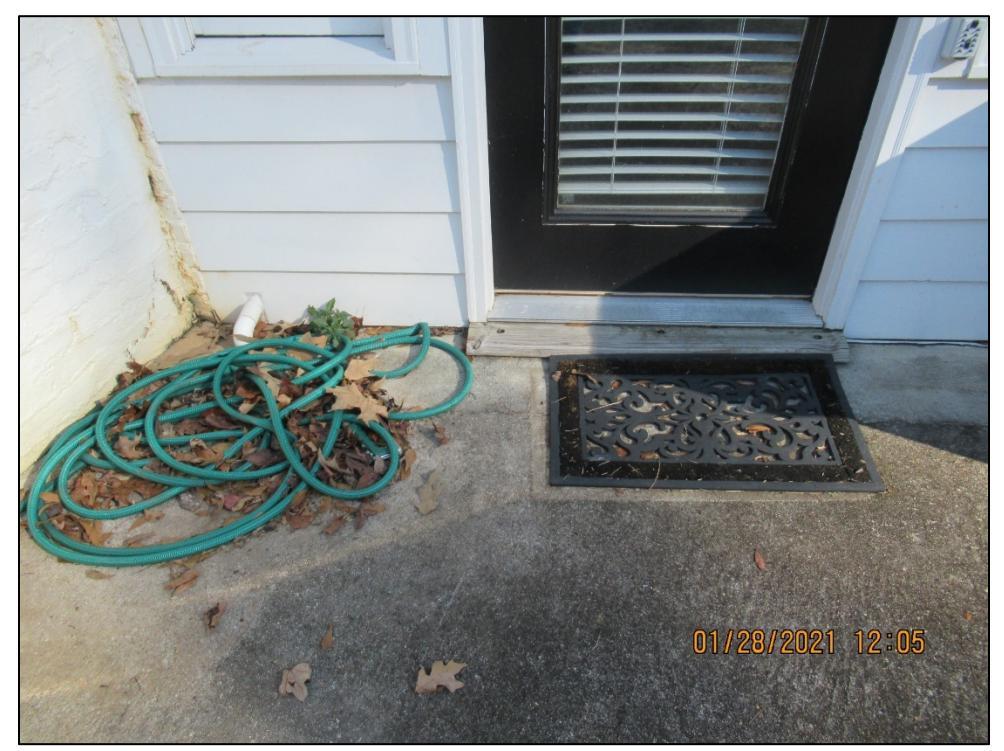
- 57. The driveway had numerous settlement and displacement issues.
- 58. The grade at the right side of the house appears to be above the foundation wall and it does not slope away from the house.

Photo 32: The driveway was placed too high exposing the basement to water infiltration. Note the modern siding and doors.

- 30. The driveway would require replacement.

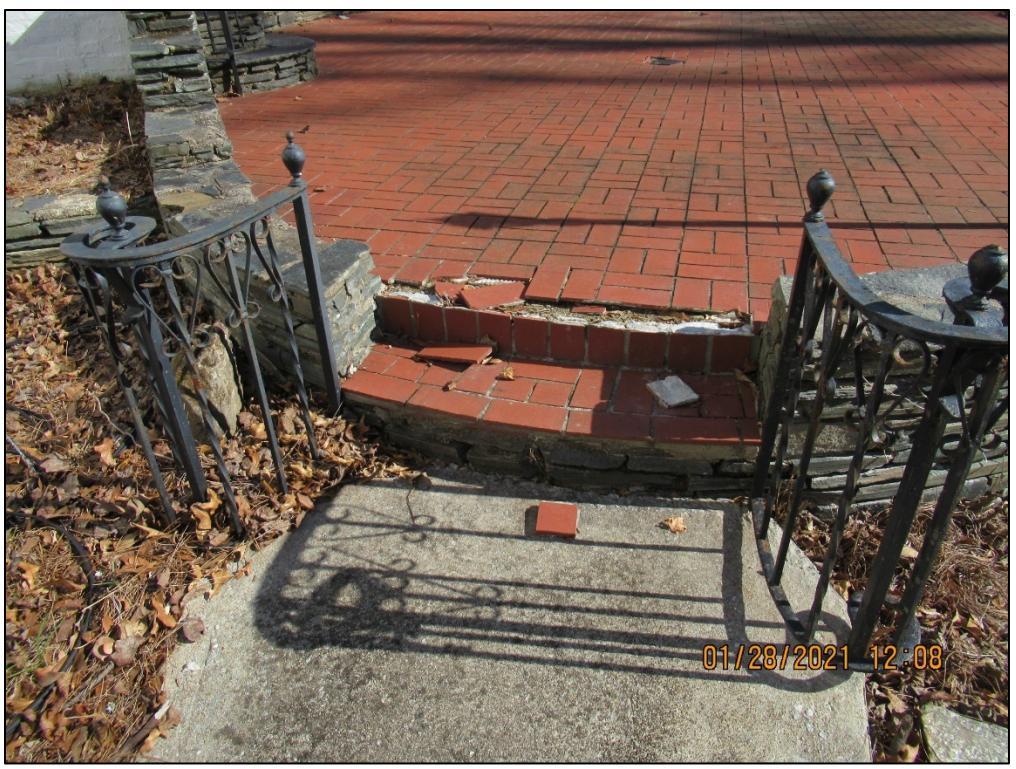
- 65. The steps and pavers for the patio had deteriorated.

Photo 33: The patio had many issues such as settlement and paver deterioration.

- 26. The exterior grade would require modifications to prevent ponding of water next to the house and to prevent decay of the wood structure.
- 27. The rear patio would require replacement.

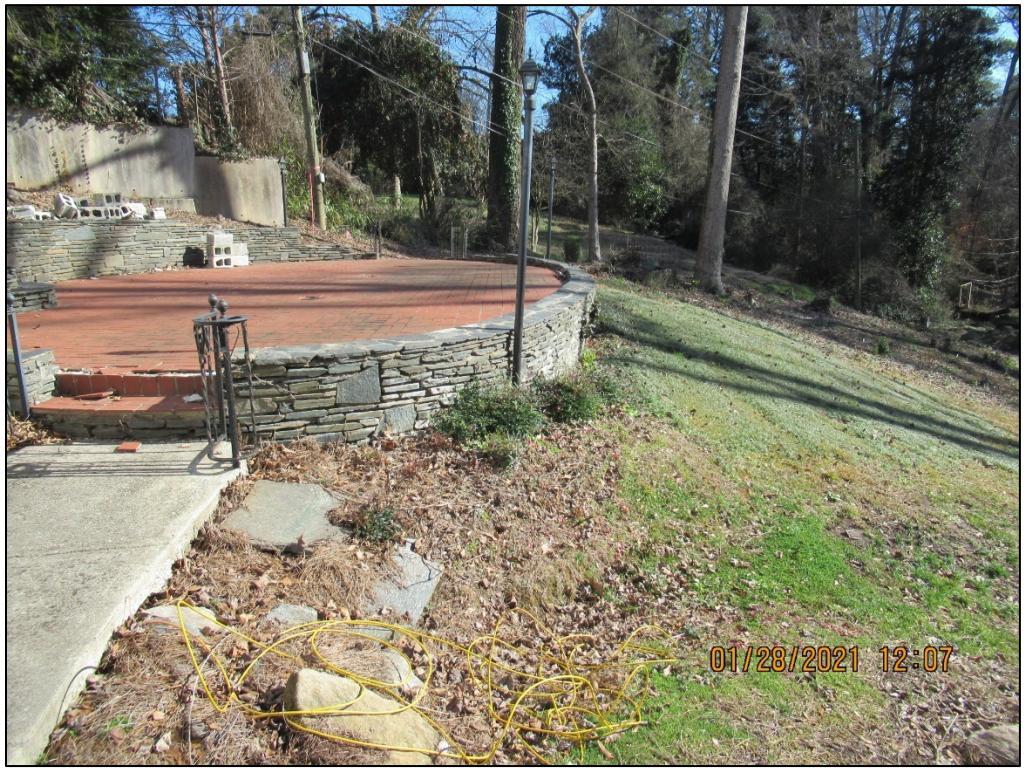
- c. The riser height exceeds the code requirements.
- 64. The retaining wall for the patio at the rear of the house was failing and will have to be replaced.

Photo 34: The patio retaining wall is failing.

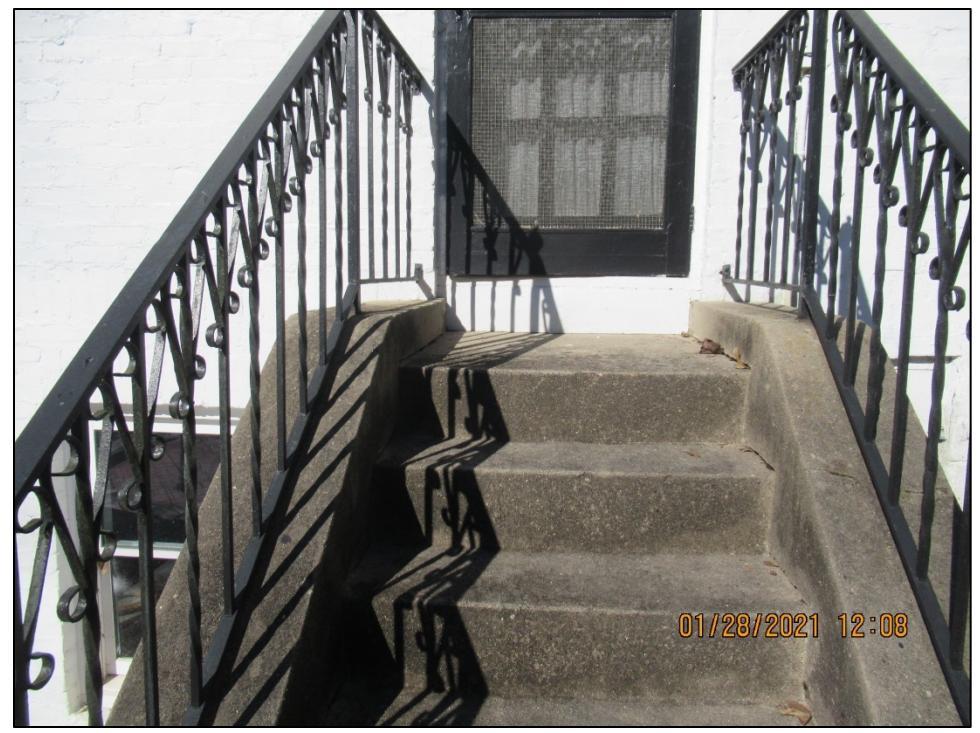
- 63. The stairs at the rear of the house have issues.
 - a. The stairs do not have the minimum width.
 - b. A landing is missing at the door and at the bottom of the stair flight that complies with the IRC.

Photo 35: The stairs at the rear of the house do not have an adequate landing at the top and bottom of the stair flight. The risers are too high.

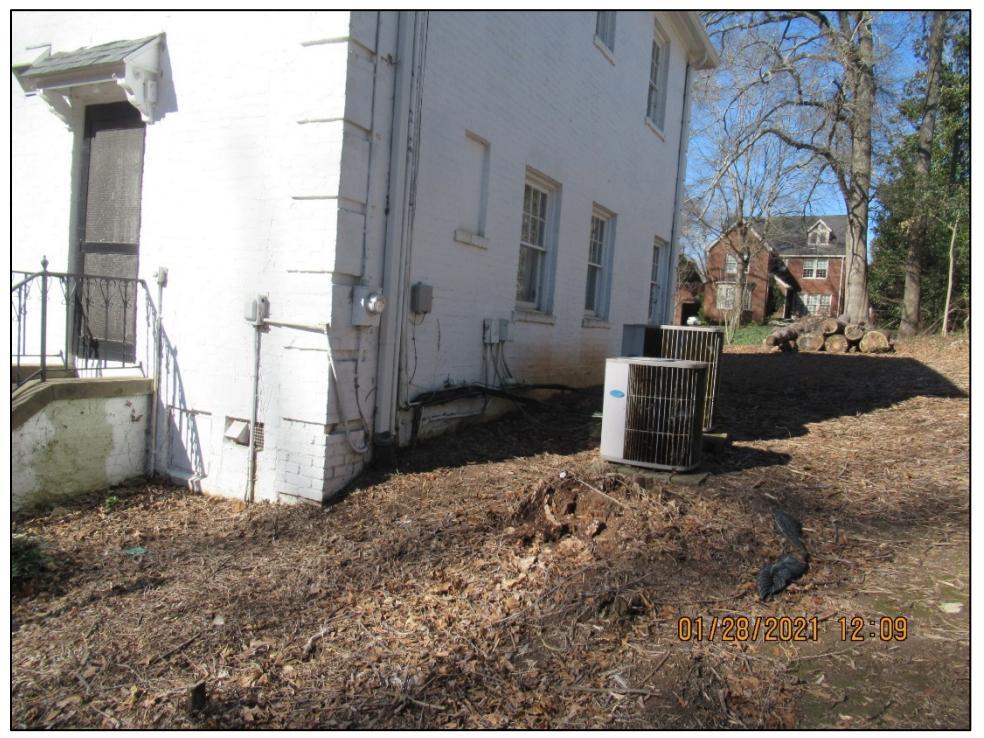
Photo 36: At the left side, the grade slopes toward the house and it appears to be above the foundation wall.

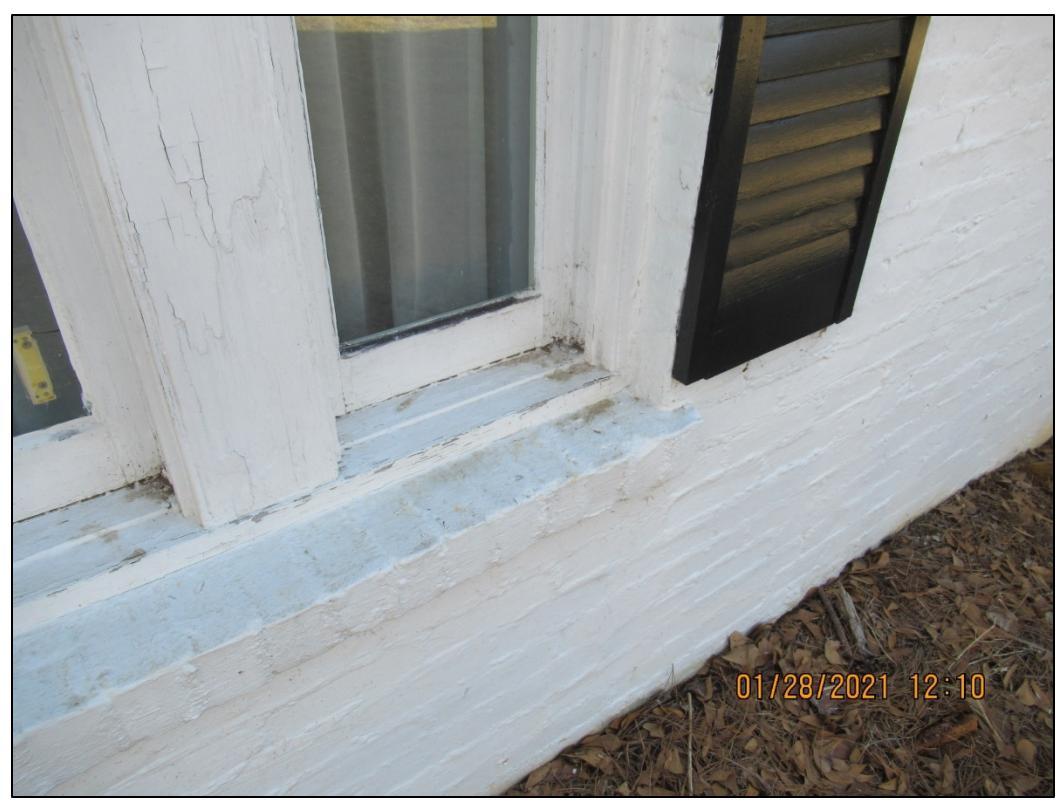
- 61. Window frames, both original and replacements, had extensive water damage and decay.
- 62. The landing and steps at the front door do not comply with the code requirements with regard to landing size, step riser heights and step riser variance.

Photo 37: Typical window that has decay at the frames and sill.

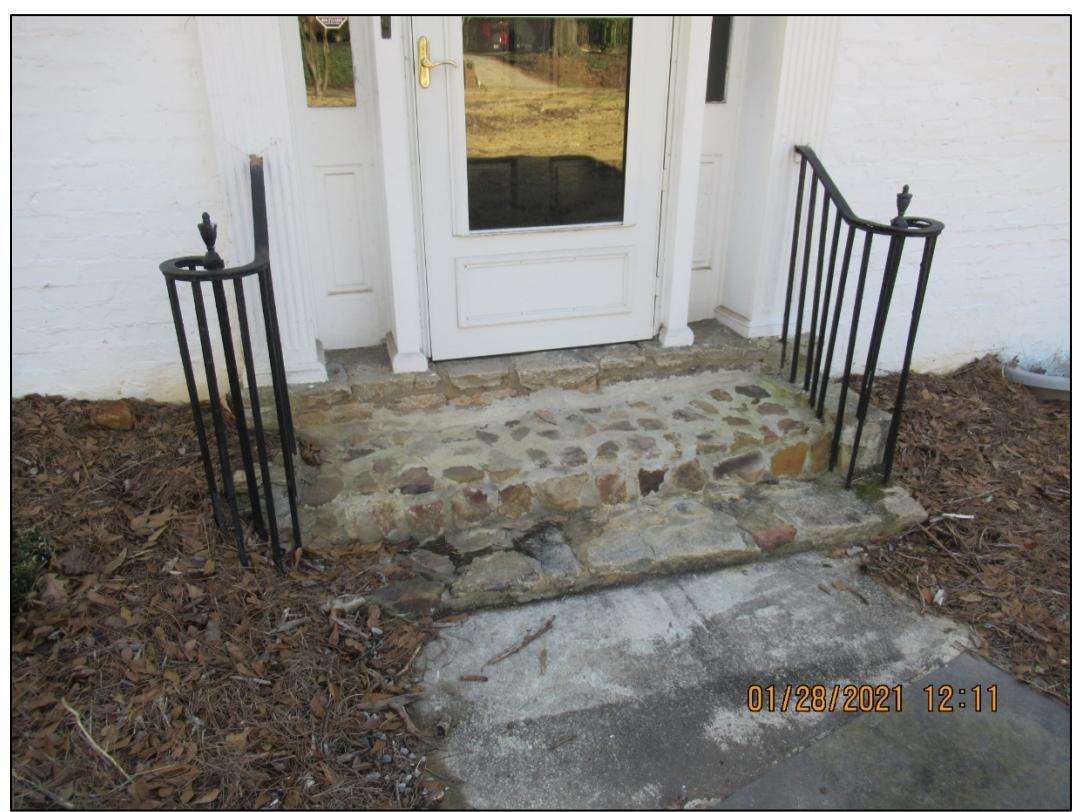
Photo 38: The landing at the front door does not comply with the code requirements for depth. The bottom step has deteriorated.
