DeKalb County Historic Preservation Commission

Monday, April 15th, 2024- 6:00 P.M.

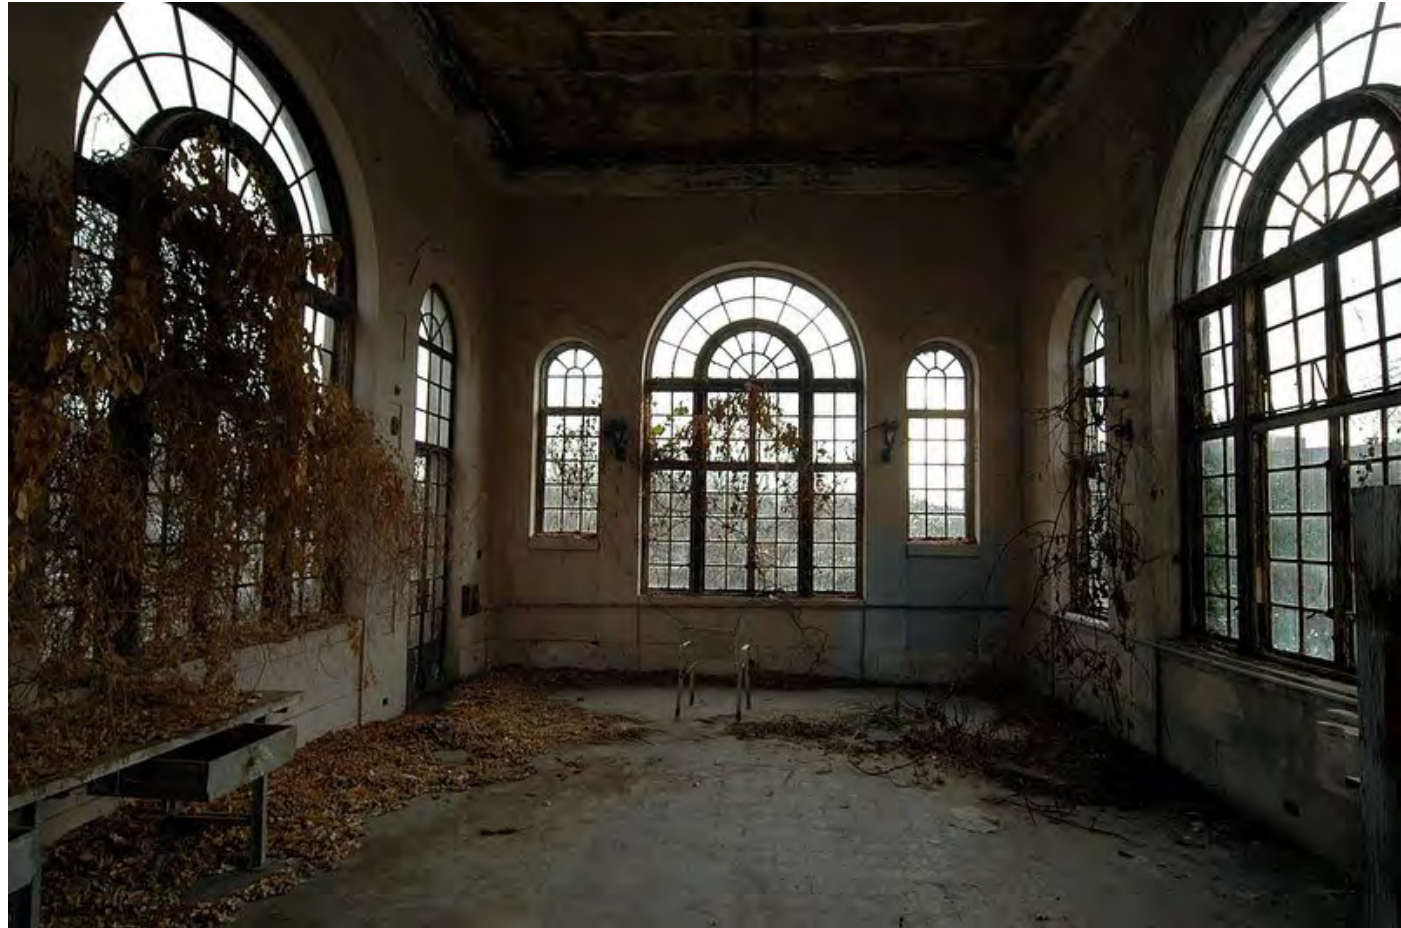
1925-48: Candler Additions

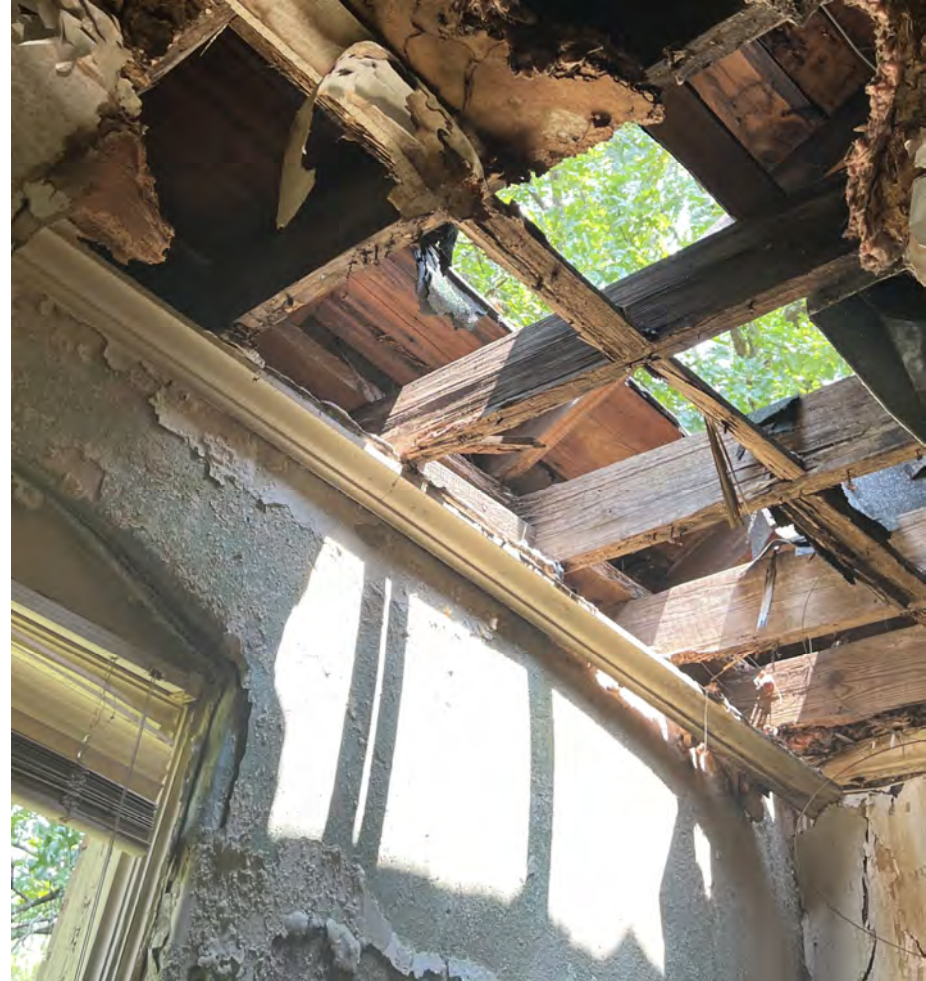
Condition - Exterior

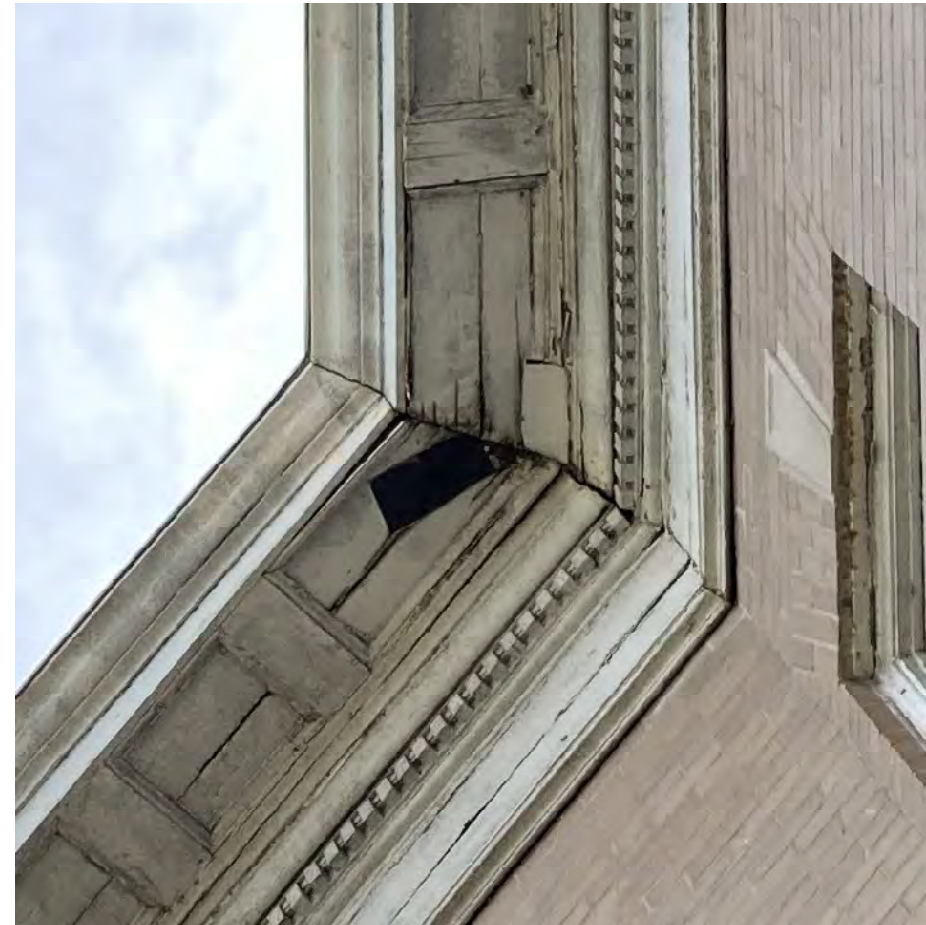
Condition - Exterior

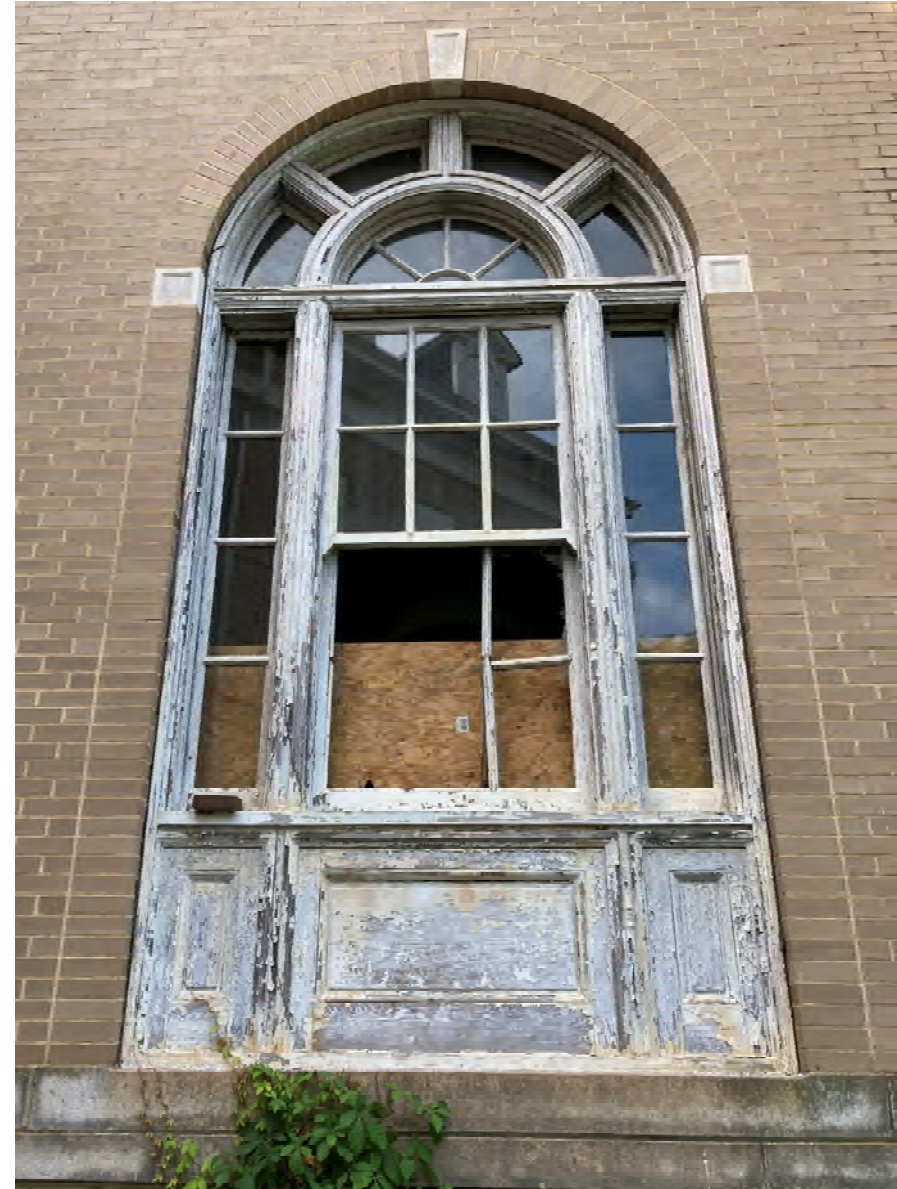
Condition - Interior

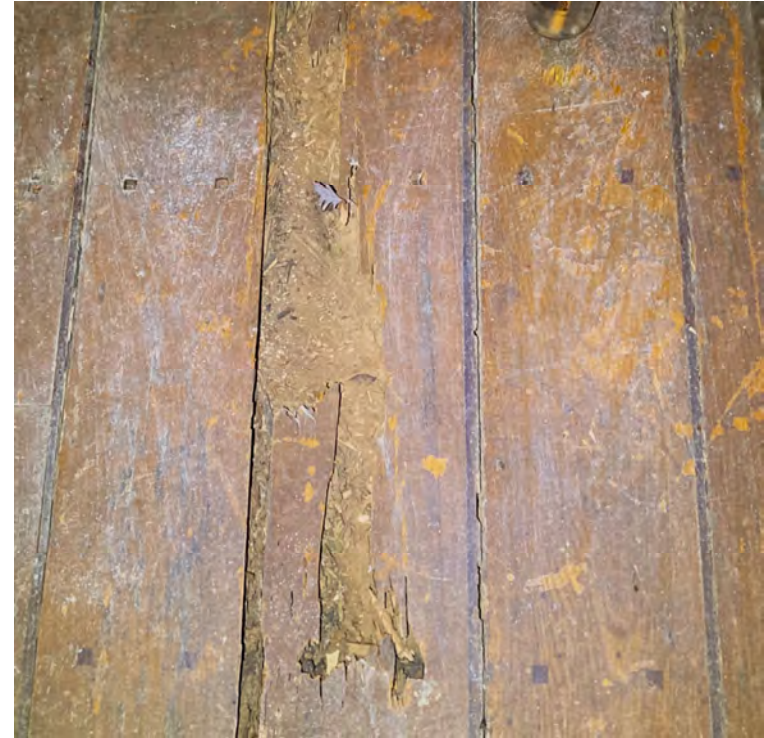
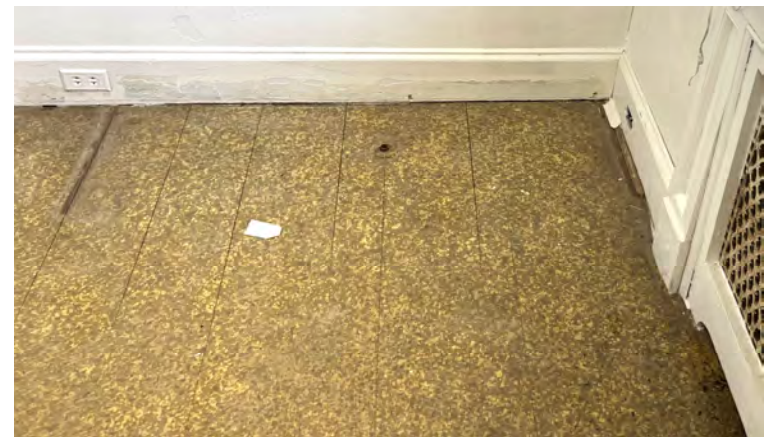
*Condition - Interior

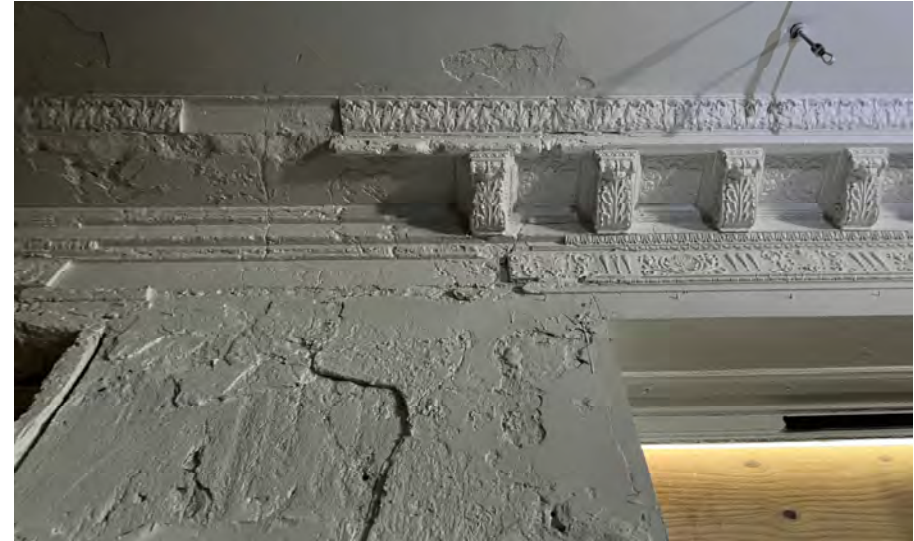
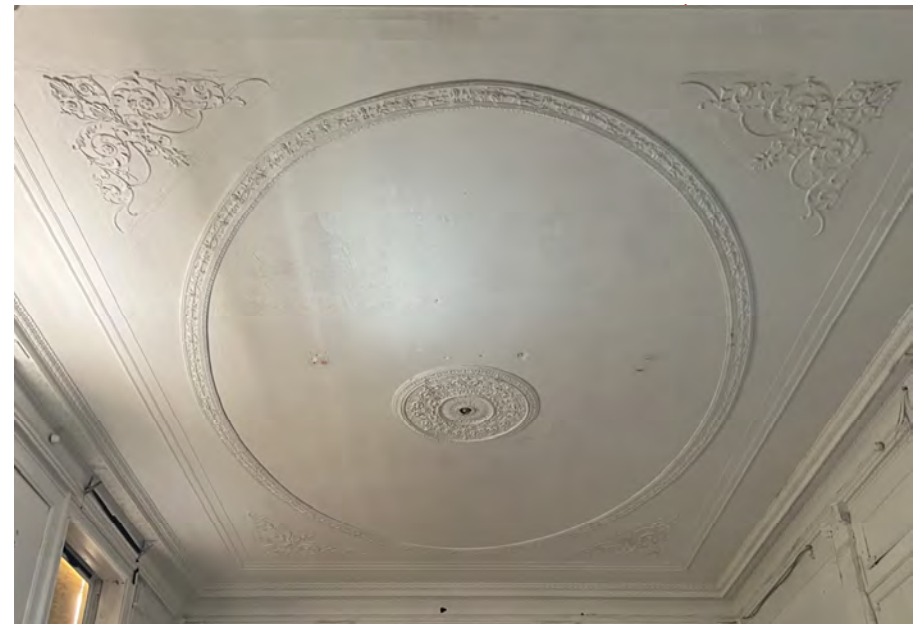
Wood Paneling: Wall and ceiling paneling at the Library and Music Hall have been subject to the same damage as the plaster walls/ceilings but have also been affected by 25 years of temperature and humidity in the unconditioned building.

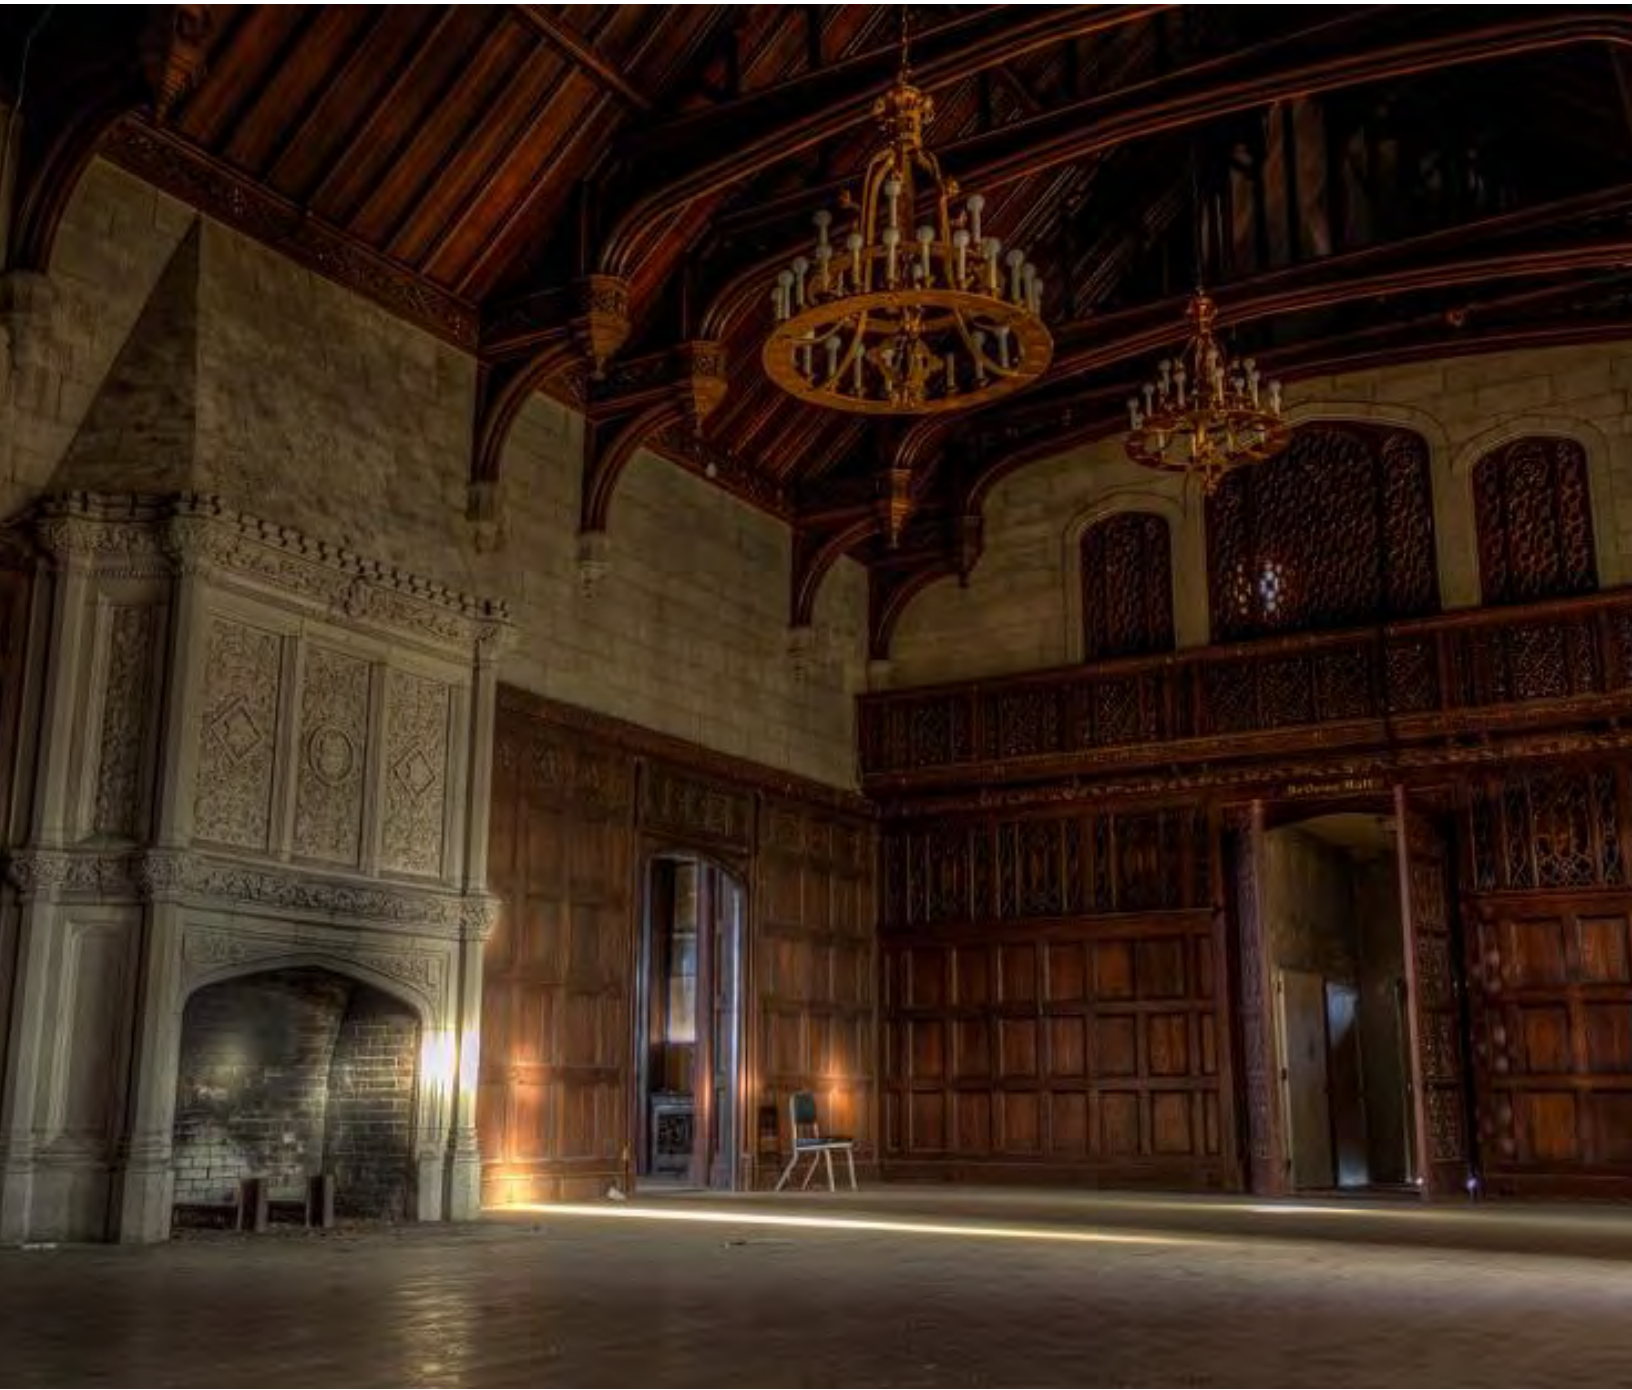
Candler Mansion Conditions Assessment & Schematic Design Scope

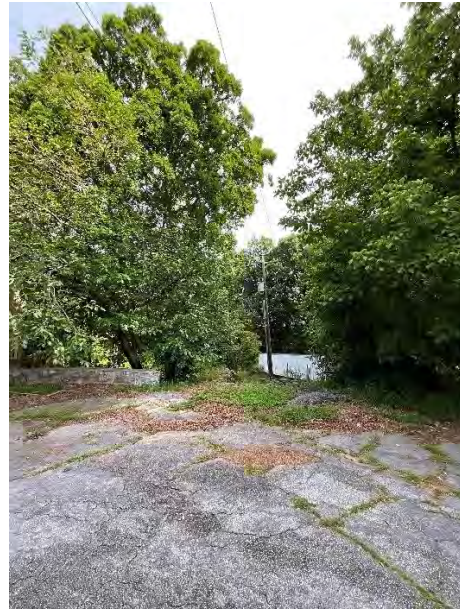
Figure 2: Existing Single-Phase Overhead Electrical Service – Back Buildings

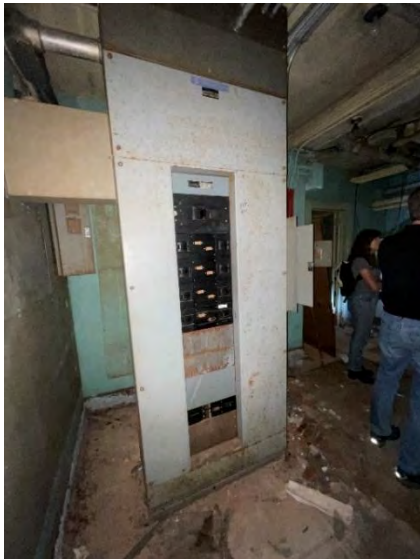
Figure 3: Existing Building Main Switchboard

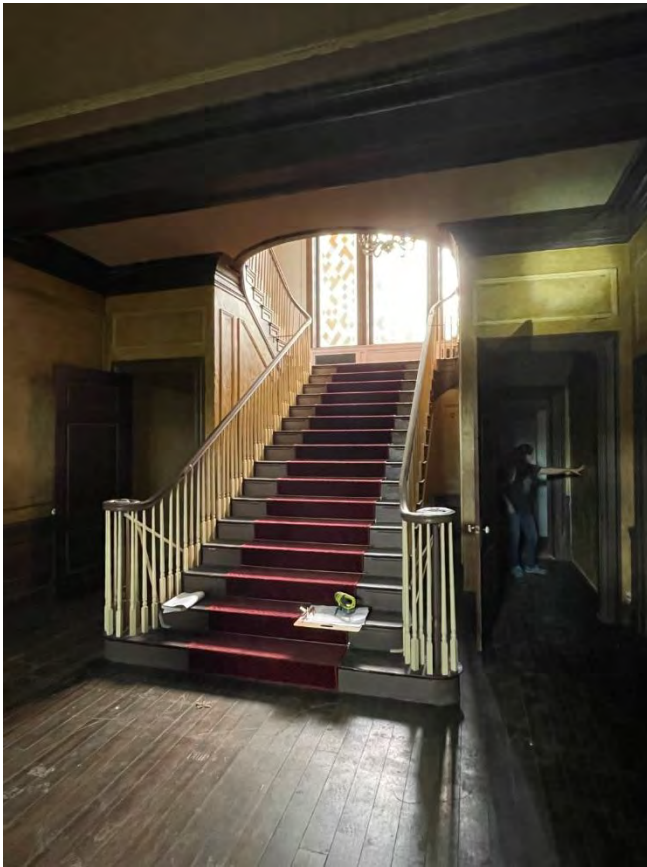
IMG 109-1: Entry Hall Main Stairs. Remove Non-Historic infill under 2nd stair runs. Remove/replace non-historic rail and balusters. Visible flooring is loose laid LVT plank over original 1 1/2" T&G wood flooring.

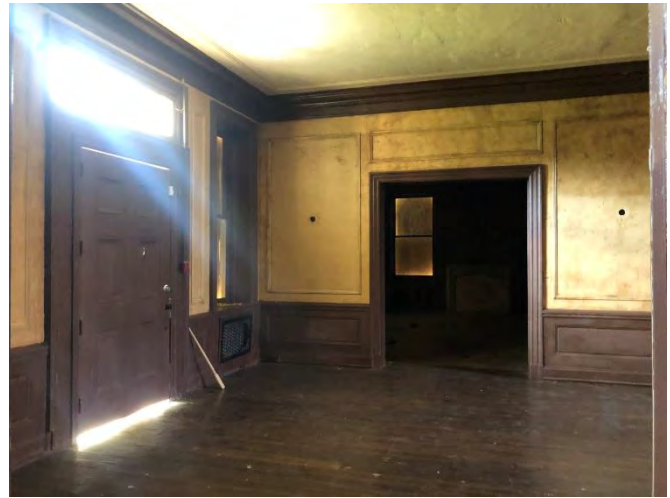
IMG 109-2: Front door and opening into wood paneled Library 104. Paint and textured plaster finish to be removed.

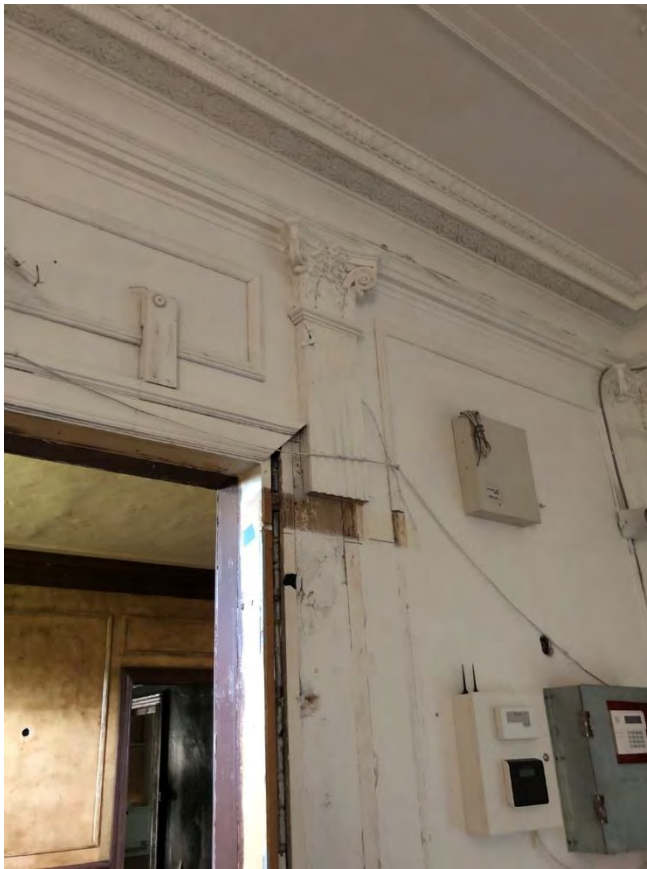
IMG 110-3: Damaged/Missing trim elements.

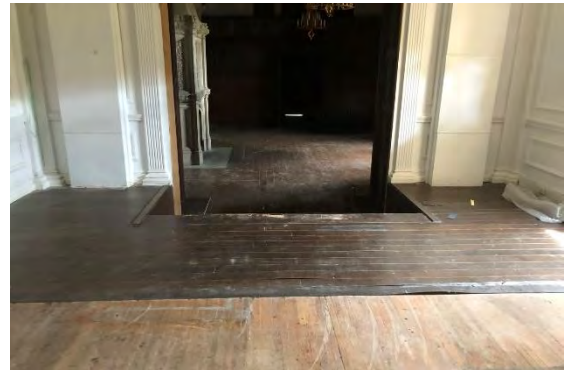
IMG 110-4: Stairs over Original to be removed.

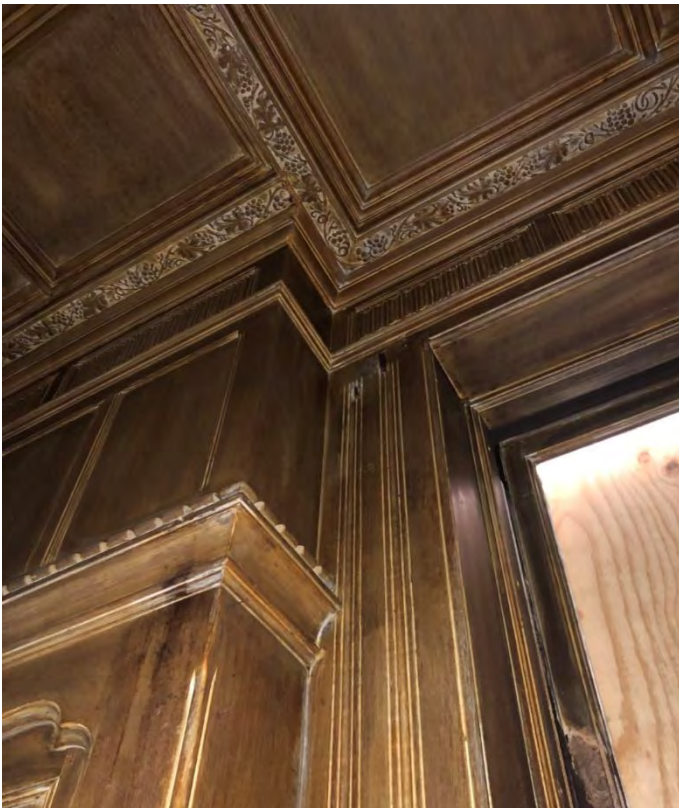
IMG 104-3: Heavily detailed trim in good condition.

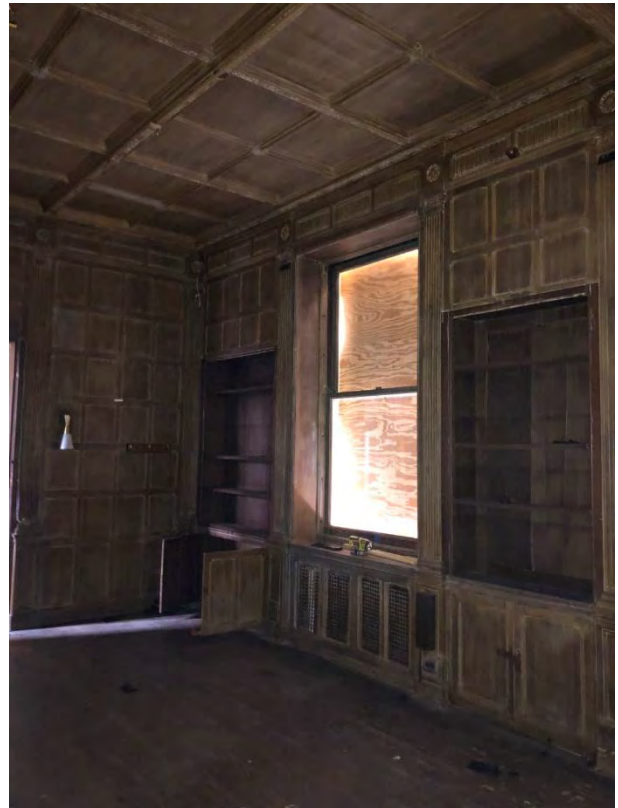
IMG 104-4: Built in shelves. Shelves at right in photo water damaged. Back of shelf to be replaced in-kind.

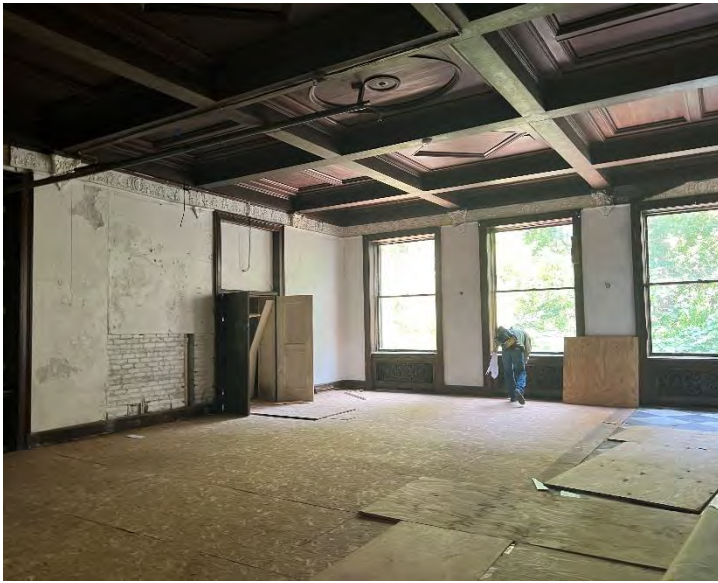
IMG 122-1: Banquet Hall – Original floors assumed lost. 6” ornamental plank similar to Music Hall.

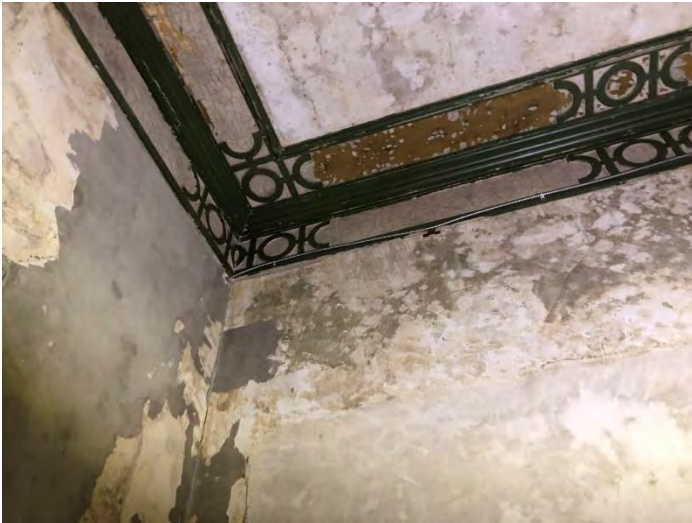
IMG 111-1: Family dining room original crown molding which depicts the garden lattice theme of the original space. Similar wall applied elements are missing but historic photographs are available.

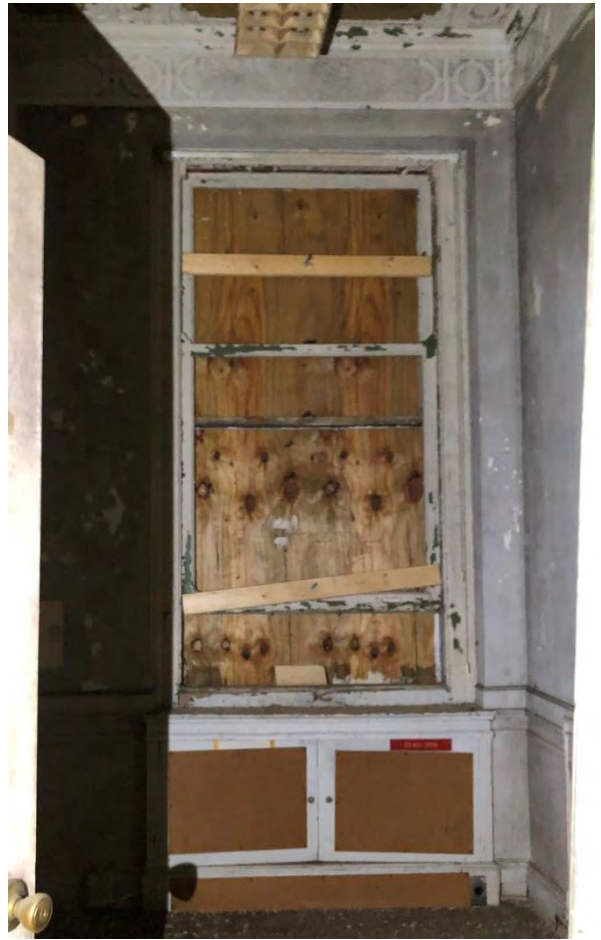
IMG 111-2: The space is currently divided up into various office spaces used in the institution era. This wood window will be removed to create an opening to a new LULA elevator in Lightwell 1.

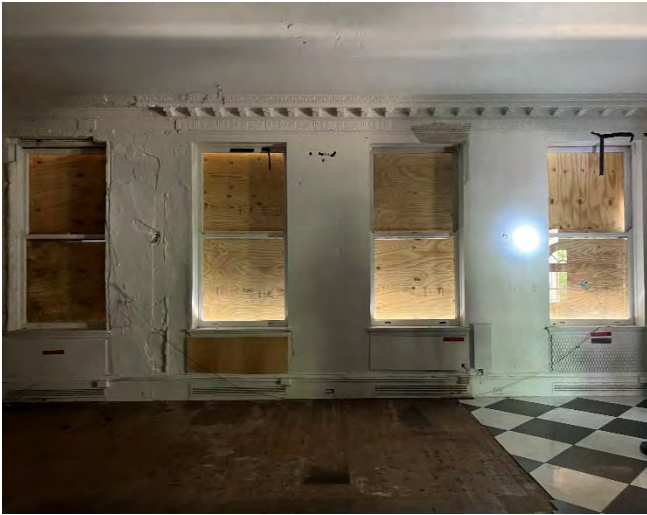
IMG 102-1: Family Living Room with water damage located on the left side of the image, effecting both the wall and ornate plaster crown molding with corbels. Tile floor section not original. 1 ½" T&G oak typical at Main House 1st Floor

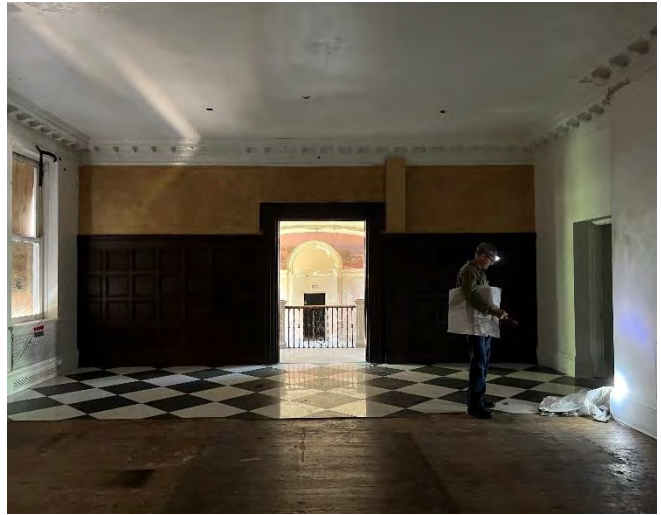
IMG 102-2: Family Living Room looking west towards Solarium. Black and white tile, paneling, and textured paint are non-historic movie set additions.

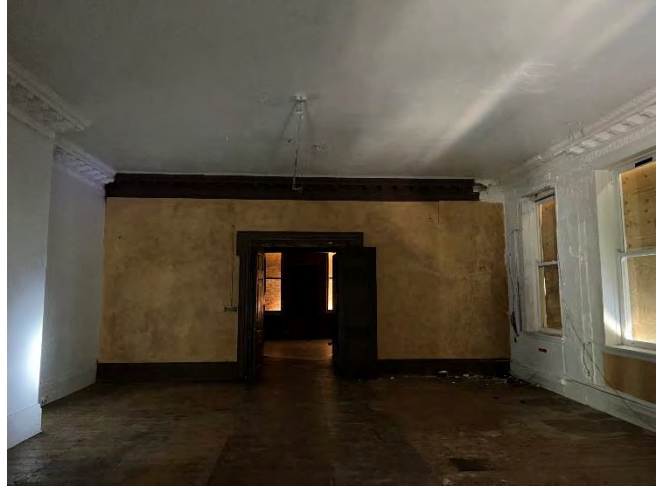
IMG 102-4: Family Living Room looking west toward South Hall and Library. Again, the textured plaster and doors are not original. Note: water damage in back right corner mentioned in image 1.

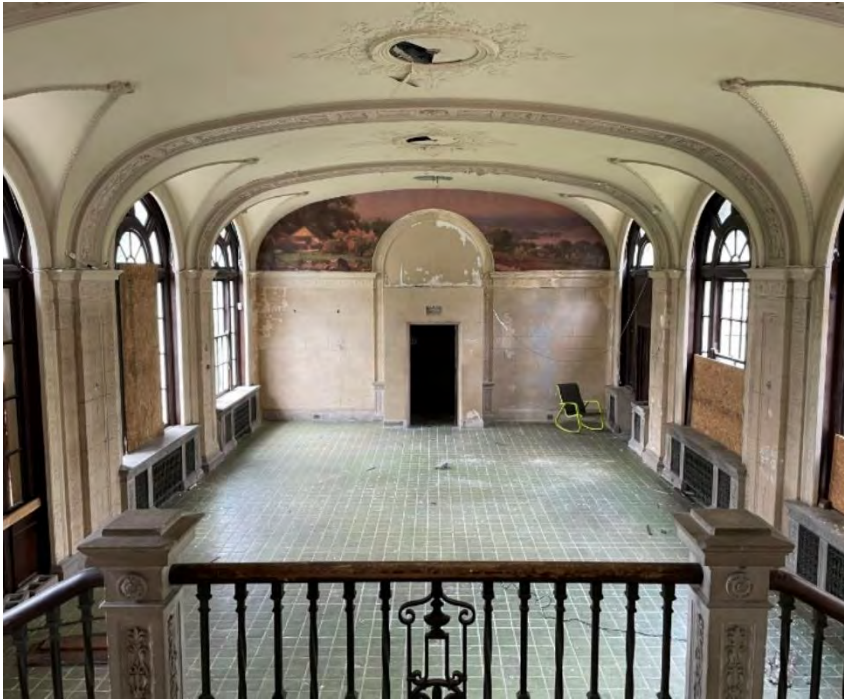
IMG 101-1: Solarium looking west from stair landing. Door and vestibule "box" leading to egress stair to be removed. Mirrored imitation of typical window to be installed in arched opening original arched opening.

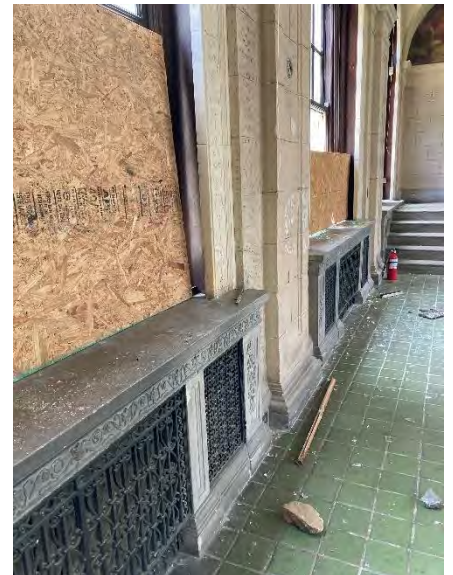
IMG 101-4: Rusticated stone veneer pilasters and typical arched opening carved detailing.

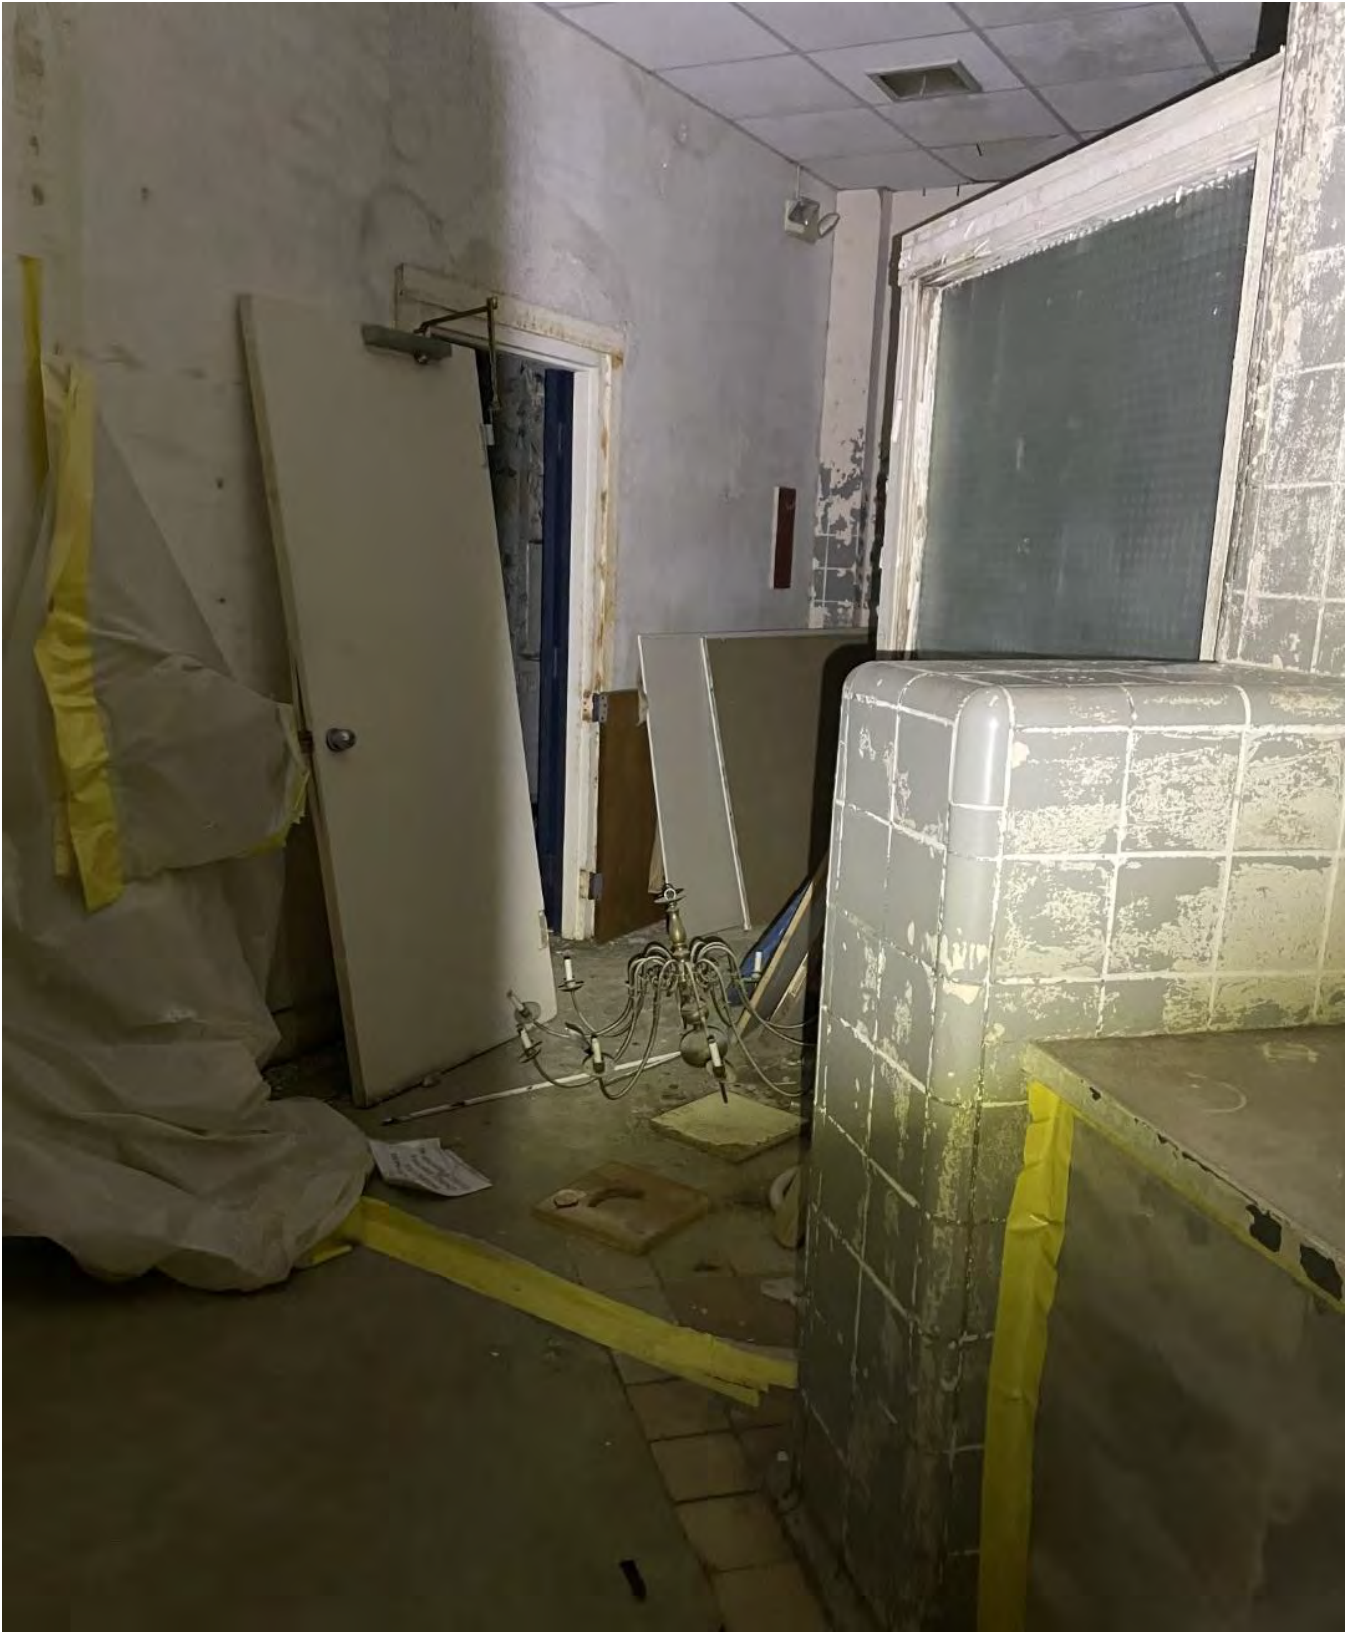
IMG 114-1: Original Kitchen was divided up into many rooms during the institution era. Tile @ floors, full height walls and even ceilings appear to be original materials. Area of mansion to contain new restrooms serving future event/assembly uses.

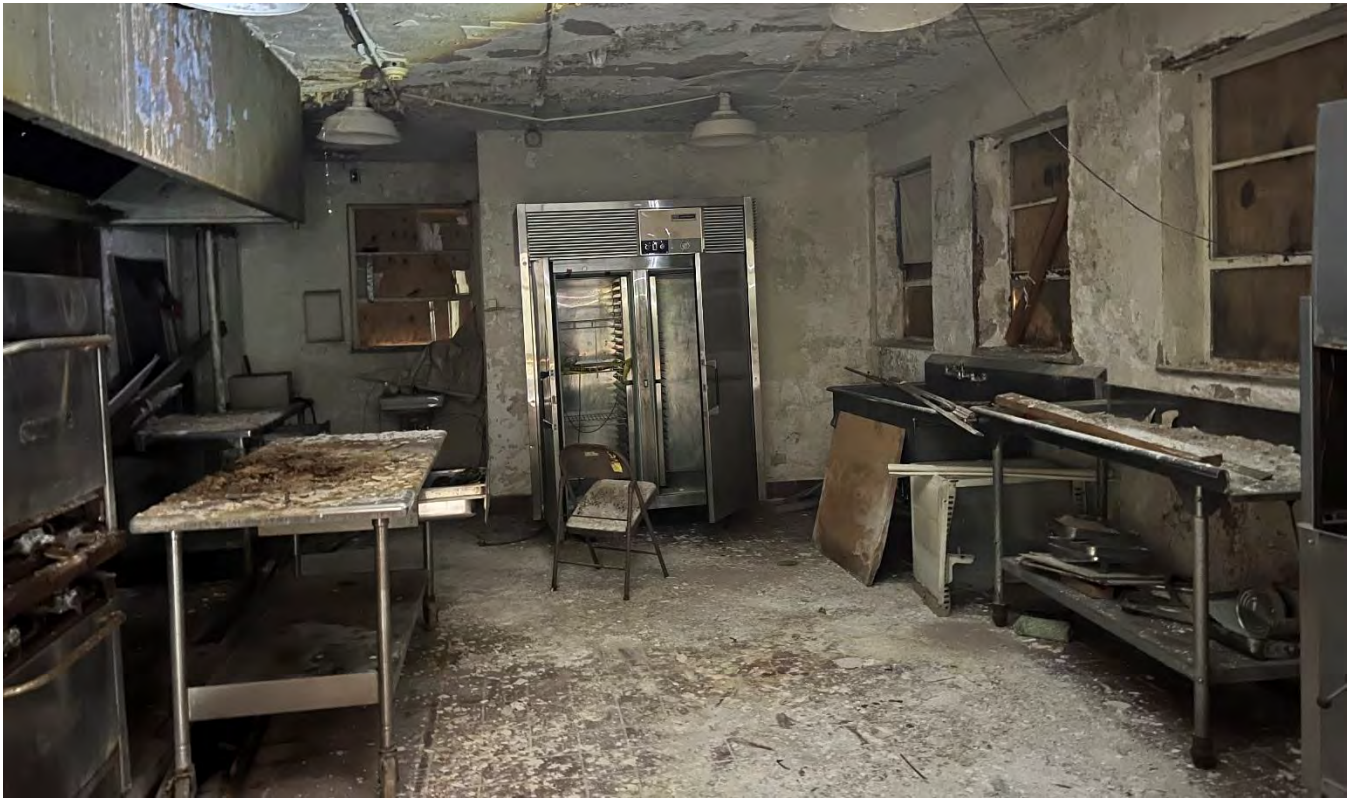
IMG 123-1: Institutional Kitchen addition off of the Banquet Hall in poor condition.

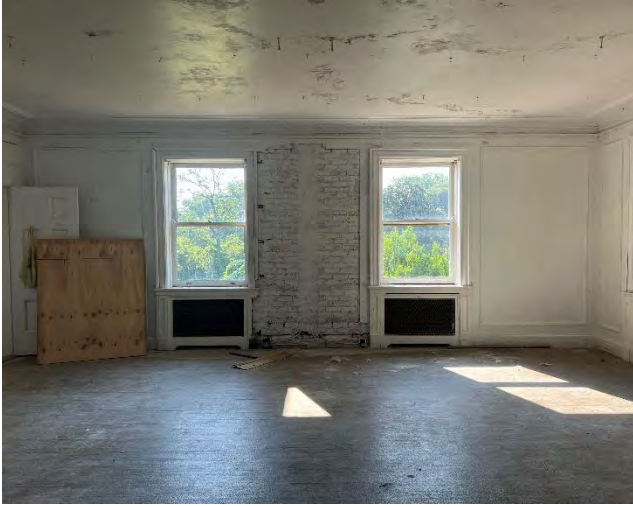
IMG 208-1: Candler's bedroom which showcases water damage on the front side of the mansion in between two windows.

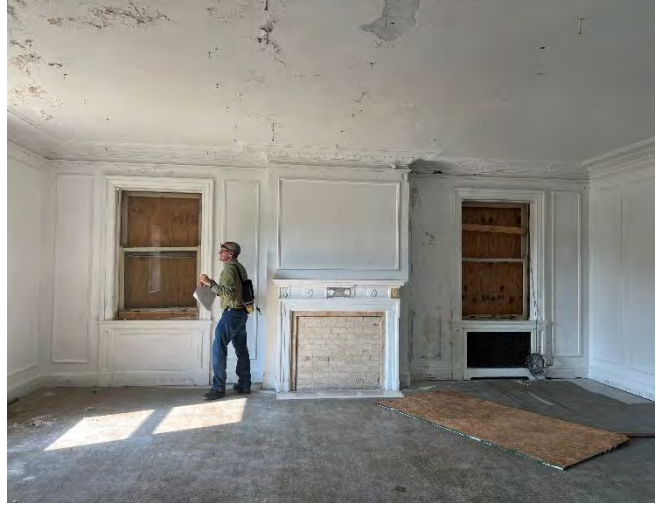
IMG 208-2: Directly above the Library, marble mantle at closed-up fireplace. (Original chimney at this location has been removed from structure).

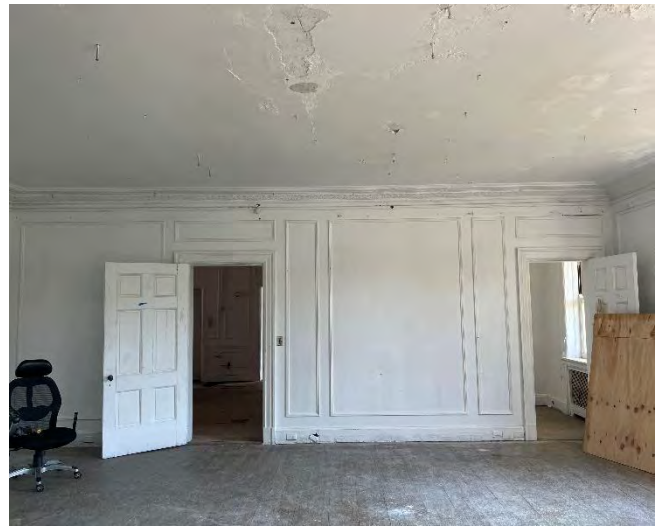
IMG 208-4: Typical smooth plaster walls with applied wood moulding creating panels. Looking north at doors leading to Stair Hall and Bath 4 & Closet. Typical ceiling damage visible after removal of ACT ceiling systems.

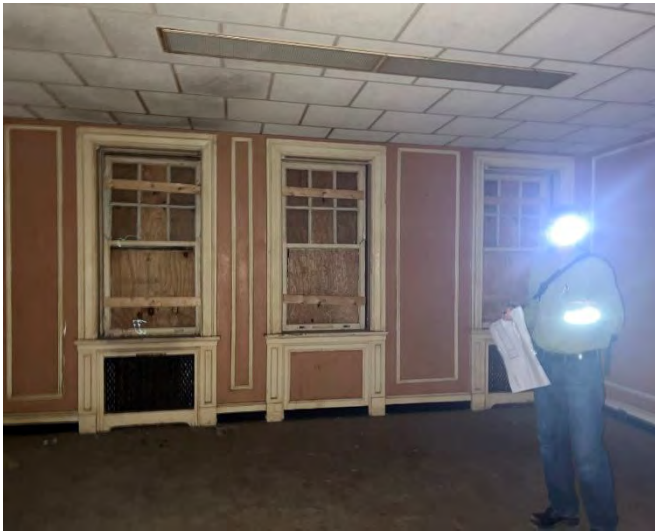
IMG 203-1: Typical bedroom on the second floor of the mansion. The radiator enclosures are typical for most of the enclosures throughout.

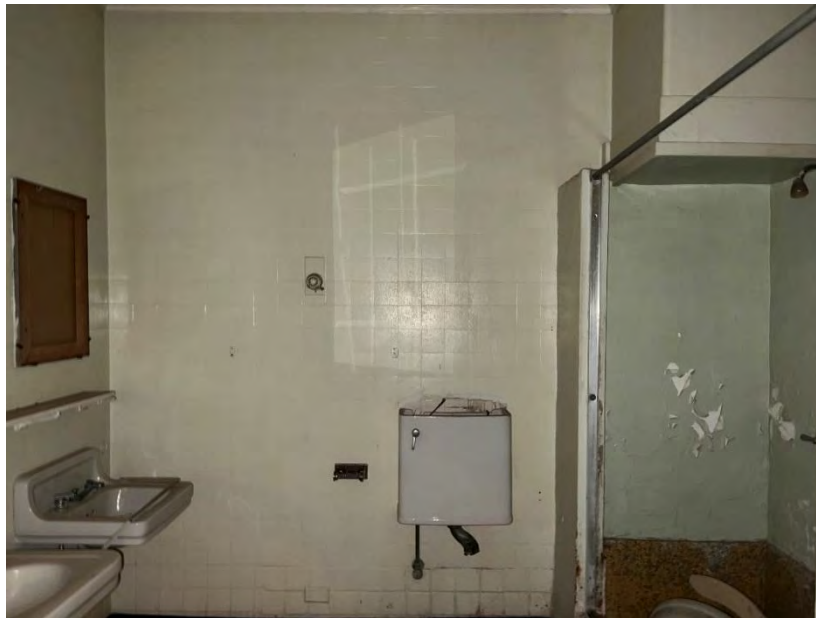
IMG 204-3: Tiles in a typical bathroom in good condition covering the walls. Existing plumbing fixtures to be removed and replaced.

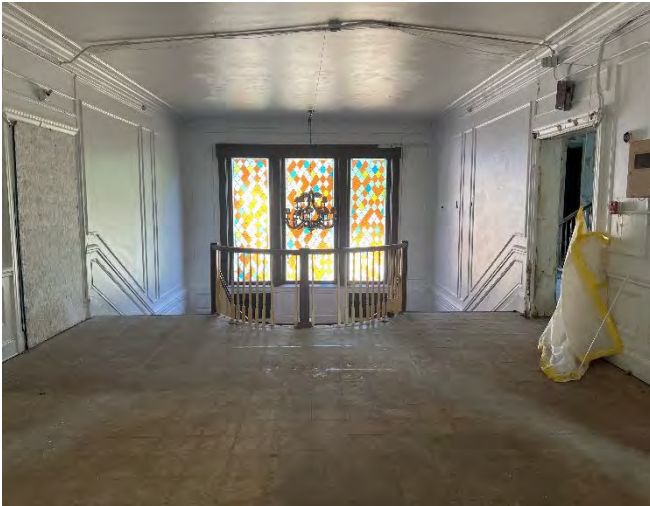
IMG 209-1: Stair Hall from first floor entry hall ascending to second floor. Non-historic faux stained-glass panels to be removed and replaced with new sashes. Fixed or double hung to-be-determined.

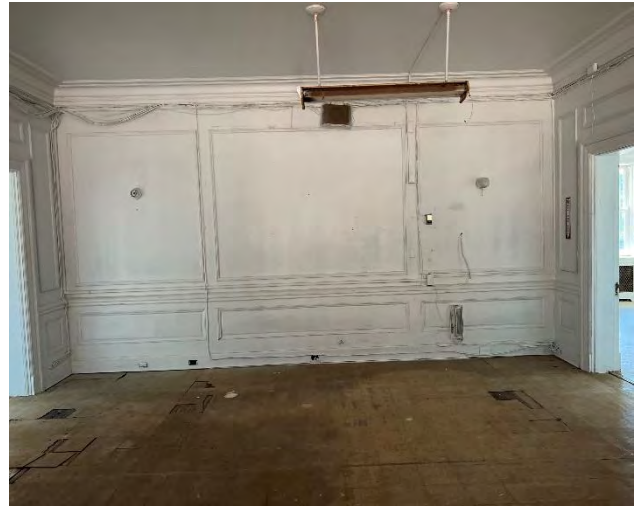
IMG 209-2: Applied Panel molding on plaster over raised panel wainscot in Stair Hall runs throughout second floor circulation hallways.

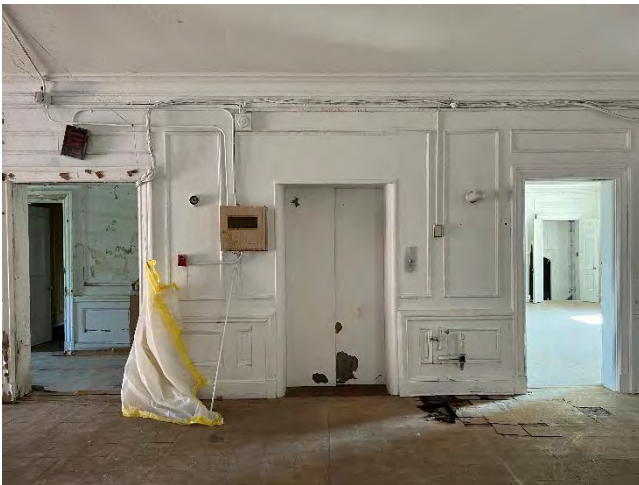
IMG 209-3: Elevator installed at former Bedroom closet location on this floor. Door on left leads into Back Stair Hall and North Hallway. Both with severe water damage to plaster and wood paneling finishes.

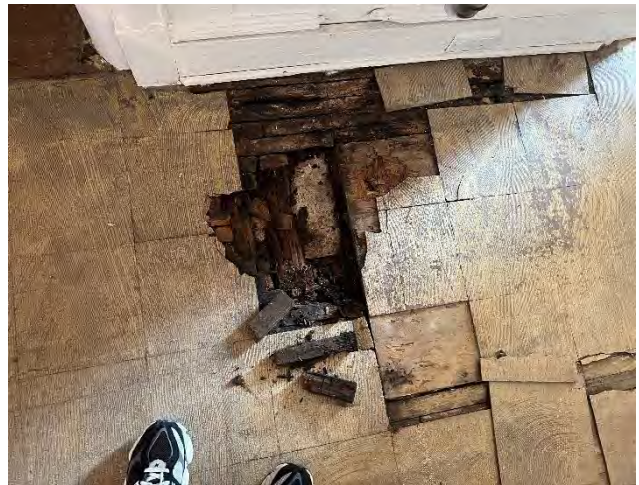
IMG 209-4: existing ACT flooring on plywood installed over original tongue and groove wood flooring. Areas of water damage revealing layers shown here.

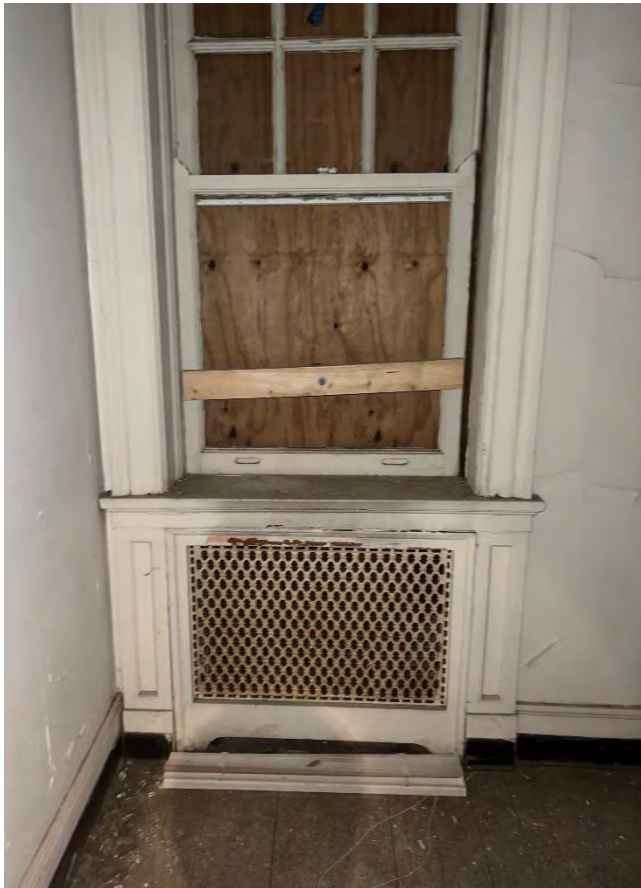
IMG 206-1: South Hallway with typical radiator enclosure as seen in most of the mansion. (this window was originally in end bedroom on this wing but became part of egress corridor when stair was added to end of wing.)
