DeKalb County Historic Preservation Commission

Monday, April 15th, 2024- 6:00 P.M.

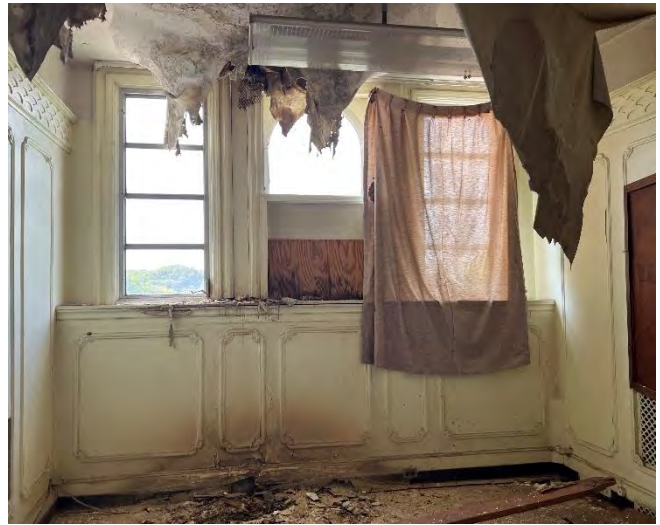
IMG 311-2: Water damaged plaster ceiling in South Alcove. Aluminum replacement windows to be removed and replaced with historically accurate wood sashes.

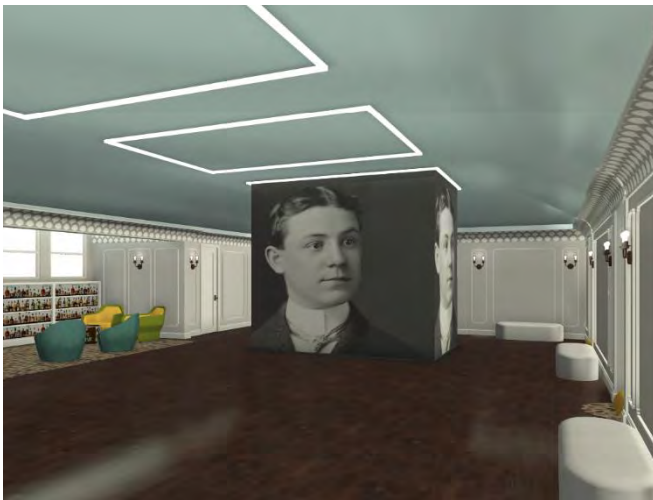
IMG 311-3: Interior rendering showing restored space. Non-historic elevator shaft to remain in current location. Ornamental cove crown moulding is still intact for restoration. The majority of original wall panel trim is also intact.

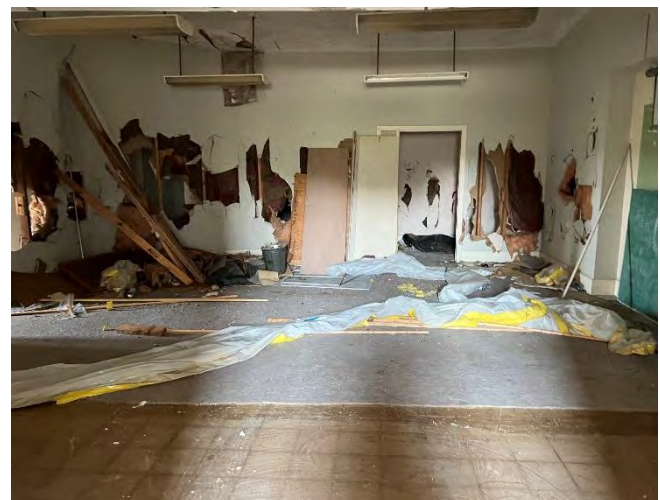
IMG 311-4: Current condition of one of the subdivided rooms in the middle of the ballroom. Note ACT flooring over original wood flooring to be removed. Wood floors may be restorable if plywood subfloor was utilized under tile but assume carpet finish for SD pricing.

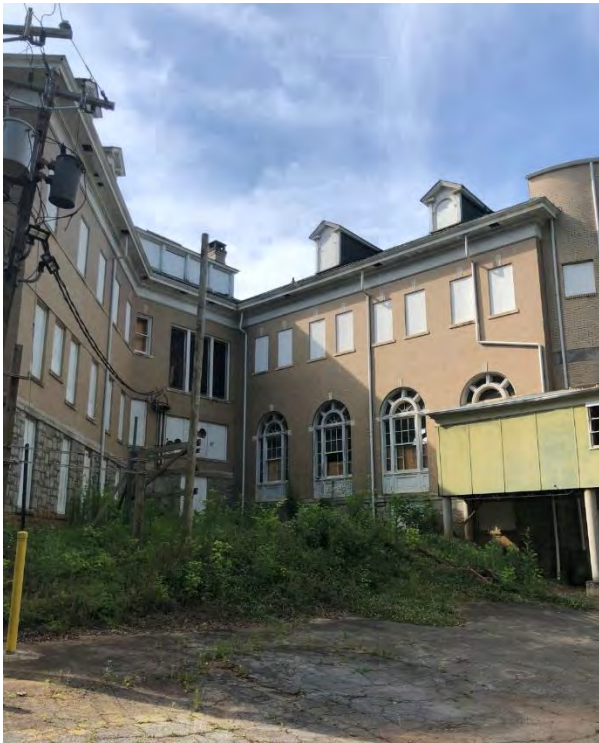
IMG EX2-1: Northwest courtyard on the back of house. Broken windows are to be fixed, and the bridge the carriage house is to be removed. This is the location of the new addition to the house which includes a new elevator.

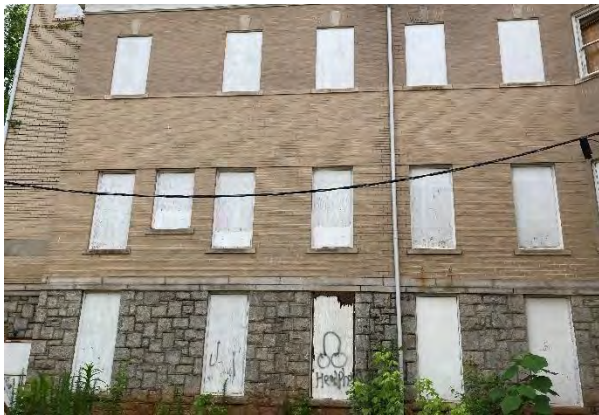
IMG EX2-3: Boarded up windows cover the East Wing of the Candler Mansion, largely protecting the broken windows that lie behind.

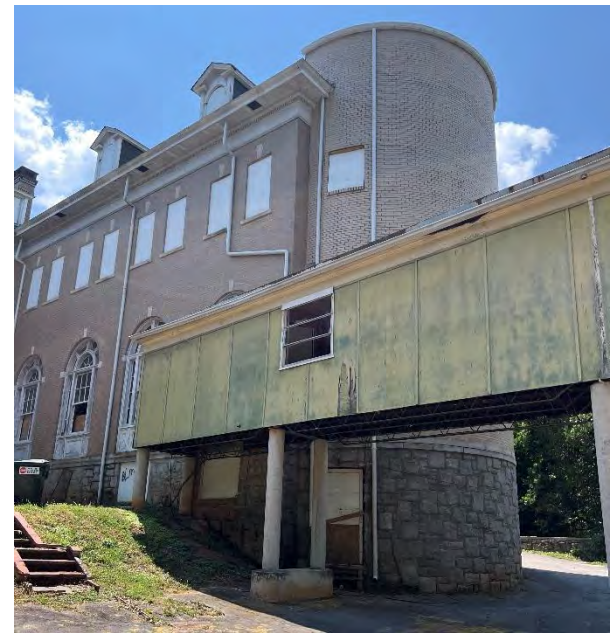
IMG EX2-4: Closer look at the Solarium half circle stair addition as well as the addition of the bridge that connects to the Carriage House.

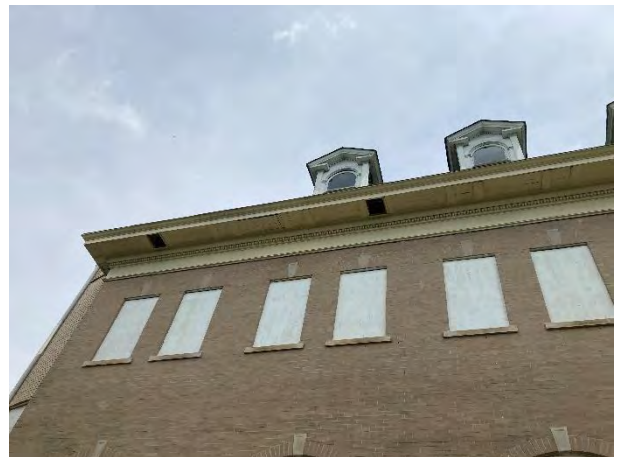
IMG EX3-4: Jack arch windows in the children's rooms above the Solarium. Brick on Southeast side is largely in good condition.

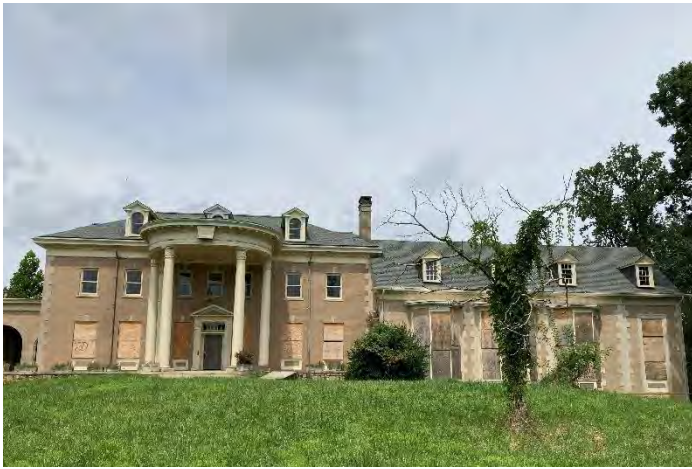
IMG EX4-1: South angle approaching the Candler Mansion.

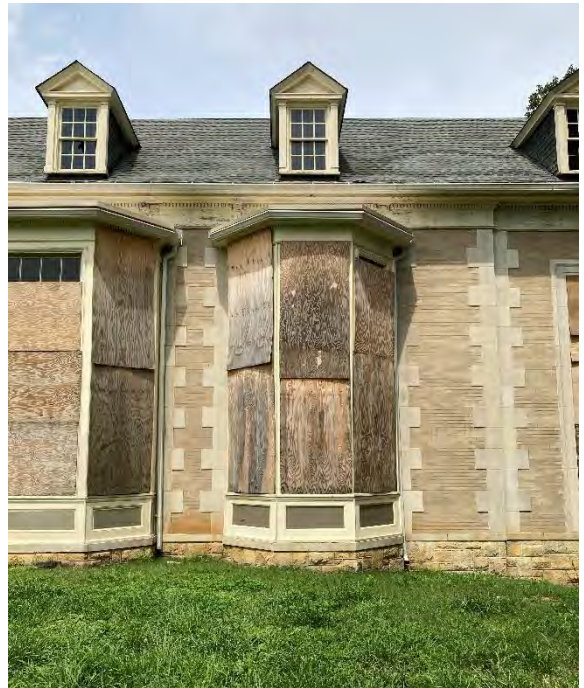
IMG EX4-2: Boarded up, damaged windows of the Music Room.

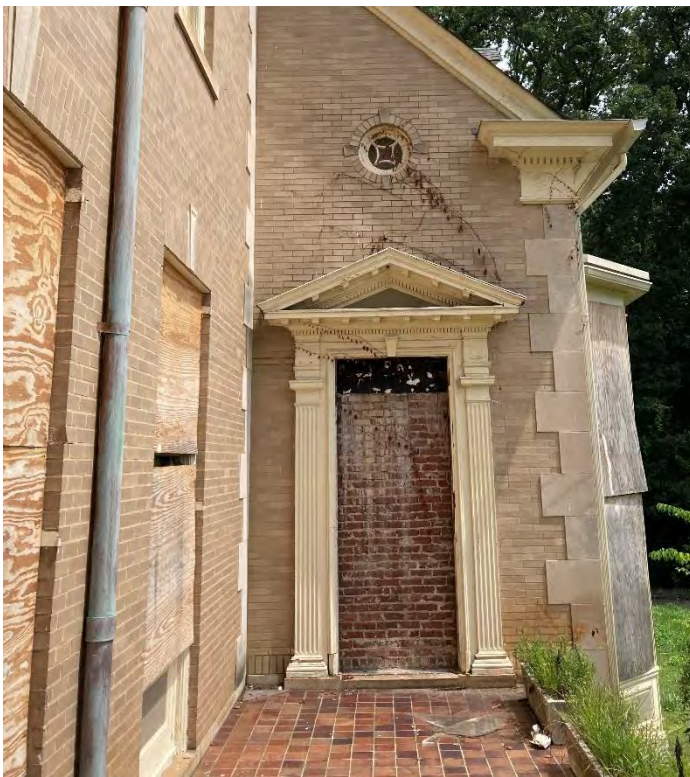
IMG EX4-3: Detailed trim of brick-filled door that leads to nothing on the interior side. Trim needs repair.

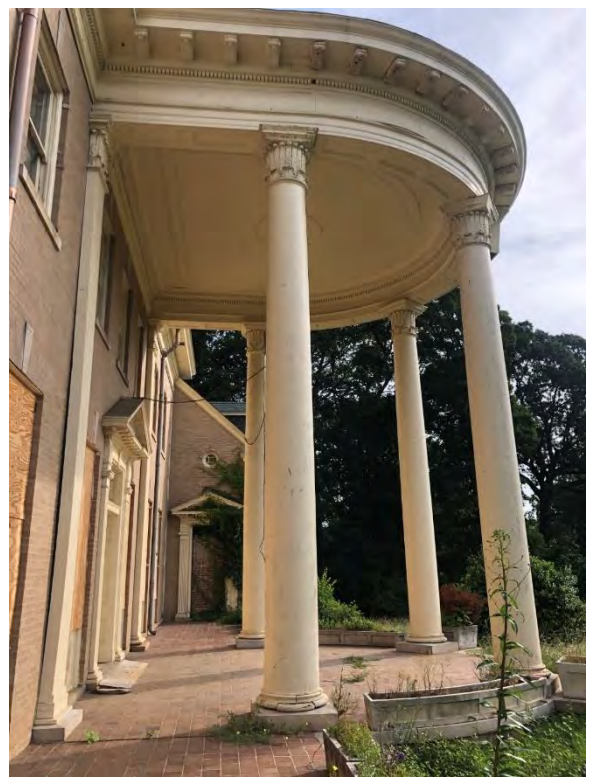
IMG EX4-4: Entry patio for main door. Column bases need to be addressed.

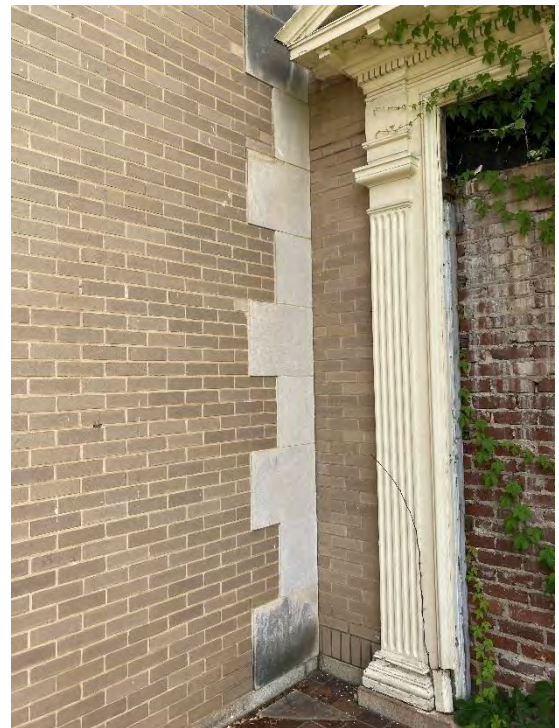
IMG EX5-5: Corner of entry patio containing many typical materials used extensively around the Candler Mansion.

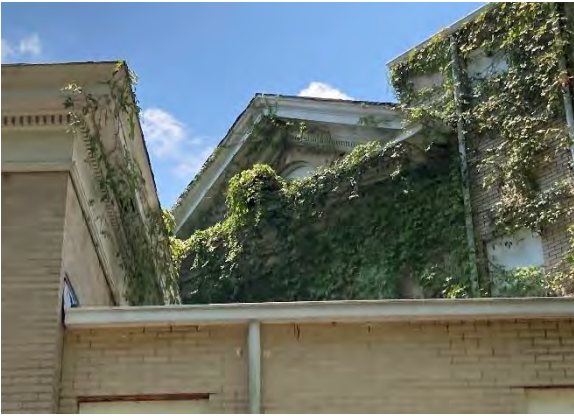
IMG EX6-1: Extensive overgrowth around the exterior. Here seen in Lightwell Two.

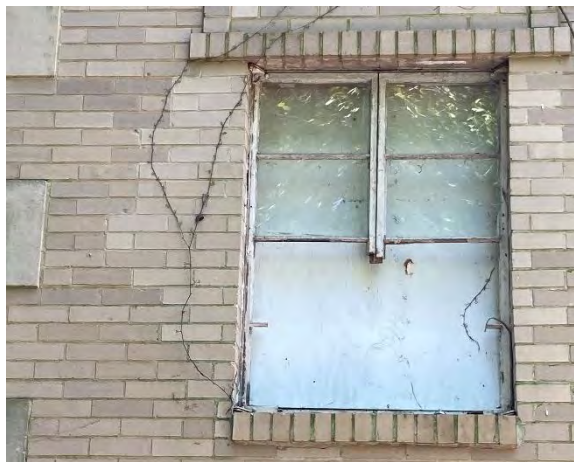
IMG EX6-5: Broken steel window on the Organ Room; typical for many steel and wood windows around the property.

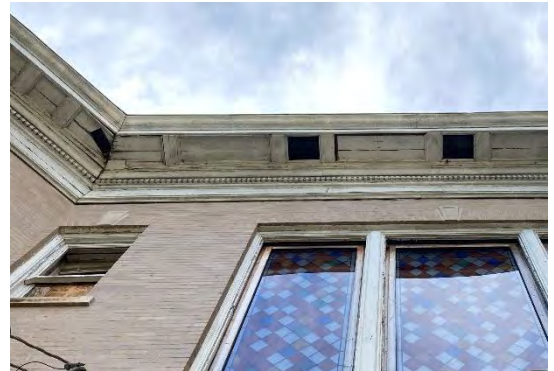
IMG EX6-4: Deteriorating roof trim on west side of mansion.

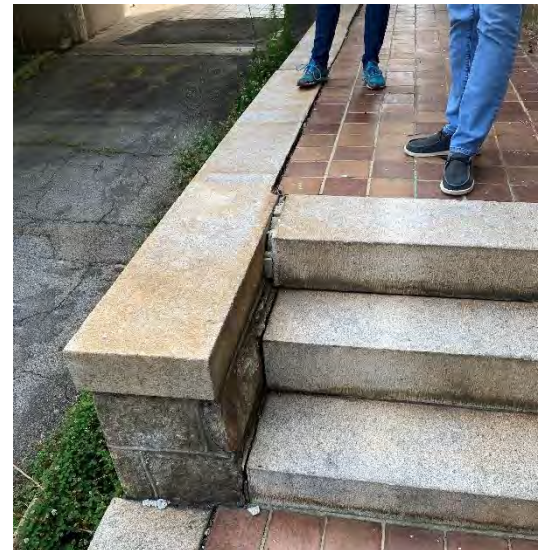
IMG EX6-6: Stone retaining wall breaking away from tile walkway; needs to be redone.

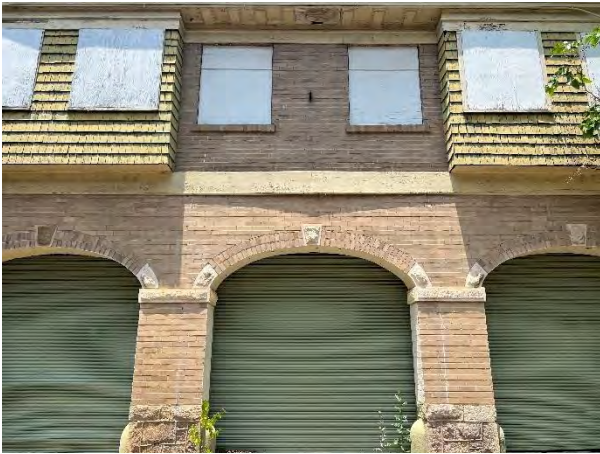
IMG CH1-1: East facing, front portion of Carriage House. Deteriorating roof trim and paneling need to be fixed.

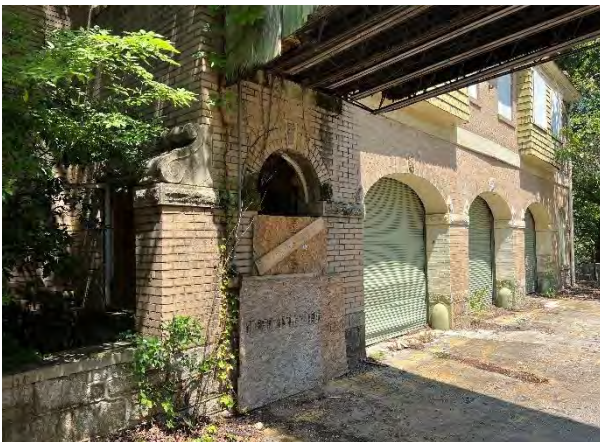
IMG CH1-3: Connection point between bridge from Solarium to second floor. Previous entry below now boarded up.

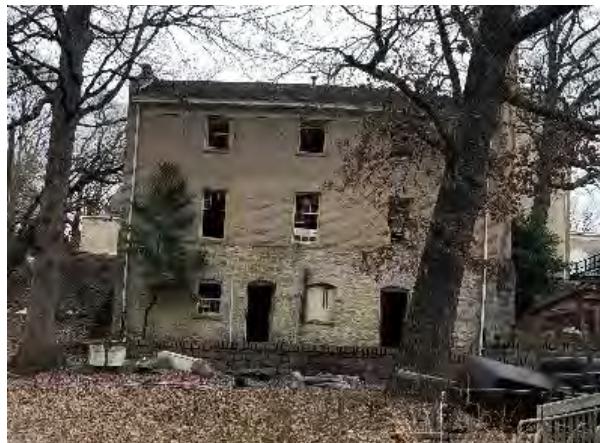
IMG CH1-4: West side entry to basement which contains many examples of deterioration. There is a large topographical change in this area.

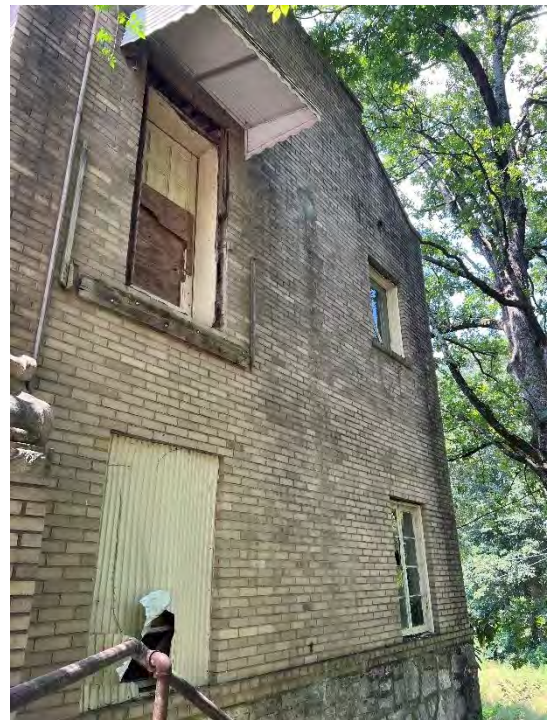
IMG CH1-2: North side with stairway down to back of Carriage House. Replace door with window matching adjacent.

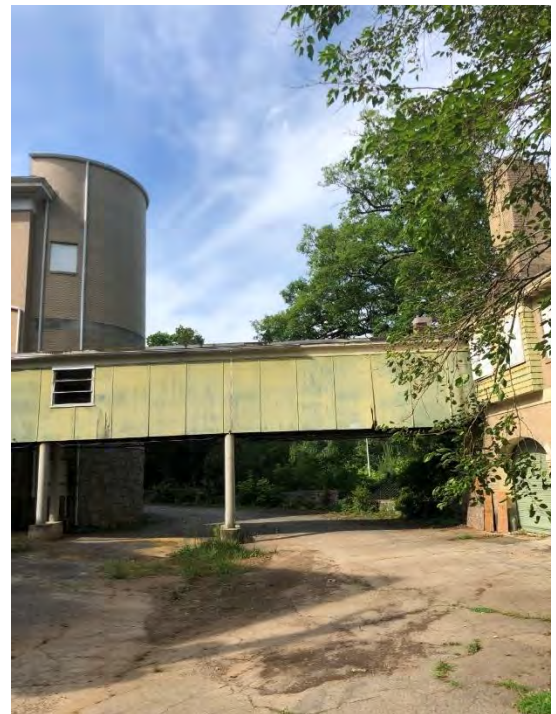
IMG CH1-5: Bridge connection from Main House to Carriage House which is to be demolished.

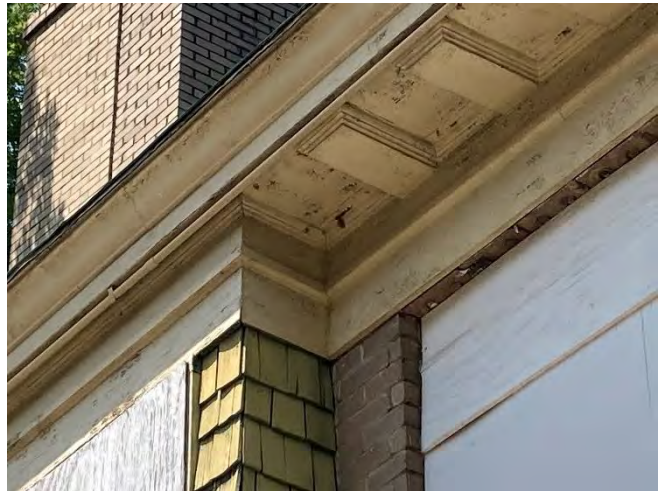
IMG CH2-4: Corner where deteriorating paneling connects with trim as well as brick wall.

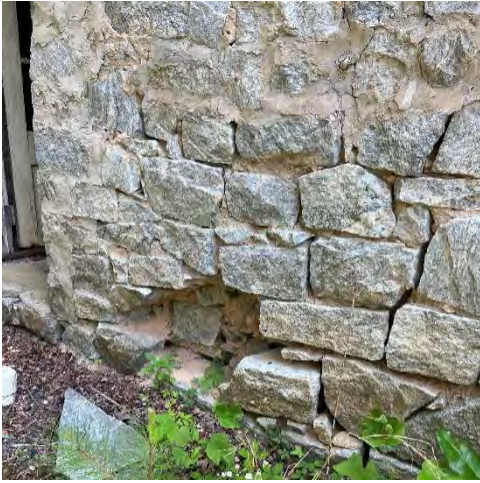
IMG CH3-1: Missing and cracked stone on basement level.

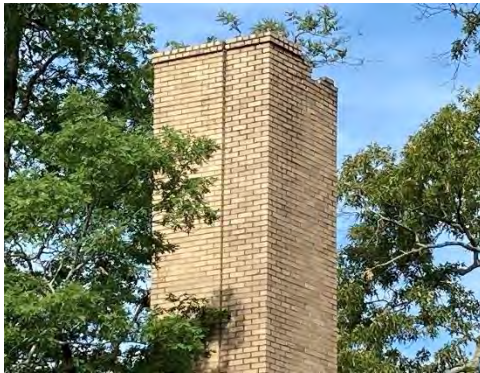
IMG CH3-3: Replacement needed on chimney with bricks missing on the top.

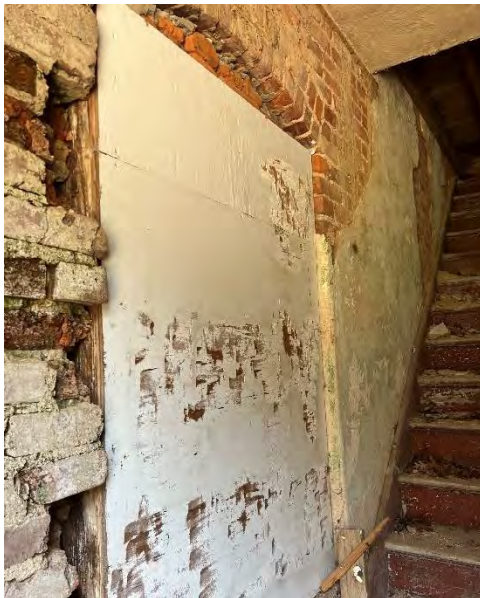
IMG CH3-4: Patched up entry and staircase on first floor.

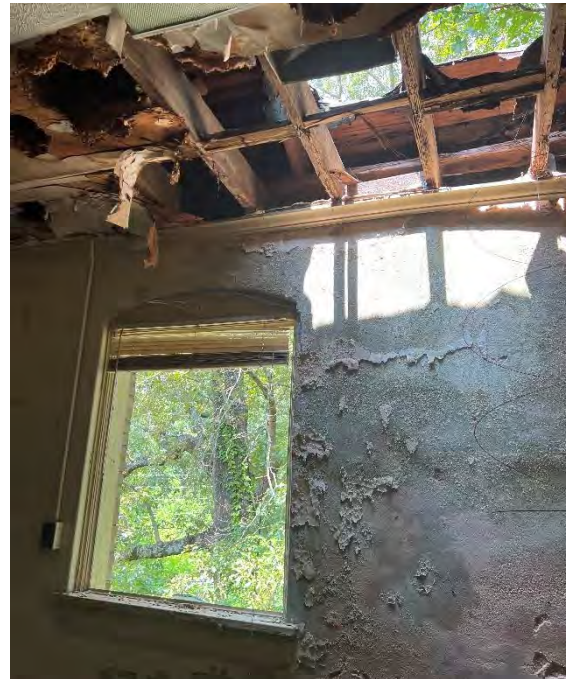
IMG CH3-2: Hole, one of two, in roof allowing structural deterioration. Framing repairs needed before roof replacement.

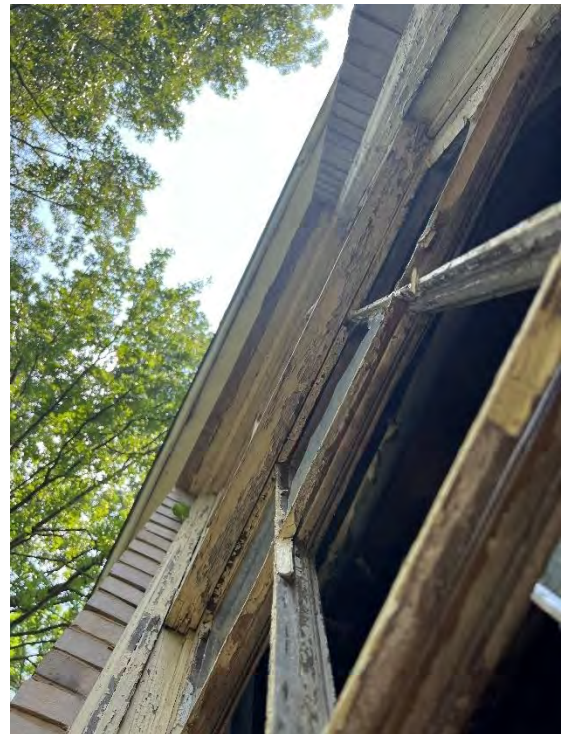
IMG CH3-5: Chipped paint and wood on windows. Window is missing windowpanes.

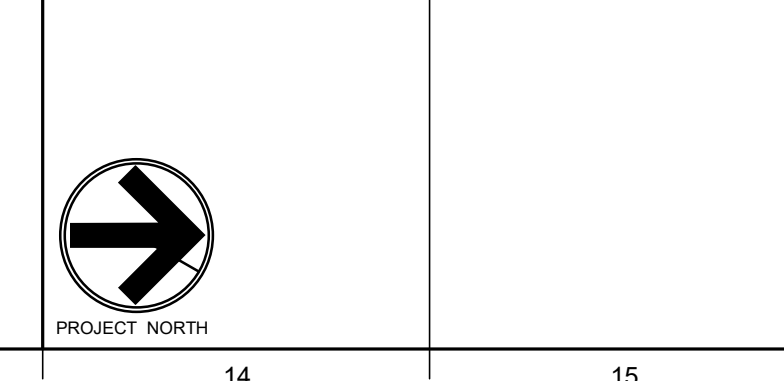
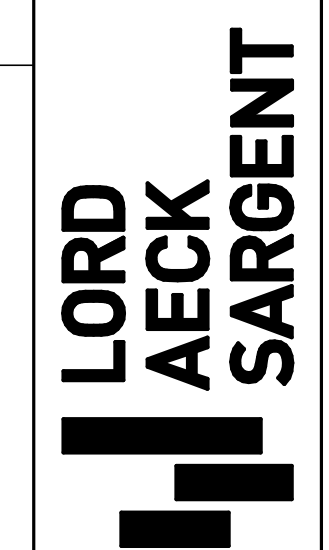
© 2023 Lord Aeck Sargent
Planning & Design, Inc.
LordAeckSargent.com

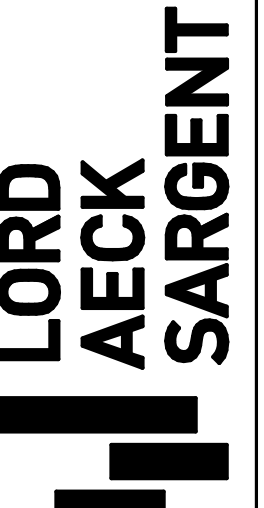
© 2023 Lord Aeck Sargent Planning & Design, Inc.
LordAeckSargent.com

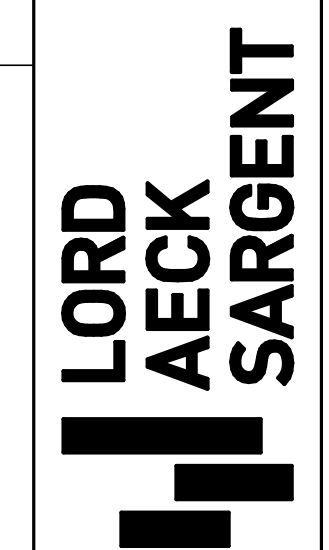
© 2023 Lord Aeck Sargent Planning & Design, Inc. LordAeckSargent.com

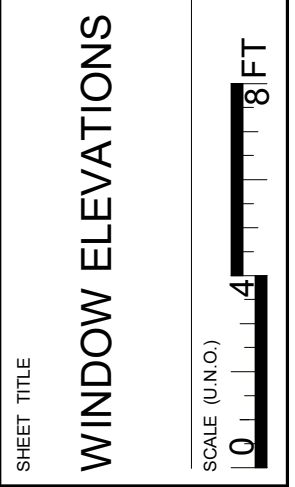
SHEET SPECIFIC NOTES

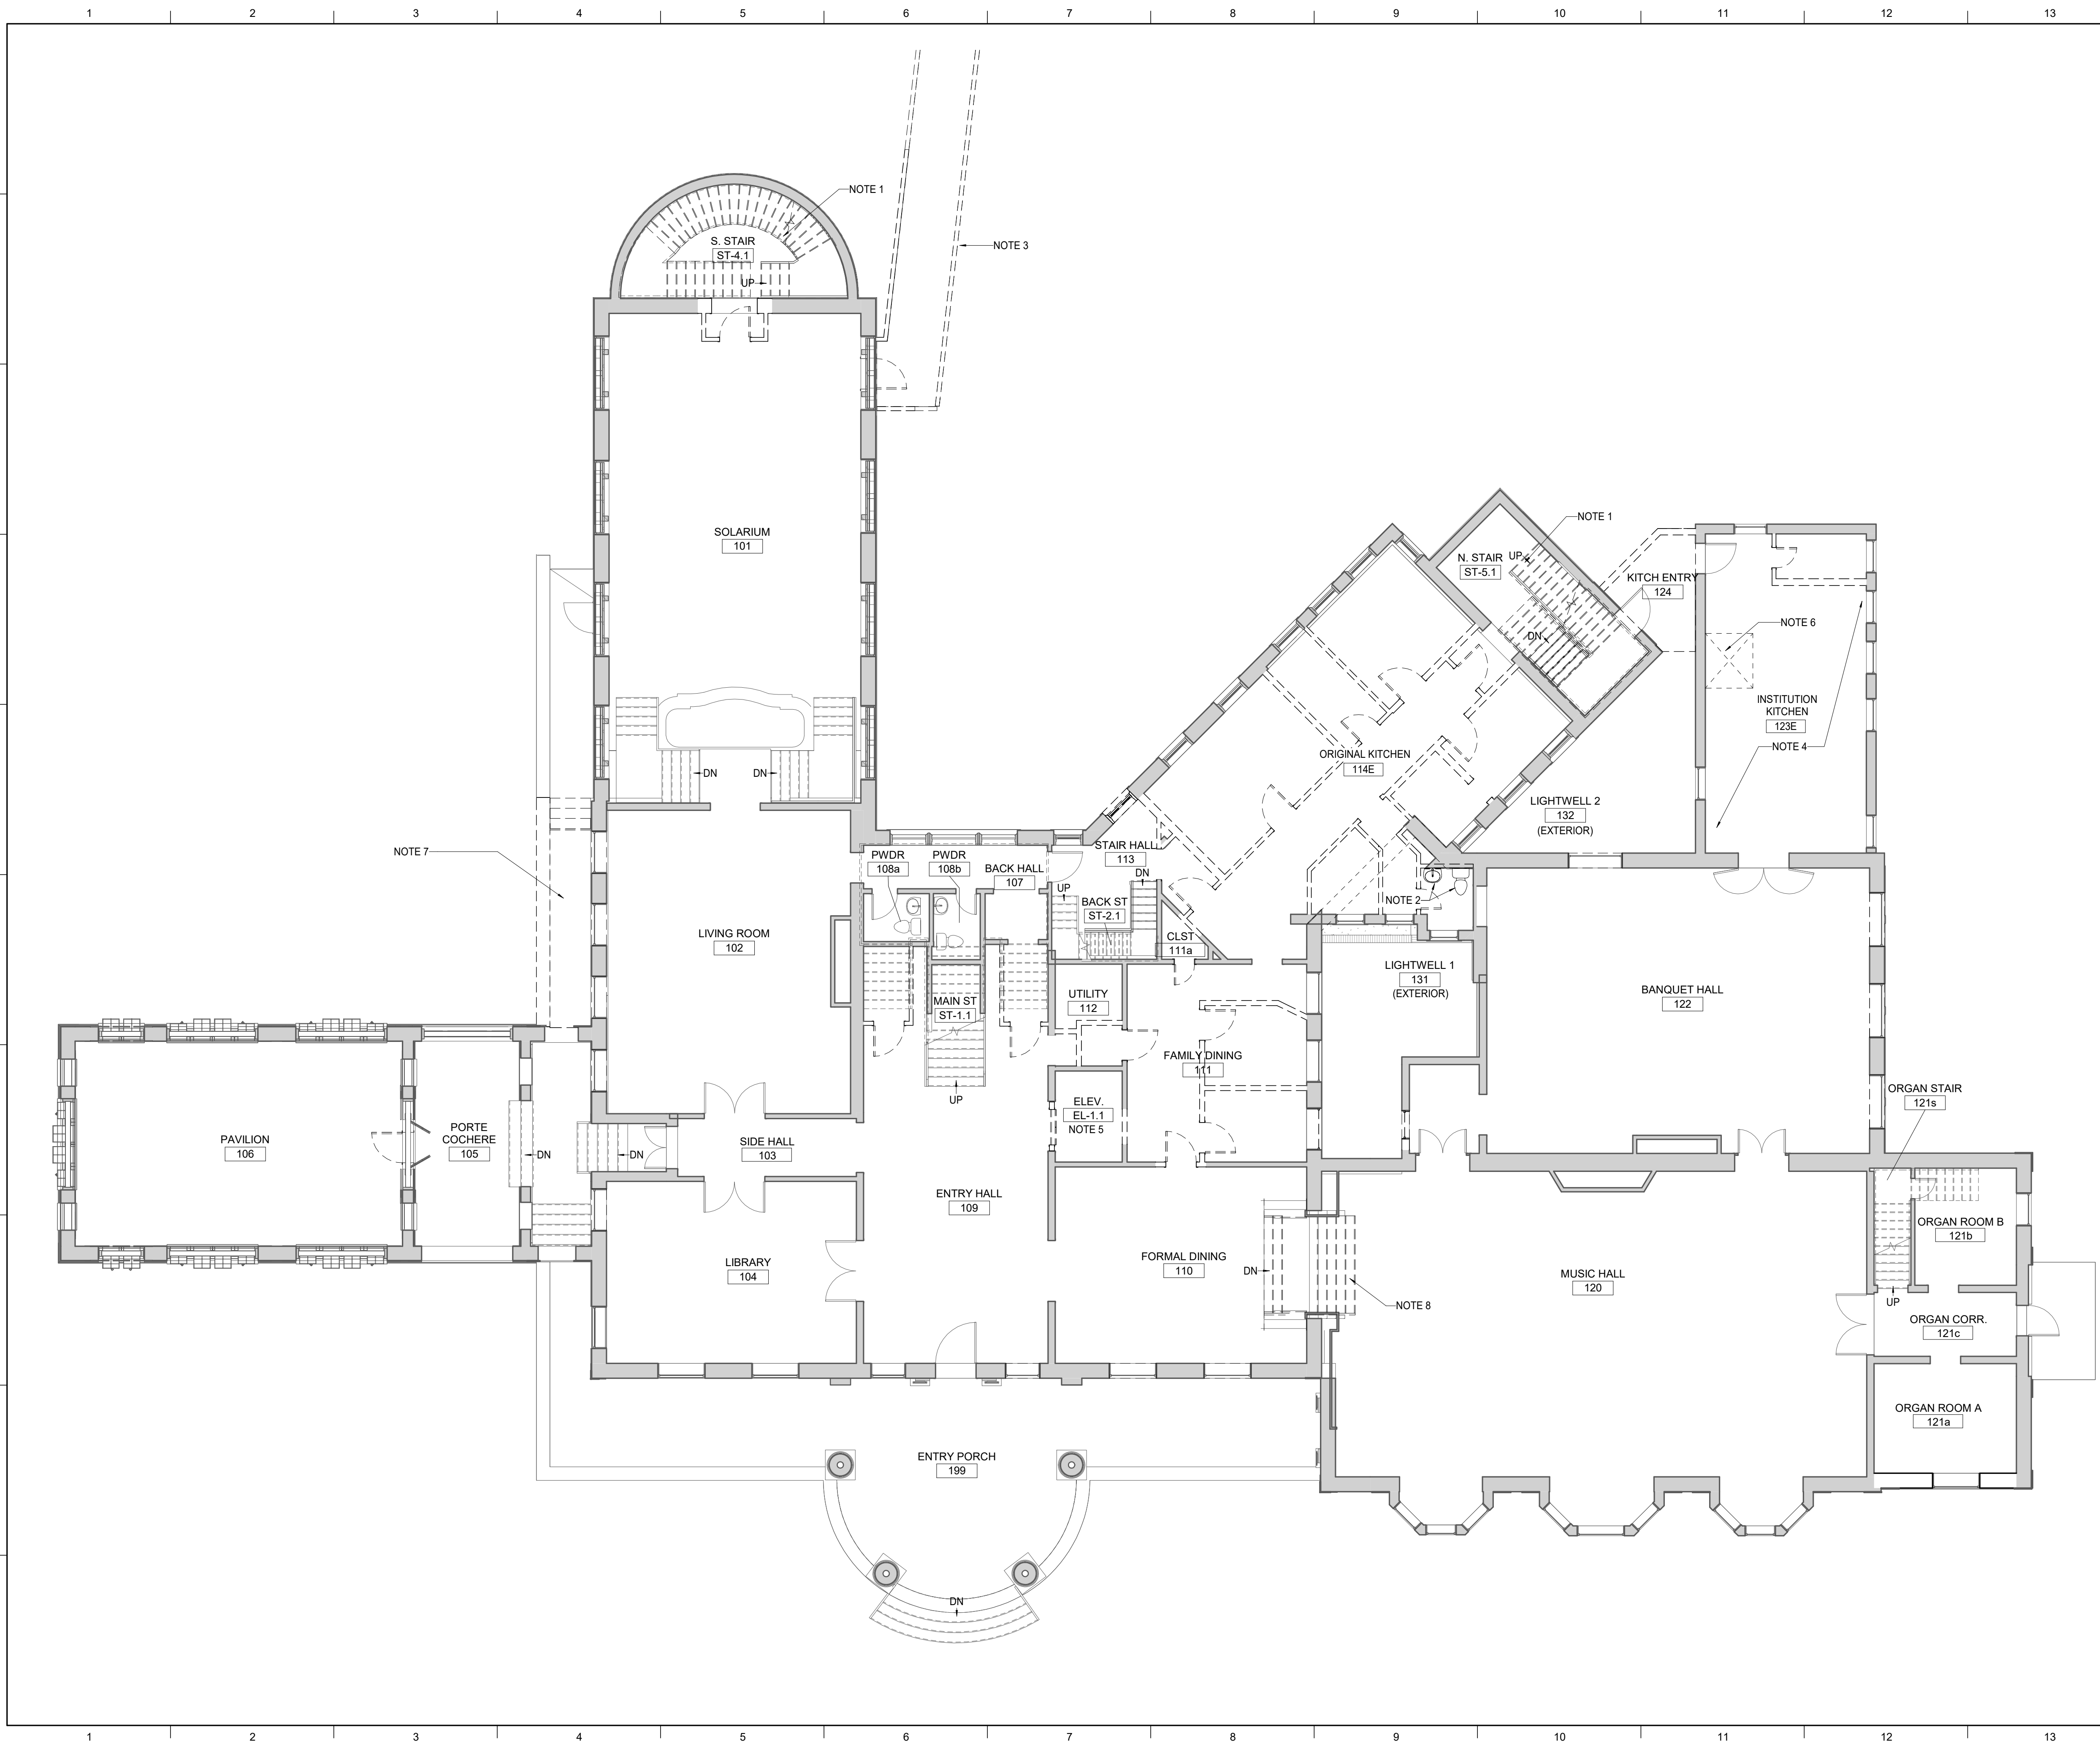
NOT FOR CONSTRUCTION

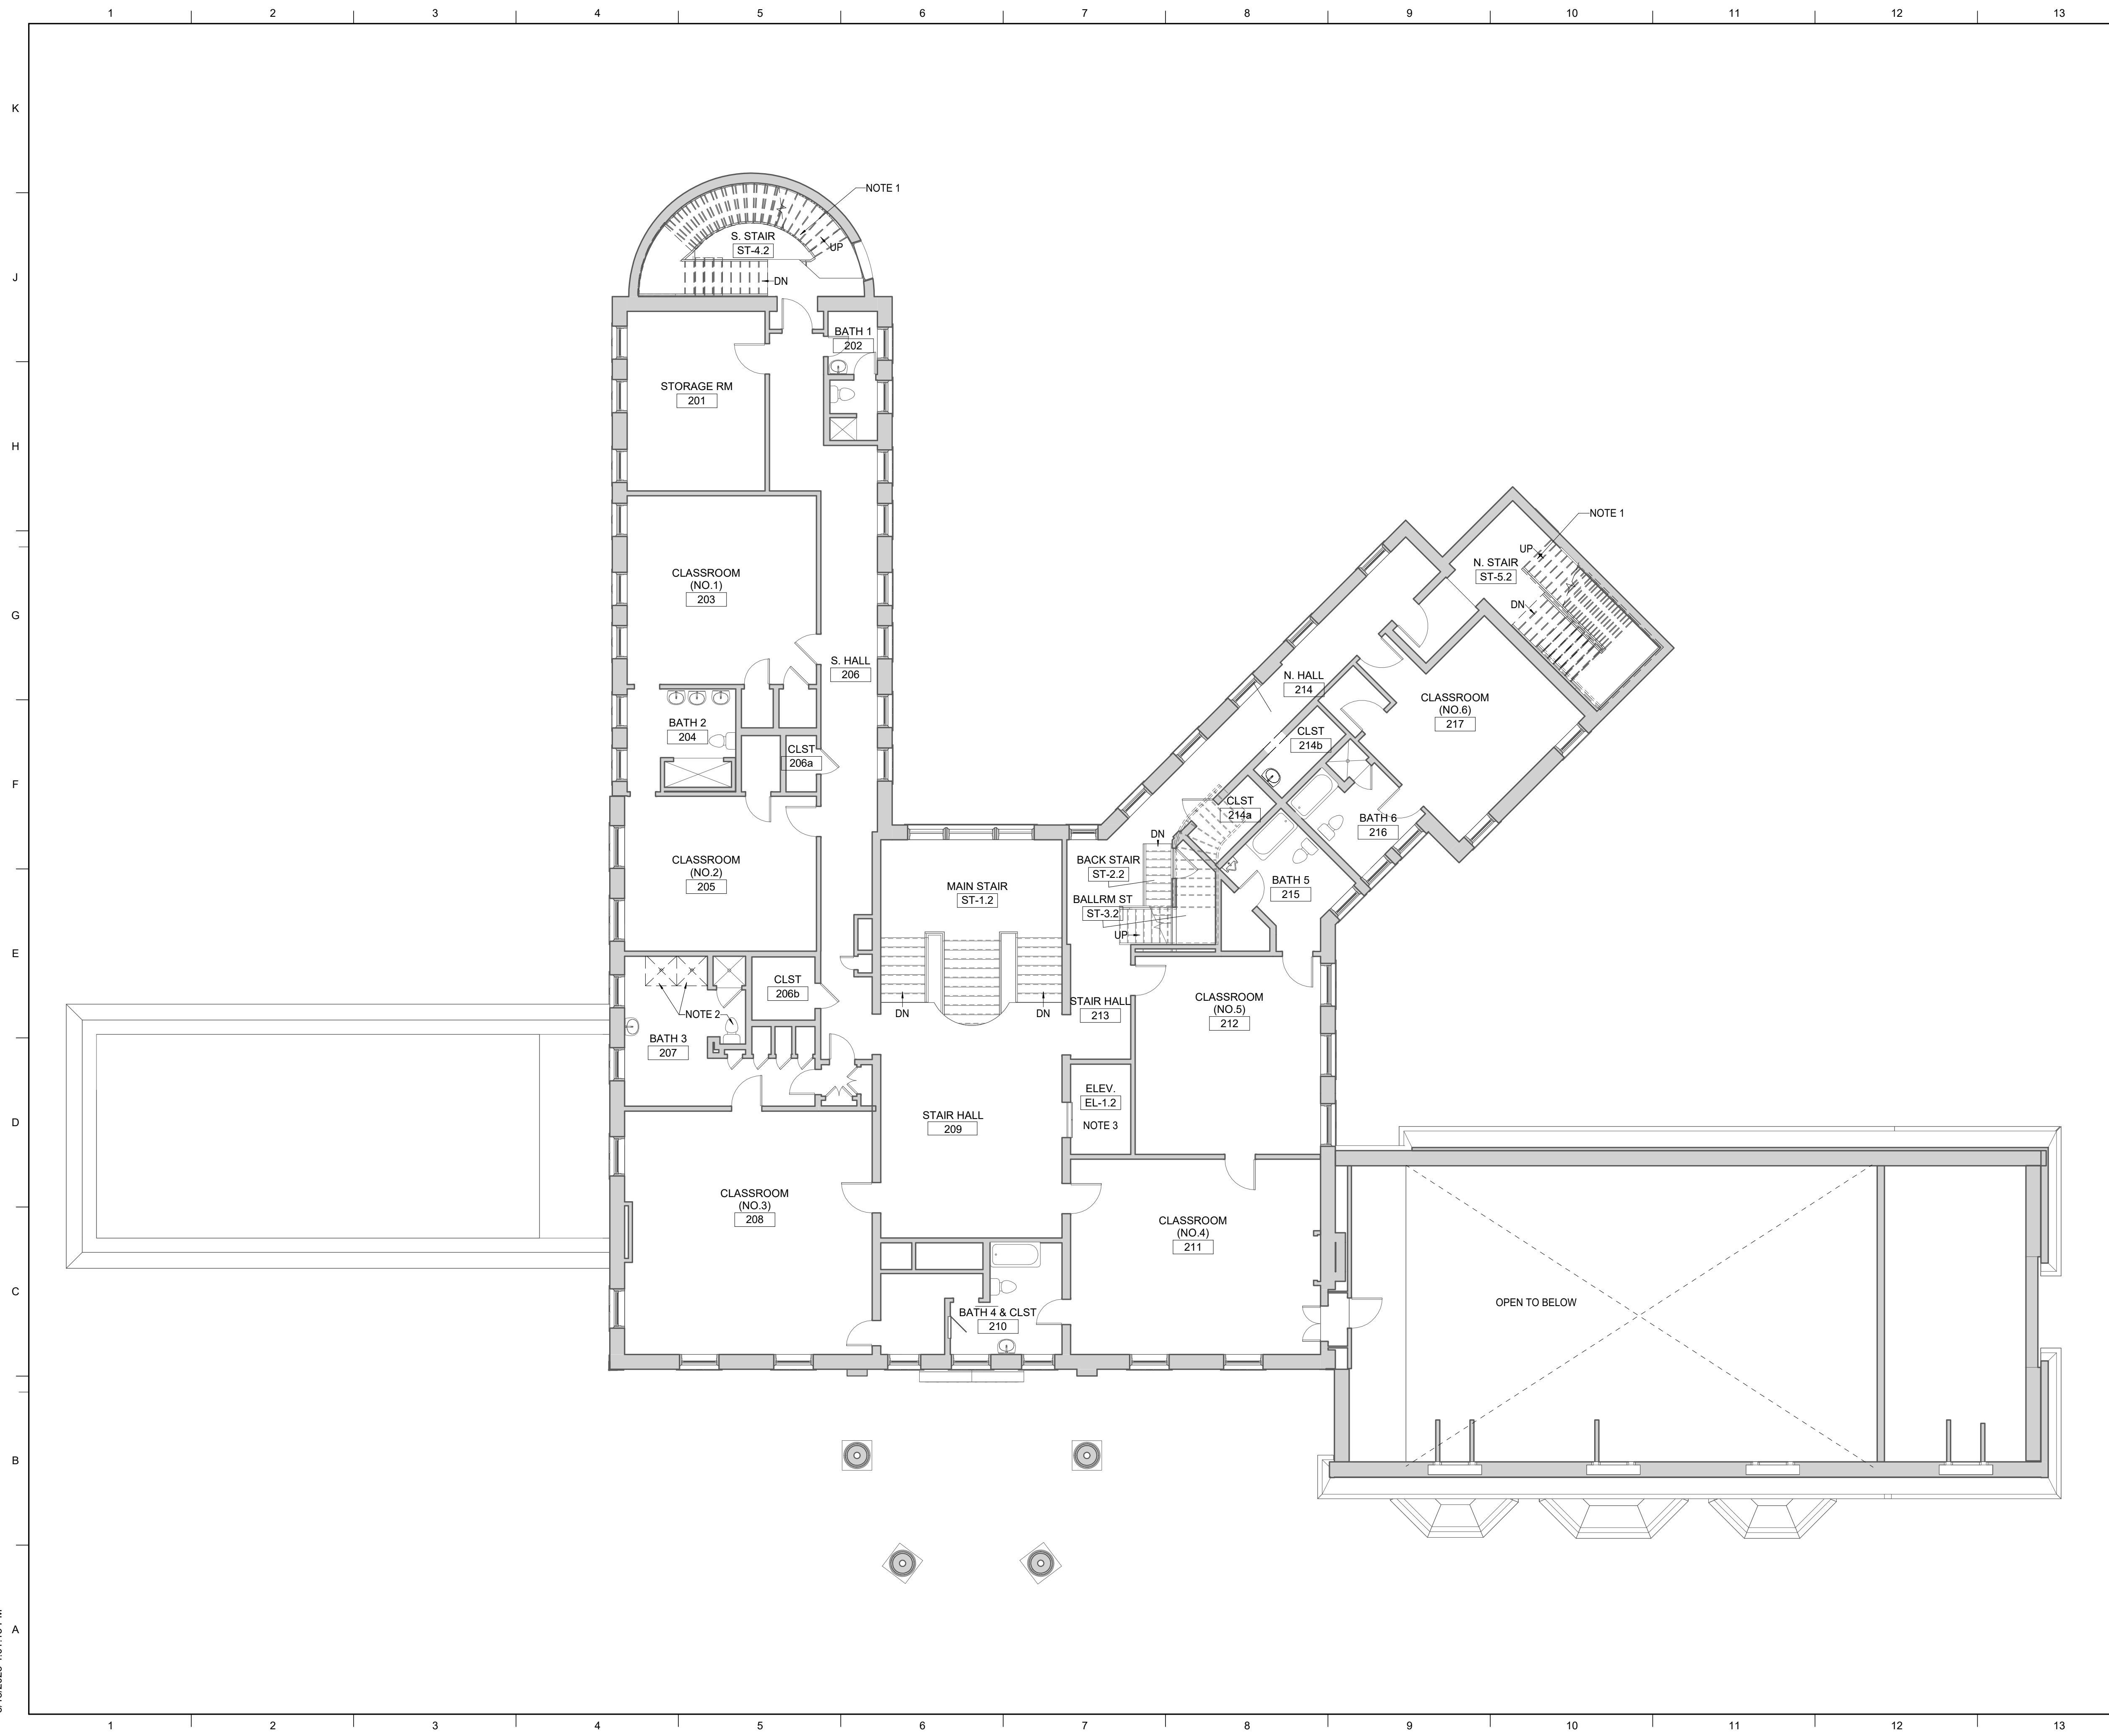
Autodesk Docs//P0035-23 Briarcliff Candler Mansion/P0035-23_Central_V23.mxd
8/18/2023 4:01:15 PM

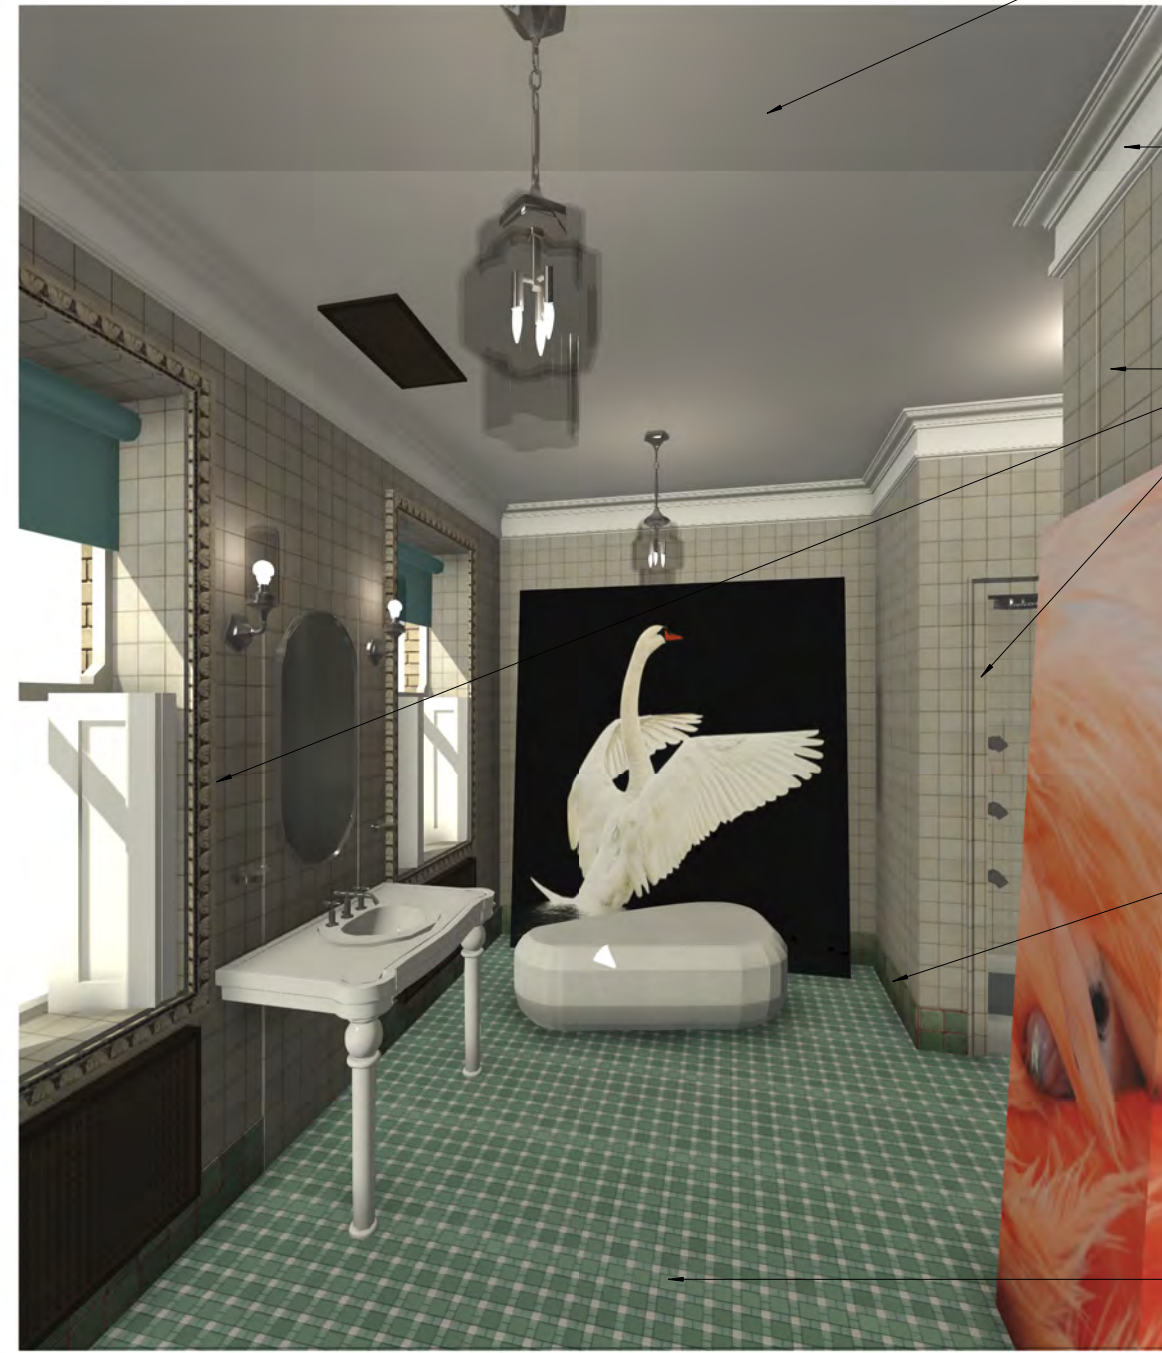
- REMOVE EXISTING LOOSE/PEELING PAINT FROM HISTORIC CEILING. REMOVE ALL CEILING MOUNTED DEVICES AND RETURN HISTORIC ELEMENTS TO OWNER FOR STORAGE. REUSE HISTORIC LIGHT FIXTURE LOCATIONS. PATCH/REPAIR/RECONSTRUCT HISTORIC PLASTER CEILING TO BE CONSISTENT THROUGHOUT ROOM. PRIME AND PAINT CEILING.

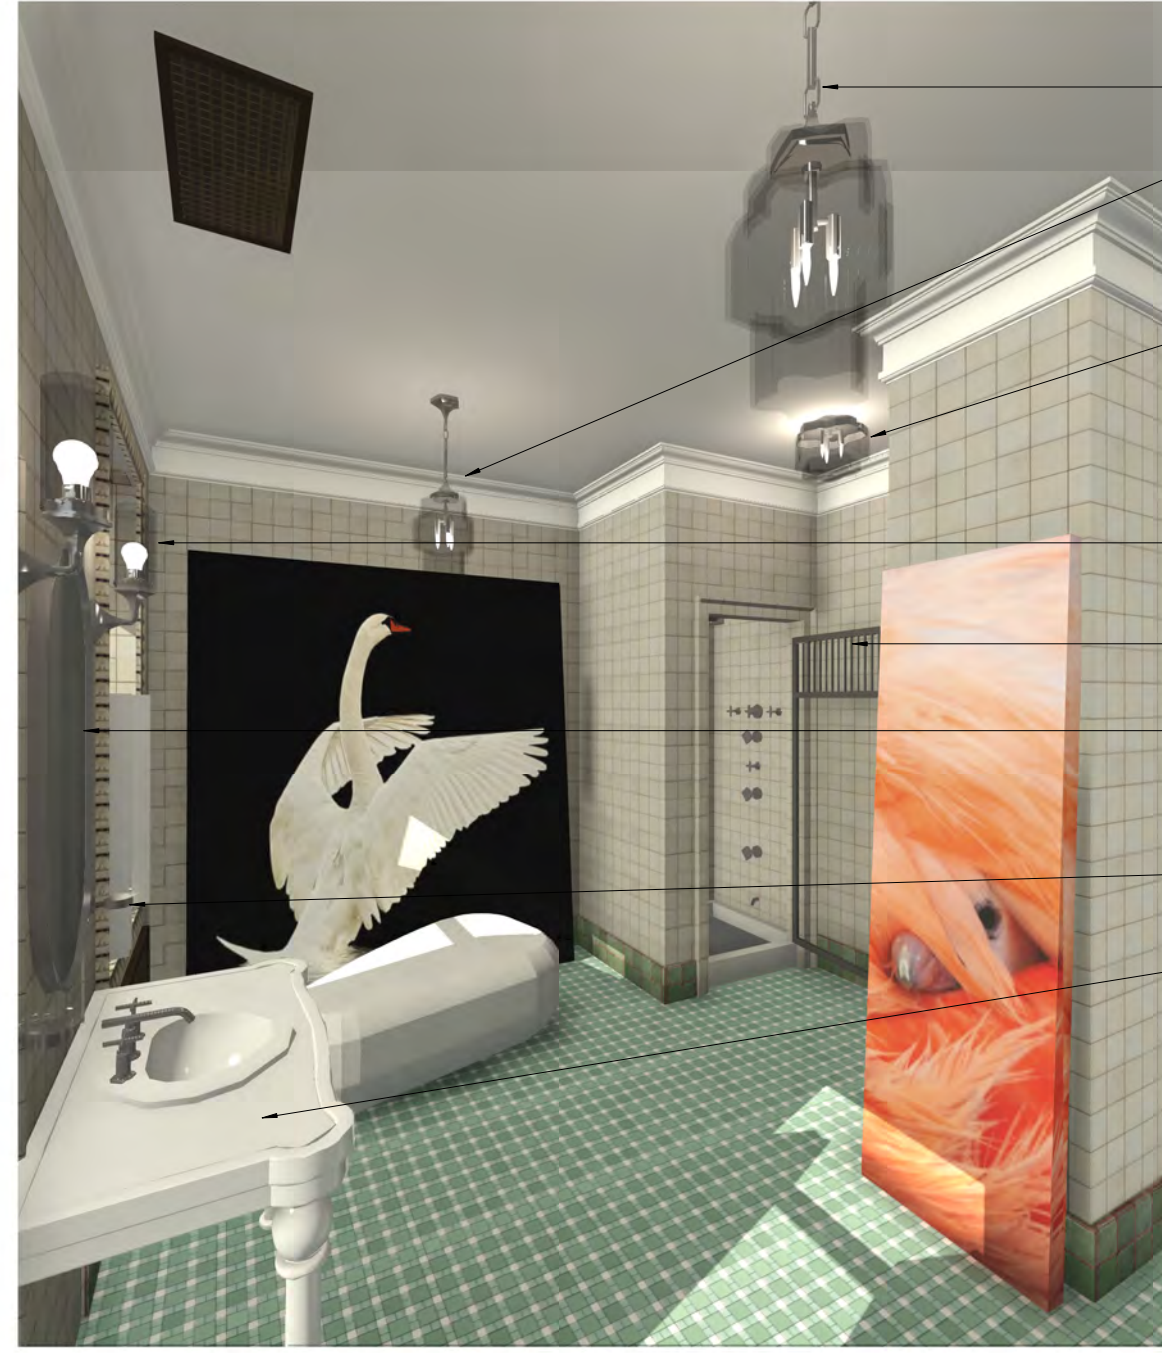
- REUSE HISTORIC LOCATIONS FOR NEW LIGHT FIXTURES. PROVIDE \$800.00 LIGHTING ALLOWANCE PER CEILING PENDANT FIXTURE.
- PROVIDE \$800.00 LIGHTING ALLOWANCE PER CEILING FLUSH MOUNT FIXTURE.

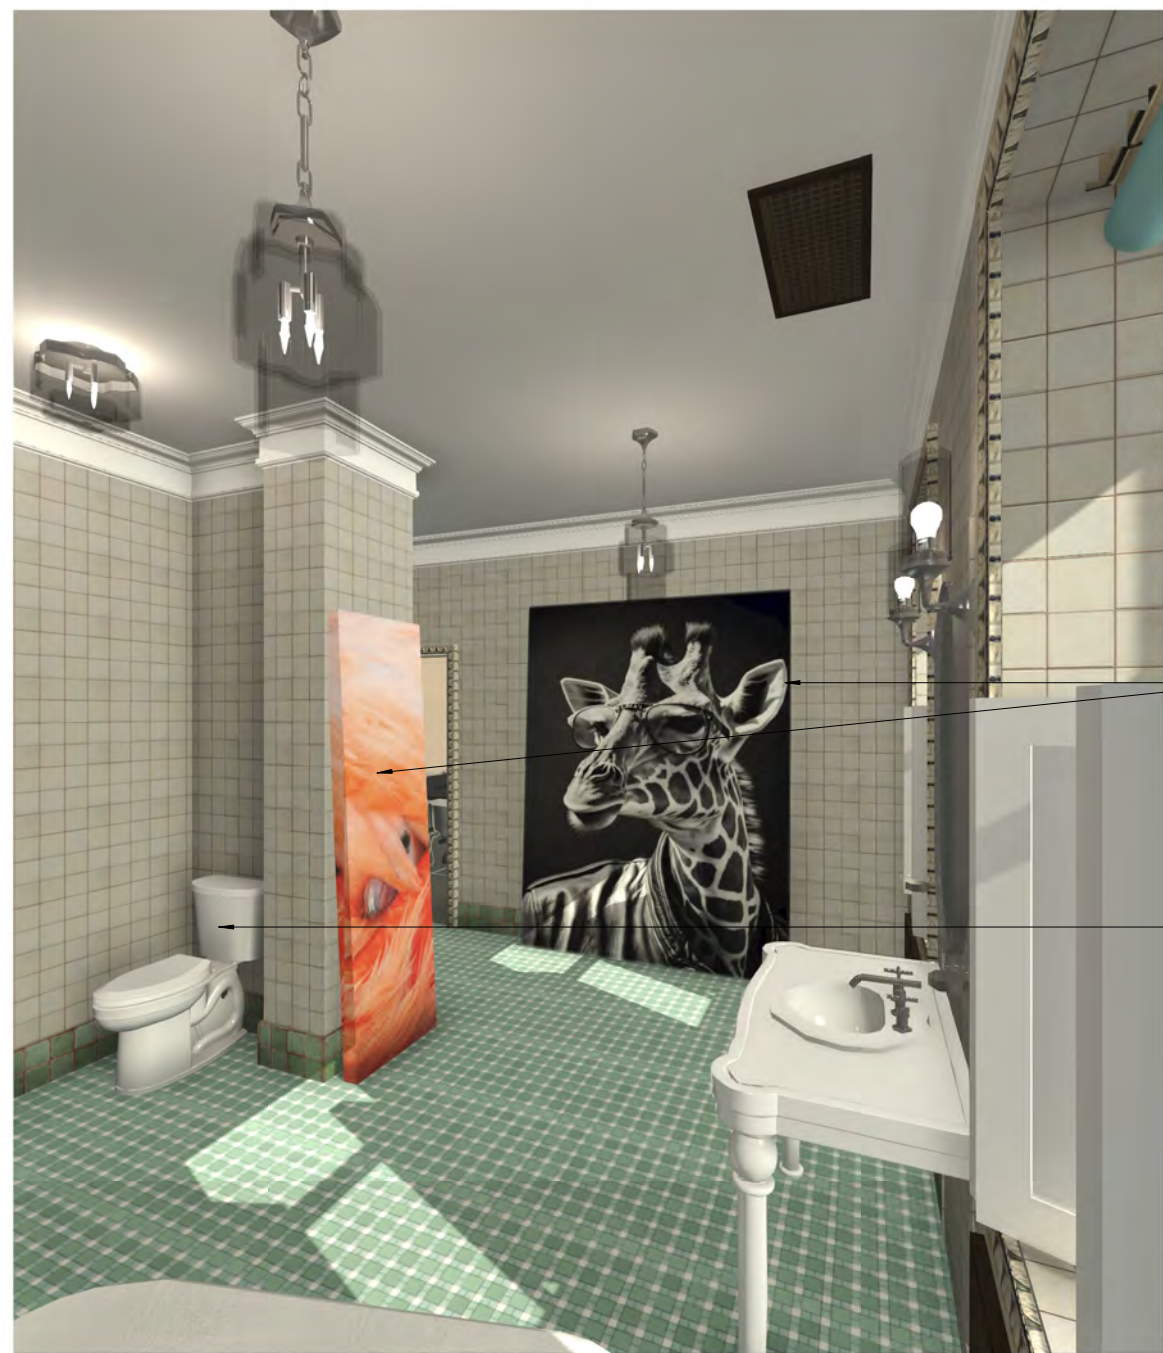
- ARTWORK BY OWNER. COORDINATE MOUNTING HARDWARE WITH OWNER TO MINIMIZE DAMAGE TO HISTORIC WALL TILE.
- REMOVE EXISTING TOILET AND RETURN TO OWNER FOR STORAGE. NEW TOILET: KOHLER, KINGSTON, TWO PIECE ELONGATED TOILET, 1.28 GPF, K-25077-SS-0, TO BE PLACED AT HISTORIC TOILET LOCATION. TOILET ACCESSORIES: K-7637 ANGLE SUPPLY WITH STOP, K-20110 BREVIA QUIET-CLOSE ELONGATED TOILET SEAT, K-5420 LOW-PROFILE BOLT CAPS, K-23726 DRAIN TREATMENT
