DeKalb County Historic Preservation Commission

Monday, April 15th, 2024- 6:00 P.M.

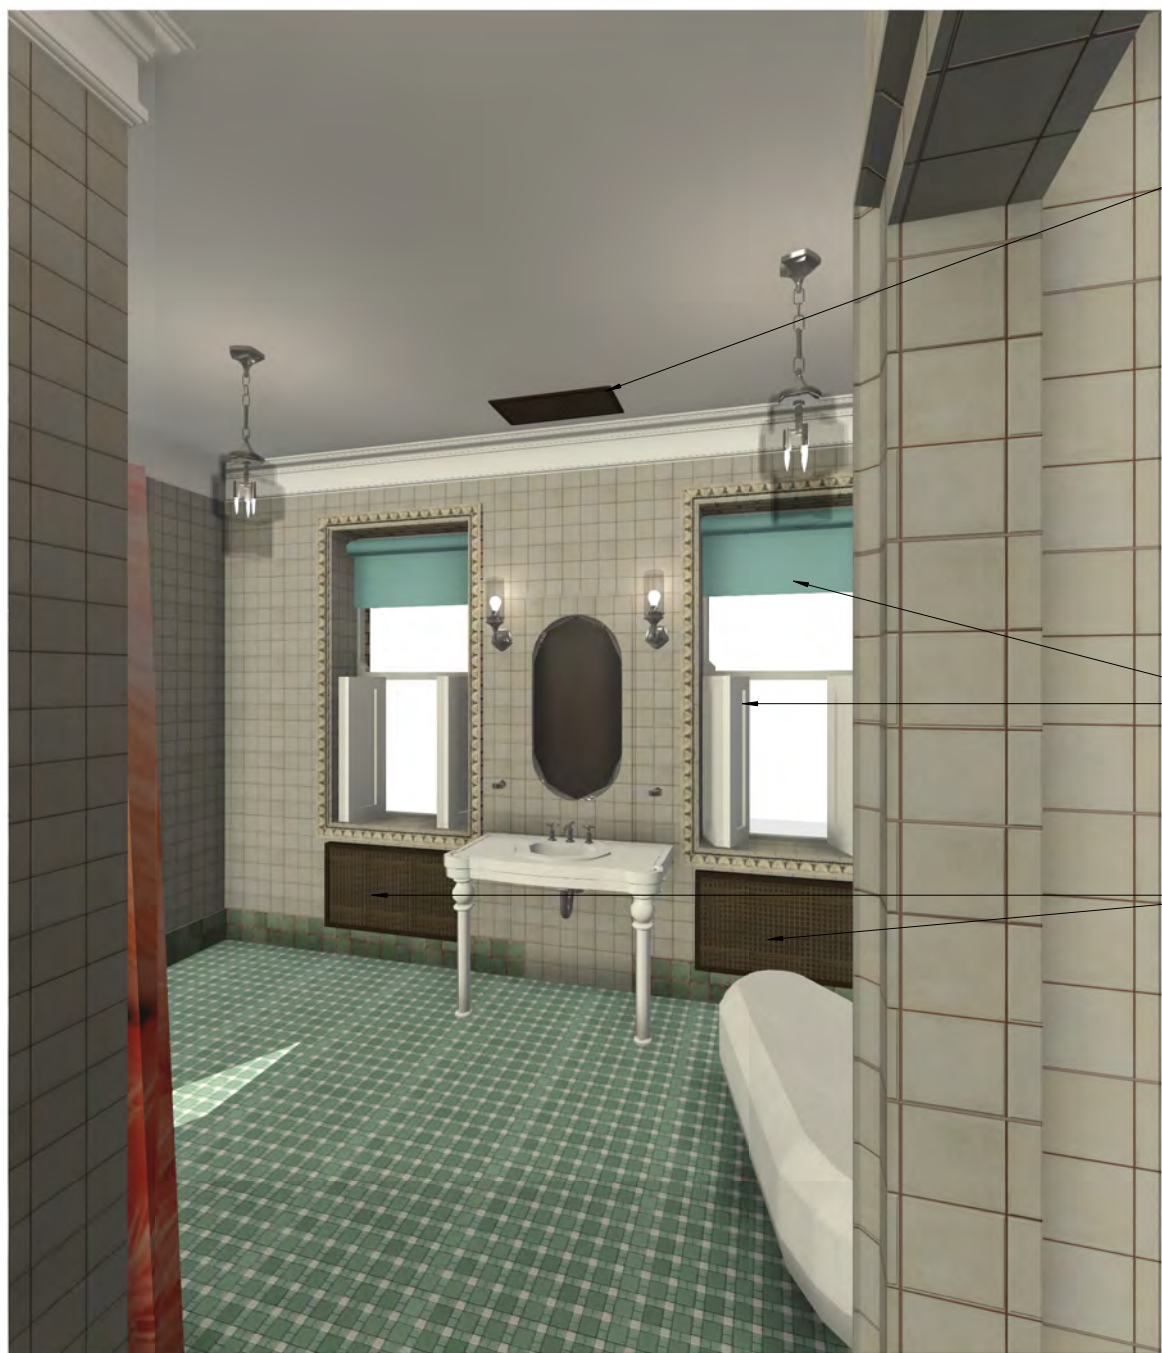
- NEW MECHANICAL GRILLE TO BE CENTERED BETWEEN WINDOWS. GRILLE FINISH AND PERFORATION PATTERN TO MATCH HISTORIC GRILLES UNDER WINDOWS.
- NEW WINDOW TREATMENTS AND ASSOCIATED HARDWARE. EACH WINDOW TO RECEIVE ROLLER SHADE AND PAIR OF SOLID WOOD SHUTTERS.
- HISTORIC MECHANICAL GRILLES TO BE REPAIRED AND CLEANED

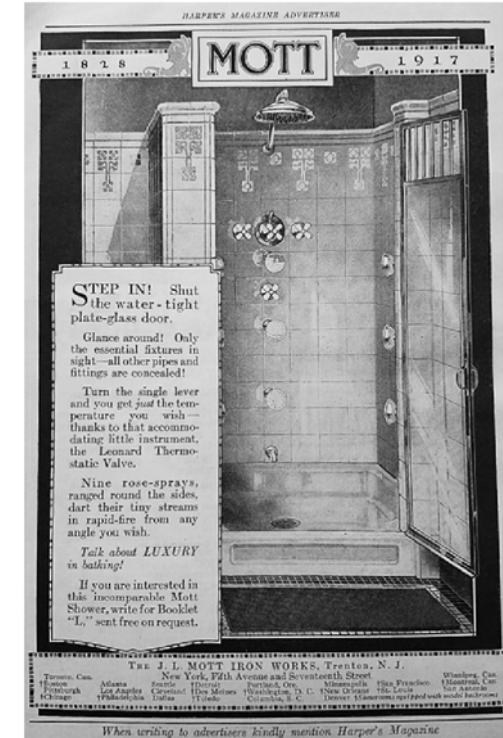
- REMOVE EXISTING COATING FROM HISTORIC SHOWER AND CORNER TRIM TILES. REMOVE ALL WALL MOUNTED ACCESSORIES AND RETURN HISTORIC ELEMENTS TO OWNER FOR STORAGE. REVIEW AREAS OF WALL TILE THAT CANNOT BE PATCHED WITH OWNER AND ARCHITECT. REUSE EXISTING DEVICE LOCATIONS WHEREVER POSSIBLE TO MINIMIZE NEW TILE CUTS. COORDINATE THESE LOCATIONS WITH ARCHITECT AND ENGINEER. PATCH/REPAIR/CLEAN HISTORIC WALL TILES AND GROUT. CLEAN HISTORIC SHOWER FLOOR. COAT WALL TILES AND GROUT WITH APPROPRIATE PROTECTIVE COATING PRIOR TO OCCUPANCY. CLEAN EXISTING PLUMBING FIXTURES AND EVALUATE IF MISSING FIXTURES CAN BE RESTORED.

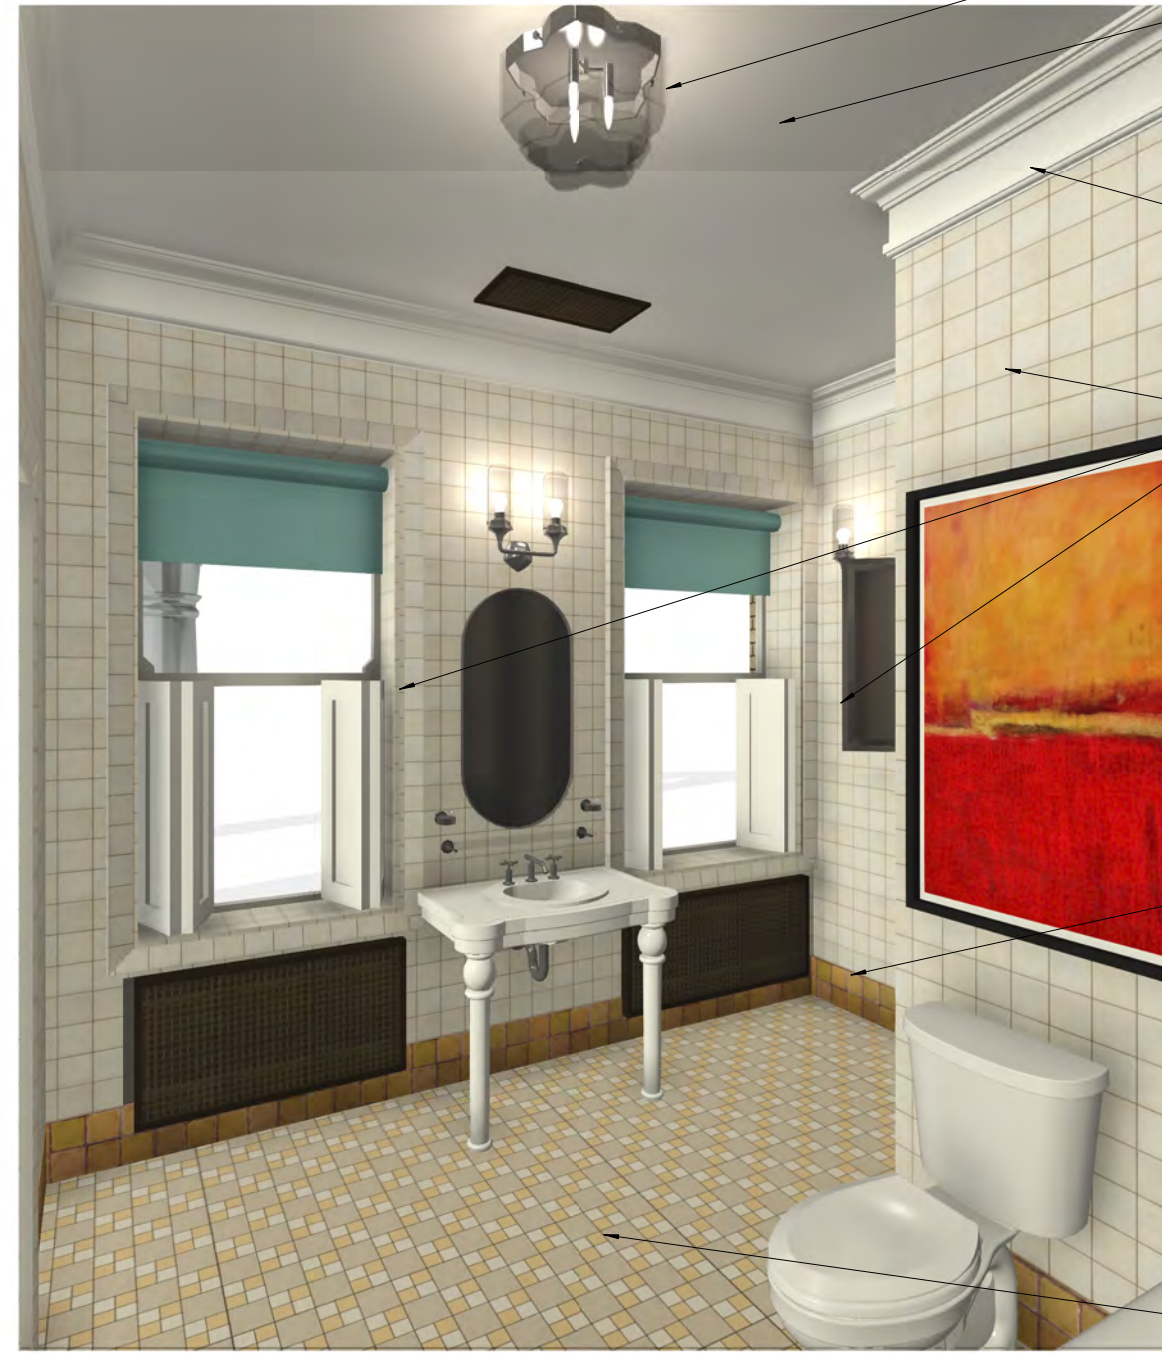
- PROVIDE \$800.00 LIGHTING ALLOWANCE PER LIGHT FIXTURE.
- REMOVE EXISTING LOOSE/PEELING PAINT FROM HISTORIC CEILING. REMOVE ALL CEILING MOUNTED DEVICES AND RETURN HISTORIC ELEMENTS TO OWNER FOR STORAGE. REUSE HISTORIC LIGHT FIXTURE LOCATIONS. PATCH/REPAIR/RECONSTRUCT HISTORIC PLASTER CEILING TO BE CONSISTENT THROUGHOUT ROOM. PRIME AND PAINT CEILING.

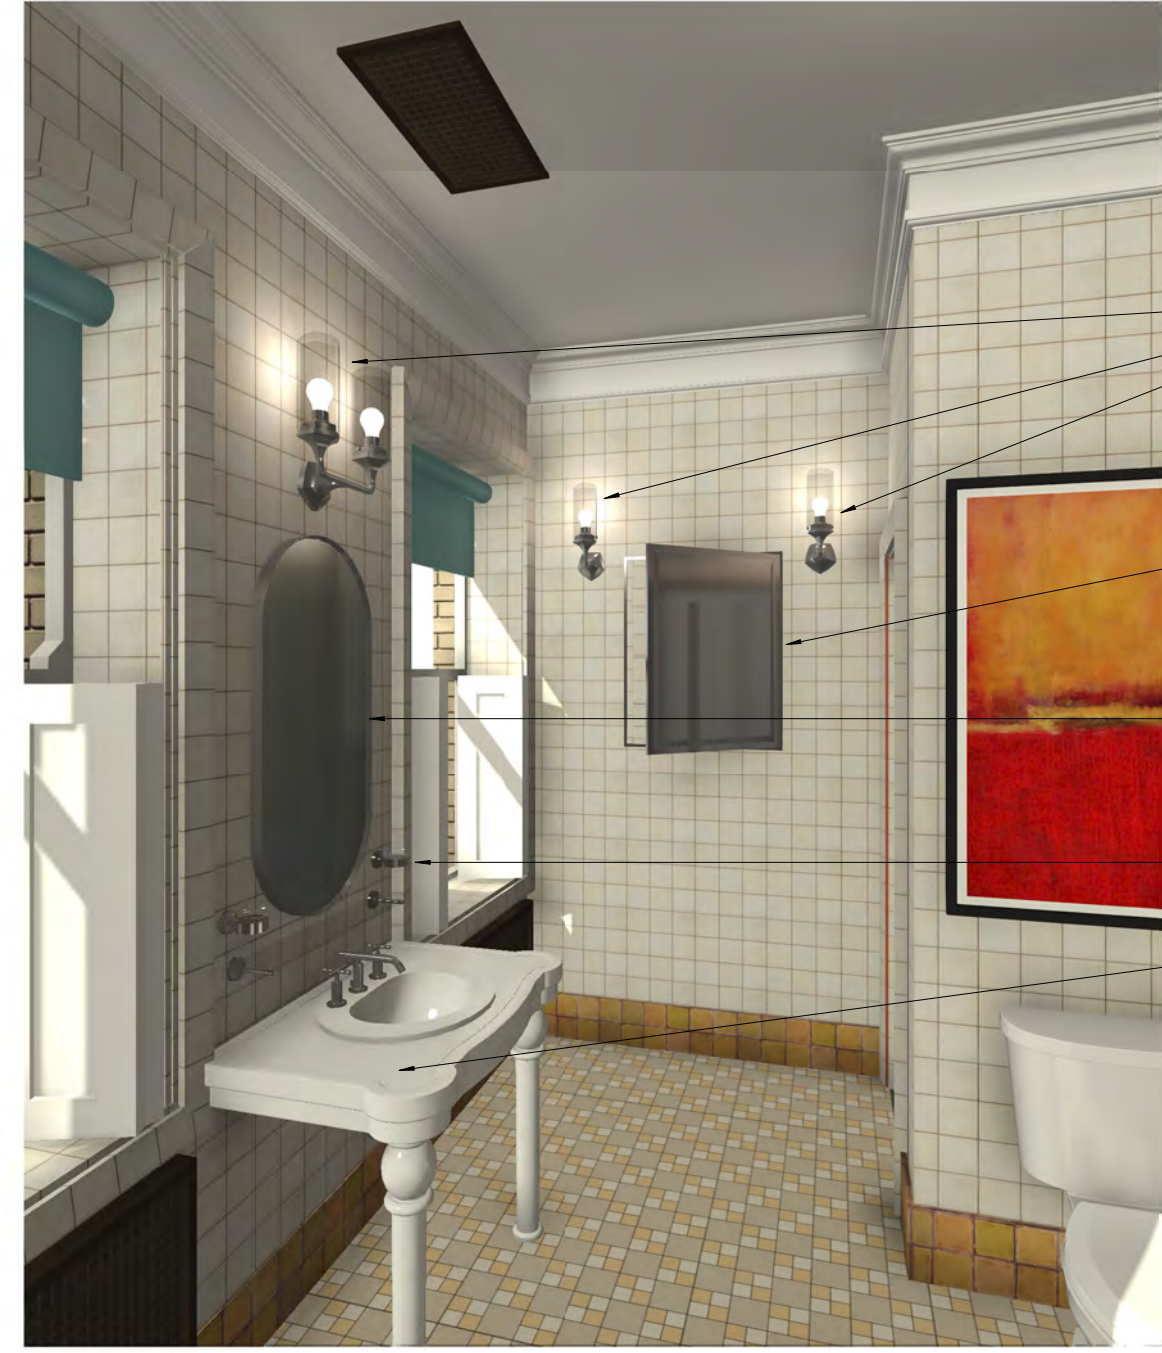
- PROVIDE \$800.00 LIGHTING ALLOWANCE PER LIGHT FIXTURE.
- CLEAN AND REPAIR HISTORIC MEDICINE CABINET. REPLACE BROKEN MIRROR GLASS WITH SIMILAR BEVEL DESIGN AND TEMPERED GLAZING. PROTECT CABINET DURING CONSTRUCTION.

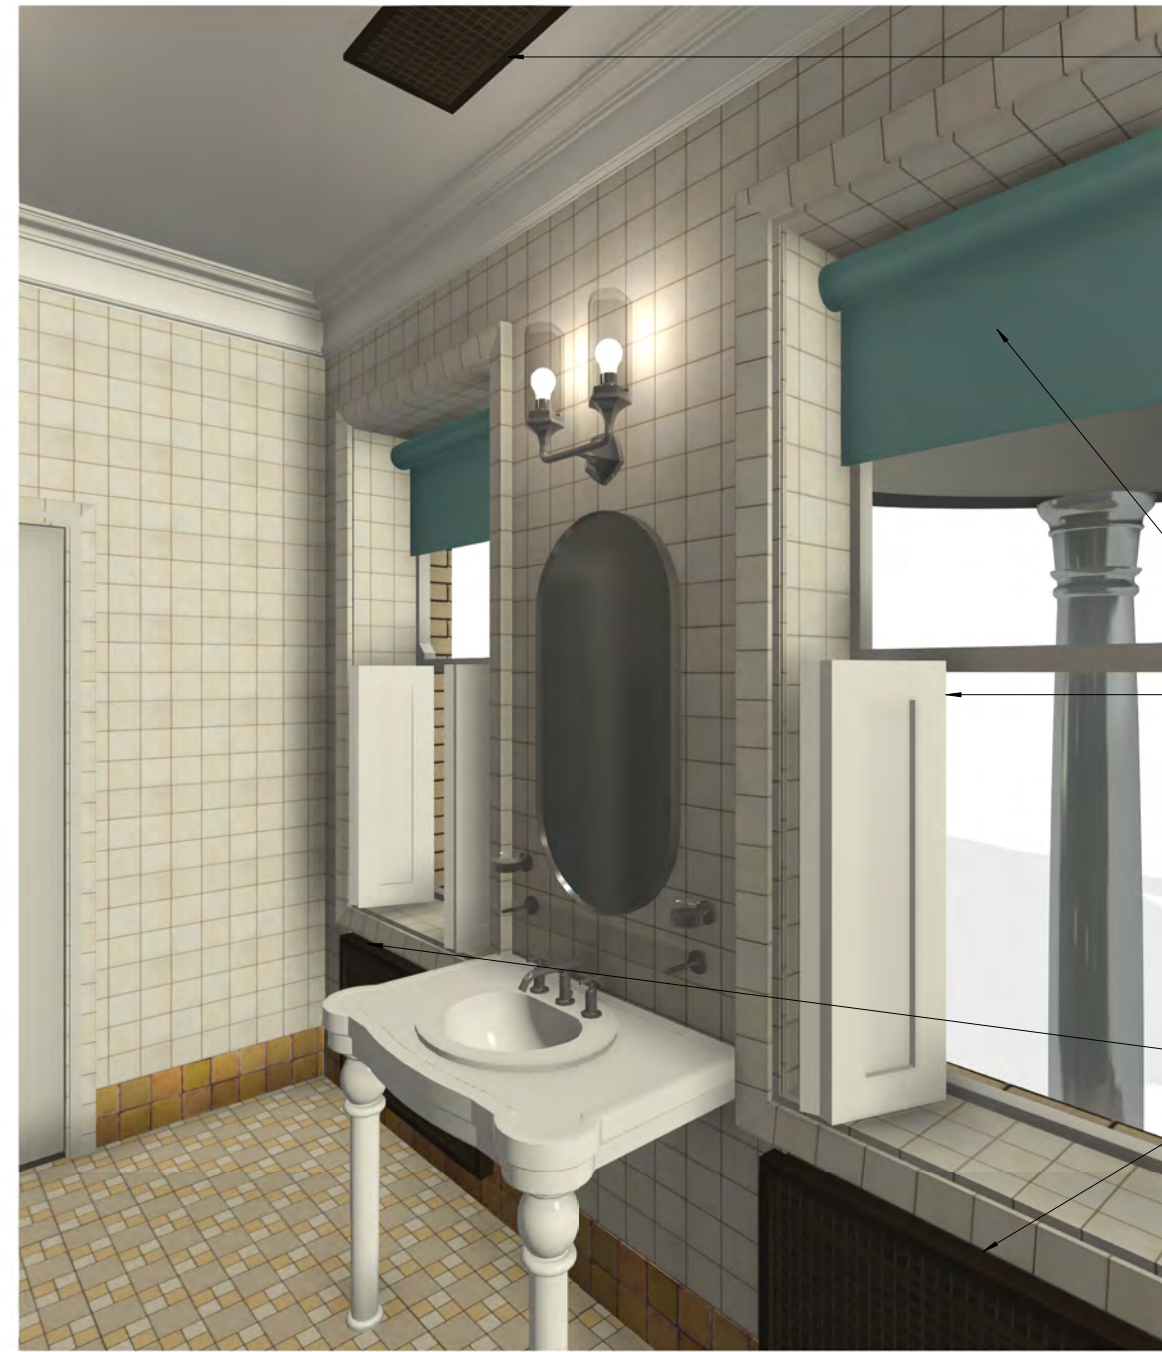
- NEW MECHANICAL GRILLE TO BE CENTERED BETWEEN WINDOWS. GRILLE FINISH AND PERFORMANCE PATTERN TO MATCH HISTORIC GRILLES UNDER WINDOWS.
- NEW WINDOW TREATMENTS AND ASSOCIATED HARDWARE. EACH WINDOW TO RECEIVE ROLLER SHADE AND PAIR OF SOLID WOOD SHUTTERS.
- HISTORIC MECHANICAL GRILLES TO BE REPAIRED AND CLEANED.

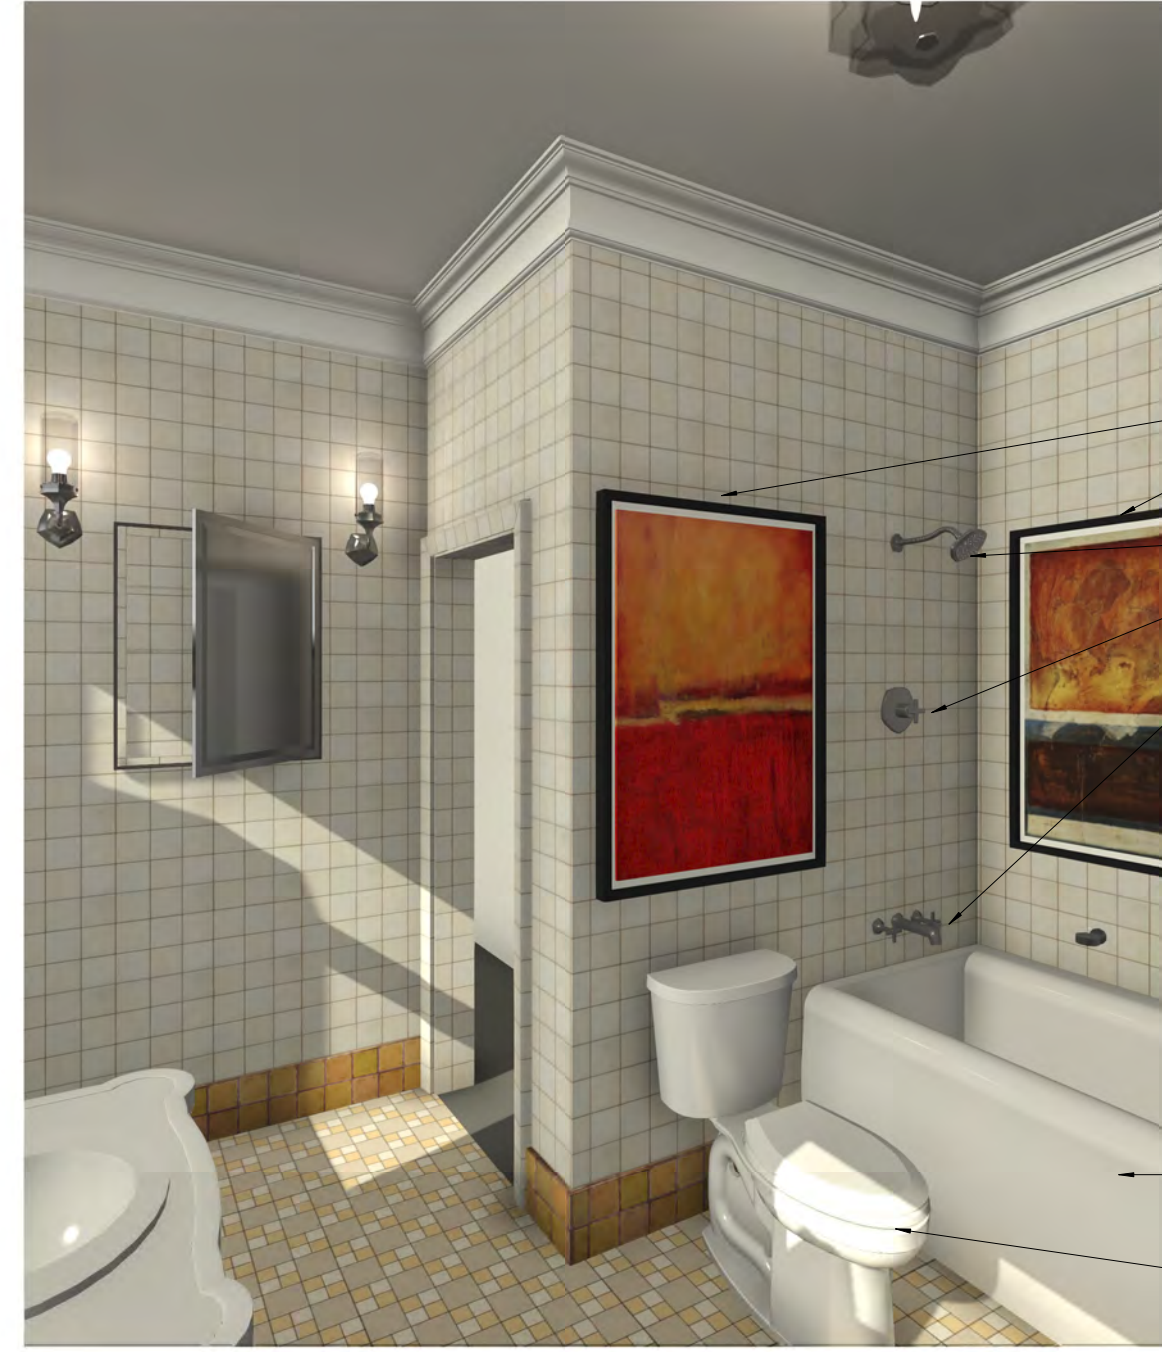
- ARTWORK BY OWNER. COORDINATE MOUNTING HARDWARE WITH OWNER TO MINIMIZE DAMAGE TO HISTORIC WALL TILE.
- REMOVE EXISTING BATH HARDWARE AND RETURN TO OWNER FOR STORAGE. ACCESS NEW PLUMBING THROUGH ADJACENT CLOSET. DO NOT DISTURB EXISTING WALL TILES. BATHTUB FAUCETS: KOHLER, OCCASION, K-77013-CP. BATHTUB SPOUT: KOHLER, OCCASION, K-27115-CP. BATHTUB MIXER: KOHLER, OCCASION, K-T27044-4-CP. BATHTUB SHOWER ARM AND FLANGE: KOHLER, OCCASION, K-27054-CP. BATHTUB SHOWERHEAD: KOHLER, OCCASION, K-27050-G-CP.

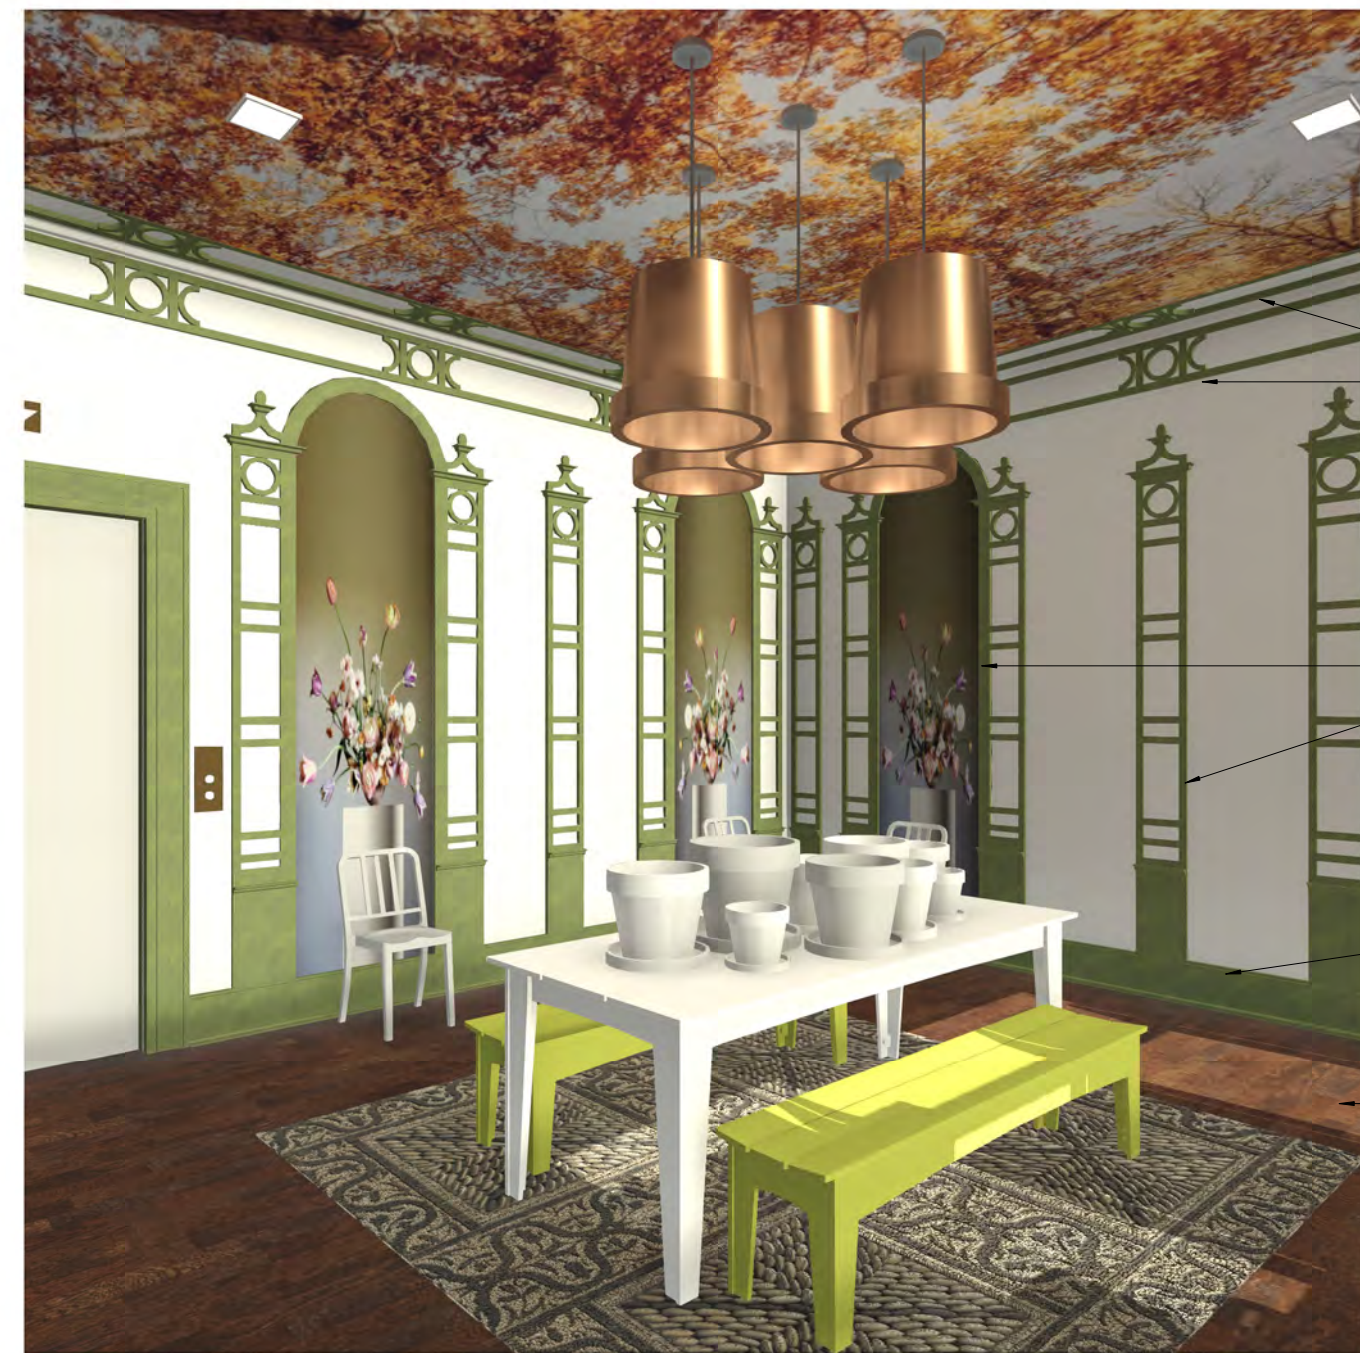
REMOVE EXISTING LOOSE/PEELING PAINT FROM HISTORIC CEILING.
REMOVE ALL CEILING MOUNTED DEVICES AND RETURN HISTORIC ELEMENTS TO OWNER FOR STORAGE.
REUSE ORIGINAL HISTORIC LIGHT FIXTURE LOCATION.
PATCH/REPAIR/RECONSTRUCT HISTORIC PLASTER CEILING TO BE CONSISTENT THROUGHOUT ROOM.
PRIME AND PAINT CEILING.

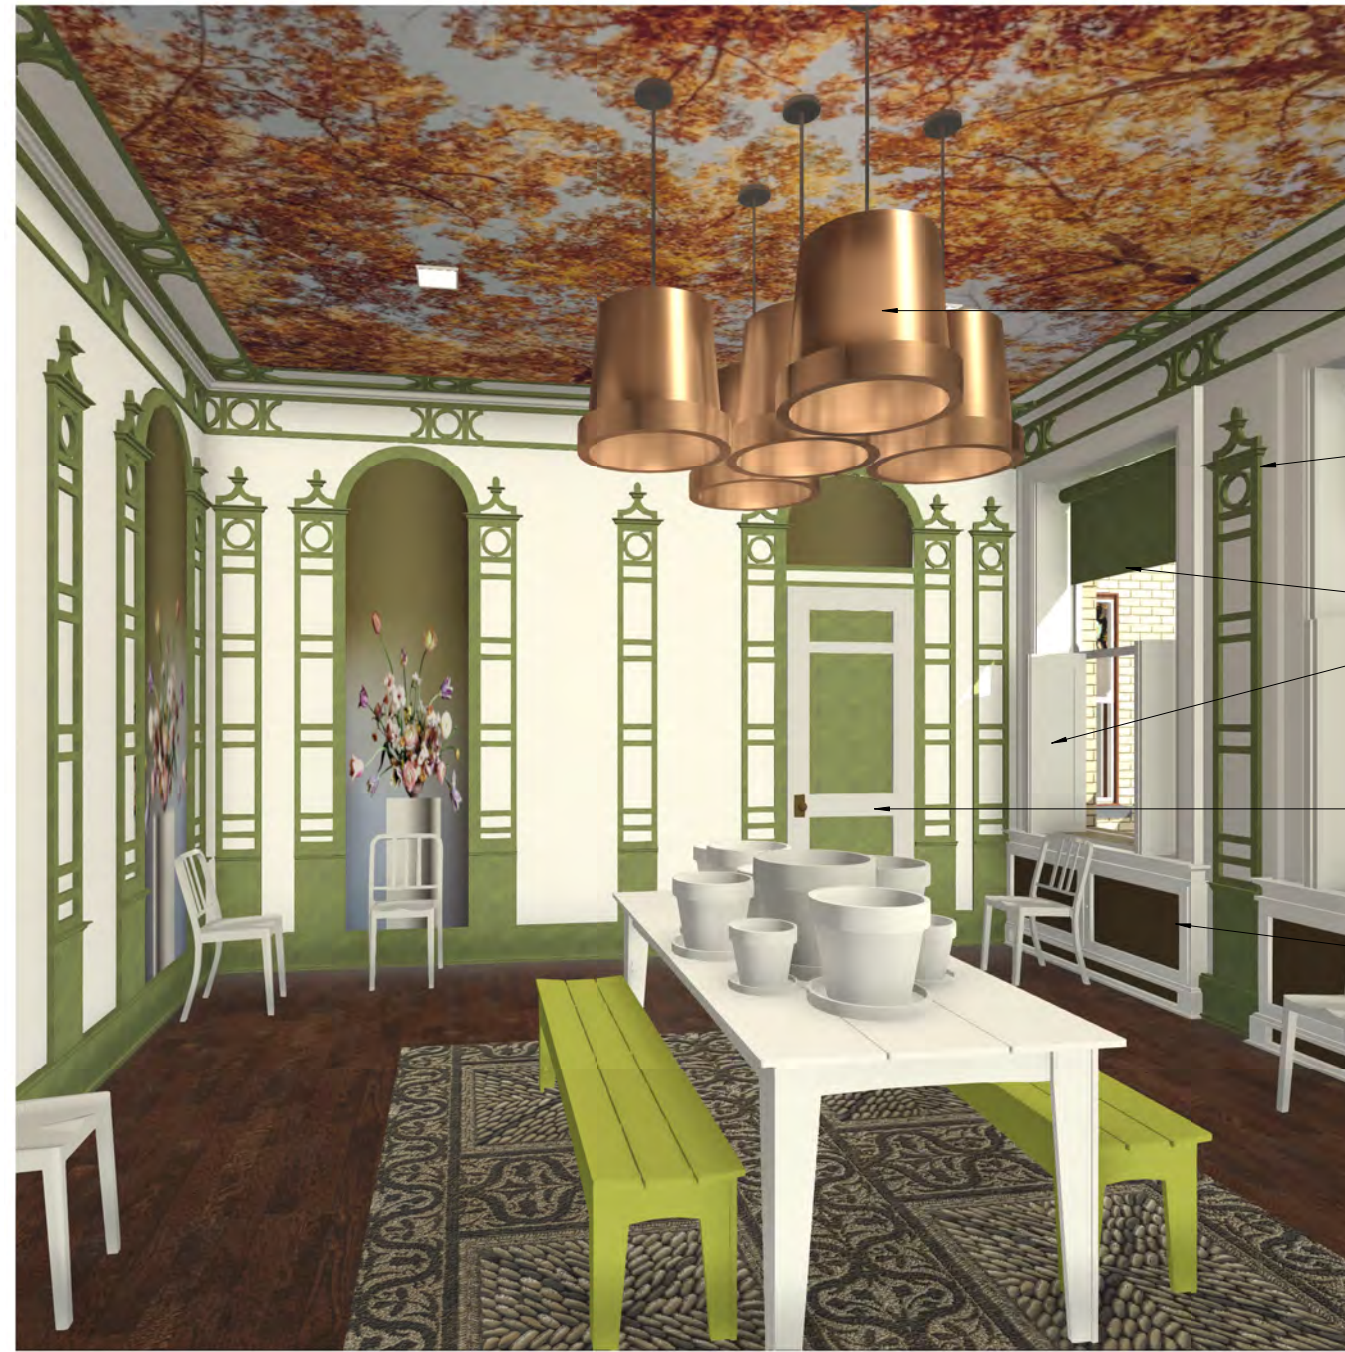
PROVIDE \$1500.00 LIGHTING ALLOWANCE PER CEILING PENDANT FIXTURE.

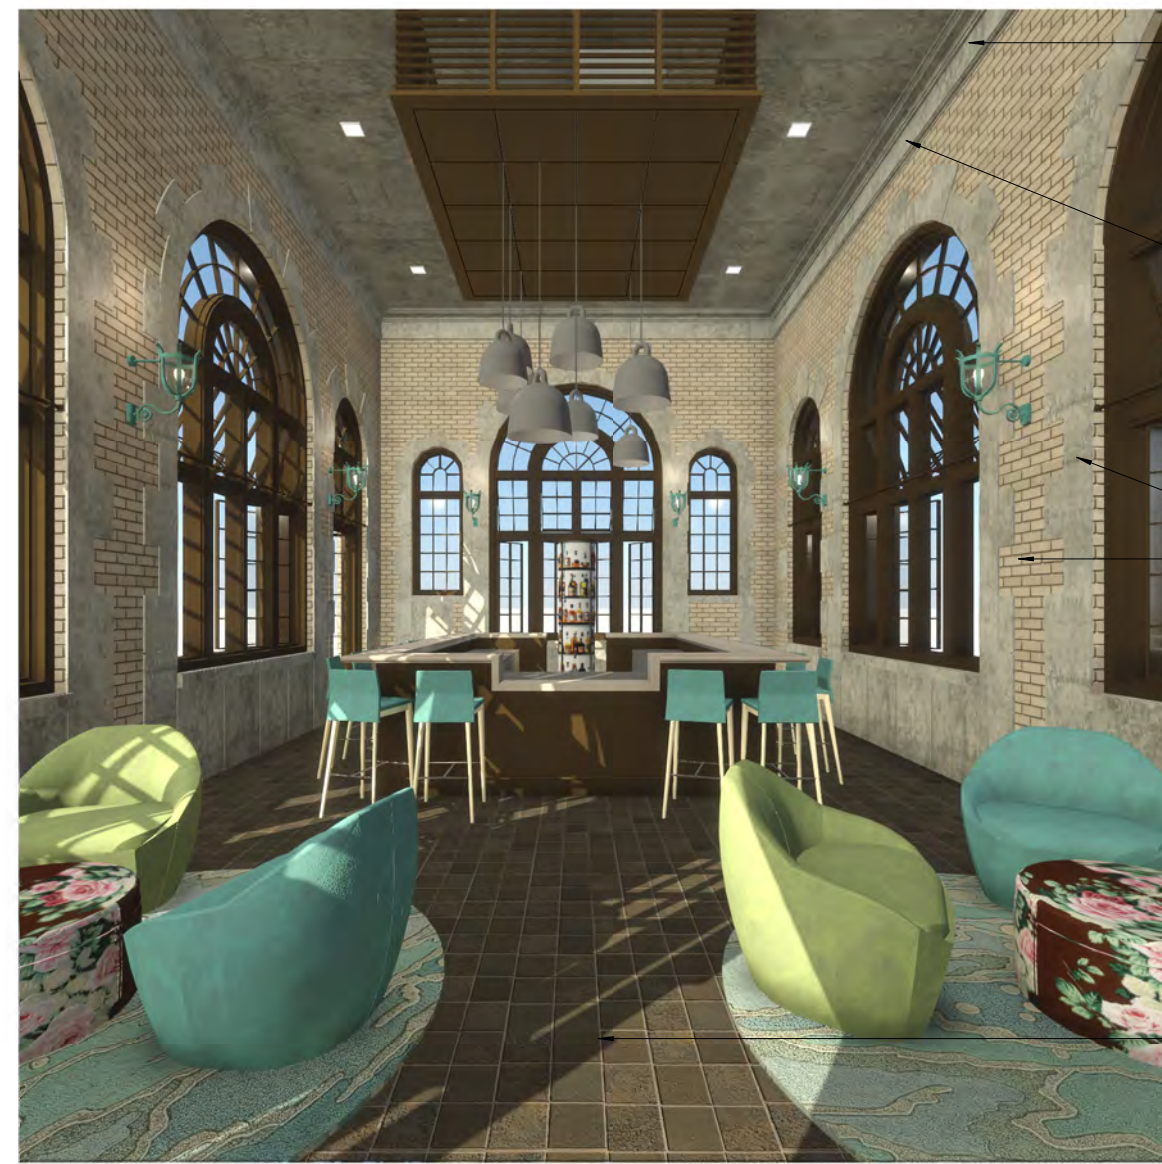
REMOVE EXISTING LOOSE/PEELING PAINT AND DEBRIS FROM HISTORIC CEILING.
REMOVE ALL CEILING MOUNTED DEVICES AND RETURN HISTORIC ELEMENTS TO OWNER FOR STORAGE. REUSE ORIGINAL HISTORIC LIGHT FIXTURE LOCATION WHERE POSSIBLE.
PATCH/REPAIR/RECONSTRUCT HISTORIC PLASTER CEILING TO BE CONSISTENT THROUGHOUT ROOM.

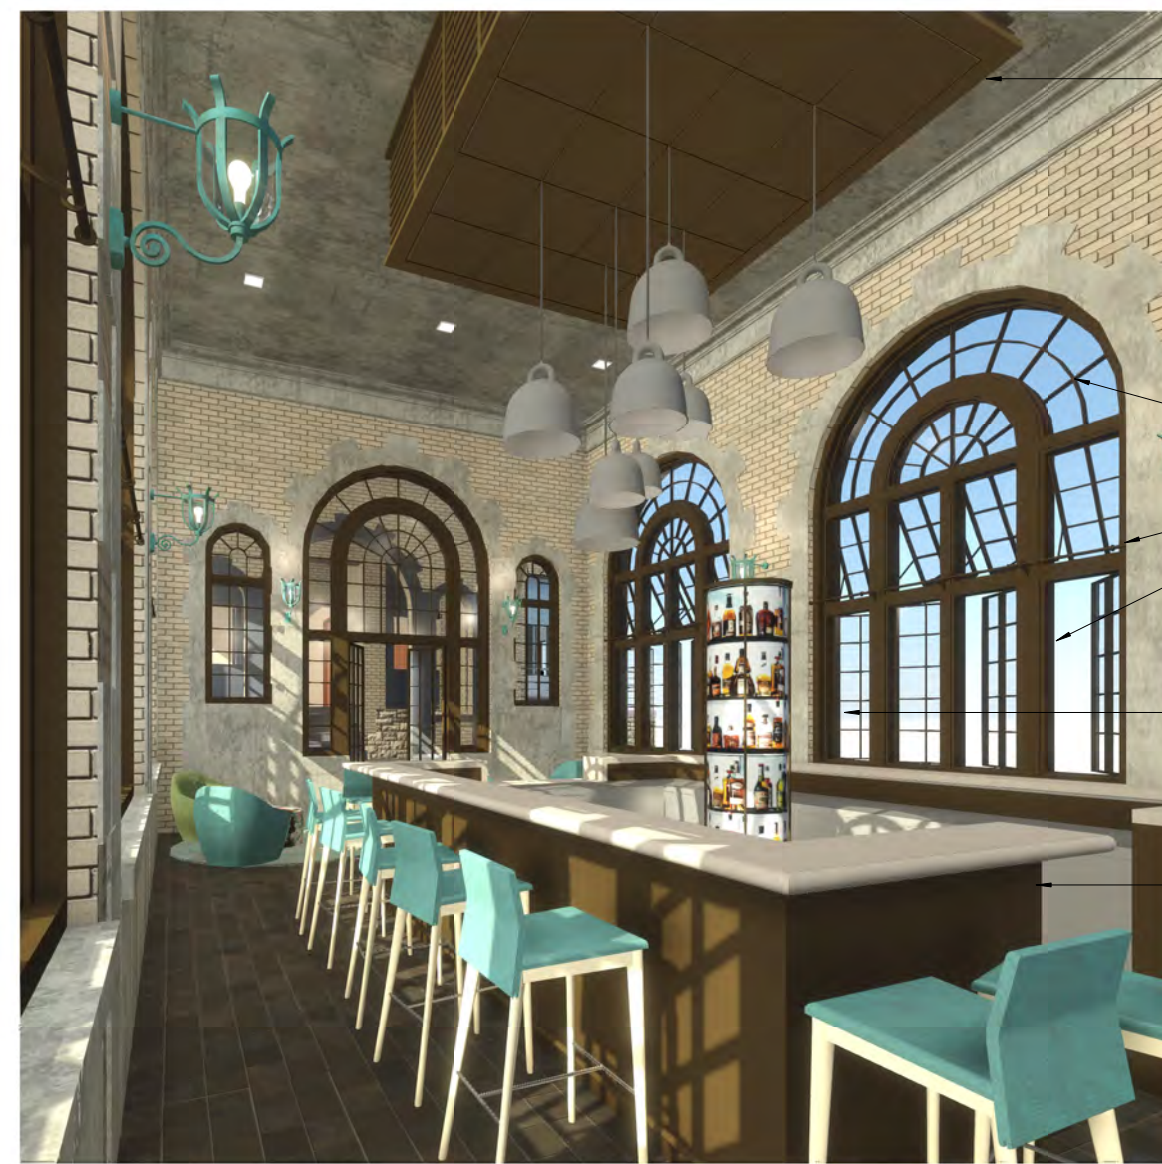
NEW HVAC CEILING SHROUD OVER BAR TO CONCEAL NEW MECHANICAL SYSTEM.
SHROUD CONSTRUCTED OF STAIN GRADE WOOD LUMBER AND WOOD VENEER PANELS. PAINTED METAL LOUVERS SURROUND THE SHROUD.

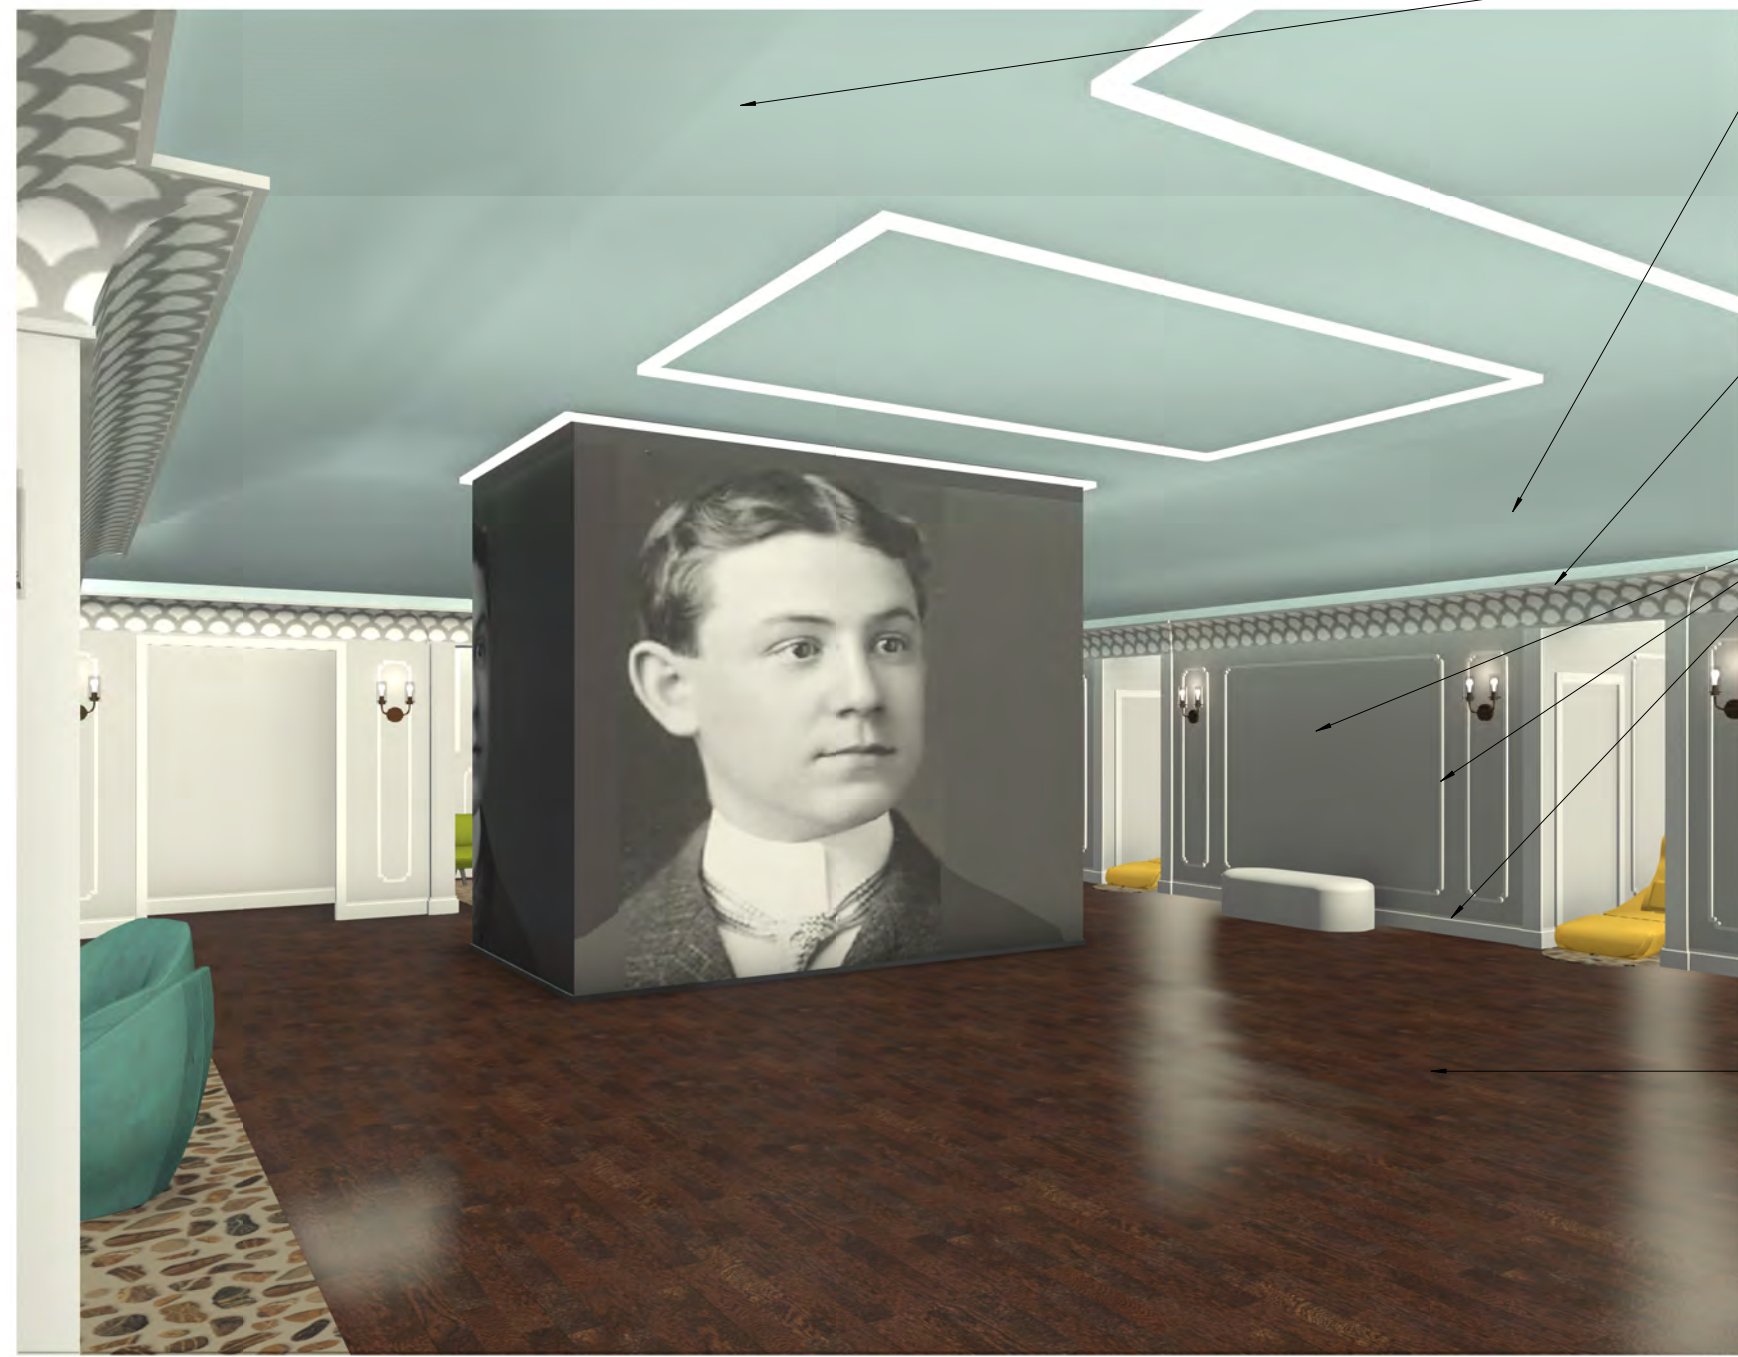
REMOVE EXISTING LOOSE/PEELING PAINT FROM HISTORIC CEILING.
REMOVE ALL CEILING MOUNTED DEVICES AND RETURN HISTORIC ELEMENTS TO OWNER FOR STORAGE.
PATCH/REPAIR/RECONSTRUCT HISTORIC PLASTER CEILING TO BE CONSISTENT THROUGHOUT ROOM.
PRIME AND PAINT CEILING.

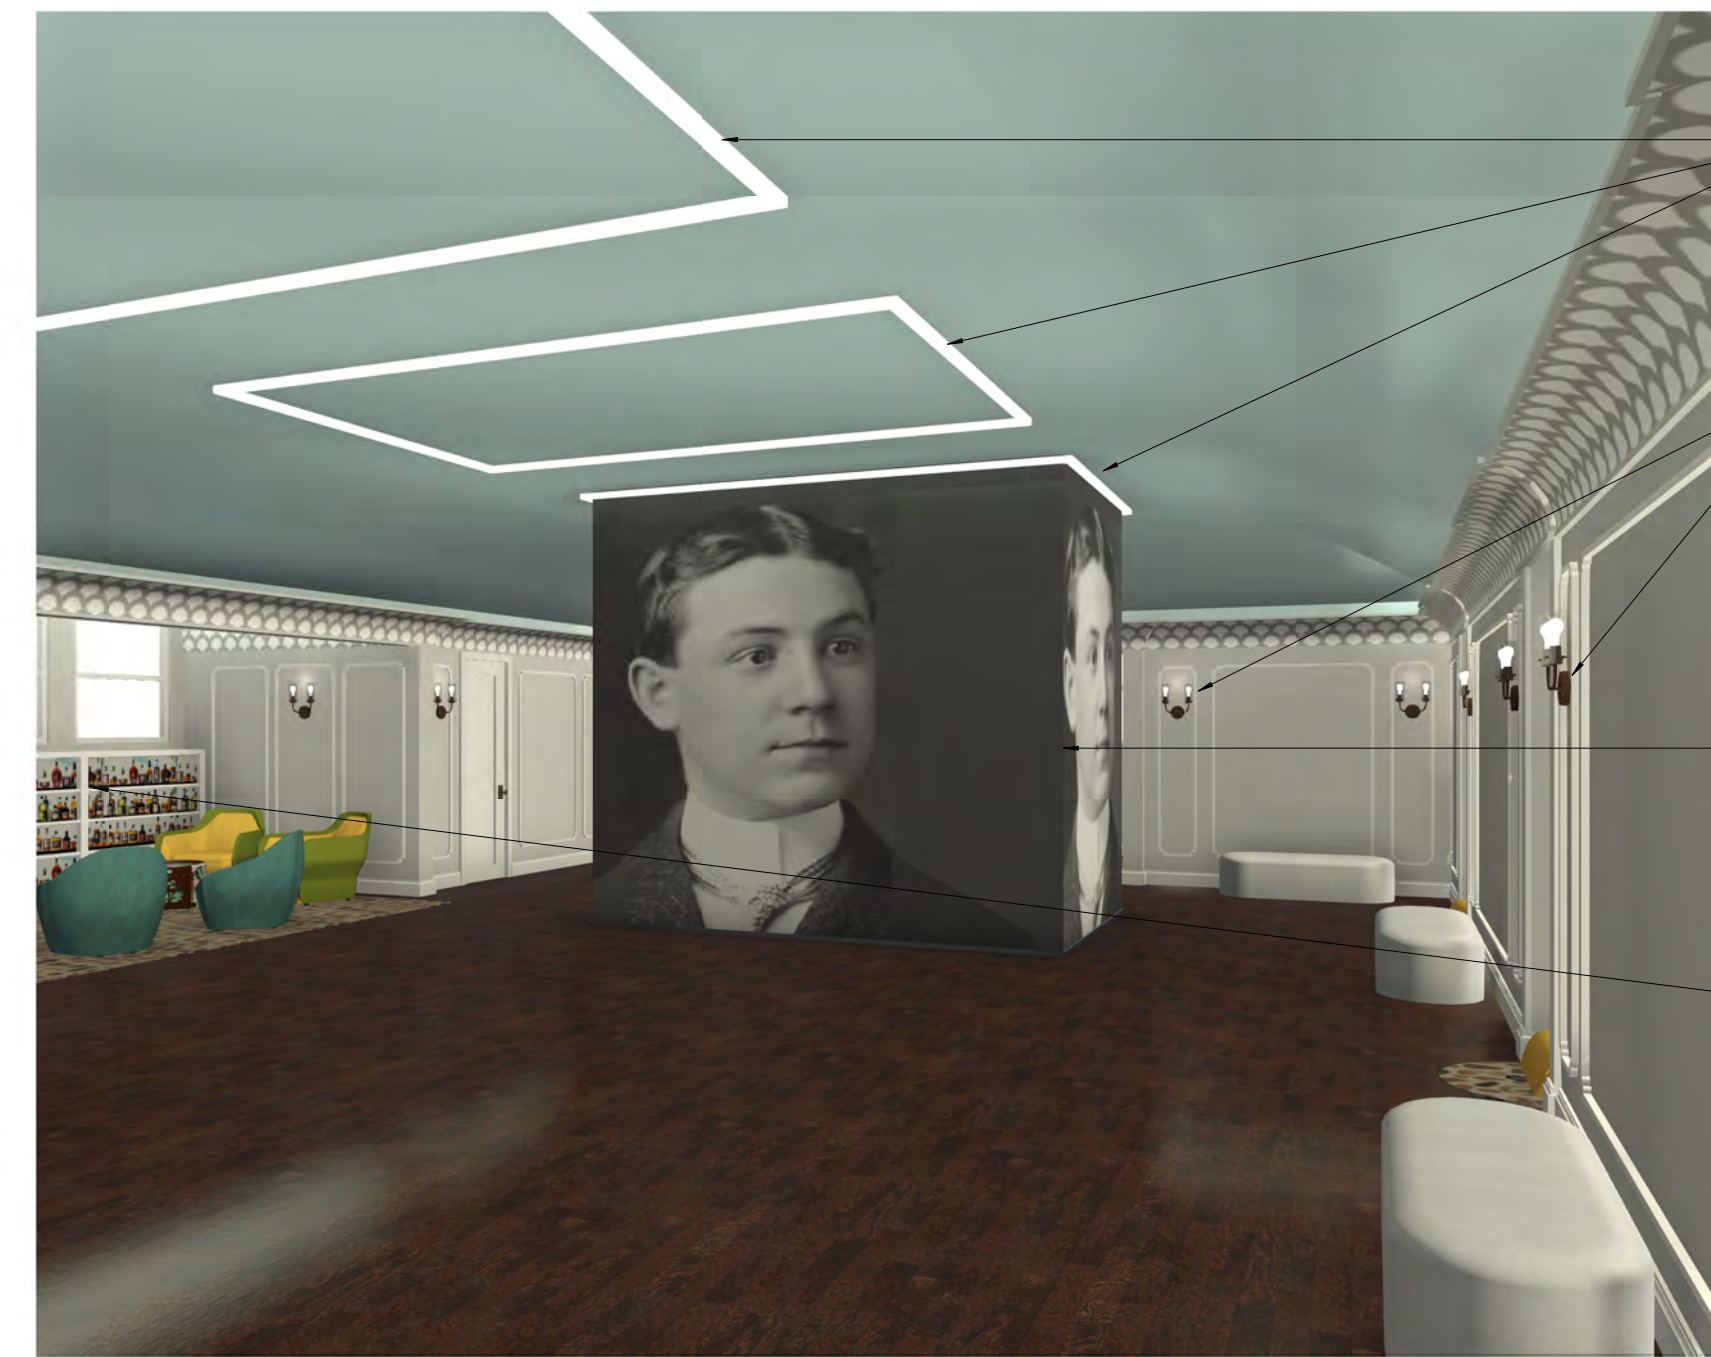
FOCAL POINT LIGHTS SEEM 2 LED DIRECT LINEAR SURFACE MOUNT FIXTURES. CONFIGURATION TO BE RECTANGULAR WITH CUSTOM SIZE 8'-9" X 13'-3" LENGTHS.
FSM2LS-FL-1000LF-30K-1C-UNV-L11-SM-WH-105X159R

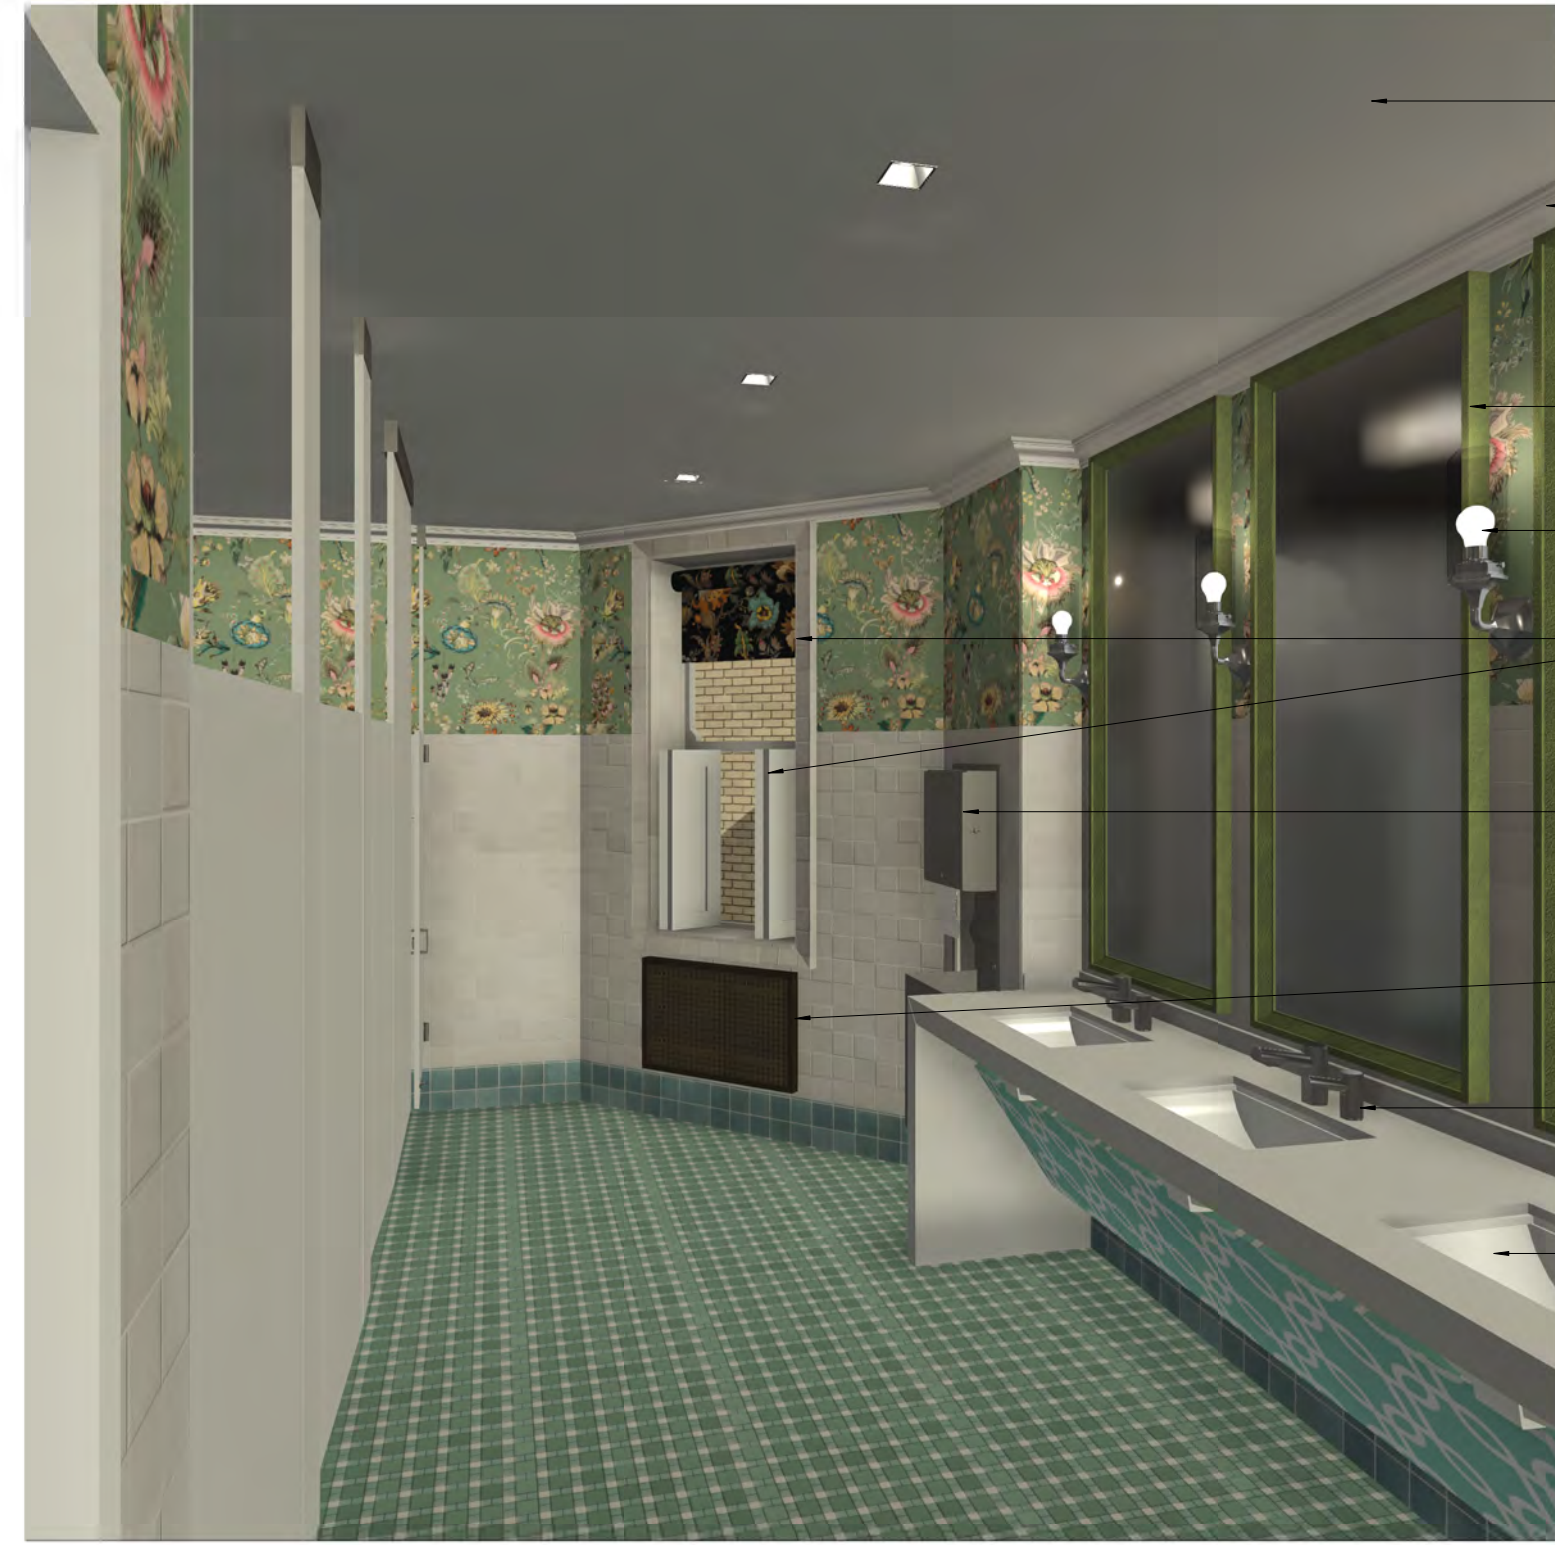
- NEW PAINTED GYPSUM BOARD CEILING
- NEW PAINT GRADE CORNICE MOULDING
- NEW DECORATIVE MIRROR WITH PAINTED WOOD MOULDING
- PROVIDE \$500.00 LIGHTING ALLOWANCE PER SCONCE FIXTURE.
- NEW WINDOW TREATMENTS AND ASSOCIATED HARDWARE. EACH WINDOW TO RECEIVE ROLLER SHADE AND PAIR OF SOLID WOOD SHUTTERS.
- BOBRICK B-39747 CLASSICSERIES® AUTOMATIC ROLL TOWEL DISPENSER/WASTE RECEPTACLE EQUIPPED WITH LED LIGHT
- HISTORIC MECHANICAL GRILLES TO BE REPAIRED AND CLEANED
- BRADLEY CORPORATION, VERGE COORDINATED SOAP DISPENSER AND FAUCET SET - METRO SERIES, POLISHED CHROME, P15-PC
- AMERICAN STANDARD STUDIO UNDER COUNTER SINK, O61400.020, WHITE
- COUNTER TOP, SPLASH, TURN DOWN, LEGS: CAMBRIA, CLASSIC SERIES, WHITEHALL,
- WILSONART, SAFI KASBAH, Y0176, 60 MATTE FINISH
