DeKalb County Historic Preservation Commission

Monday, April 15th, 2024- 6:00 P.M.

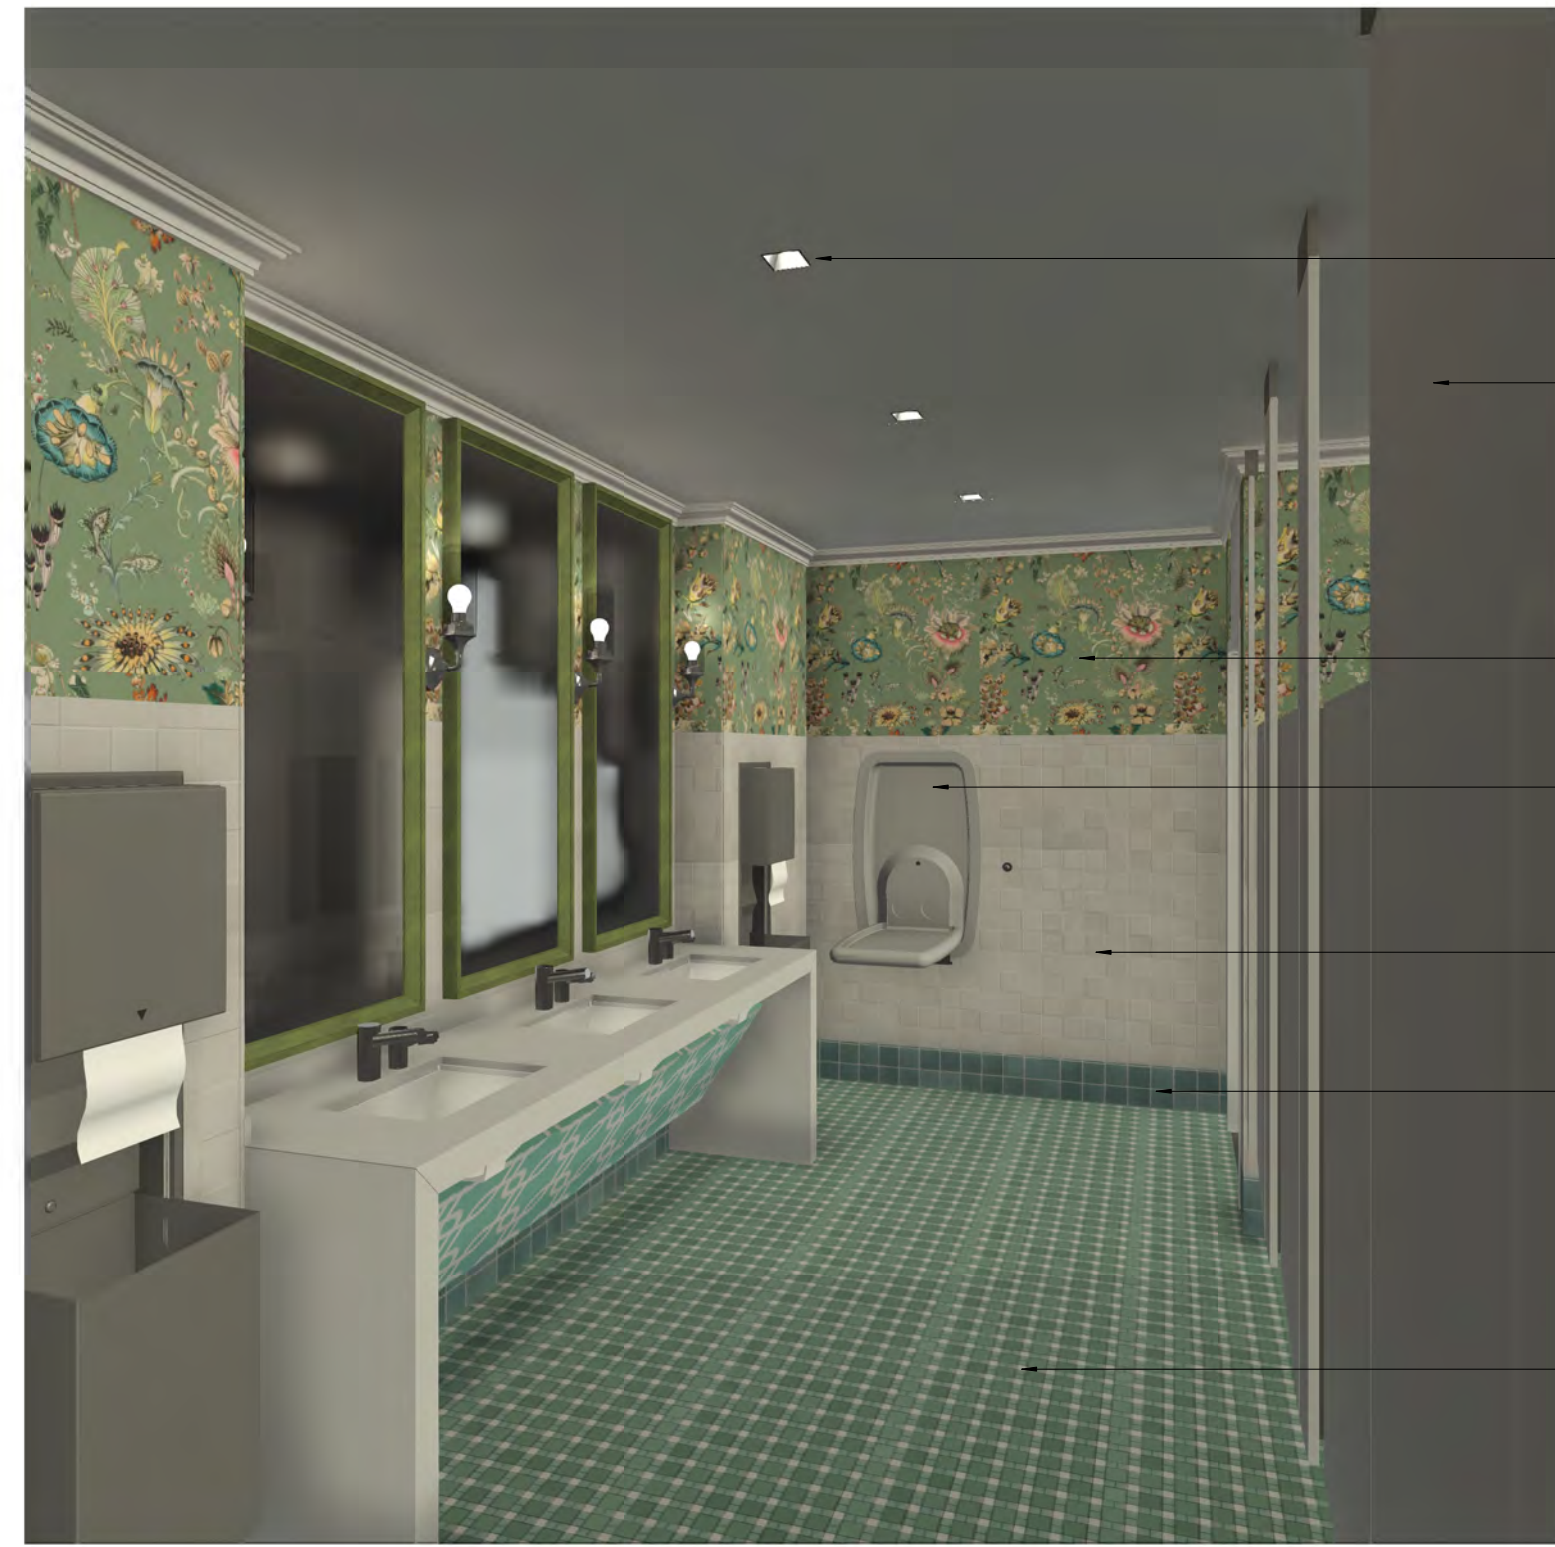
- FOCAL POINT DOWNLIGHT ID+ 2.5'X2.5'
- BRADLEY CORPORATION, PHENOLIC PRIVACY PARTITION, CEILING HUNG, SERIES 600, MISSION WHITE, 933
ADD ALTERNATE:
BRADLEY CORPORATION, EURO STYLE PARTITIONS, LOFT SERIES, WHITE 10140
- WALLCOVERING: HOUSE OF HACKNEY, FLORA FANTASIA, VERDIGRIS
- BOBRICK, KOALA KARE, KB111-SSRE VERTICAL RECESSED MOUNTED BABY CHANGING STATION, BRUSHED STAINLESS STEEL FINISH
- WALL TILE: TILEBAR, PORTMORE, 4X4, WHITE
- BASE TILE: TILEBAR, PORTMORE, 4X4, AQUA
- FLOOR TILE:
DAL TILE KEYSTONES PATTERN: DP2033
TILE 1: D617 ARTIC WHITE
TILE 2: D148 SPA
TILE 3: D192 AEGEAN

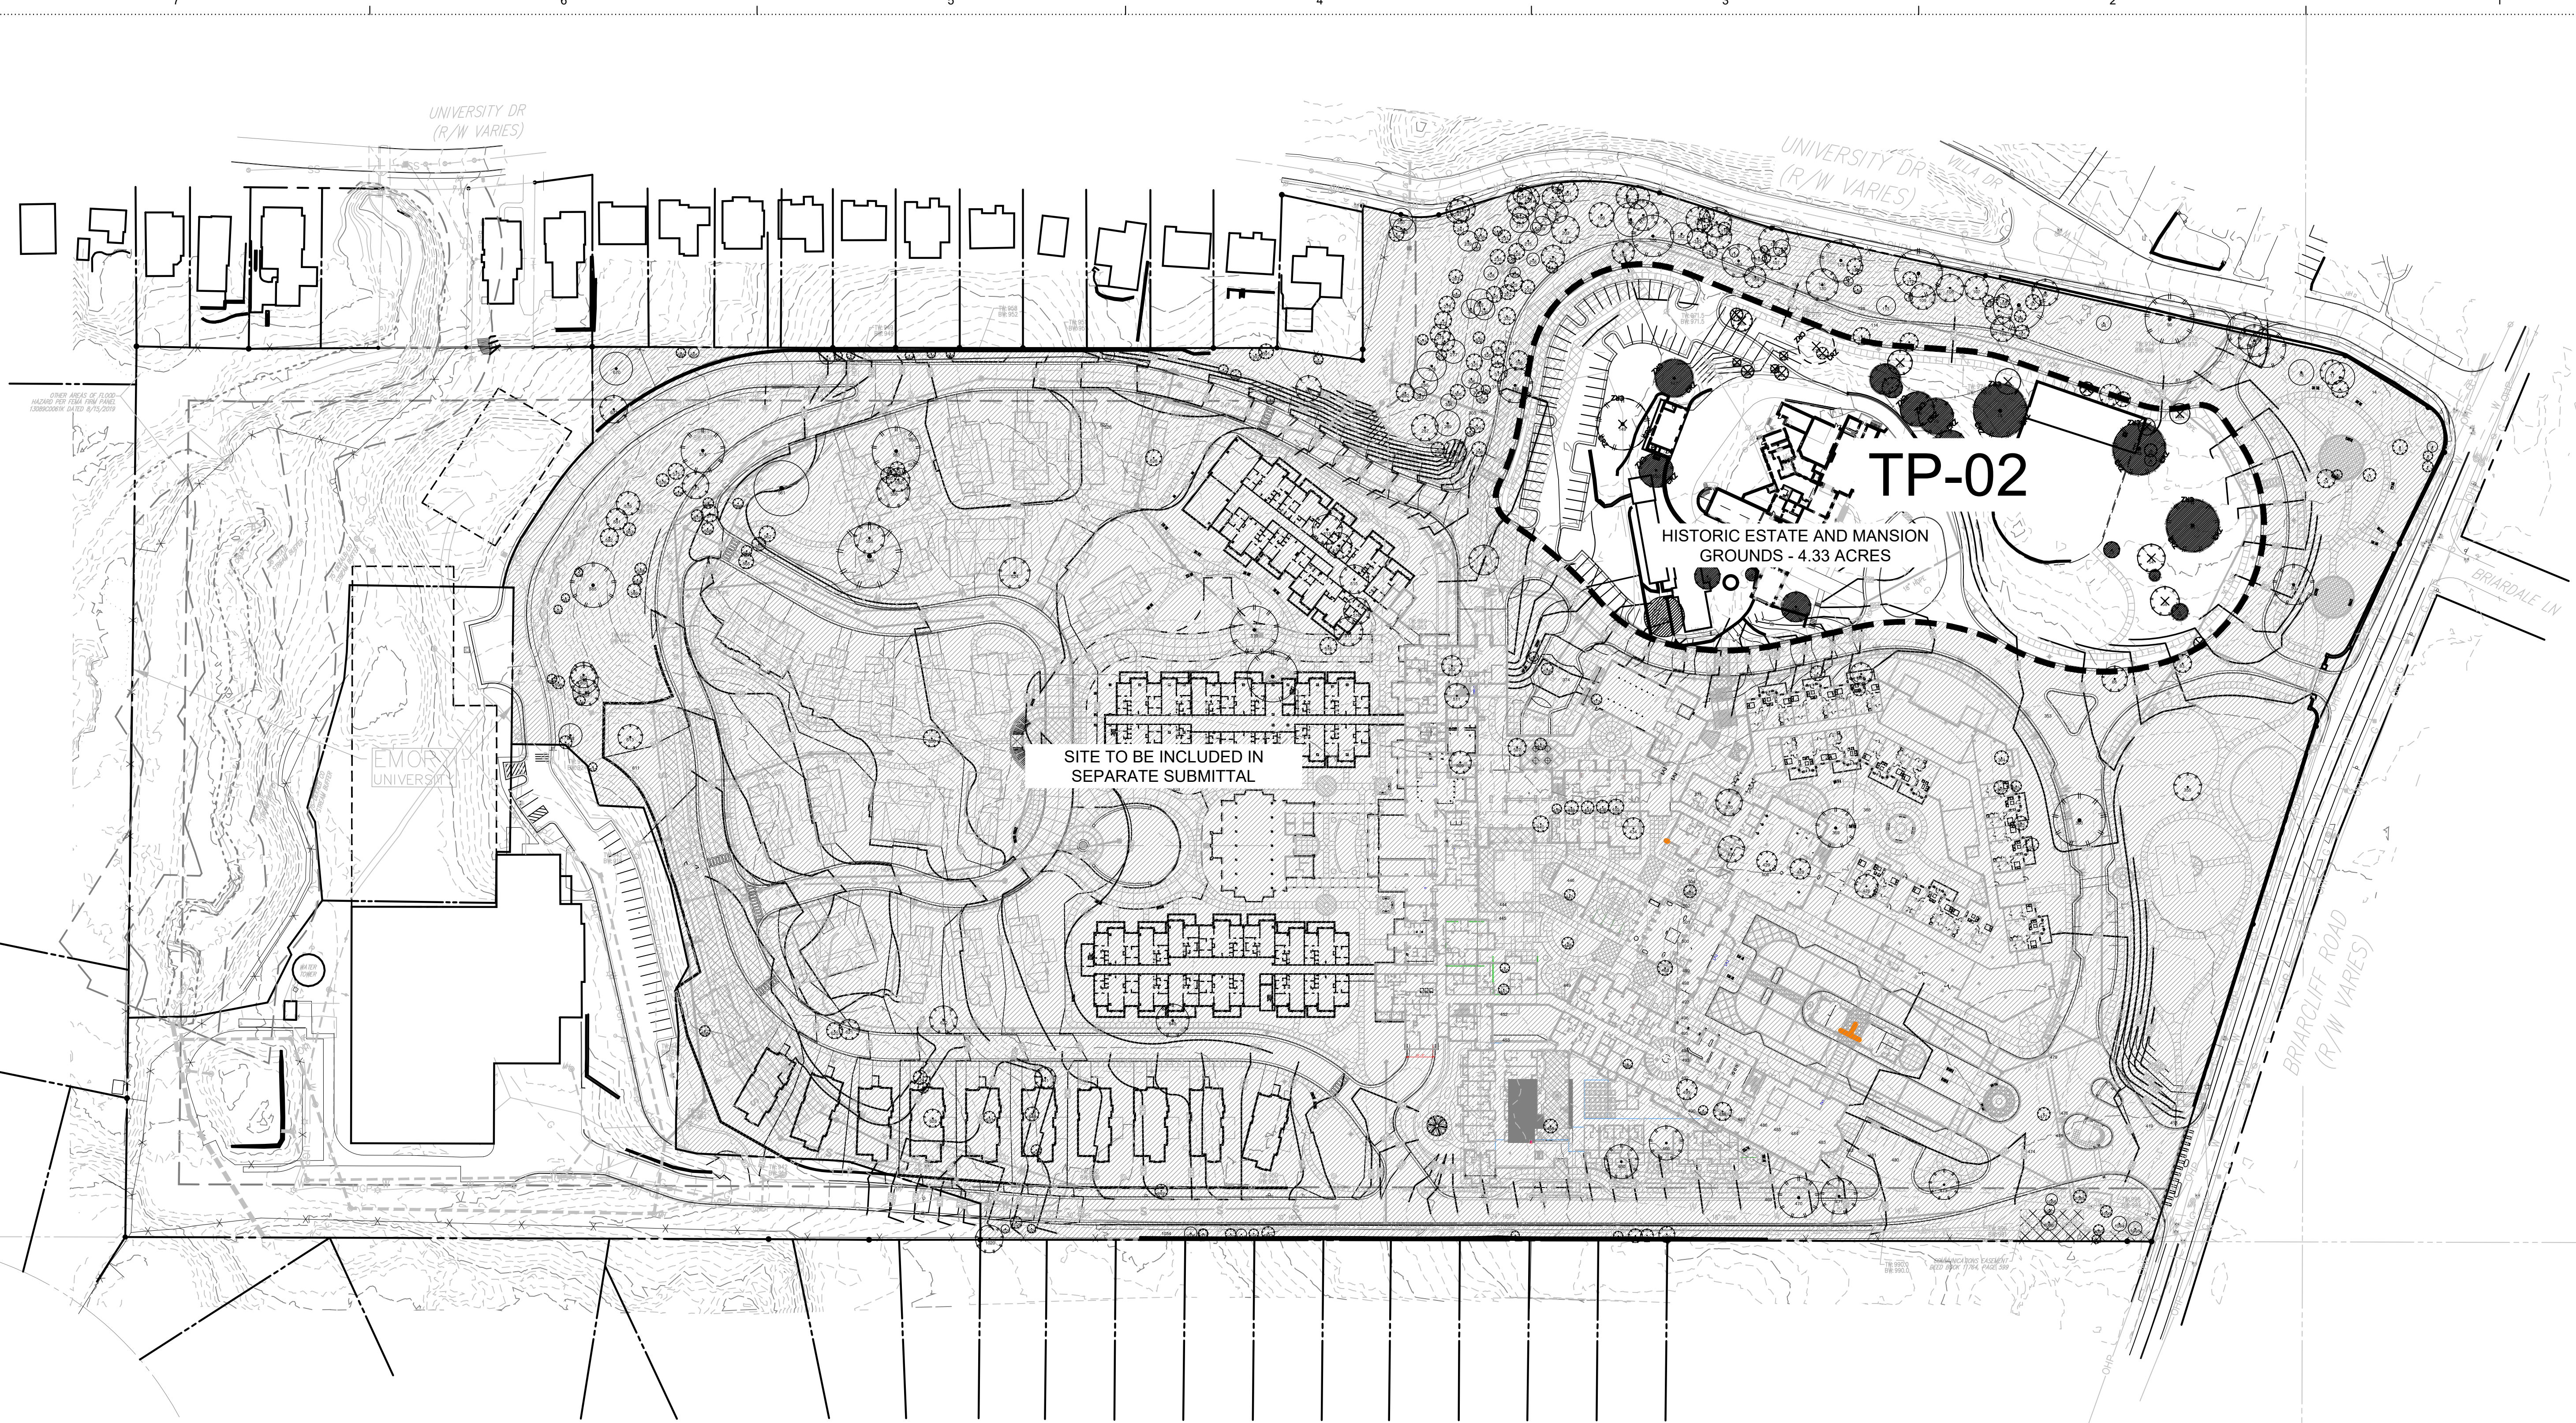
- NOTE:**
1. SIZE OF TREE SYMBOL DIRECTLY REFLECTS CRITICAL ROOT ZONE AREA
 2. ALL TREE PROTECTION AREAS TO BE PROTECTED FROM SEDIMENTATION.
 3. ALL TREE PROTECTION DEVICES TO BE INSTALLED PRIOR TO LAND DISTURBANCE AND MAINTAINED UNTIL FINAL LANDSCAPING.
 4. ALL TREE PROTECTION FENCING TO BE INSPECTED DAILY AND REPAIRED FOR REPLACED AS NEEDED.
 5. LANDSCAPING IS INSTALLED.
 6. NO PARKING, STORAGE OR OTHER CONSTRUCTION ACTIVITIES TO OCCUR WITHIN TREE PROTECTION AREAS OR WITHIN SIX (6) FEET OF THE CRZ.
 7. ALL REQUIRED VEGETATION MUST BE MAINTAINED FOR TWO GROWING SEASONS AFTER DATE OF FINAL INSPECTION.

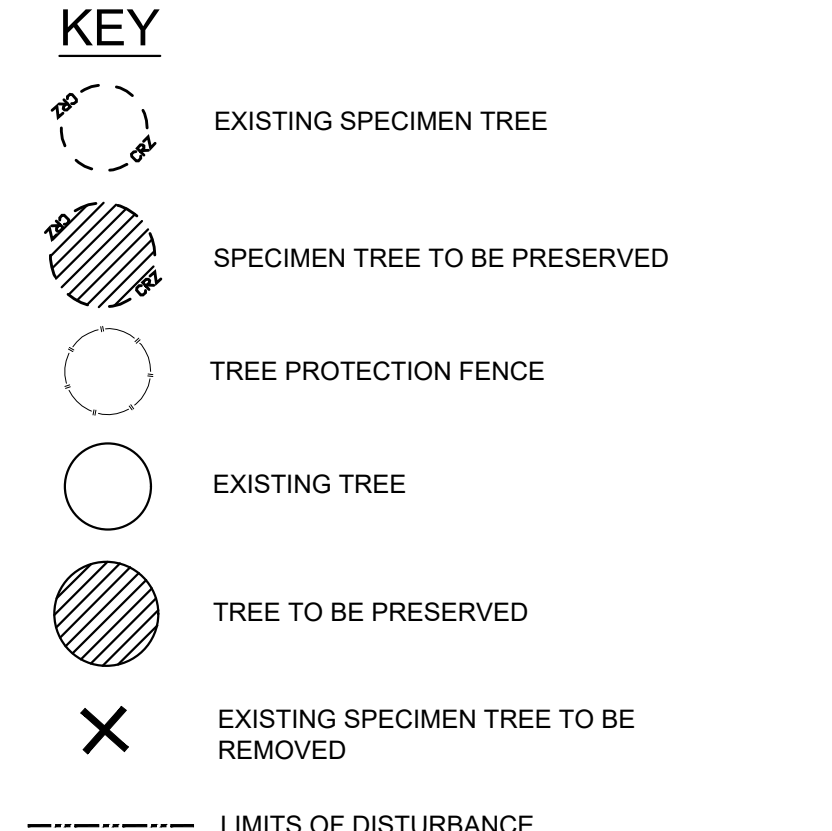
TREE PRESERVATION REQUIREMENTS

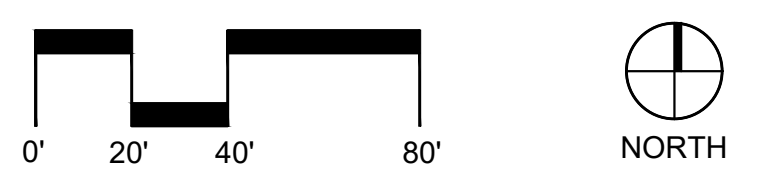
A TREE REPLACEMENT KEY PLAN
 TP-03 SCALE: 1" = 80'-0"

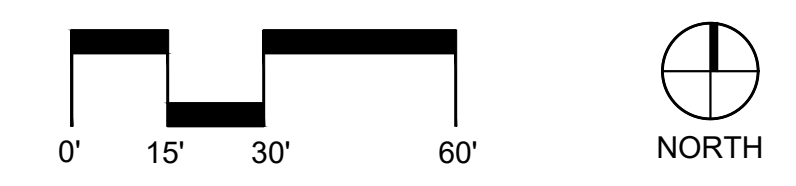
Last modified on 01/19/24 by M.EFFCOAT
 File located in S:\2023\23018\Graphics\CAD\06 - Regulatory\2301806WI - HPC Plan_Historic.dwg

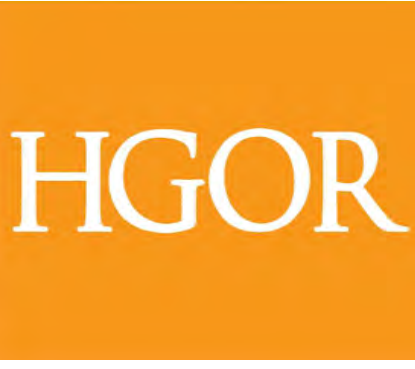
3525 Piedmont Road NE
 Building 8, Suite 320
 Atlanta, Georgia 30305
 www.hgor.com
 p. 404-248-1960
 f. 404-248-1092
