DeKalb County Historic Preservation Commission

Staff Report

I. 1320 Harvard Road, Dave Price. Rehabilitate historic garage and accessory structure. **1247501**

RE: Structural Assessment for 1320 Harvard Road, Atlanta, GA 30306

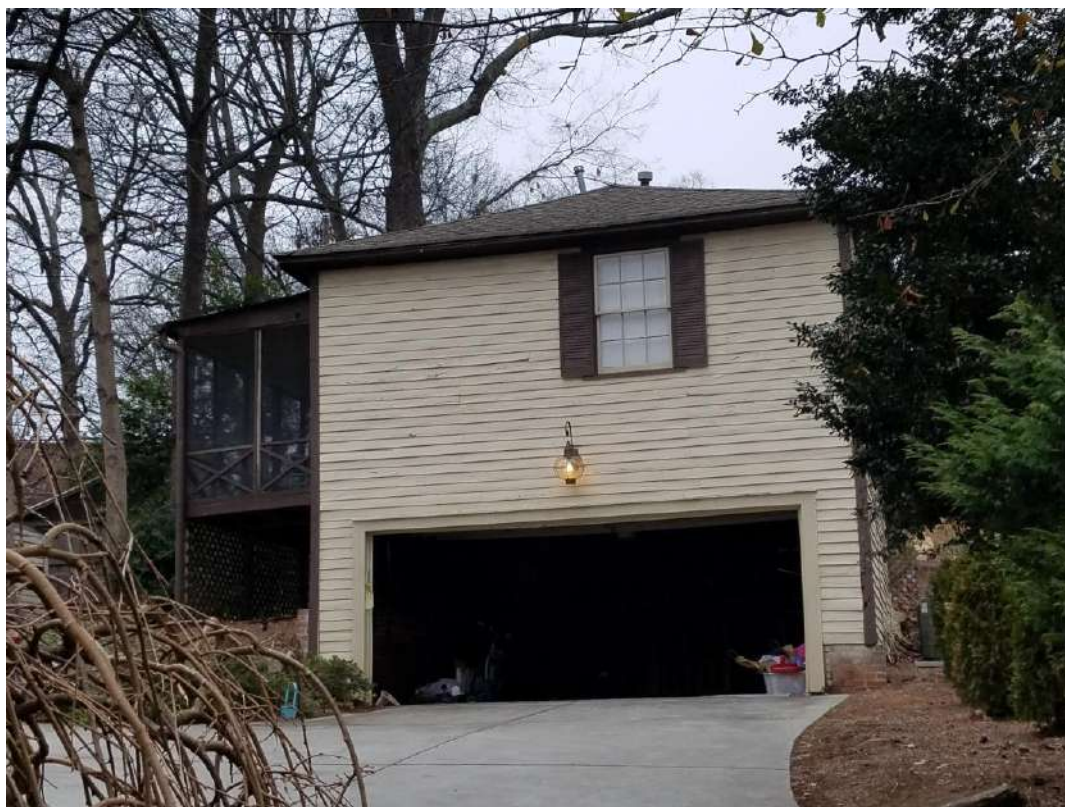
Front garage wall. New footings and portal framed header required.

4. Provide new footings at front corners of garage. Add new portal frame with LVL header for lateral bracing per code.
5. Add approximately 4 concrete footings under "left" side brick foundation wall @ 48", cut in to slab and underpin wall.

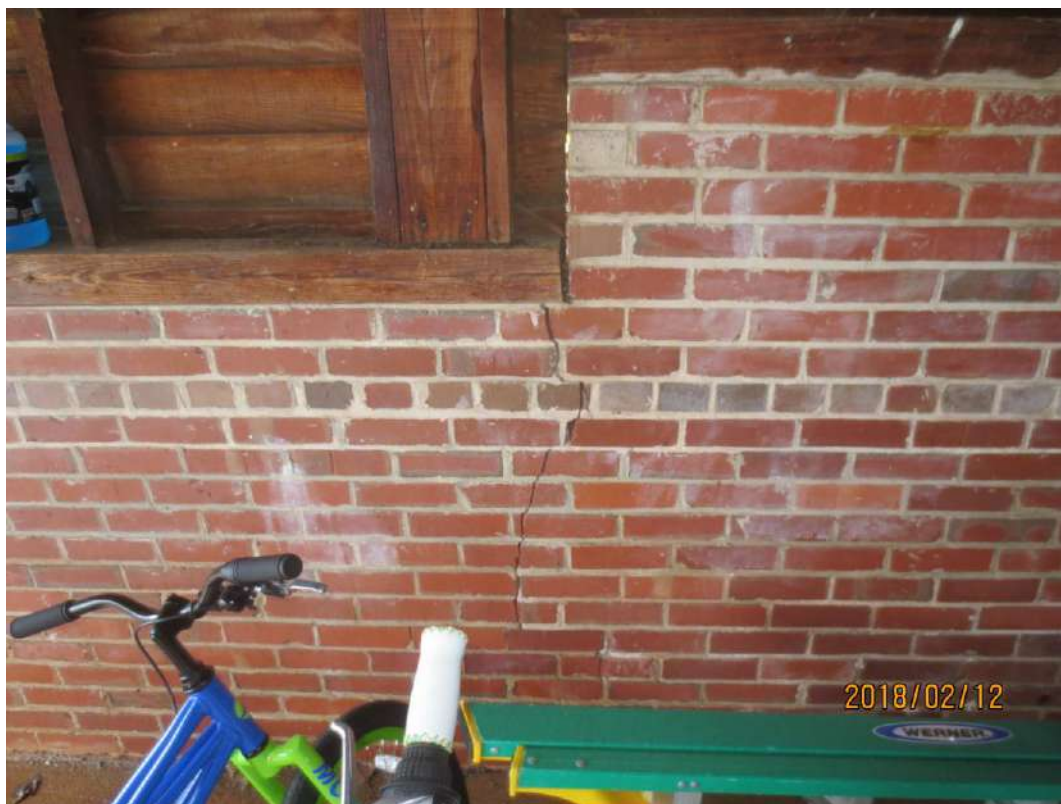
Left wall settlement crack, new underpinning footings required.

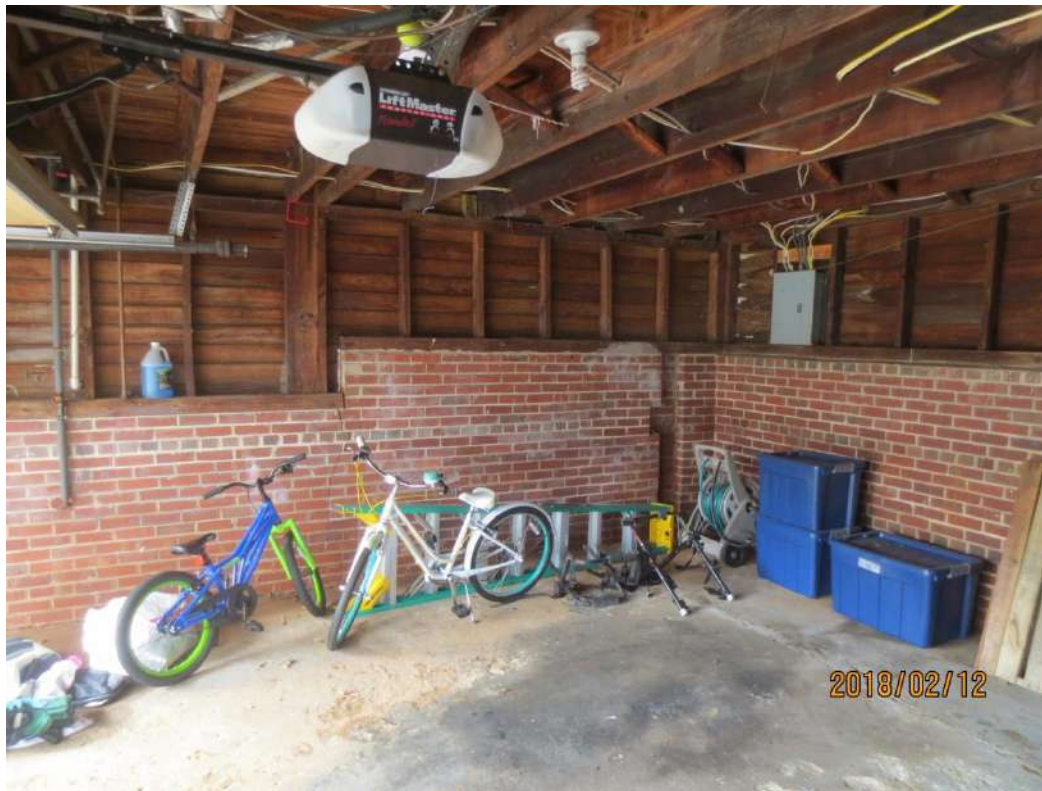
2. The floor joists over the garage are over-spanned and need to be stiffened by sistering new joists to the existing joists. New (2) 2x12 should be added to each existing joist to span the garage.

Left foundation wall and over-spanned 2x12 joists

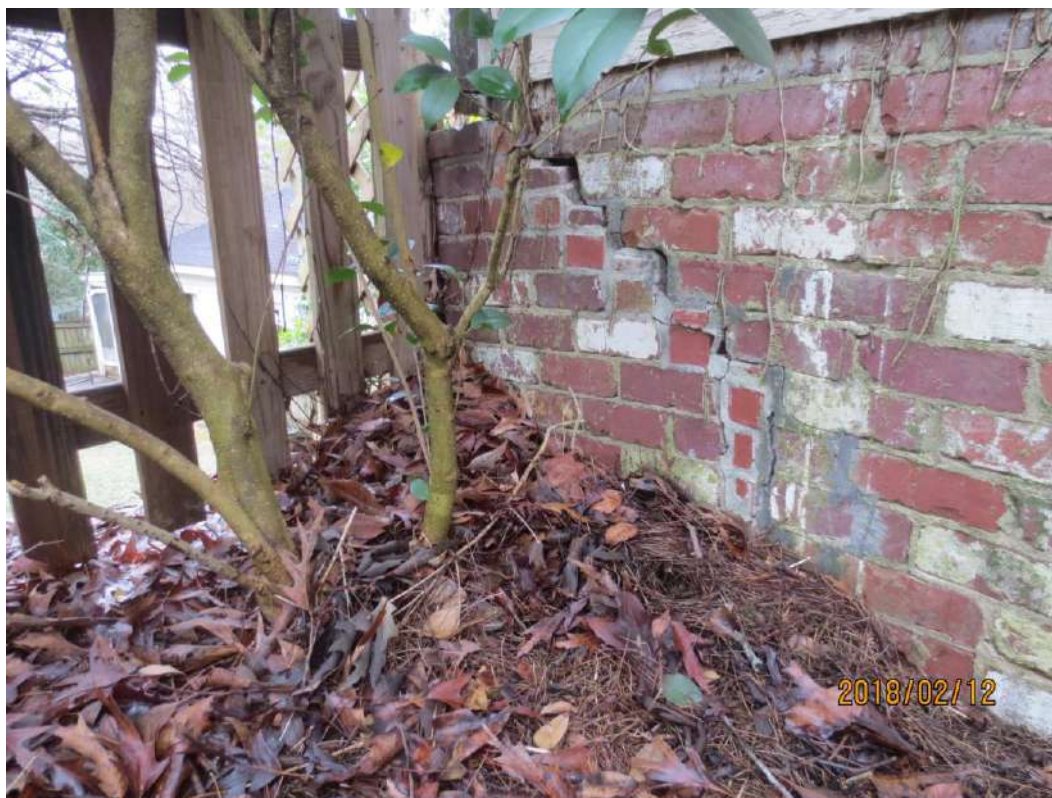
Rear addition corner settlement to be re-built with new footing and wall

1. Rear "addition" foundation wall (approximately 12 feet long) at the north\east side needs to be replaced. A new footing at the rear corner is required, which will have to be excavated down approximately 3 feet to firm soil, or supported on a helical pier.

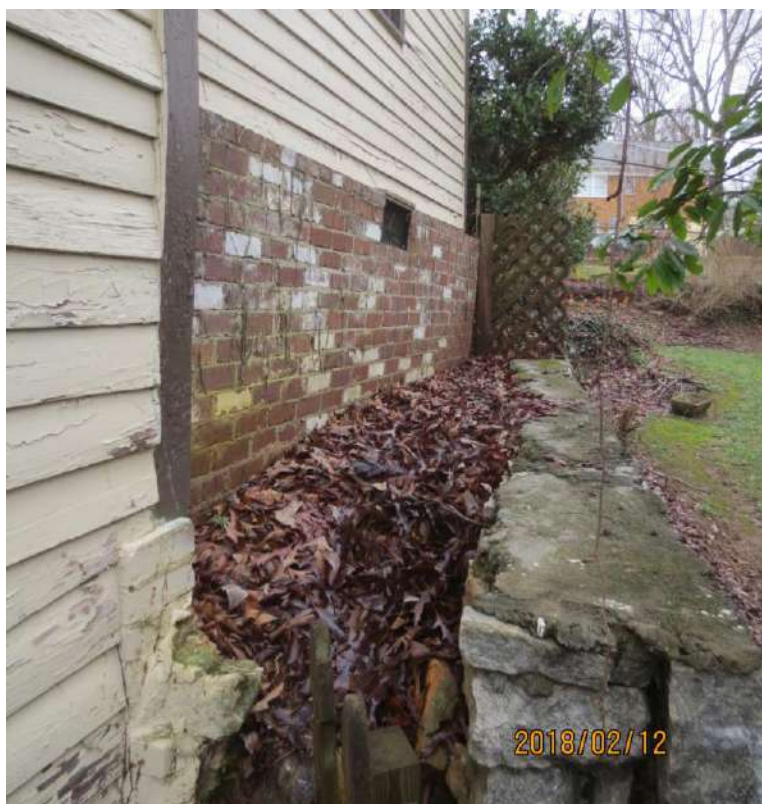
Addition side wall to be replaced

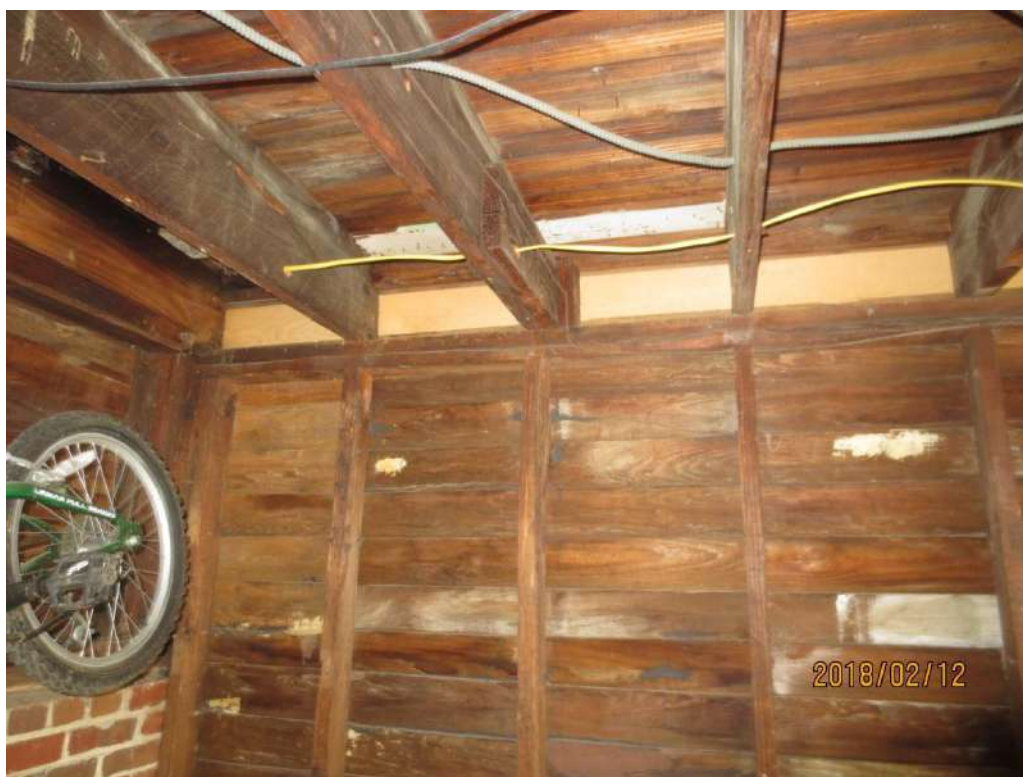
Damaged wall framing to be replaced

3. Rebuild exterior garage walls with 2x4 @ 16" with 7/16" OSB sheathing to replace existing wall with termite damage and no lateral bracing. This will require shoring support for the existing floor and walls above.

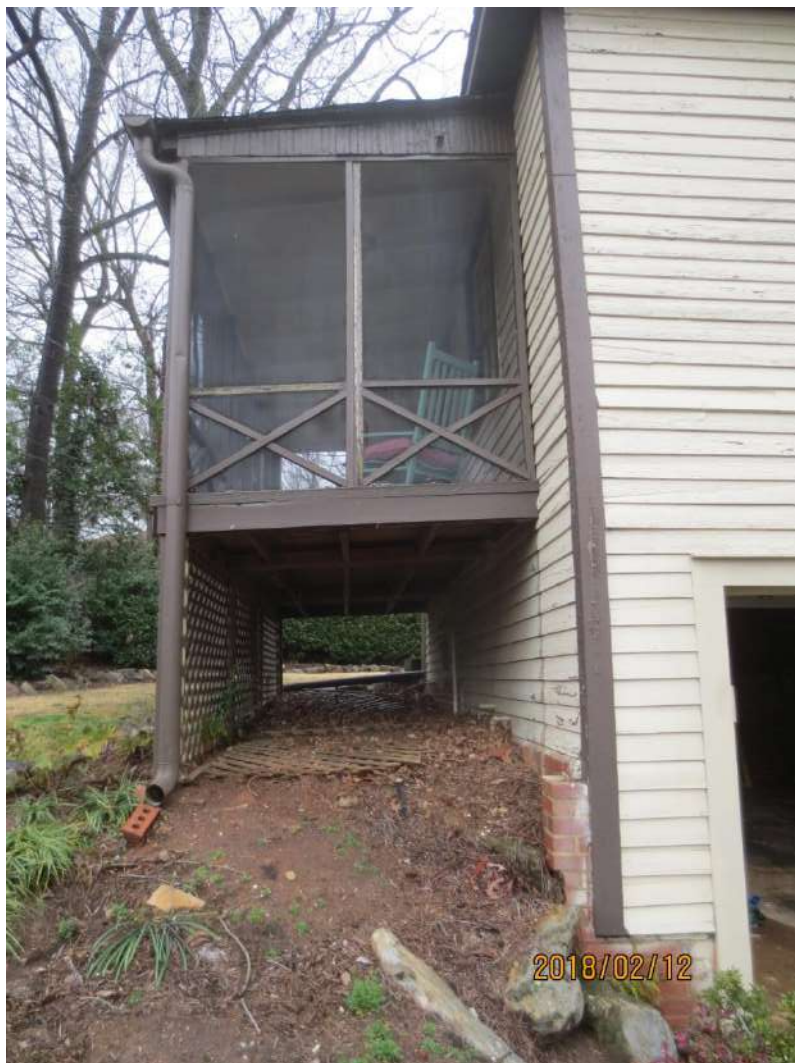
Side porch to be re-built
