Annual Report #3

Civil Action No. 1:10cv4039 - WSD

DeKalb County Department of Watershed Management

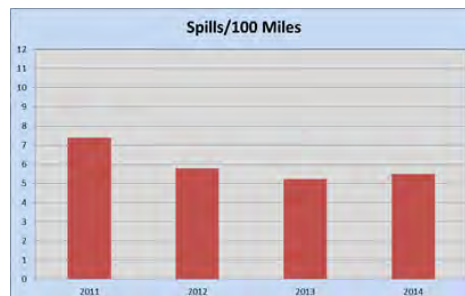
Figure 2 Spills per 100 Miles of Sewer Line

In **Figure 2** the reportable spills per 100 miles of line indicate a decreasing linear trend from 2007 to the present. It should also be noted that the overall annual variance is not extreme in either a dry year such as 2009 or a wet year in 2011.

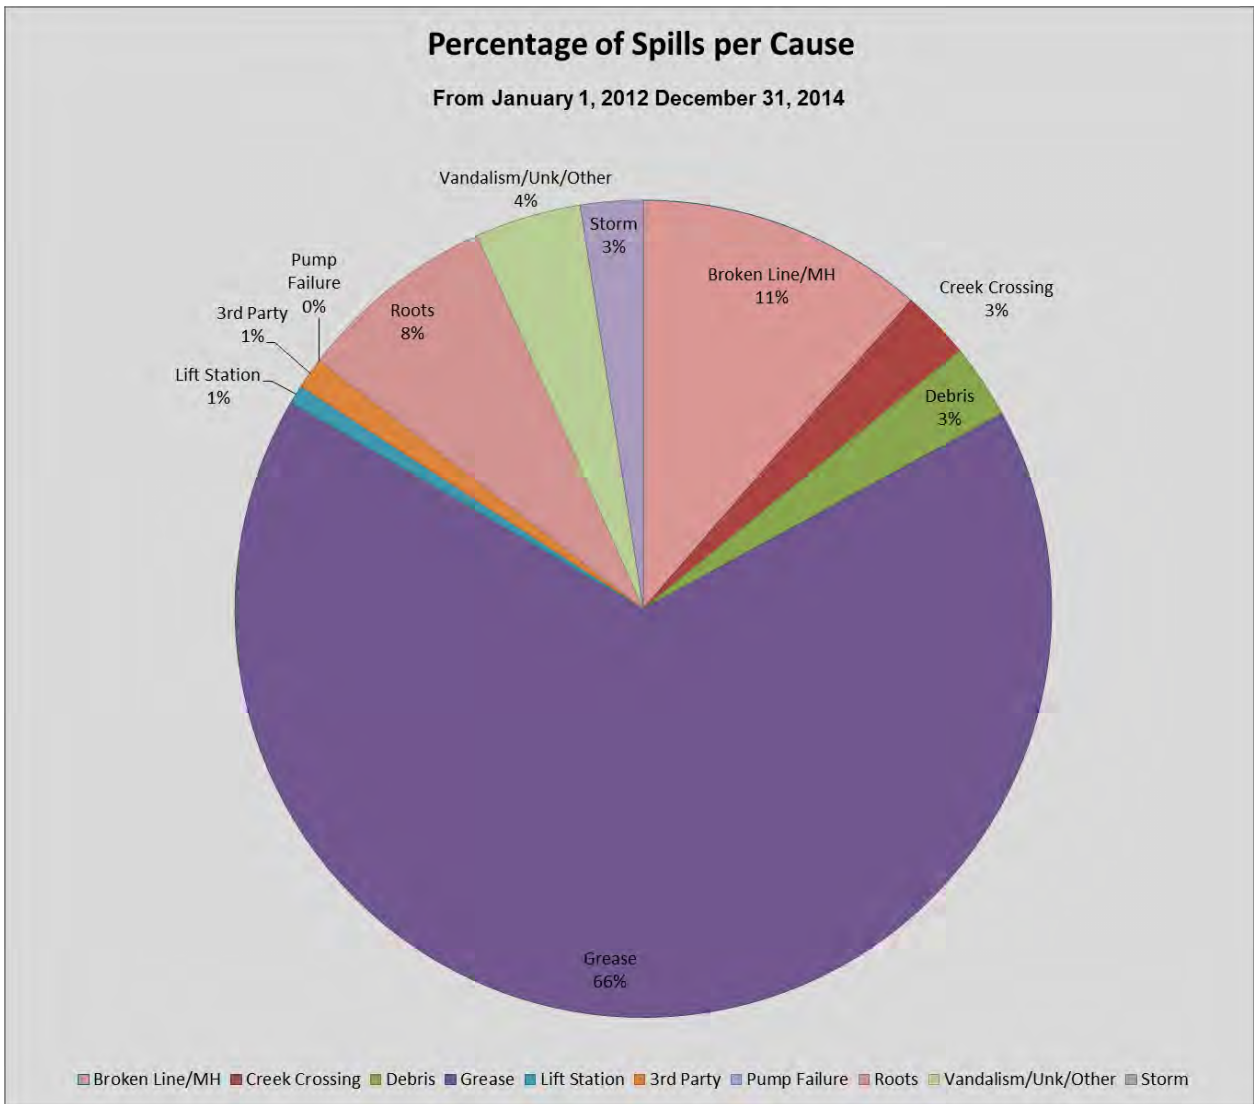
Figure 3 Spill Cause Breakdown

As shown in **Figure 3**, that the majority (66%) of reportable spills are still grease related. The percentage remained consistent for 2013 (67%) and 2014 (66%). The next highest areas are broken lines and structures at 11% (down from 2013 with 13%) and roots at 8% (down from 2013 with 9%).

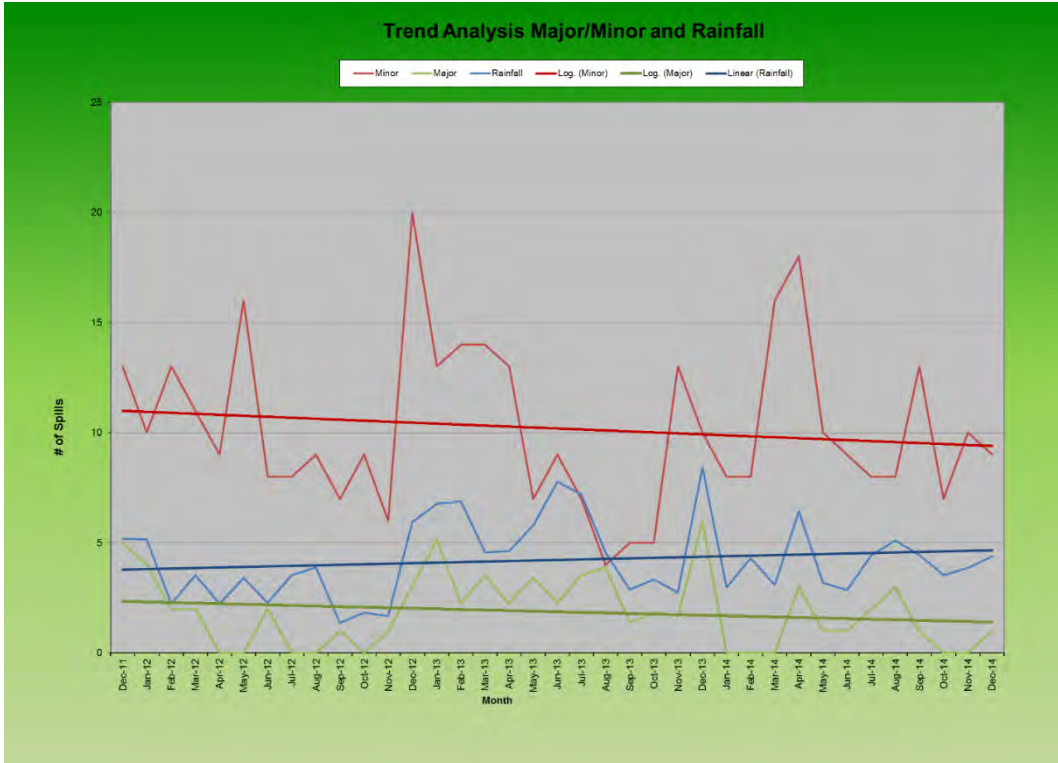
Figure 8 Rain and Spill Numbers

Figure 8 the comparison of rain to spill numbers is reviewed. As noted in the chart there is no conclusive correlation to spills and rainfall amounts. This conclusion is also present in the 6 previous years to this period.

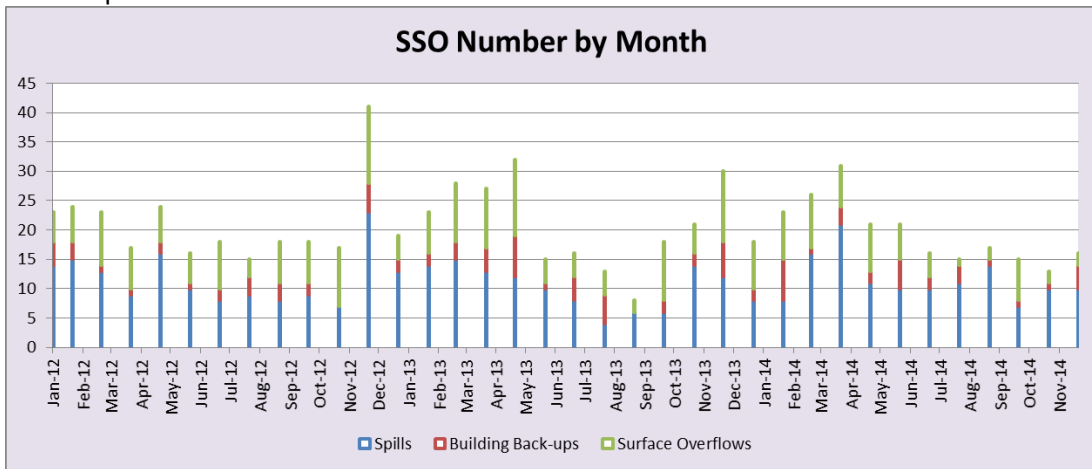
Figure 9 SSO Events by Month and Type

Figure 9 lays out SSOs by month. The trend from 2013 and 2014 seem to show that SSOs increase during the first half of the year and then decline during the summer months.

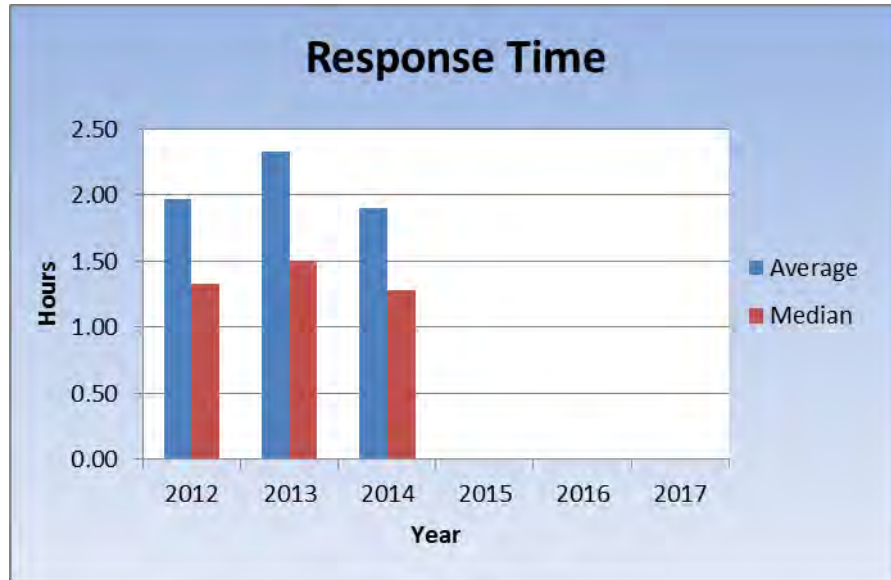
Figure 10 Annual Median and Average Response Time

The response time from the initial notification to the County and the restoration of flow is shown in **Figure 10** for each year. The overall trend remains very good at the 2 hour mark or less from call to cessation of the spill.

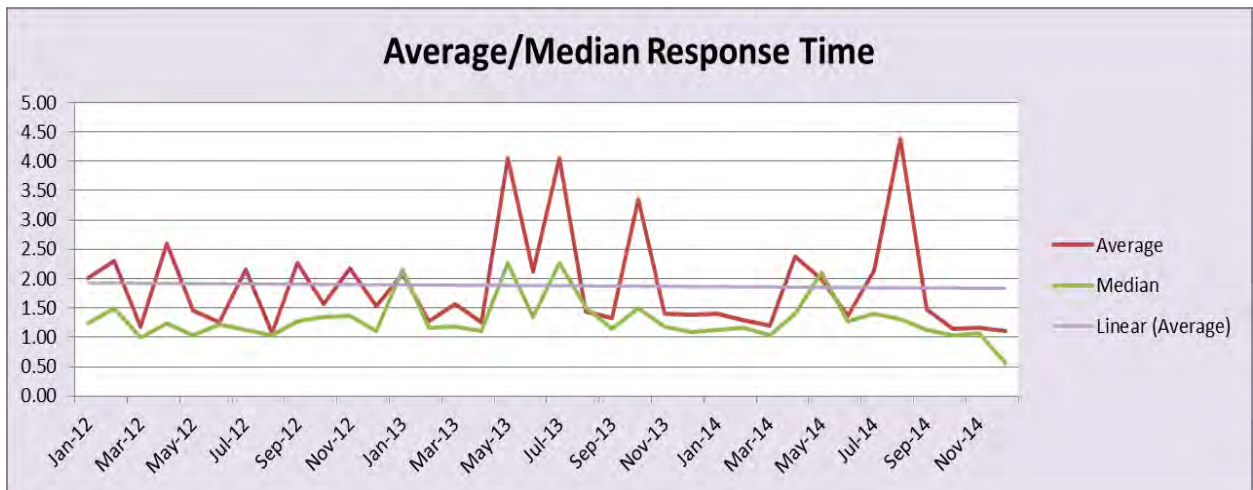
Figure 11 Response Time Call to Cessation of Spill

Figure 11 shows the monthly variations over time for both the average and median responses. The larger peaks, influenced by a single complex spill, have tended to be large lines or complicated spills where by-pass pumps were difficult to put in place.

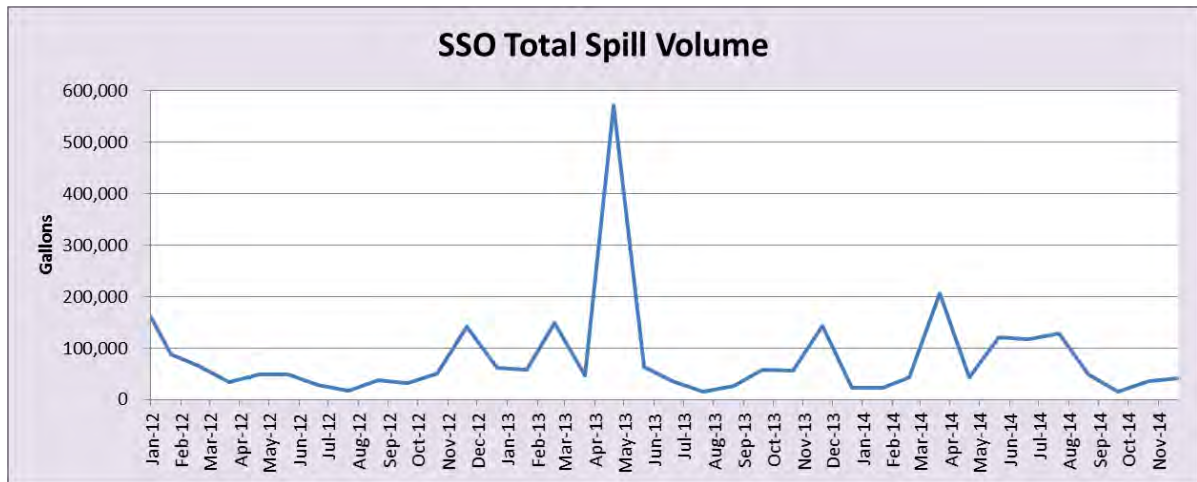
Figure 12 SSO Volume by Month

In **Figure 12** the monthly spill volume is indicated above. Through 2014 the amount remained relatively stable with the exception of the large volume spills in 2013.

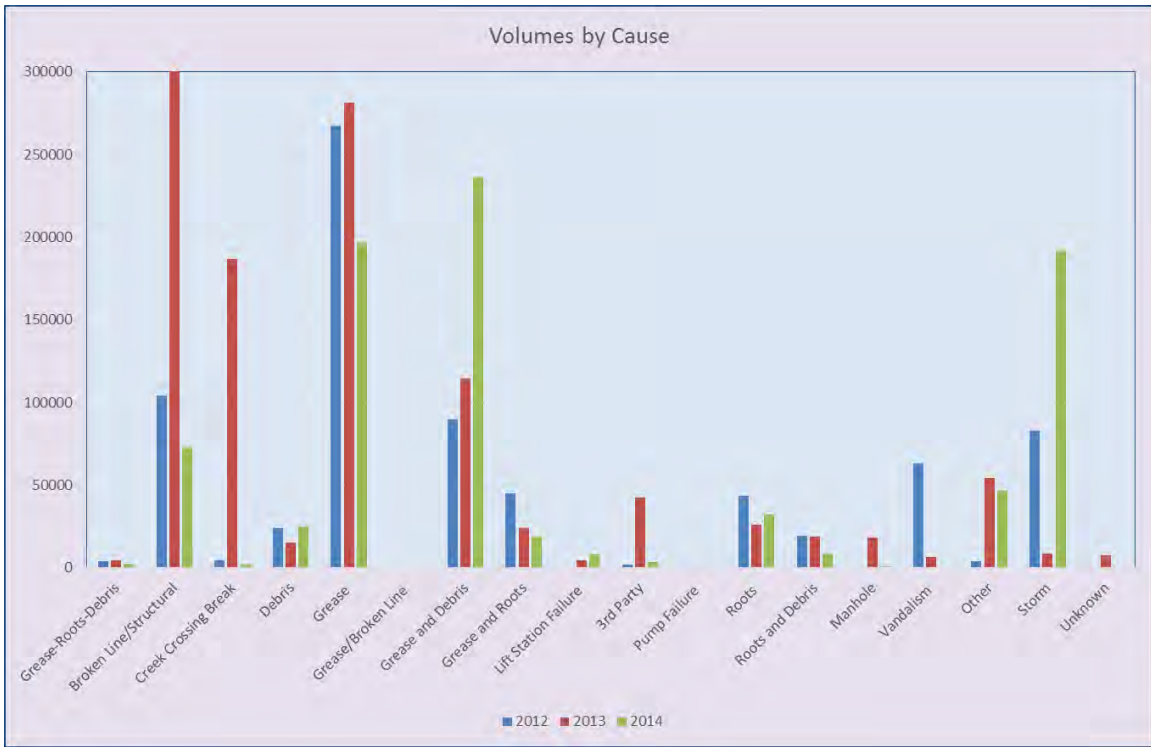
Figure 14 shows a graphical representation of volumes and causes. The graph seems to confirm grease related issues as again the primary cause of the volume of SSOs (after taking into consideration the single structural failure on a 30 inch line in 2013 that skewed the analysis of the data).

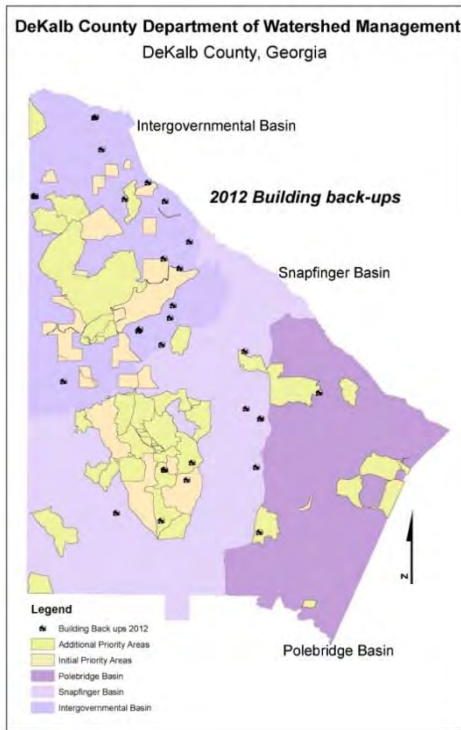
Map 3 Building Back-up Distribution

In review of **Map 3** of the building back-ups for the period the distribution appears to be somewhat random in nature. Investigative results indicated many issues with plumbing codes that caused more interior damage than should have occurred. The owners were notified of such deficiencies. It was also noted that some of the building back-ups were caused when the County, using cleaning equipment in some cases, conducts a follow-up to either a SSO or some type of system surcharge and discovers where the homeowner did not have the appropriate backwater device in place, had removed fixtures, and had other non-compliant plumbing systems such as gaps between the floor and lines, vents out the side of the house at 4 foot high or similar issues.

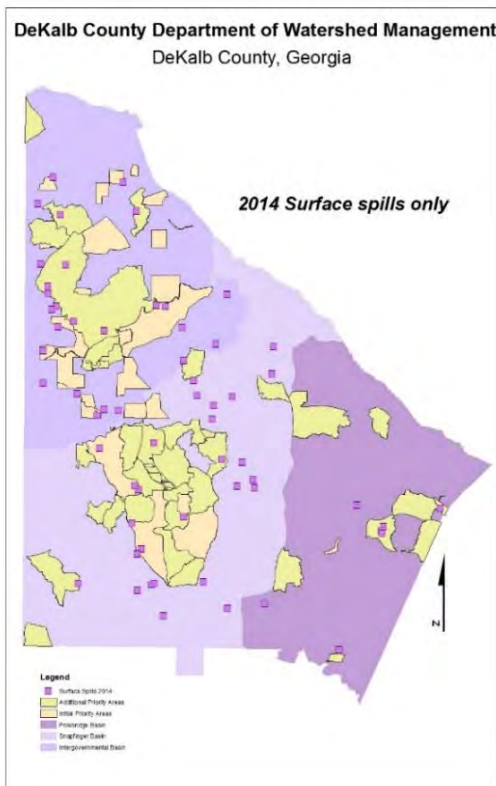
Map 4 Overflow Distribution

Map 4 demonstrates the distribution of overflows throughout the County for each of the years. As with spills, overflows are not correlated with any type of priority area and are random in nature. Further study is underway on a comparison of SSO locations to those locations that have surcharged manholes.

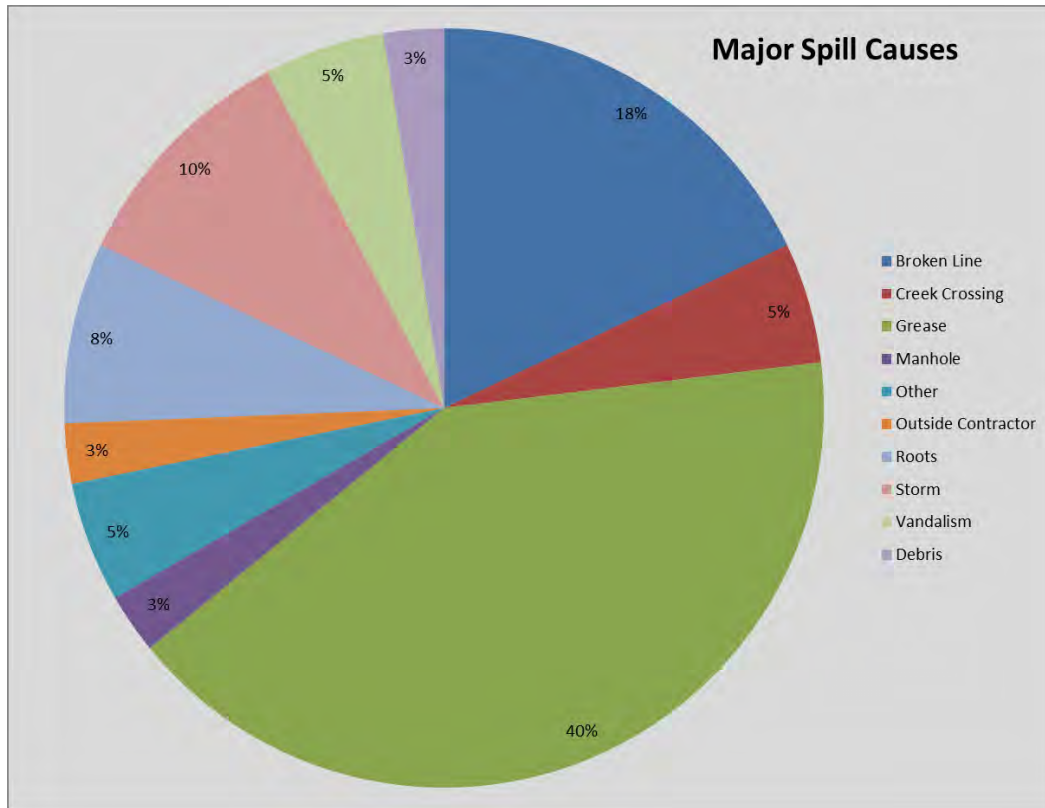
Figure 1 Major Spill Causes

Review of the causes as noted in **Figure 1** does not show any patterning or significant differences from the spill causes in the Minor category other than grease has a lower percentage.

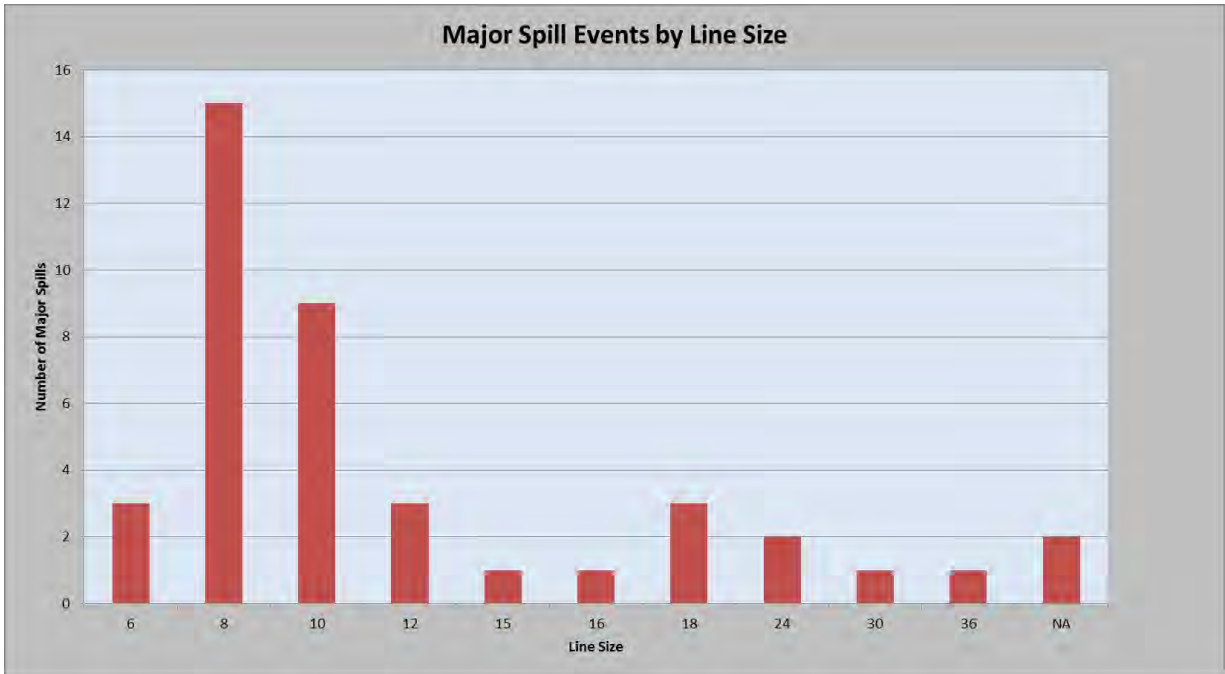
Figure 2 Major Spill Events by Line Size

A review of the major spill events by line size as shown in **Table 3** does not show any trend other than that based on the composition of line sizes in the system with 8 inch being the predominant line size. There is no trend to larger lines being directly associated with a major event. There may be a slight change in the 8 and 10 inch line sizes as the 8 inch lines are decreasing and the 10 inch increasing in relation to spills. These two line sizes accounted for 58% of the spills and 59% of the volume. The events labeled NA did not involve a line in the spill however the volume is considered in the evaluation. **Figure 2** is a graphical representation of the line size and number of events per line size.

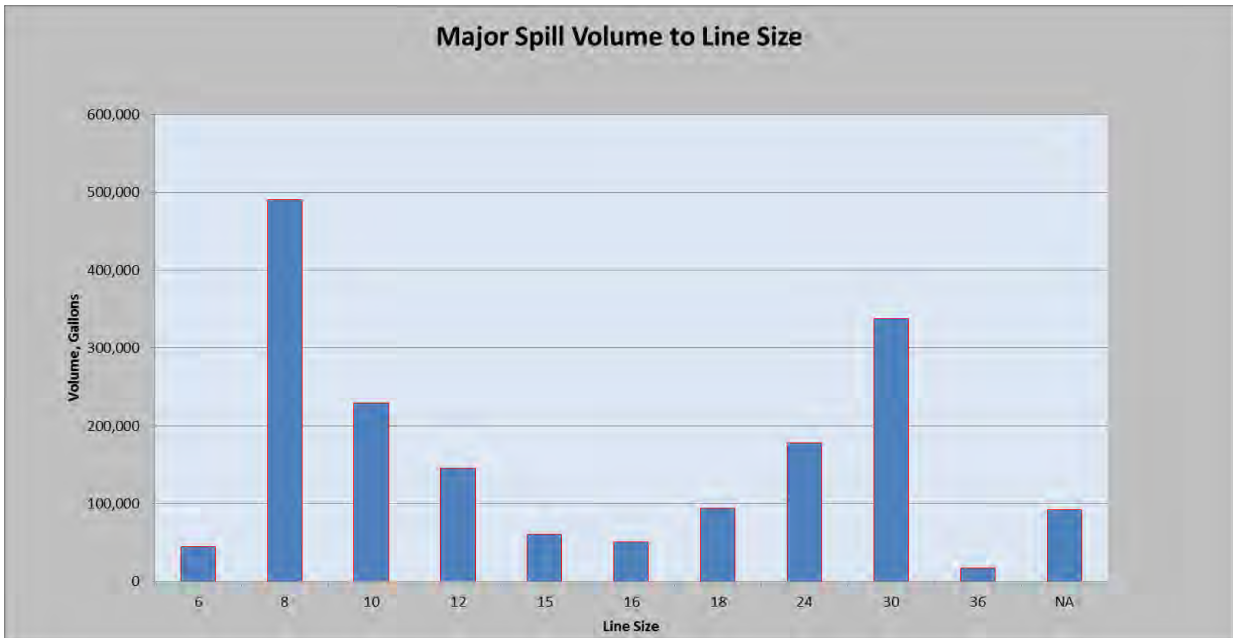
Figure 3 Major Spill Volume to Line Size

The next review in **Figure 3** was a comparison of volume to line size which continued to show proportionality to the line size distribution overall. The 30 inch event skewed the results however it was not an unexpected change based on the cause and required time to control the event.

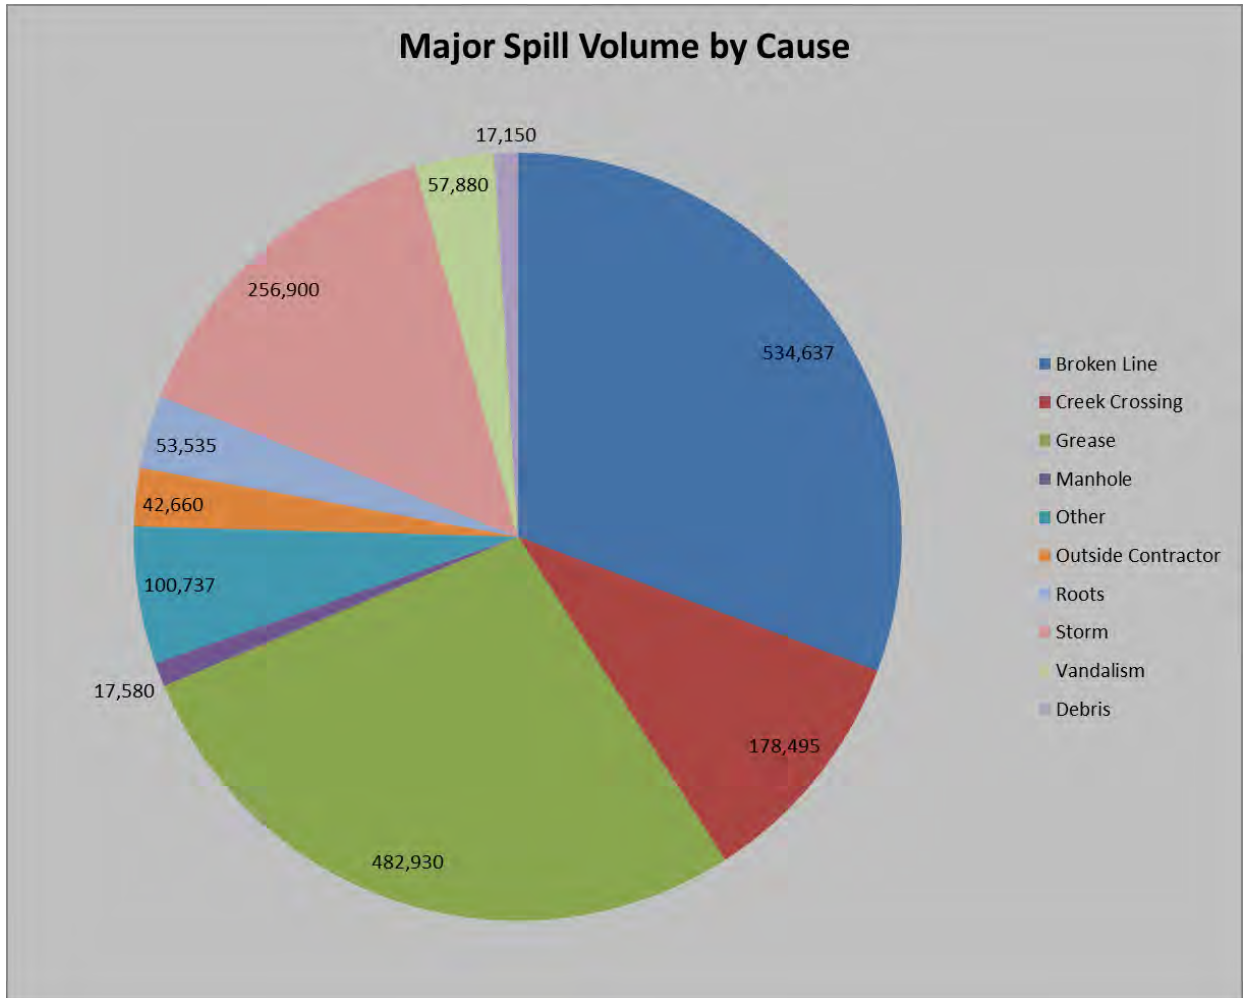
Figure 4 Major Spill Volume by Cause

As shown in **Figure 4** the Major Spill Volume by Cause is similar to the overall spill volumes by cause with the major driver being Grease after accounting for the one 30 inch event that skewed the data in **Figure 3 and 4**. It is noted that 27% (9) mechanical break events account for 58% of the total

volume with the 30 inch event accounting for 337,902 gallons. Using the data in **Table 1** we see that 10% of our total spills are major and they account for 58% of the total volume spilled.

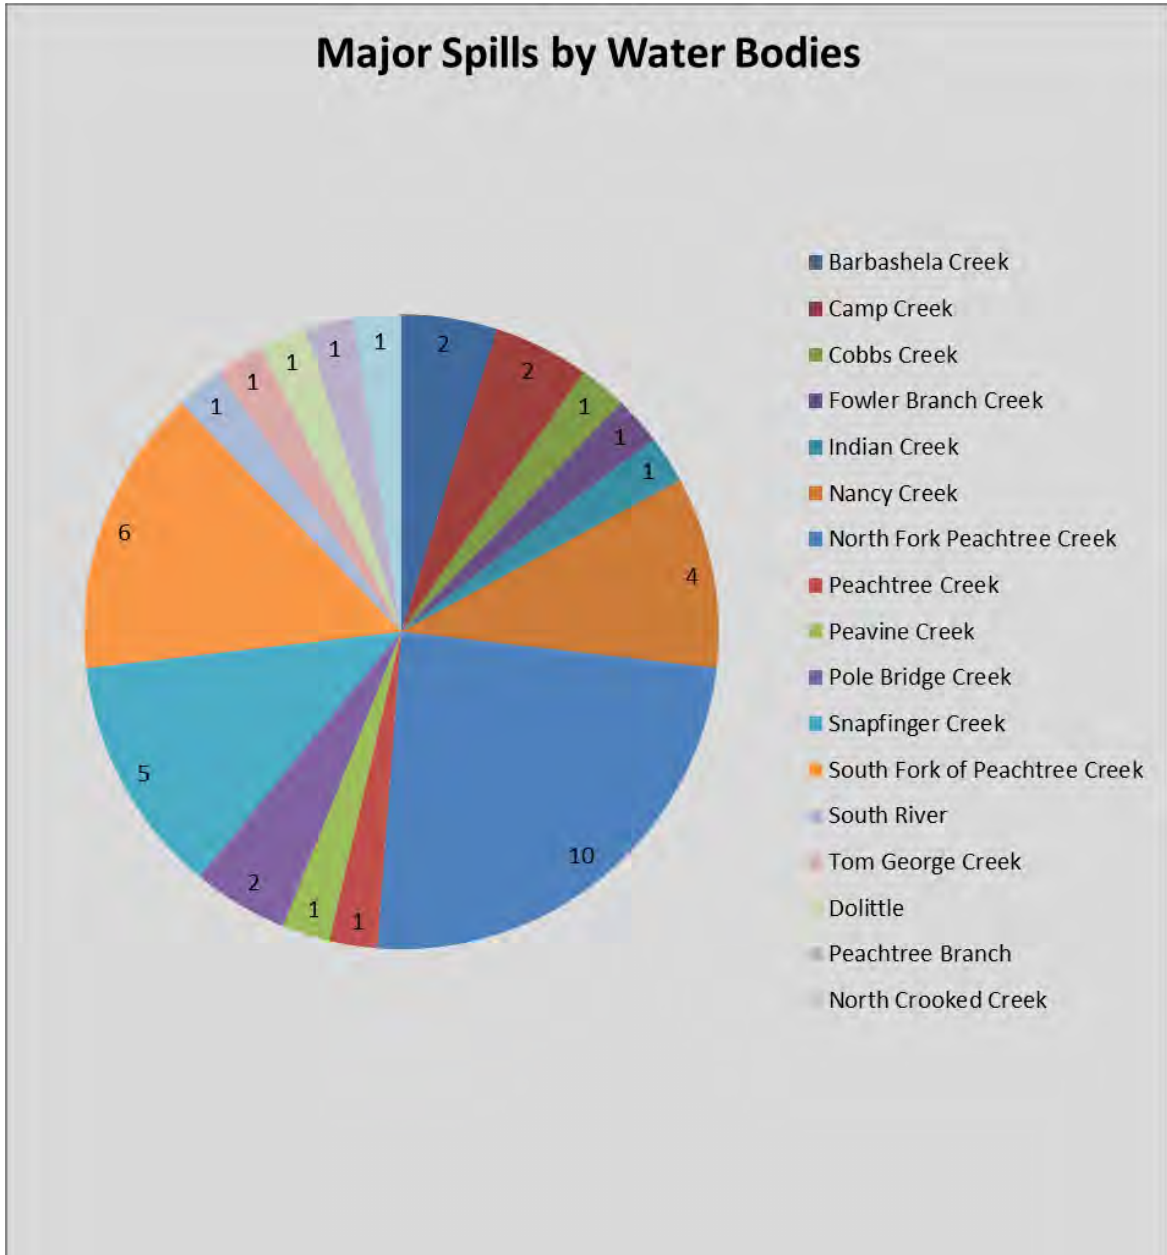
Figure 5 Major Spill Events by Water Body

As noted in **Figure 5** the major spill events are distributed proportionally to the water bodies in the County with more events being in the larger streams as would be expected in a random distribution pattern.

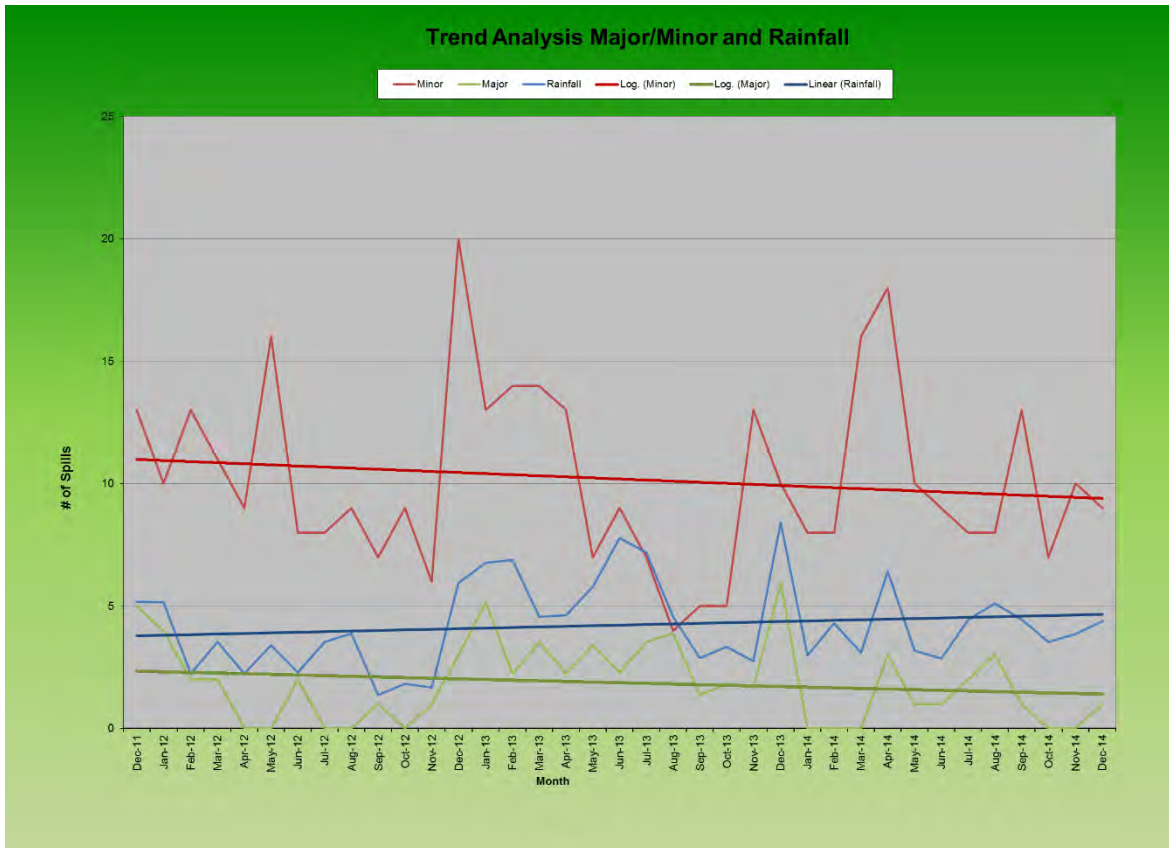
Figure 6 Rain and Spill Numbers

As noted in **Figure 6** the logarithmic trend lines show progress over time in decreasing the number of both major and minor spills that have any small relationship to rain events. Those few major spills that are directly connected to rain events are part of three very large studies underway on 3 large trunk lines. A few events, where a very limited area of the County has received a micro-burst rain event of sometimes 6 inches of rain in less than 2 hours, created some weather related spill events. However, no direct cause of rainfall infiltration was found during the follow-up investigations along with no repeat spills on the same line occurring.
