Application for Certificate of Appropriateness

Address of Subject Property: 11/6 Lullwater Road A	tlanta, GA 30307
Applicant: Dave Price - Price Residential Design	E-Mail: dave@priceresidentialdesign.com
Applicant Mailing Address: 1595 Nottingham Way A	tlanta, Georgia 30309
Applicant Phone(s): 404-245-4244	Fax: 404-245-4244
Applicant's relationship to the owner: Owner □ Architect: □ Contract	
Owner(s): David Martin	
Clizabath Cianarty Martin	E-Mail:
Owner(s) Telephone Number:	
Approximate age or date of construction of the primary structure on the project:vacant lot	e property and any secondary structures affected by this
Nature of work (check all that apply):	
New construction ☐ Demolition ☐ Addition ☐ Moving a built New accessory building ☐ Landscaping ☐ Fence/Wall ☐ Gign installation or replacement ☐ Other ☐	ding □ Other building changes □ Other environmental changes □
Description of Work:	Salaman arran Larra and Standard Larra and an
Build new two-story brick Colonial Revival res

LULLWATER RESIDENCE 1176 LULLWATER RD ATLANTA, GEORGIA

Tree Evaluation Report

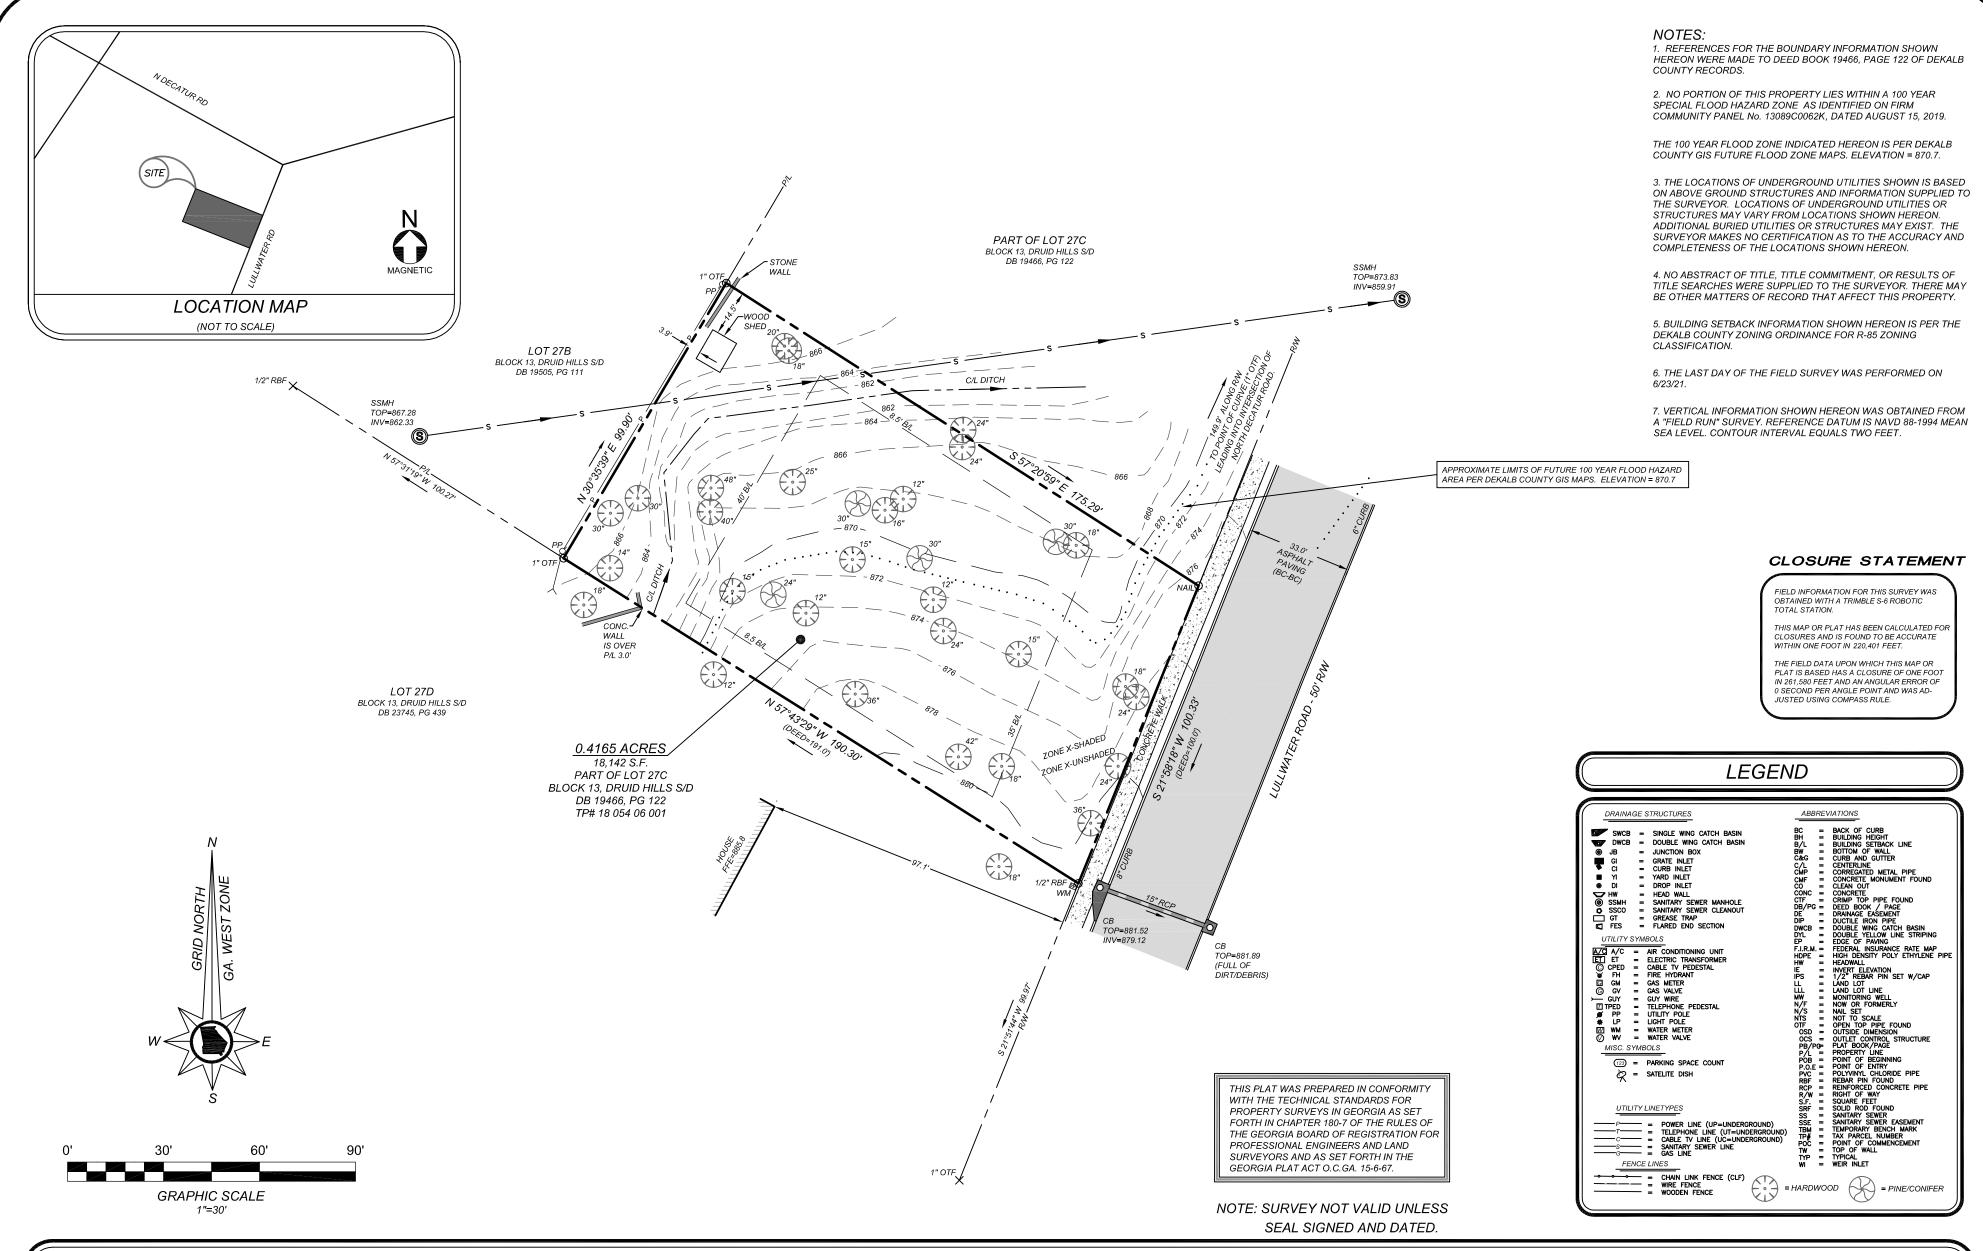
BOUNDARY, TOPOGRAPHIC, AND TREE SURVEY FOR:

1176 LULLWATER ROAD

PART OF LOT 27C, BLOCK 13, DRUID HILLS S/D LAND LOT 2, 18th DISTRICT, DEKALB COUNTY, GEORGIA TAX PARCEL No. 18 054 06 001

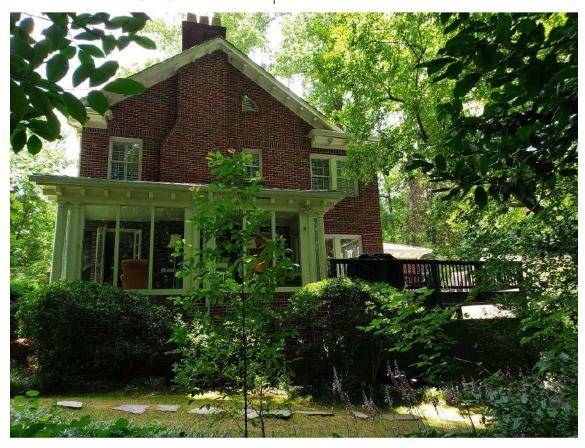
Both adjacent houses (this is the rear of the house on North Decatur that faces the project) have two full floors with large attics and basement below because of the extreme topography.

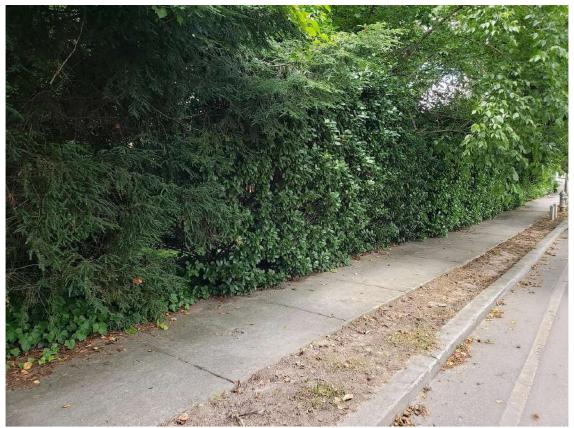
This massive mature (camelia?) hedge will be retained for a visual buffer, though it will be pruned back.

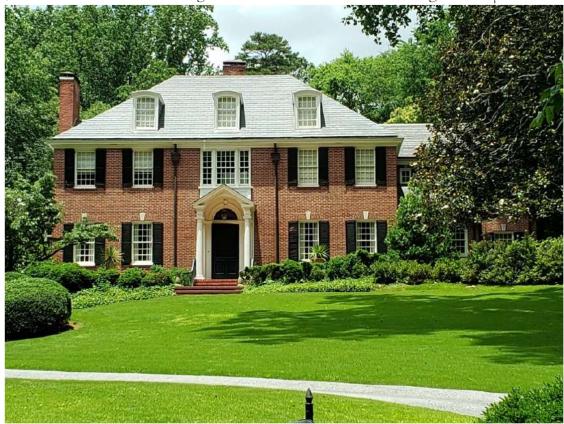
This is one of many examples of Colonial Revival houses along this side of Lullwater Road with dormers on the roof. None of the Colonials nearby the project have a dormer, as we propose, but dormers are nonetheless common. There are only Colonial Revivals in the area of influence so we will continue that style in order to retain the directional emphasis, shape, massing, proportion, rhythm, scale/height, and the architectural features that are prevalent nearby.

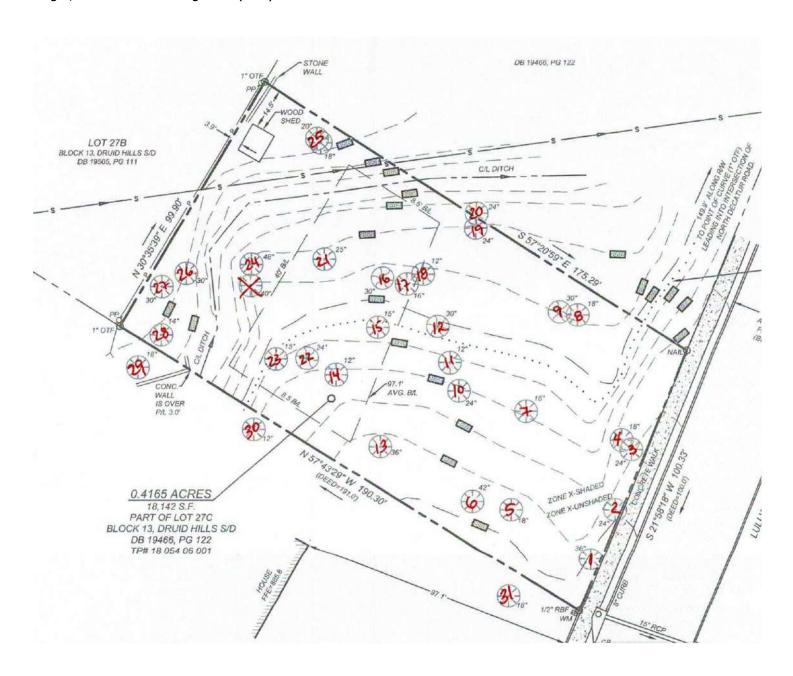
This is a vacant undeveloped lot with proposed new construction. Twenty-eight trees exist on the site with three boundary trees noted. There are eight specimen-sized trees on the property and one off site.

Observations: All observations were visual and made from the ground. No invasive tests, underground or aerial inspections were performed. The site visits were conducted on July 1, 2021. Diameters were measured at breast height, 4½ feet above the ground (DBH) and current conditions noted.

Tree #	Species	Actual DBH	Condition	Specimen	Dead	Buffer	Boundary	Target
1	Water Oak	37"	Bifurcated upper trunk, Covered in vines	Υ	N	N	N	Υ
2	Water Oak	24"	Covered in vines	N	N	N	N	Υ
3	Ash	24"	Covered in vines	N	N	N	N	Υ
4	Ash	18"	Covered in vines	N	N	N	N	Υ
5	Yellow-poplar	18"	Appears Healthy	N	N	N	N	Υ
6	Yellow-poplar	25"	Appears Healthy	N	N	N	N	N
7	Sweetgum	15"	Appears Healthy	N	N	N	N	N
8	Ash	19"	Appears Healthy	N	N	Υ	N	N
9	Loblolly Pine	30"	Appears Healthy	Y	N	Υ	N	N
10	Yellow-poplar	25"	Appears Healthy	N	N	N	N	N
11	Yellow-poplar	12"	Appears Healthy	N	N	N	N	N
12	Loblolly Pine	33"	Termites at the base, <20% LCR	Υ	N	Υ	N	N
13	Beech	41"	1 broken limb, Appears Healthy	Υ	N	N	N	Υ
14	Hardwood	12"	Appears Healthy	N	N	N	N	N
15	Hardwood	15"	Appears Healthy	N	N	N	N	N
16	Loblolly Pine	33"	Appears Healthy	Υ	N	Υ	N	N
17	Yellow-poplar	13"	Appears Healthy	N	N	Υ	N	N
18	Hardwood	12"	Lean >20 degrees, decay in main trunk	N	N	Υ	N	N

19	Yellow-poplar	31"	Appears Healthy	Υ	N	N	N	N
20	Yellow-poplar	28"	Appears Healthy	N	N	N	N	N
21	Tupelo	24"	Appears Healthy	N	N	Υ	N	N
22	Loblolly Pine	28"	Appears Healthy	N	N	N	N	Υ
23	Yellow-poplar	15"	Appears Healthy	N	N	N	N	Υ
24	Yellow-poplar	53"	Appears Healthy	Υ	N	Υ	N	N
25	Pecan	8"	Appears Healthy	N	N	Υ	N	N
26	Yellow-poplar	24"	Roots starting to become eroded, Appears Healthy	N	N	Y	N	N
27	Yellow-poplar	30"	Appears Healthy	Υ	N	Υ	N	Υ
28	Hardwood	10"	Appears Healthy	N	N	Υ	N	N
29	Sweetgum	~18"	Appears Healthy	N	N	Υ	Υ	Υ
30	Hardwood	12"	Appears Healthy	N	N	N	Υ	Υ
31	Post Oak	27"	Appears Healthy	N	N	N	Υ	Υ
