Application for Certificate of Appropriateness

Date Received: Application No.:
Address of Subject Property: 1325 Emory Road Atlanta, Georgia 30306
Applicant: Dave Price - Price Residential Design E-Mail: dave@priceresidentialdesign.co
Applicant Mailing Address: 1595 Nottingham Way Atlanta, Georgia 30309
Applicant Phone(s): 404-245-4244 Fax: 404-245-4244
Applicant's relationship to the owner: Owner □ Architect: □ Contractor/Builder □ Other 💢 <u>Designer</u>
Dwner(s): David Howe E-Mail: davelh206@gmail.com
E-Mail:
Owner(s) Mailing Address: 1325 Emory Road Atlanta, Georgia 30306
Dwner(s) Telephone Number: 404-391-4319
approximate age or date of construction of the primary structure on the property and any secondary structures affected by this project:1947
lature of work (check all that apply):
lew construction □ Demolition M Addition X Moving a building □ Other building changes □

Price Residential Design Photos at 1325 Emory Road

1325Emory Road Tree Assessment

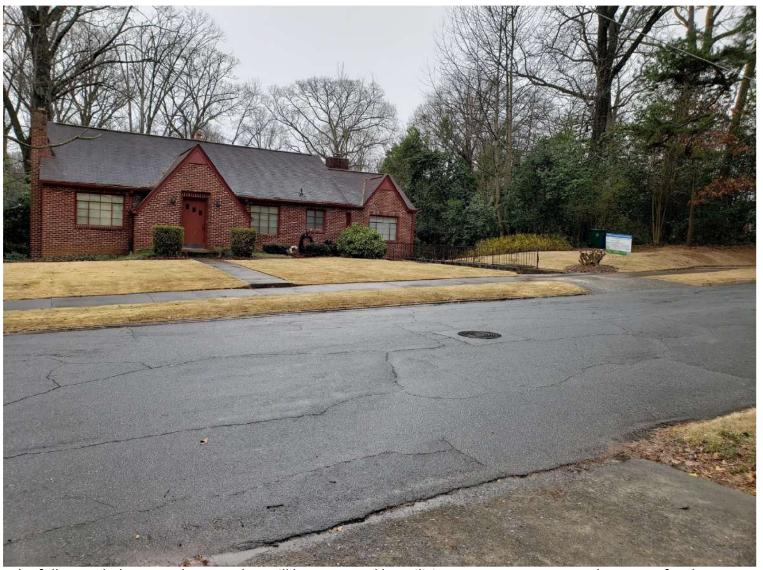
This photo shows the fully wooded area to the west that will be preserved by utilizing an unnecessary grass lawn area for the new garage rather than extending the house and driveway into the wooded area. The existing front entry gable will be highlighted as a focal point in the current, more compact design rather than being demphasized in design that stretches out in one plane to the east, particularly a design with a street facing garage. The higher existing grade to the east will require extensive regrading for a garage addition in that area, while the current design works with the existing topography to partially bury the front edge of the garage, making it clearly secondary to the much larger and taller existing primary mass.

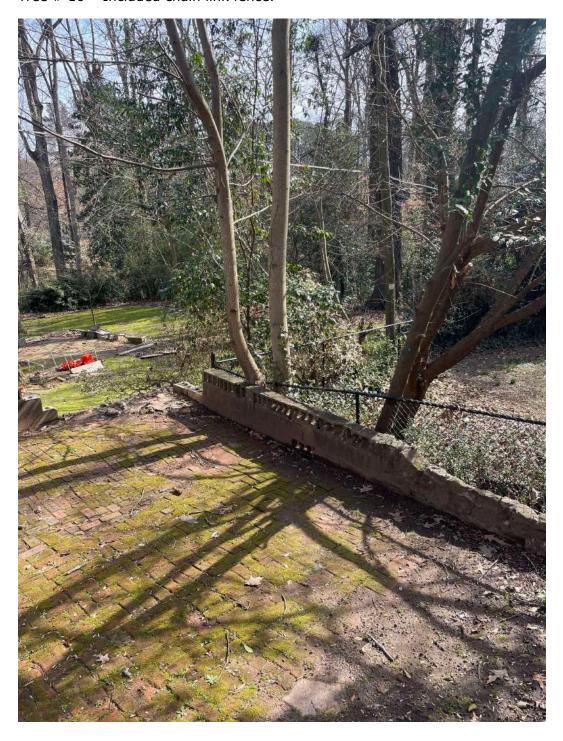
Tree # 10 - Included chain link fence.

Tag	DBH	Species	Condition	Notes
1	44	Tulip Poplar	GOOD	
2	6	Burford Holly	POOR	
3	9	Burford Holly	POOR	
4	8	Chinese Privet	INVASIVE	
5	6	Cherry Laurel	INVASIVE	
6	6	Cherry Laurel	INVASIVE	
7	8	Burford Holly	GOOD	
8	6	Cherry Laurel	INVASIVE	
9	41	Northern Red Oak	GOOD	Few large dead limbs, included rock wall
10	6, 8	Tulip Poplar	POOR	Included chain link fence, multi-stem at root crown
11	6	Cherry Laurel	INVASIVE	
12	9	Mulberry	INVASIVE	
13	11	Tulip Poplar	GOOD	
14	9	Cherry Laurel	INVASIVE	
15	6	Cherry Laurel	INVASIVE	
16	9	Ailanthus	INVASIVE	
17	8	Ailanthus	INVASIVE	
18	41	Southern Red Oak	GOOD	Phototrophic lean, few large dead limbs

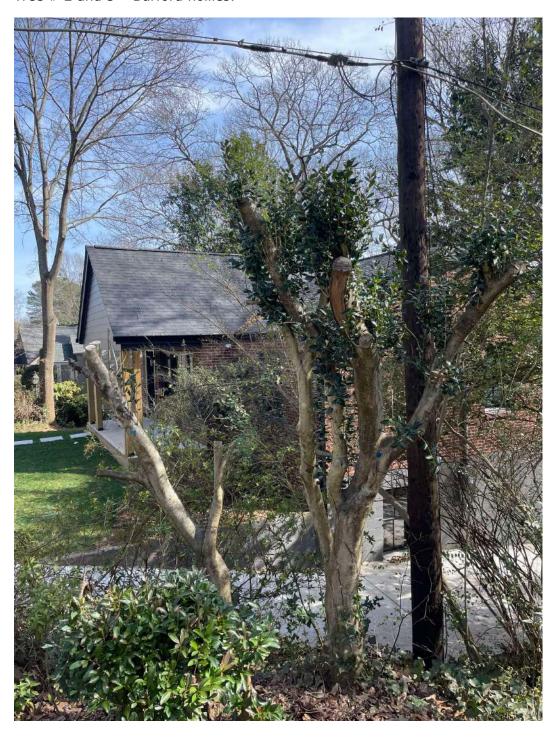
Tree # 2 and 3 - Burford hollies.

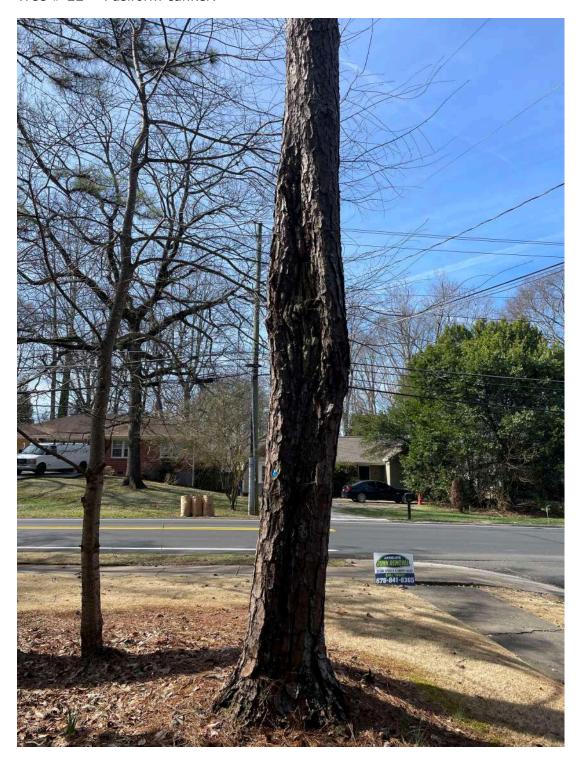
Tree # 22 - Fusiform canker.

Tag	DBH	Species	Condition	Notes	
19	36	Southern Red Oak	GOOD	Few large dead limbs	
20	7	Tulip Poplar	GOOD		
21	26	Loblolly Pine	FAIR	Leaning	
22	17	Loblolly Pine	POOR	Fusiform canker at ~ 10'	
23	16	Loblolly Pine	POOR	Contorted, no central lead	
24	23	Loblolly Pine	FAIR	Thin canopy, leaning	
25	18	Loblolly Pine	FAIR	Significant lean	
26	15	Loblolly Pine	FAIR	Contorted central lead	
27	7	Northern Red Oak	GOOD	Asymmetrical canopy	
28	22	Loblolly Pine	GOOD		
29	11	Tulip Poplar	POOR	Rot and decay present at root crown	
30	10	Tulip Poplar	GOOD		
31	10	Tulip Poplar	GOOD		
32	7	Cherry Laurel	INVASIVE		
33	8, 8	Mimosa	INVASIVE

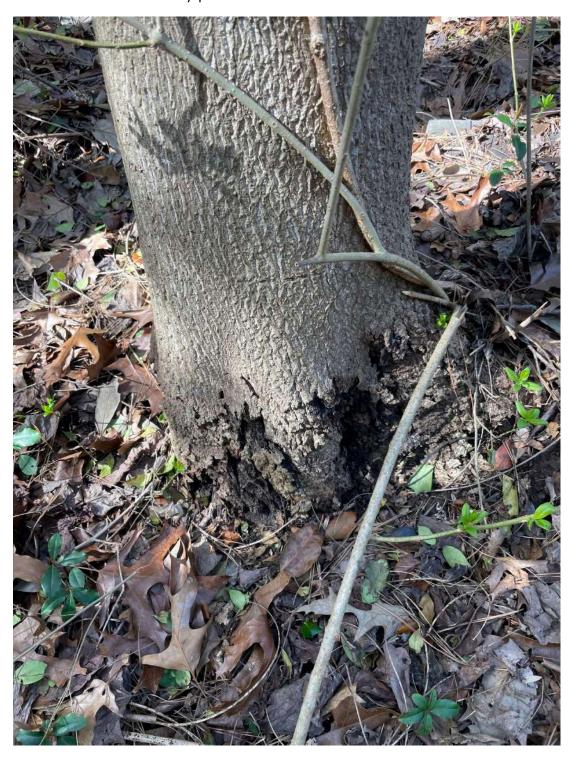
Tree # 29 - Rot and decay present at root crown.
