Application for Certificate of Appropriateness

Address of Subject Property: 1786 Ridgewood Drive NE Atlanta, Georgia 30307

Demolish existing dilapidated (likely non-historic) accessory structure (two-story w/ garage and A.D.U.). DeKalb Co historical records are not available due to flooding at courthouse but "Structure" magazine says C.M.U. block were not standardized until 1946. Regardless of exact construction date, the rehabilitation is not possible due to extensive structural failure. If demolition status is verified, we propose a new Italian Renaissance Revival two-story home with rear porch out to pool and pool patio (porous pavers). A new 9.25' wide concrete driveway w/ grass strip is proposed to access the new two-story accessory structure (garage and A.D.U.) located closer to rear lot line to provide space for proposed pool and pool patio. Proposed accessory will be the same distance from side lot line so zoning variance will be sought as well as lot coverage (proposed pool will exceed 35% maximum lot coverage). Tree and topo survey will be obtained after demolition status of existing accessory is determined.

1786 Ridgewood Dr NE  
Atlanta, GA 30307  
Project No: 23053

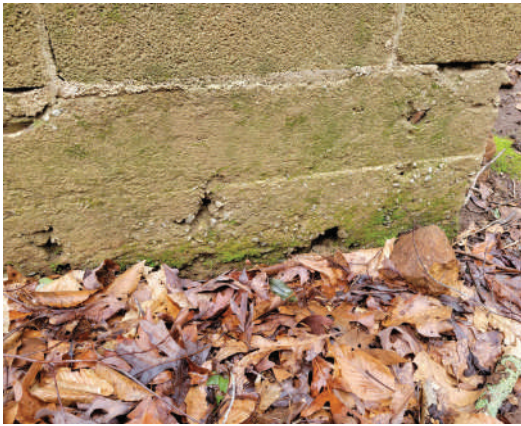
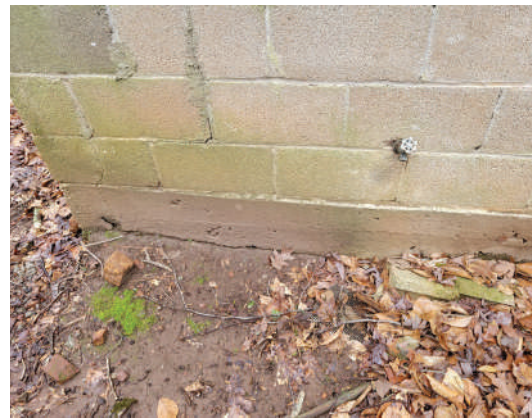
- Existing Footing: The footing that supports the CMU foundation wall shows signs of washout, as well as voids due to poor original construction (see Photos 1&2). On the day of my site review, recent water flow under the slab edge was visible. Water undermining a footing is a serious problem.

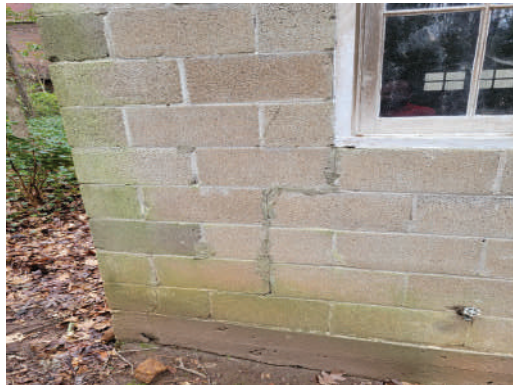
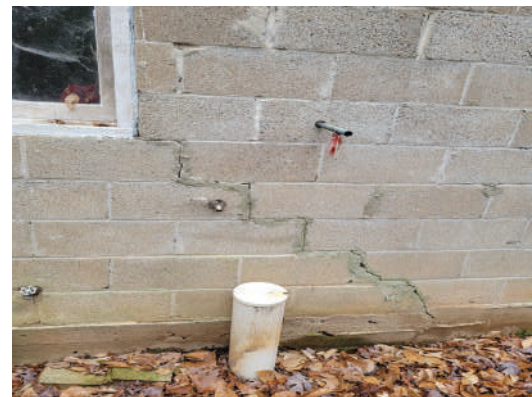
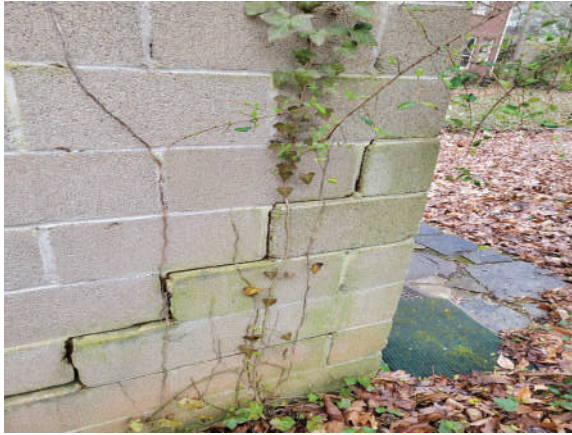
- Foundation Walls: Diagonal cracks were present throughout the entire CMU foundation wall (all 3 sides, see Photos 3-5). Diagonal cracks in CMU are typically a sign of differential settlement, which poses a serious threat to the structure that it is supporting. Vertical cracks were also present (see Photos 6-8). These cracks penetrated the full depth of CMU. Daylight was visible through one of the cracks. There was no evidence that any of the cells were grouted based on the frequency of cracks.

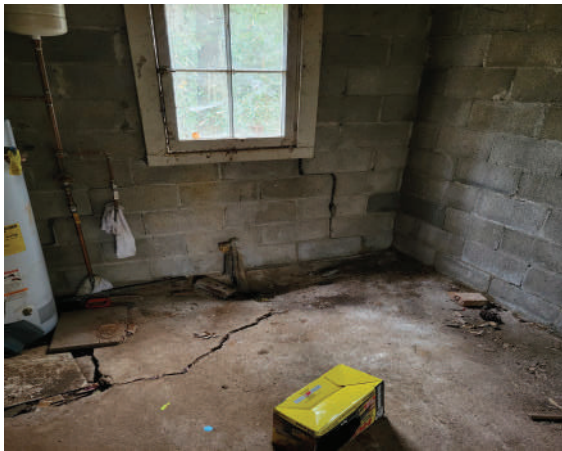
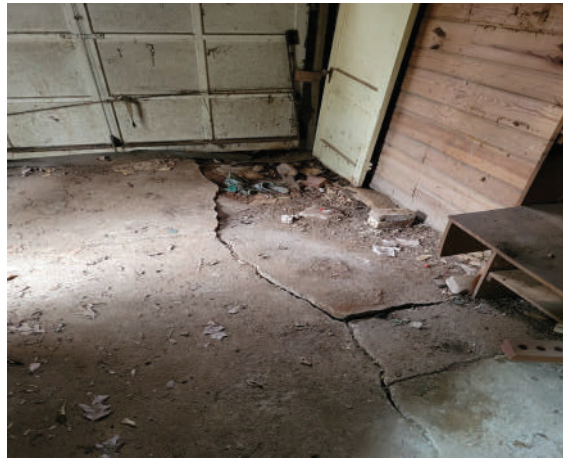
- Slab on Grade: The slab on grade is cracked and broken beyond repair (see Photos 9-10).
- Center Load Bearing Stud Wall: The center stud wall is the main load bearing wall is not fully bearing on the slab or footing and is only bearing on dirt in some locations.

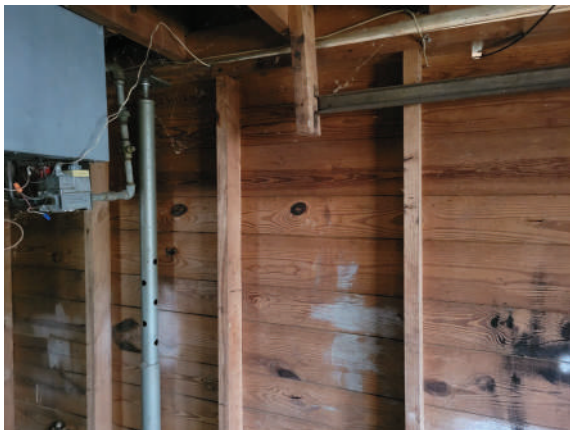
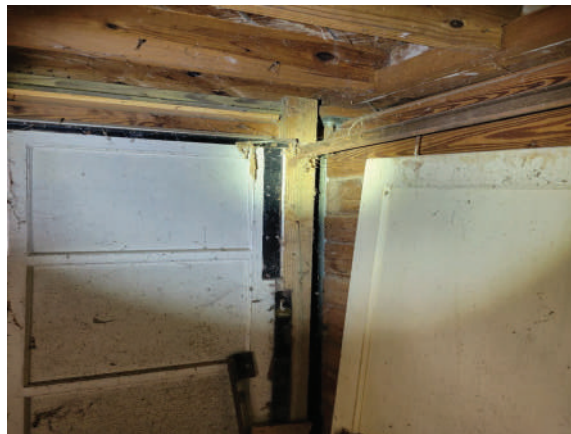
- Steel Posts: There is also at least (2) adjustable screw jack post installed in the main level. These are intended for temporary shoring and are not structurally adequate for permanent use (see Photos 11 & 12).

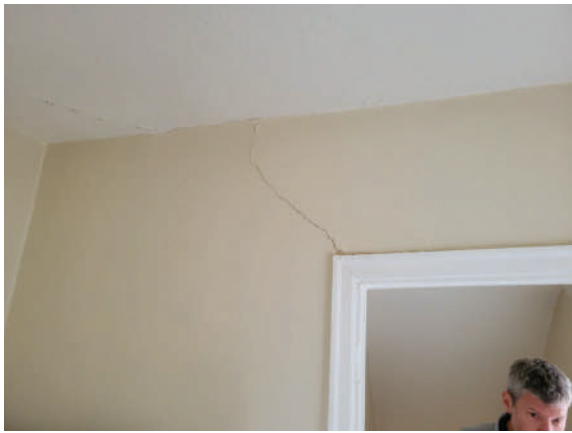
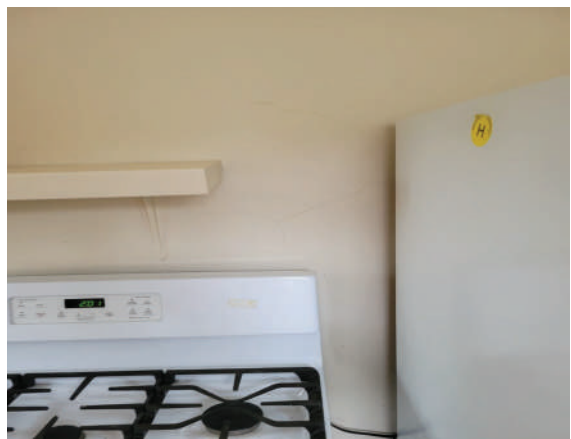
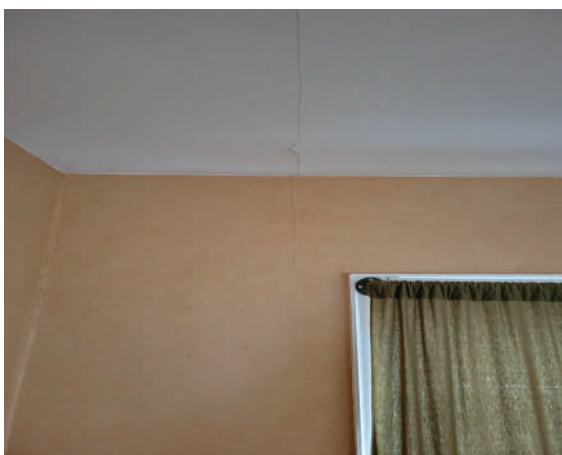
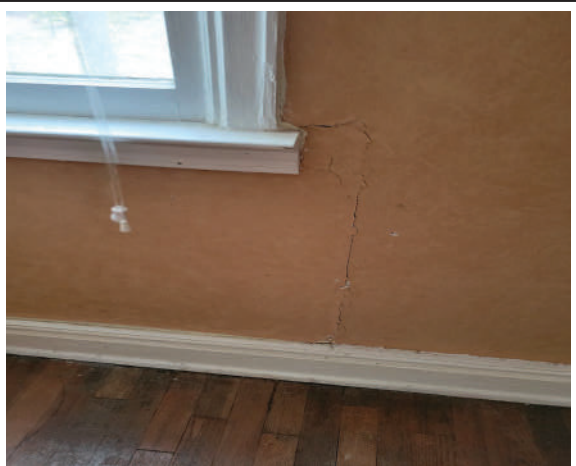
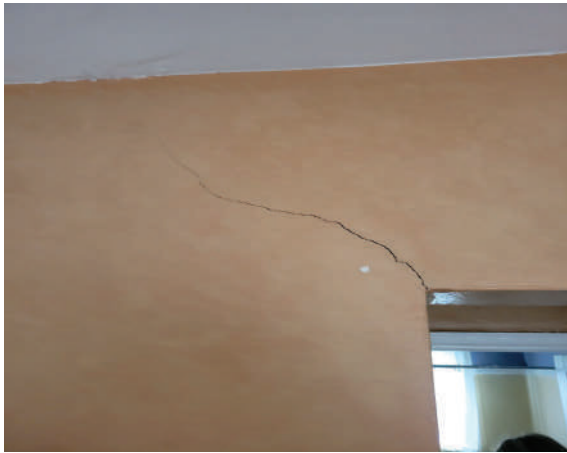
- Sloping Floors: Sloping floors were observed throughout the upper level. Some of these were due to settlement (see above), improper supports (see above) and over-spanned joists and girders. The joists/girders will continue to deflect until structural failure.
- Settling: There is evidence of settling throughout the upper level. Interior finishes are cracked on all walls (see Photos 13-17).
- Skewed Stairs: The stairs are out of skew and twisting due to all the support issues below (see Photo 18).

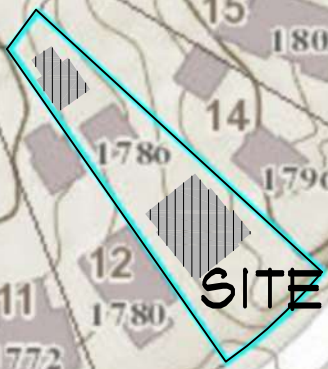
OVERALL AREA - NOT TO SCALE

EXISTING PARK ADJOINERS W/  
ACCESSORY BLDG CLOSER  
THAN 10' TO PARK LAND:

- 1. THIS IS NOT RIGHT OF WAY SO NOT SURE IT MATTERS.
- 2. OUR PROPOSED ACCESSORY IS 15'+ FROM PARK LAND.

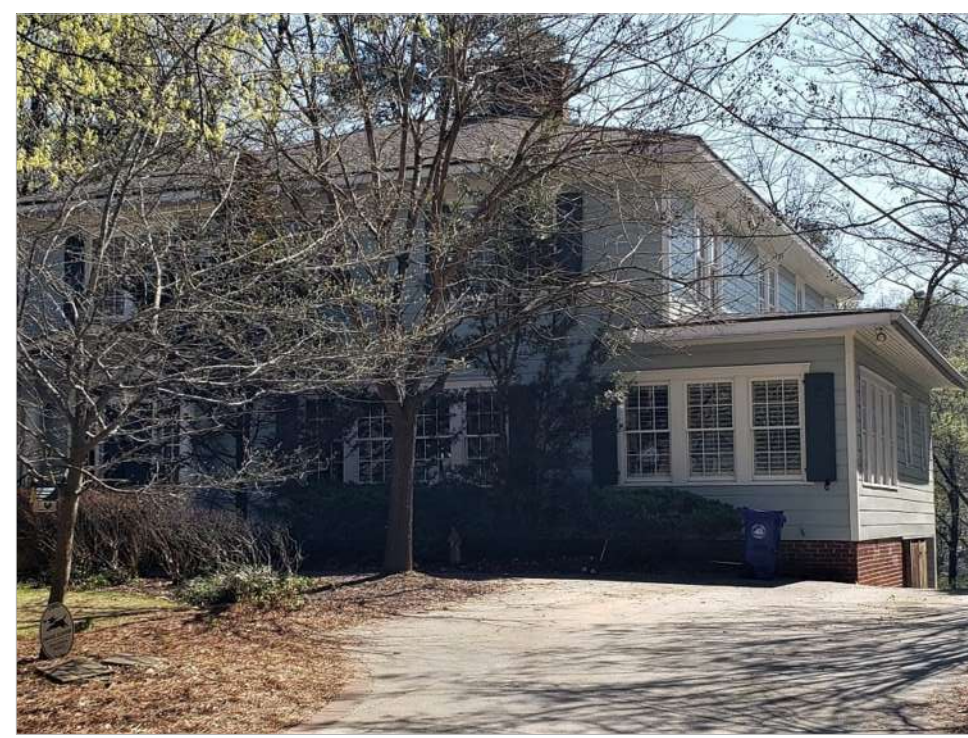
HISTORIC EXAMPLE AT 1725 RIDGEWOOD IS DEEP AS WELL AS WIDE

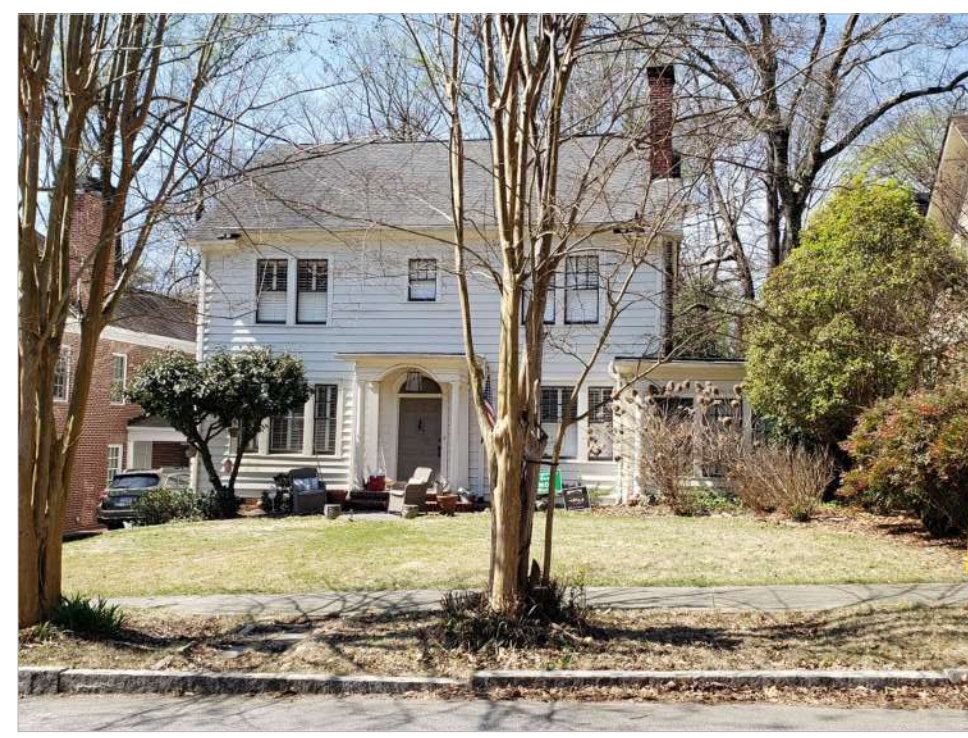
MORE HISTORIC TWO-STORY EXAMPLES AROUND THE CORNER ON EMORY DRIVE

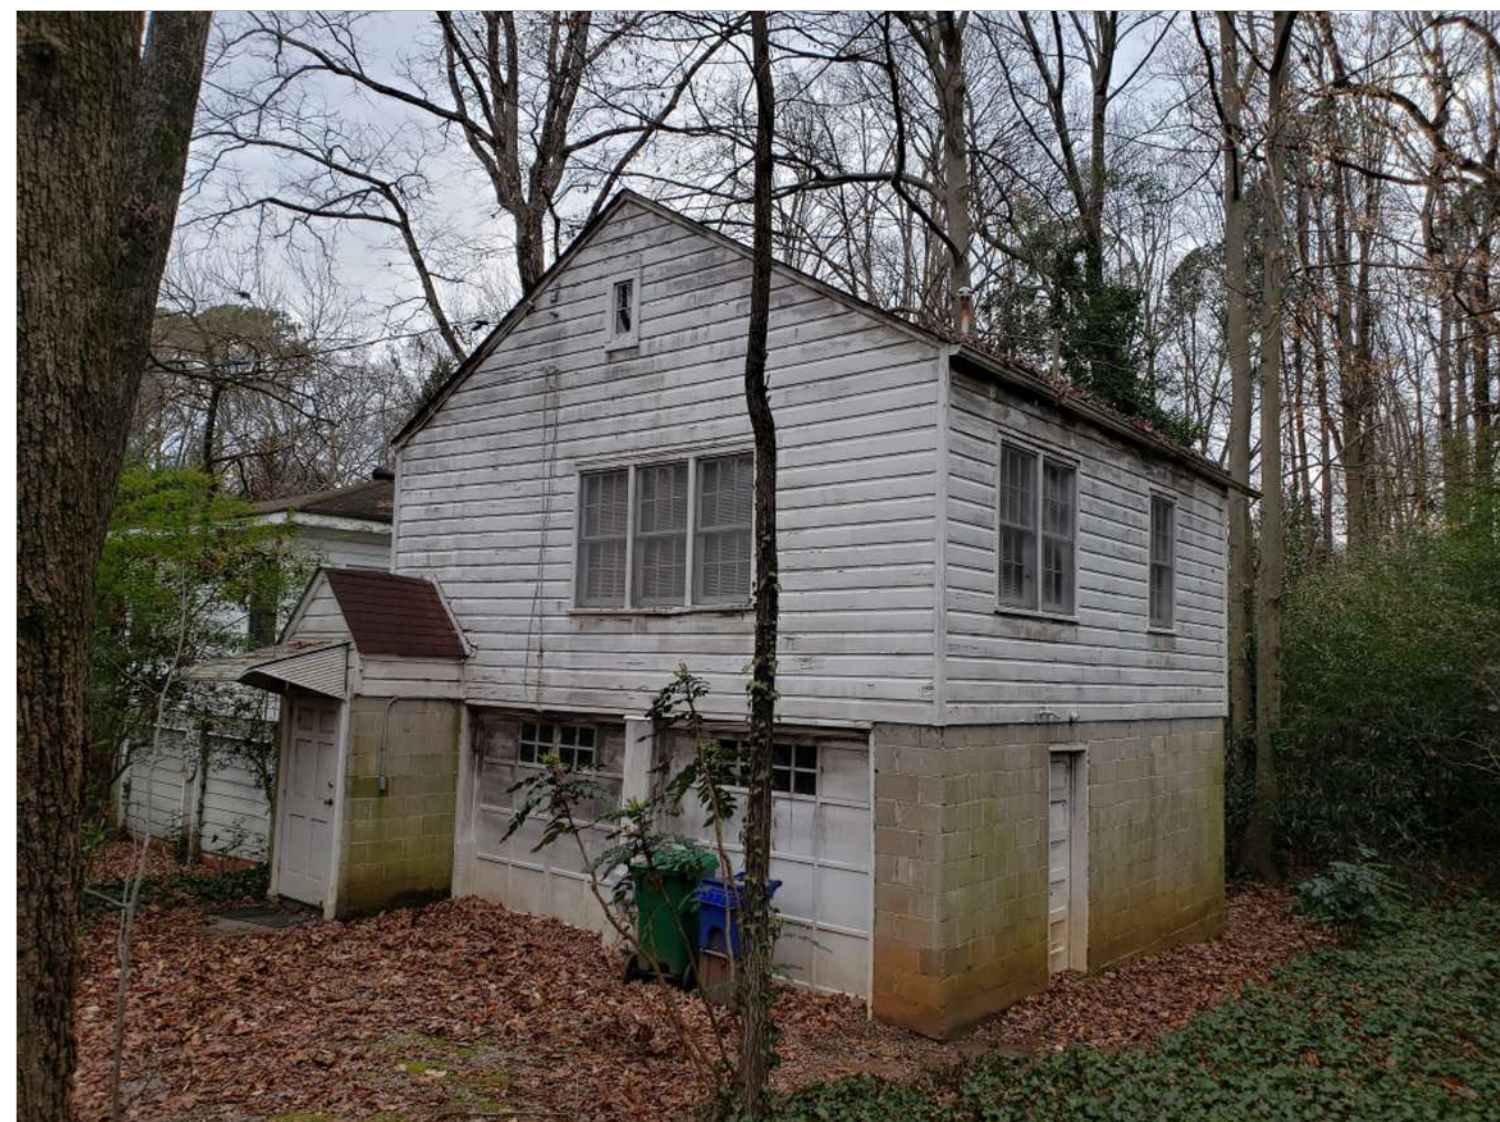
**DILAPIDATED GARAGE/ADU. TO BE DEMOLISHED**  
NEW GARAGE / ADU WILL ECHO THIS MASSING (WITHOUT FRONT-FACING GABLE) 186'4" FROM STREET CURB. EXISTING STRUCTURE IS 24' WIDE AND NEW STRUCTURE WILL BE 22' WIDE. THE LOT COVERAGE OF THE NEW ACCESSORY STRUCTURE AND NEW DRIVEWAY WILL BE LOWER THAN EXISTING ACCESSORY AND DRIVEWAY.

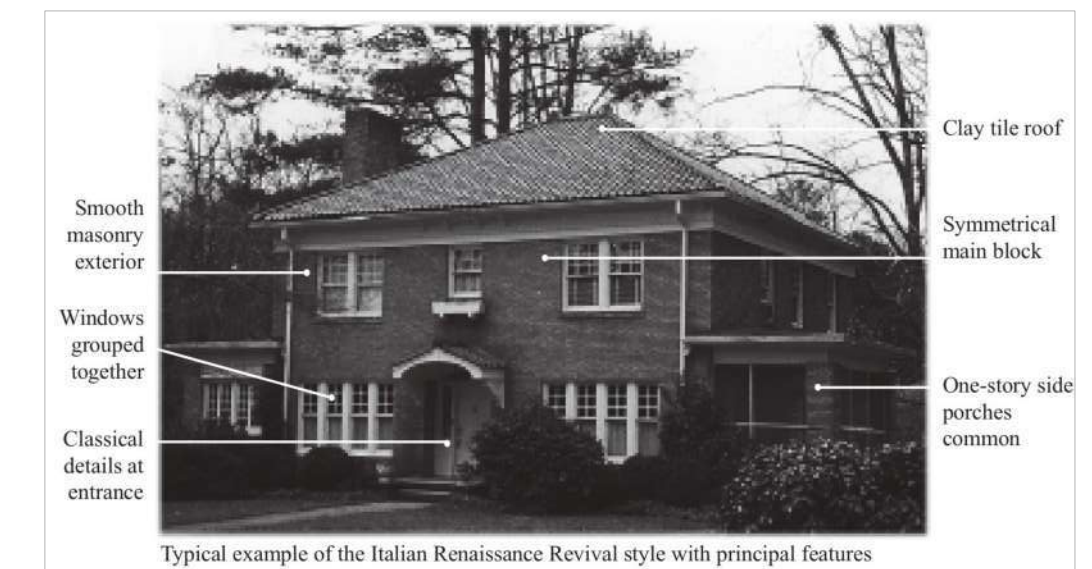
Typical example of the Italian Renaissance Revival style with principal features

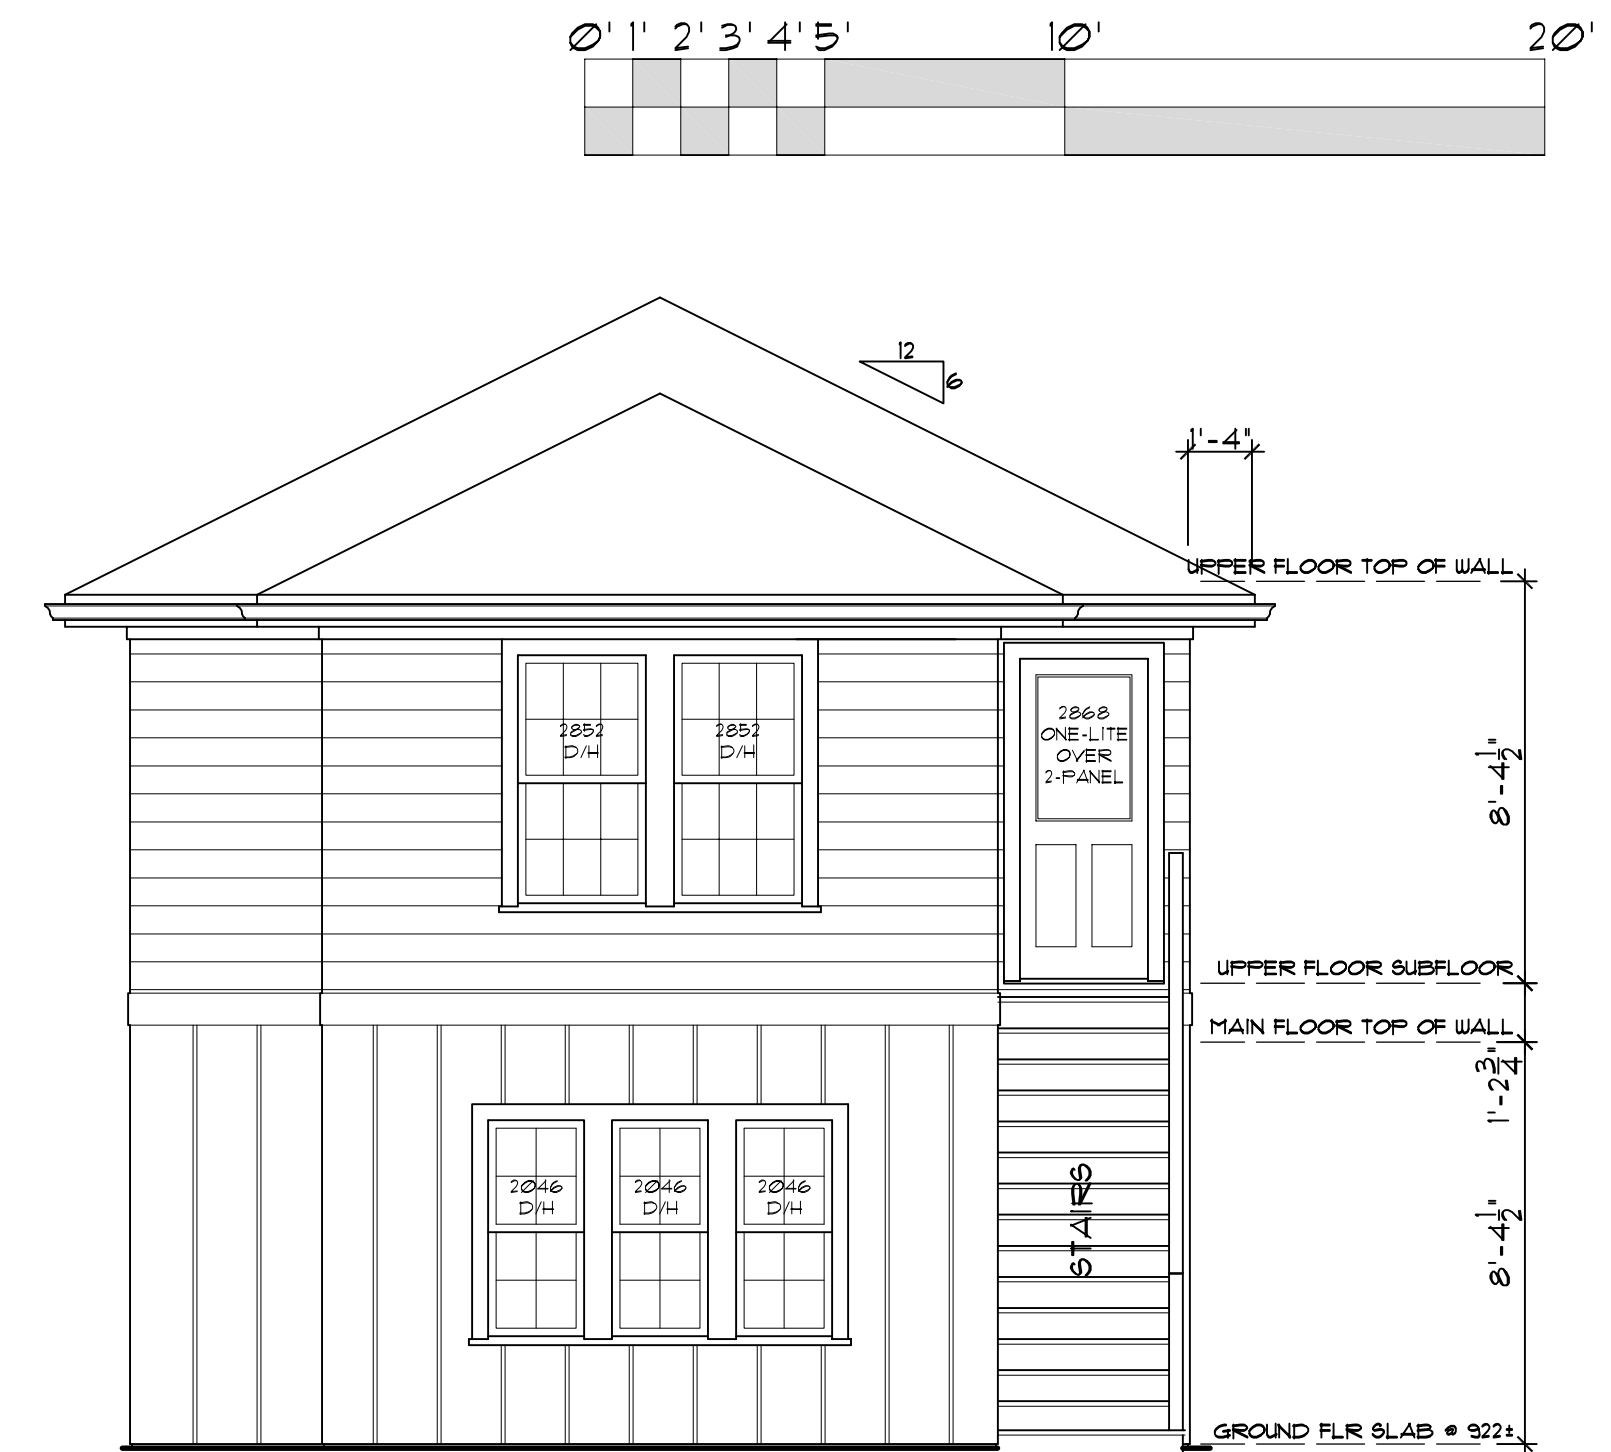
GARAGE/ADU. REAR ELEVATION  
SCALE: 1/4" = 1'-0" FACES RUTLEDGE PARK

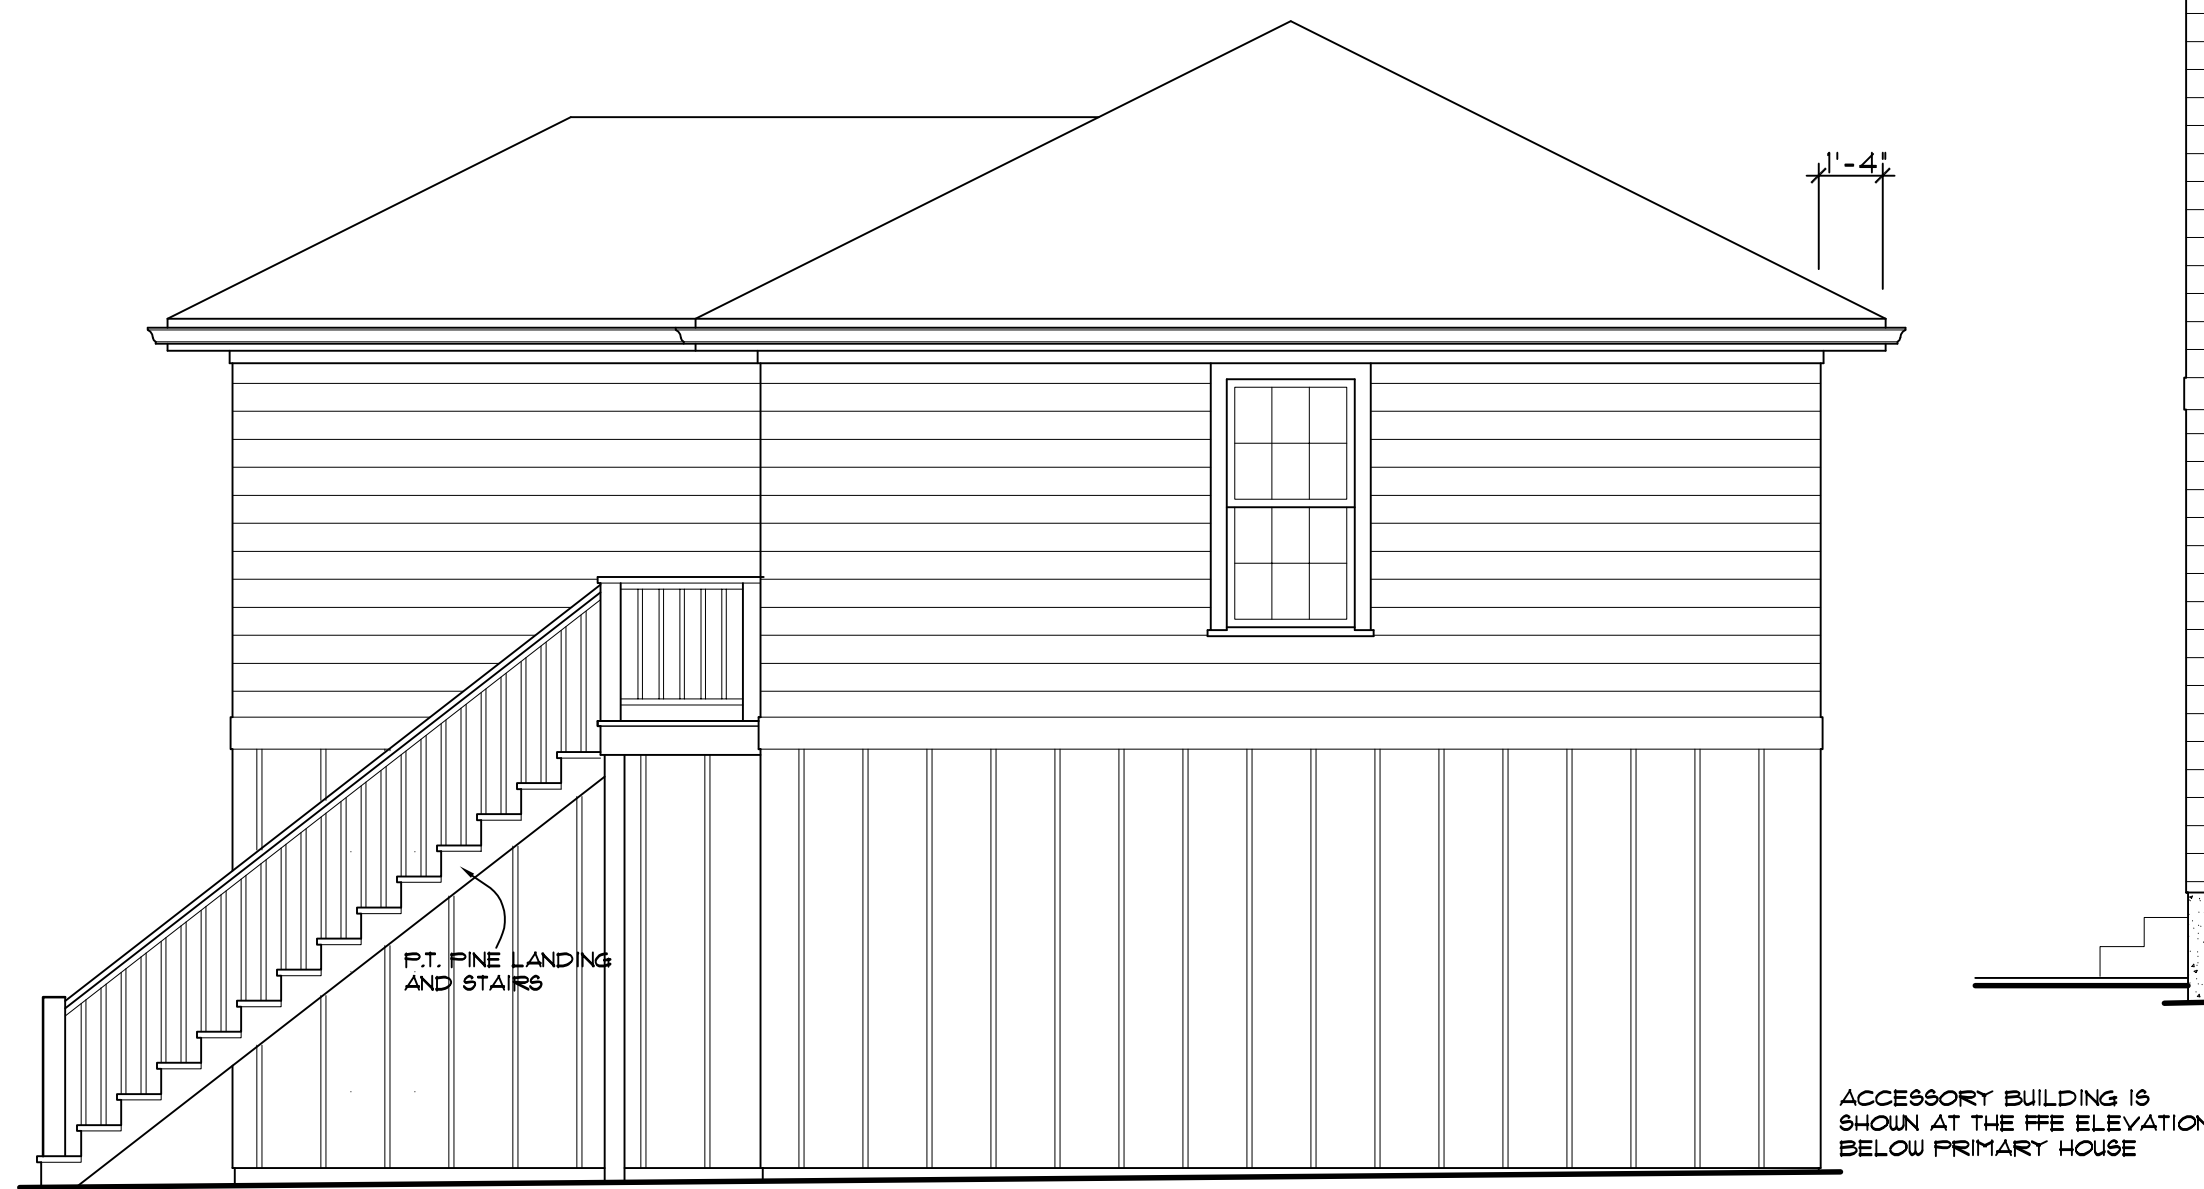
GARAGE/ADU. LEFT ELEVATION  
SCALE: 1/4" = 1'-0" FRONT FACE OF ACCESSORY IS 15' BEHIND REAR FACE OF PRIMARY HOUSE

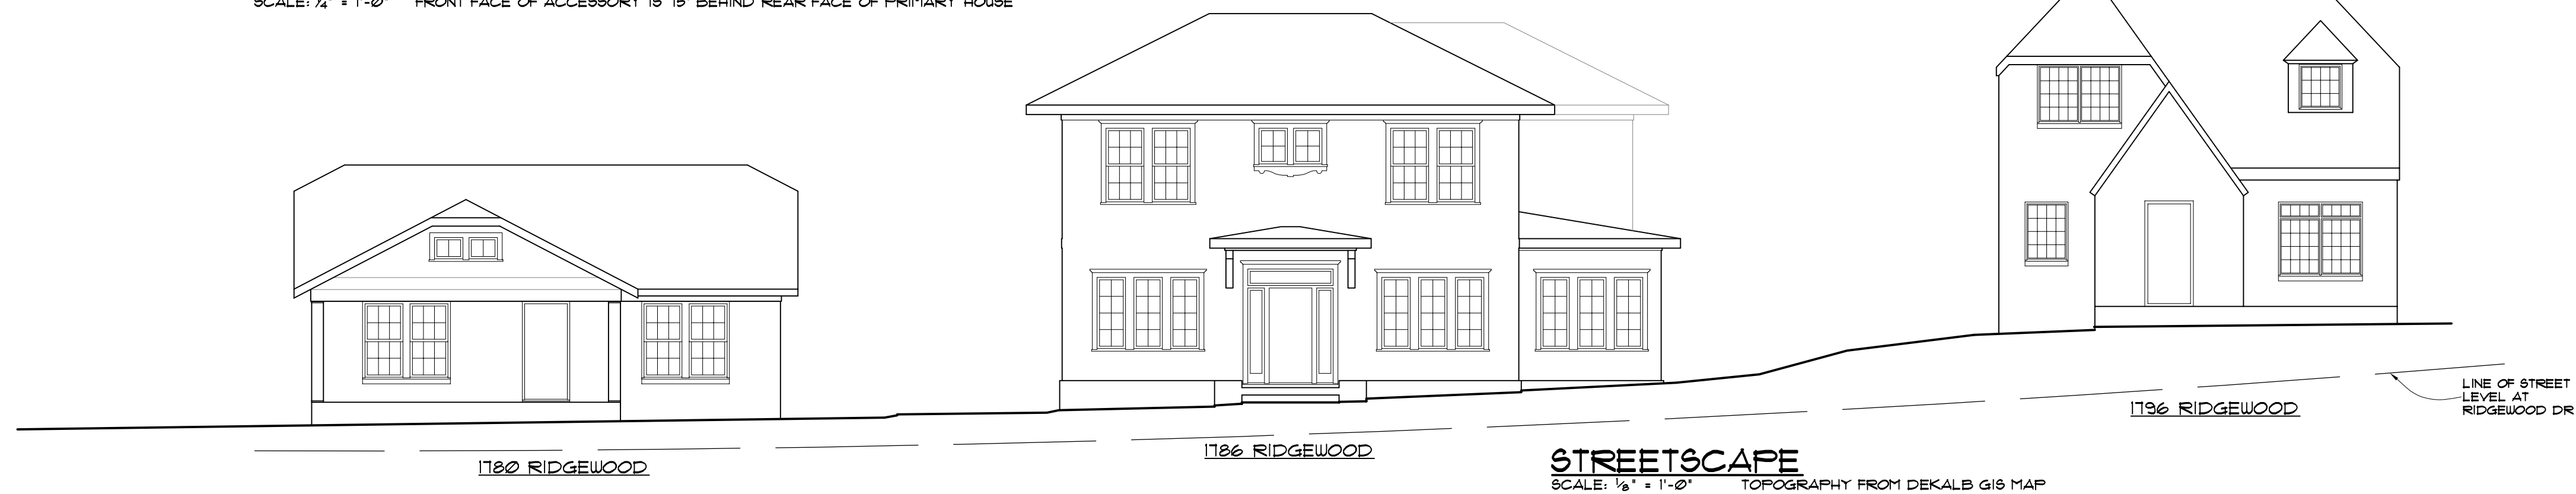
STREETSCAPE  
SCALE: 1/8" = 1'-0" TOPOGRAPHY FROM DEKALB GIS MAP
