Ecology Assessment

Intrenchment Creek Park, DeKalb County, Georgia

Project No. 6166191085

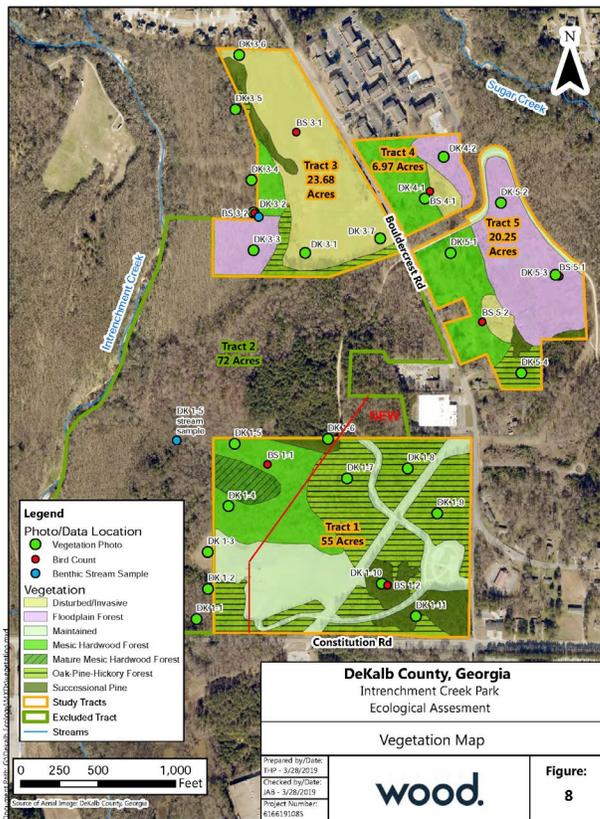
In February 2020, a decision was made to retain 9 acres of land from Tract 1 in DeKalb County ownership. The proposed boundary is depicted in red on the adjacent figure. The 9 acres to be retained consists mostly of mesic hardwood vegetation located north and west of the model airplane field, with some areas of oak-pine-hickory forest and successional pine. The area to be retained by DeKalb County also includes an area of mature mesic hardwood forest, which contains some of the older trees (80-100 years) observed during the field assessment of the Intrenchment Creek Park study area (Tract 1).
