Letter from the Owners of 1207 Oakdale RD, Atlanta, GA 30307

03/03/2021

Jerry W. Hopkins, Pres. Construction Consulting Services, Inc. Georgia Licensed Professional Engineer, 13519 Attachments:

March 1st, 2021

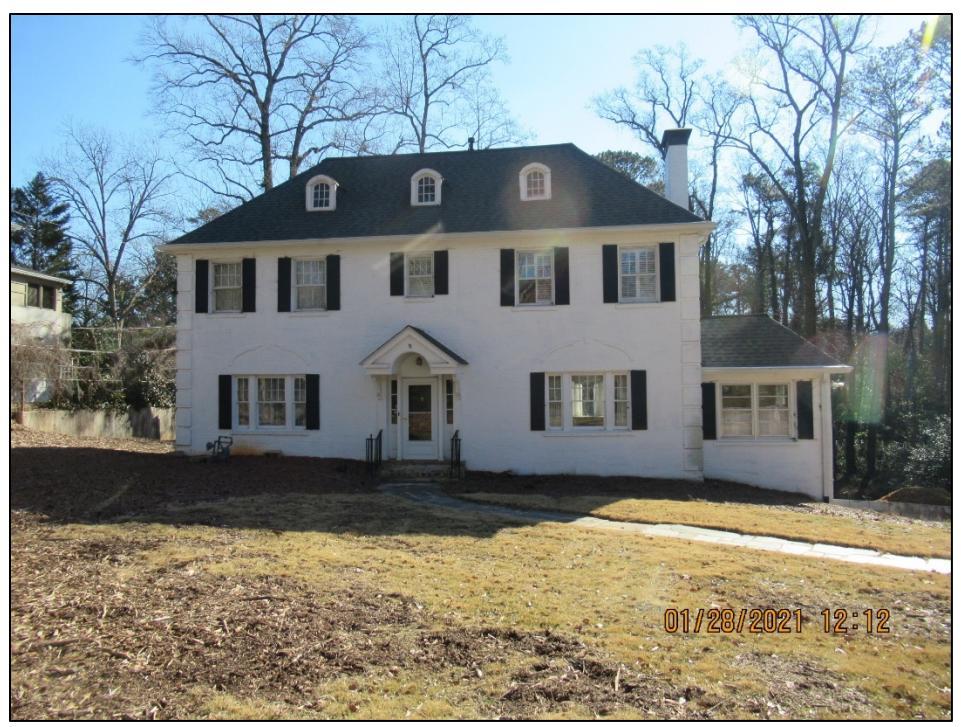
Photo 01: View of the front of the house

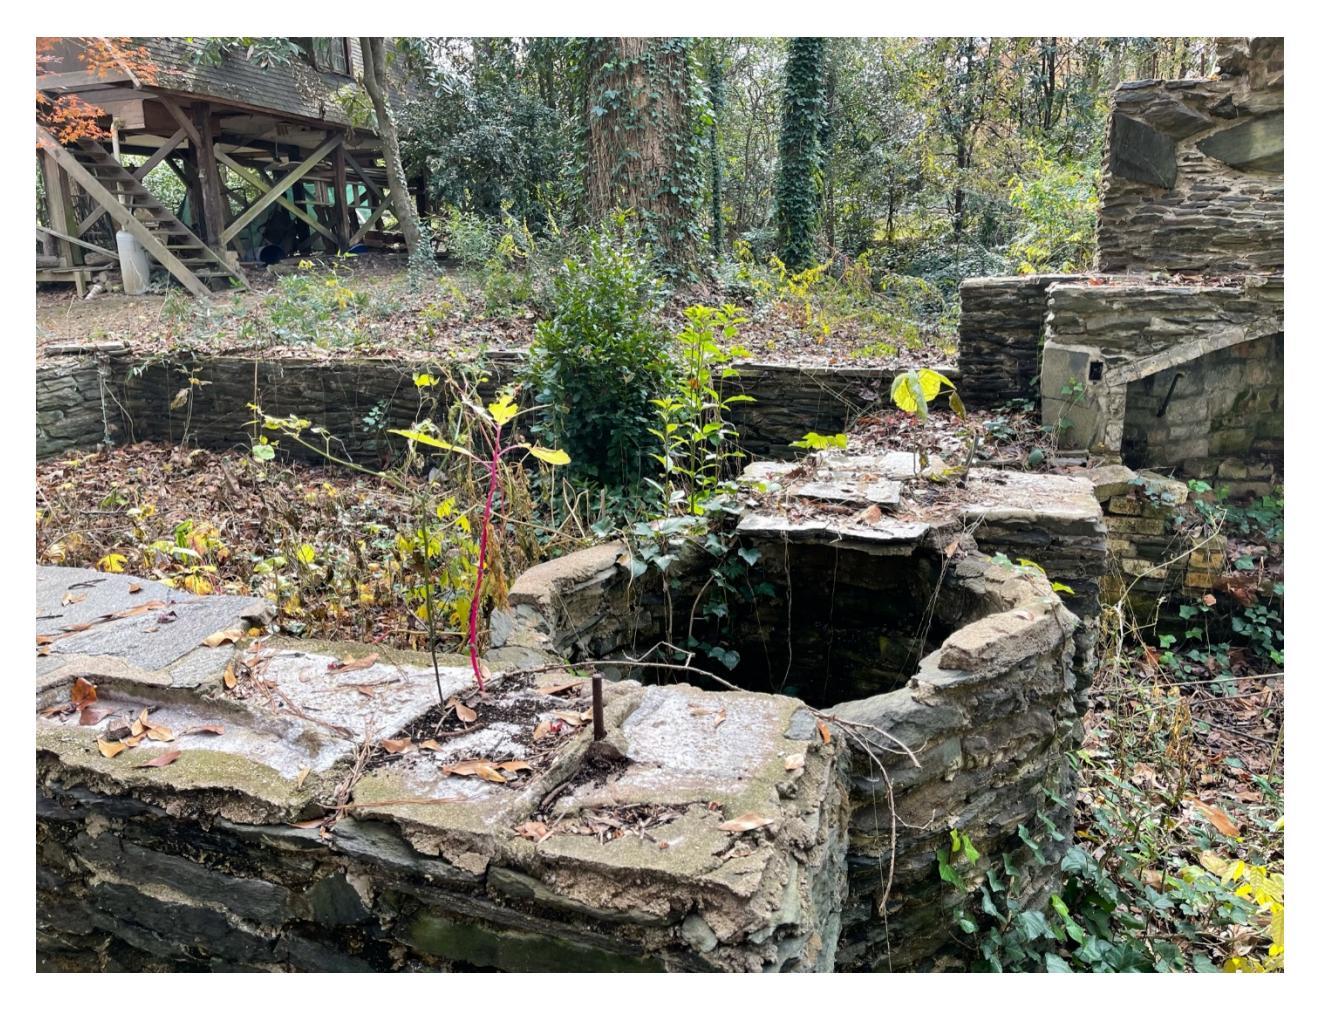
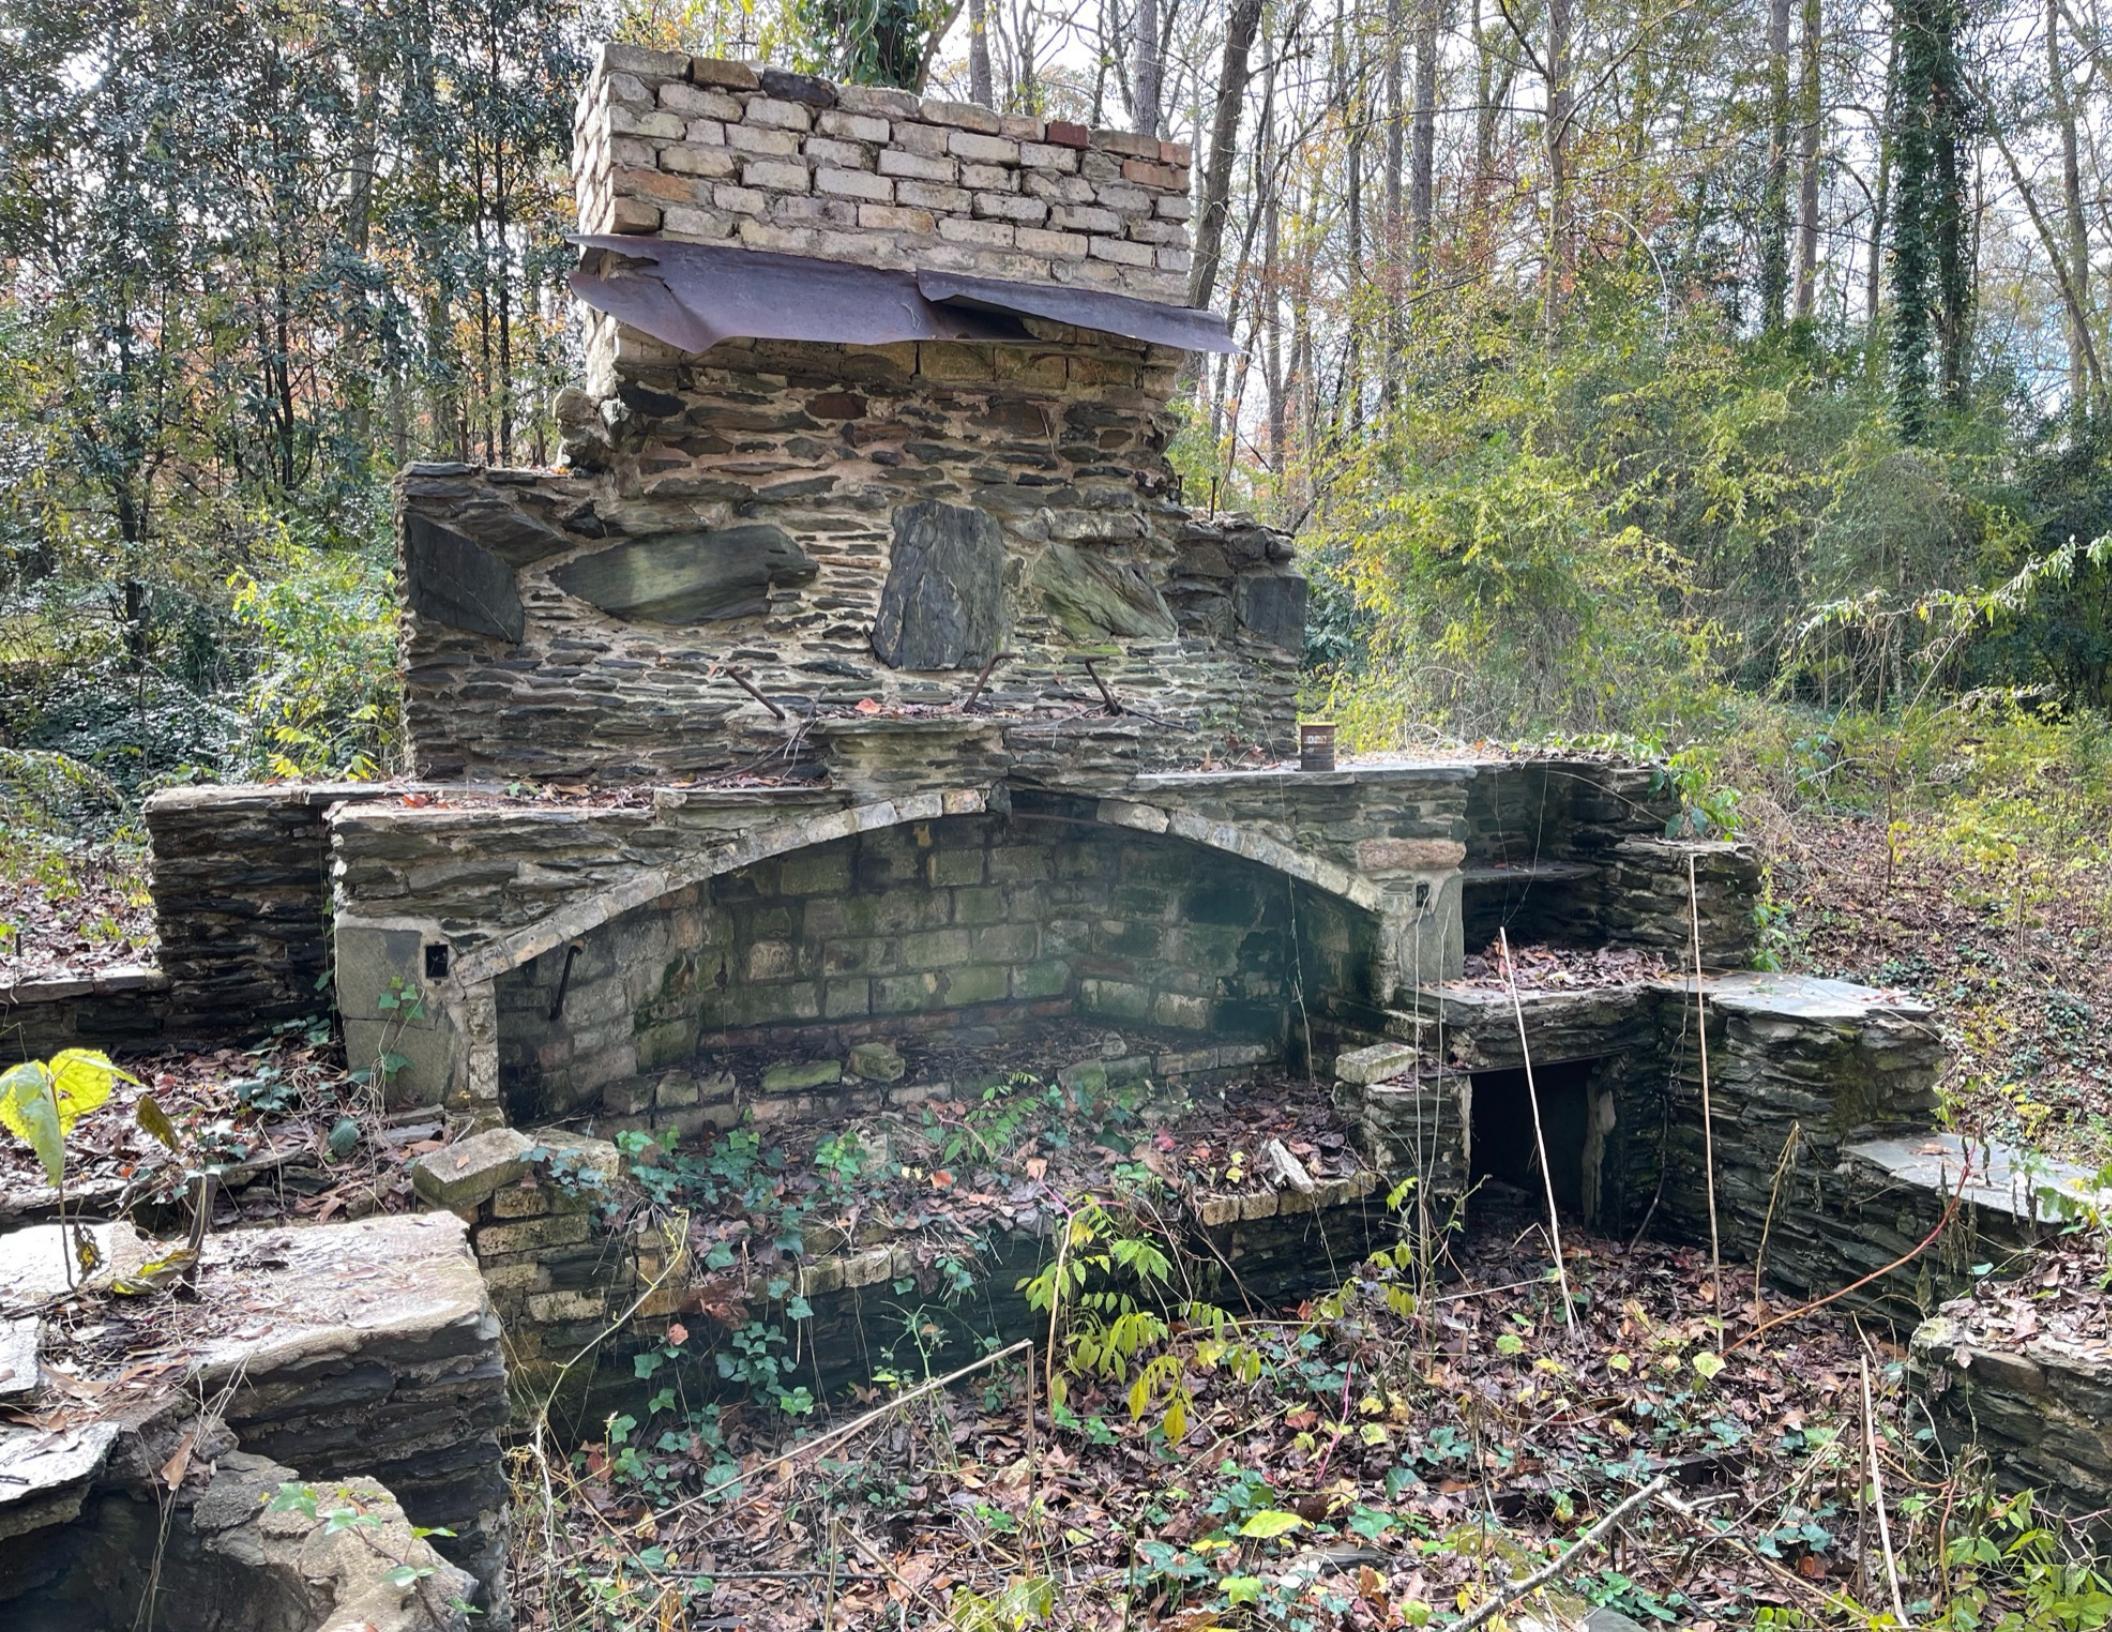
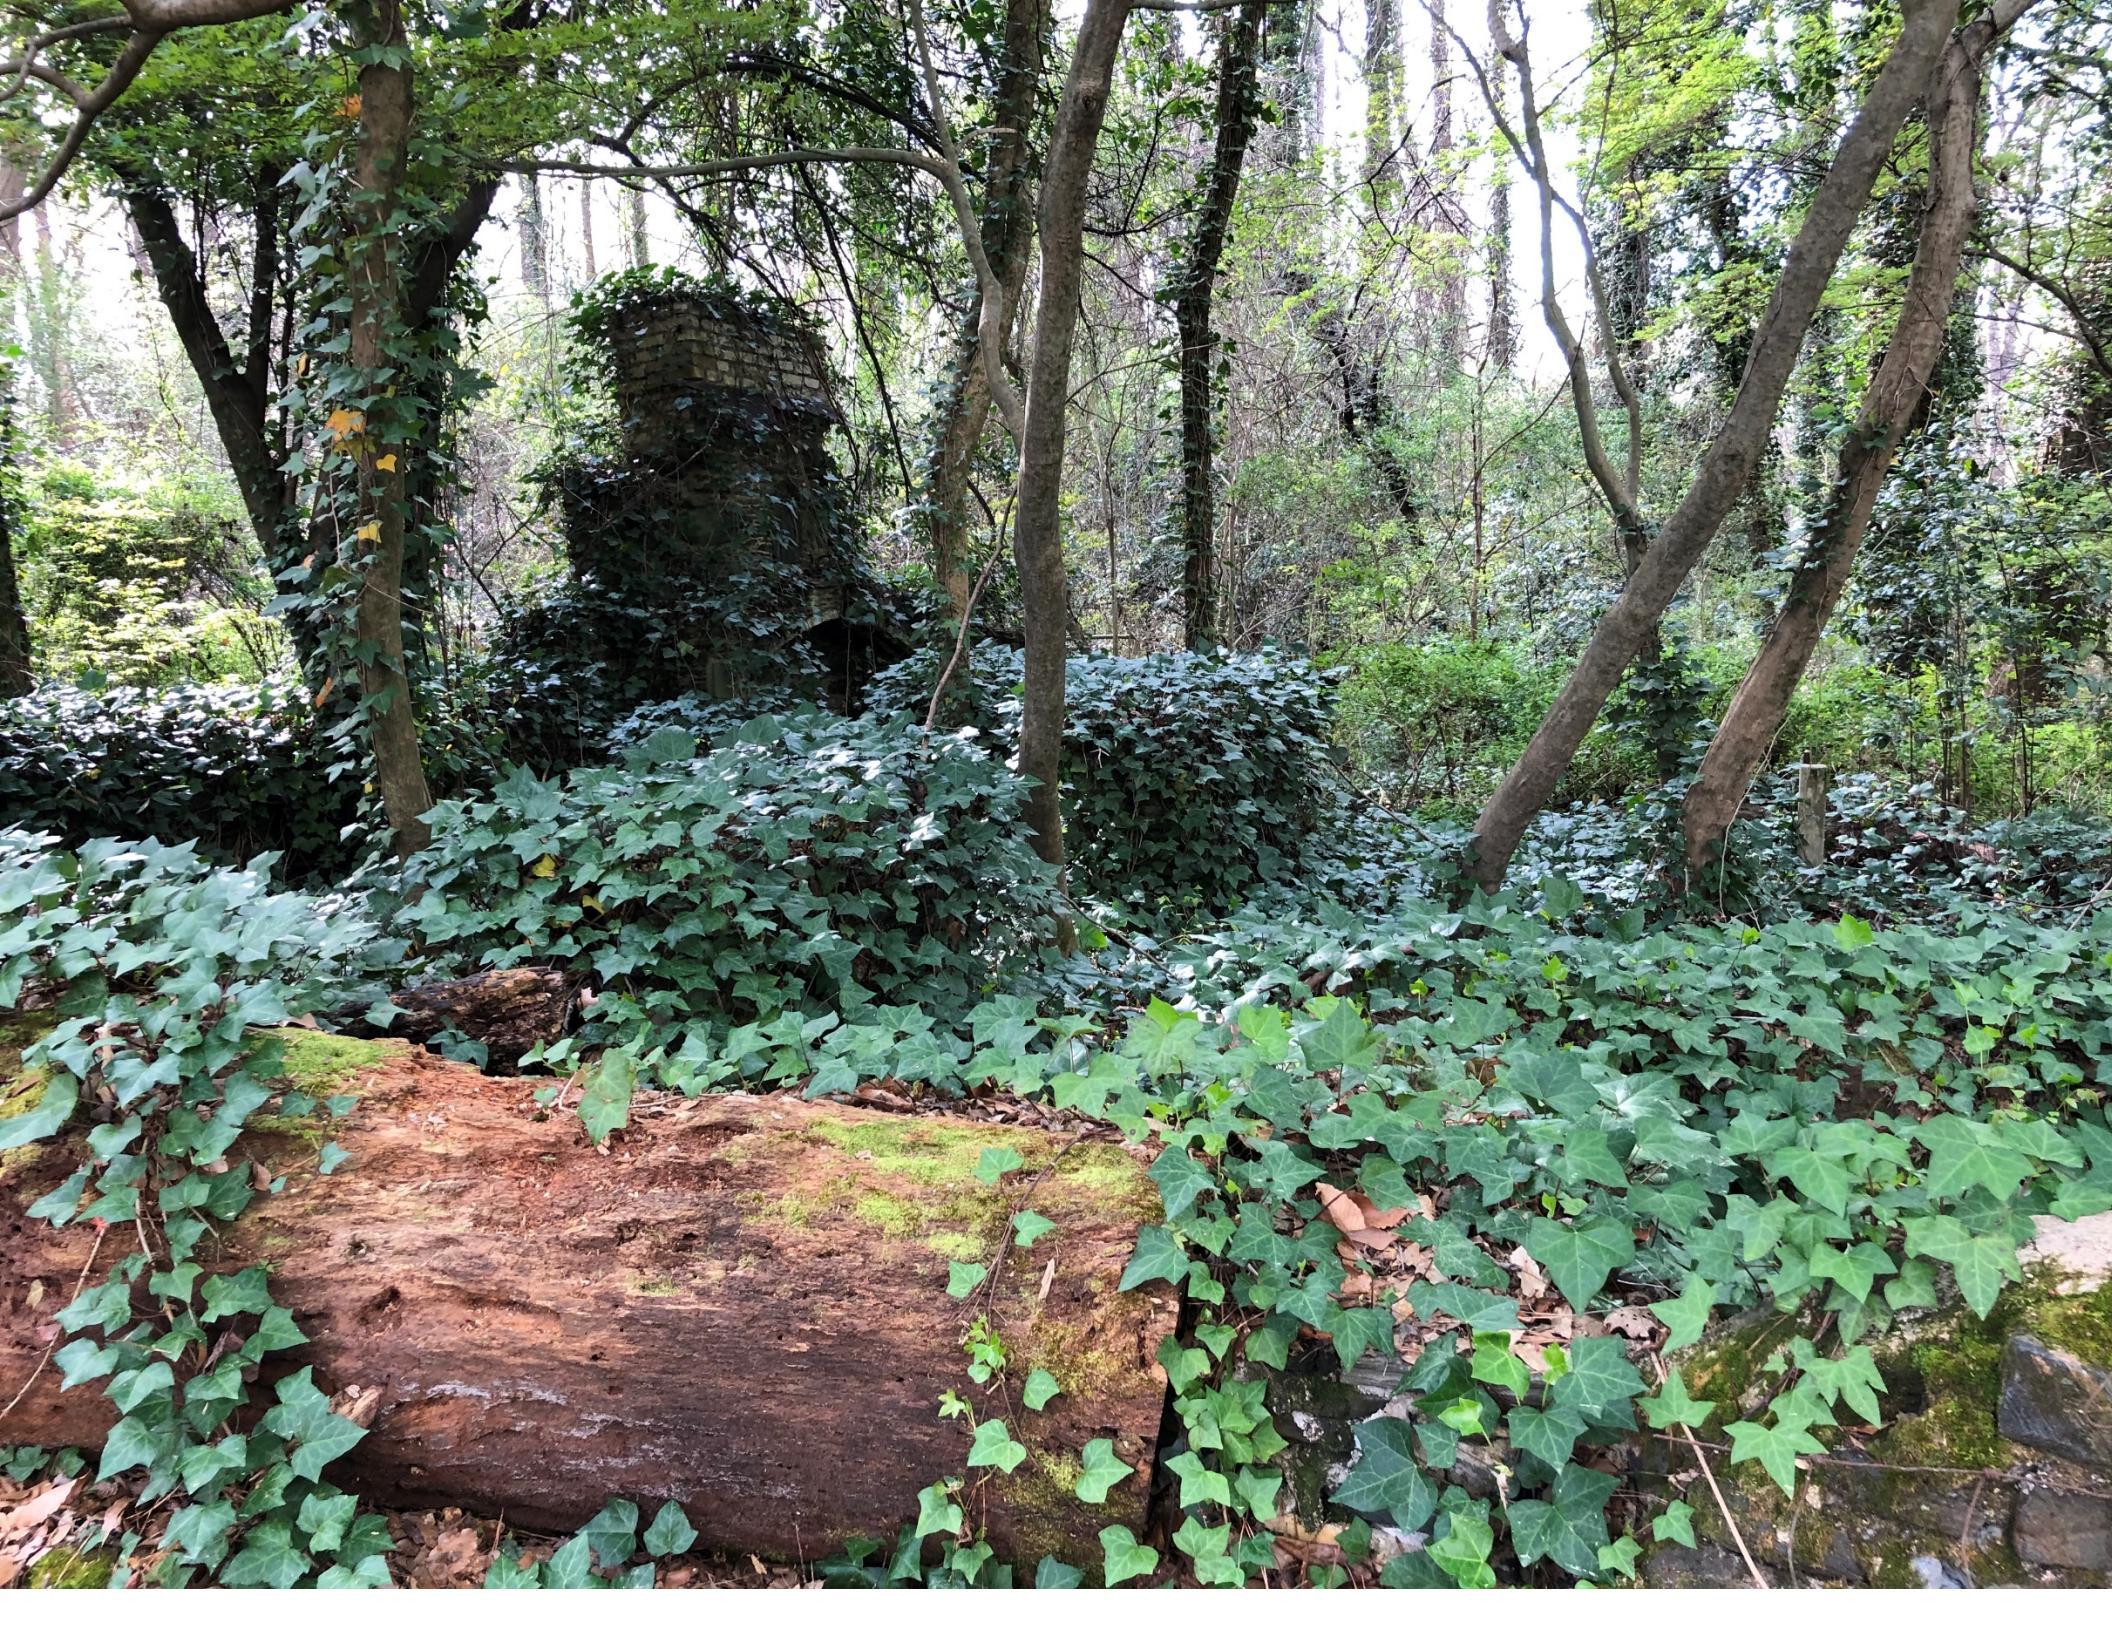
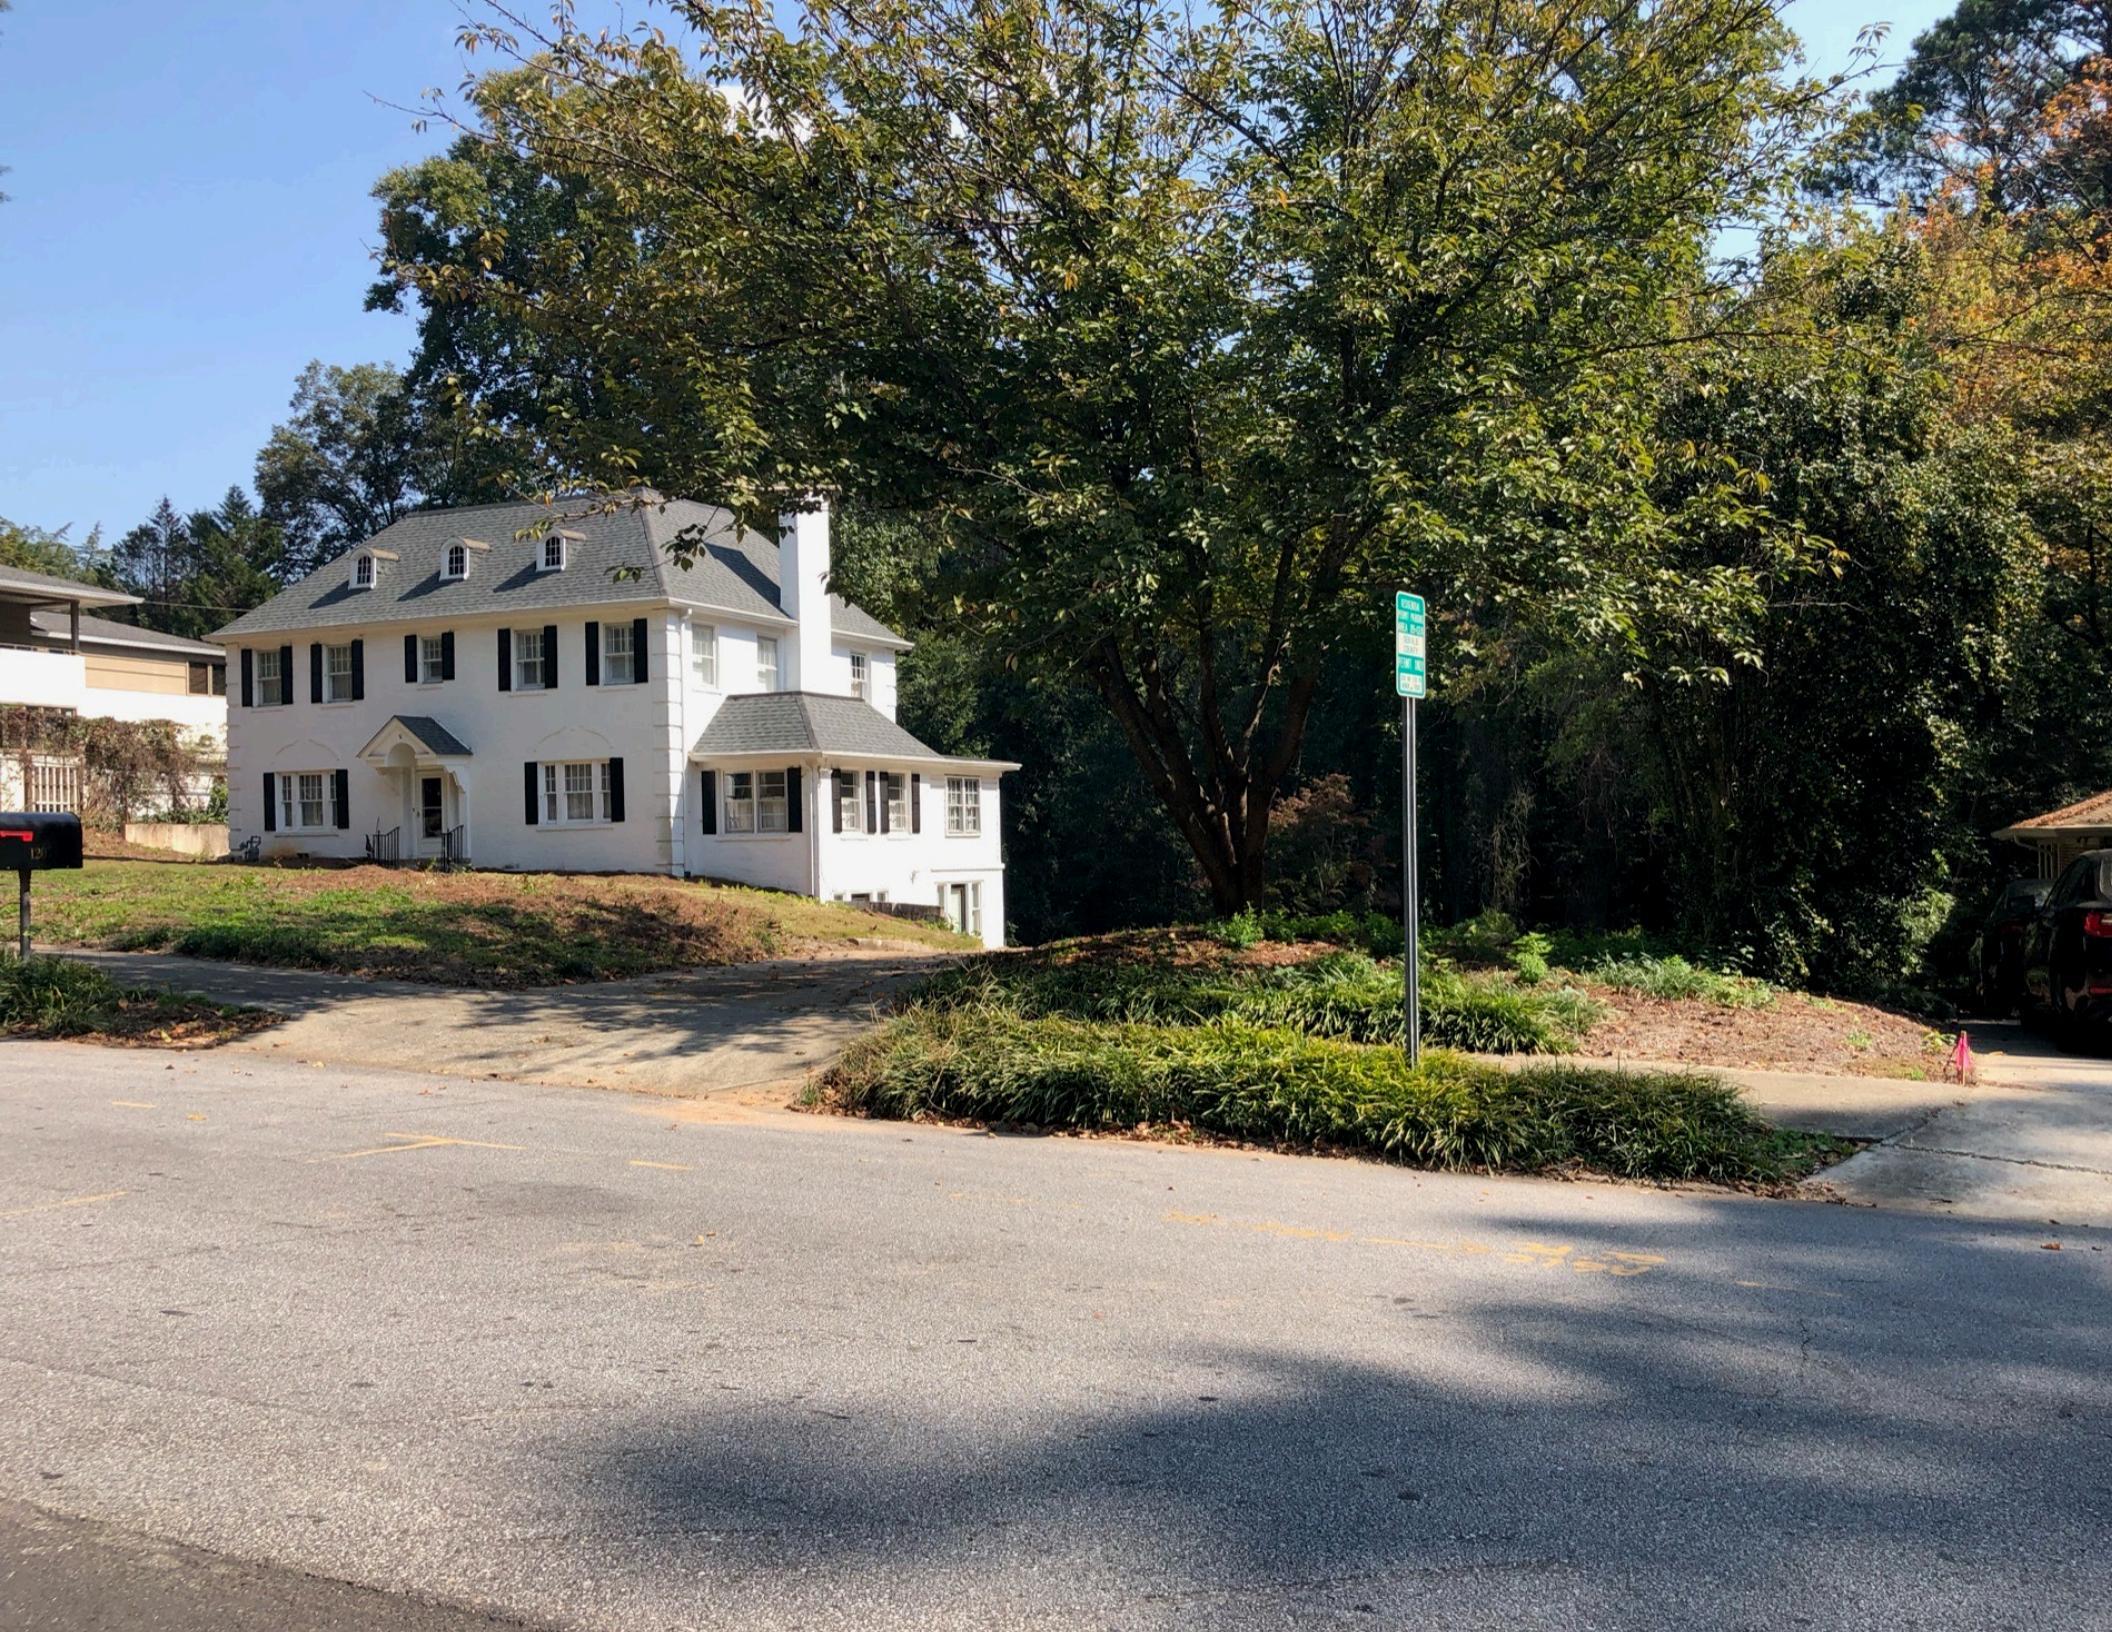
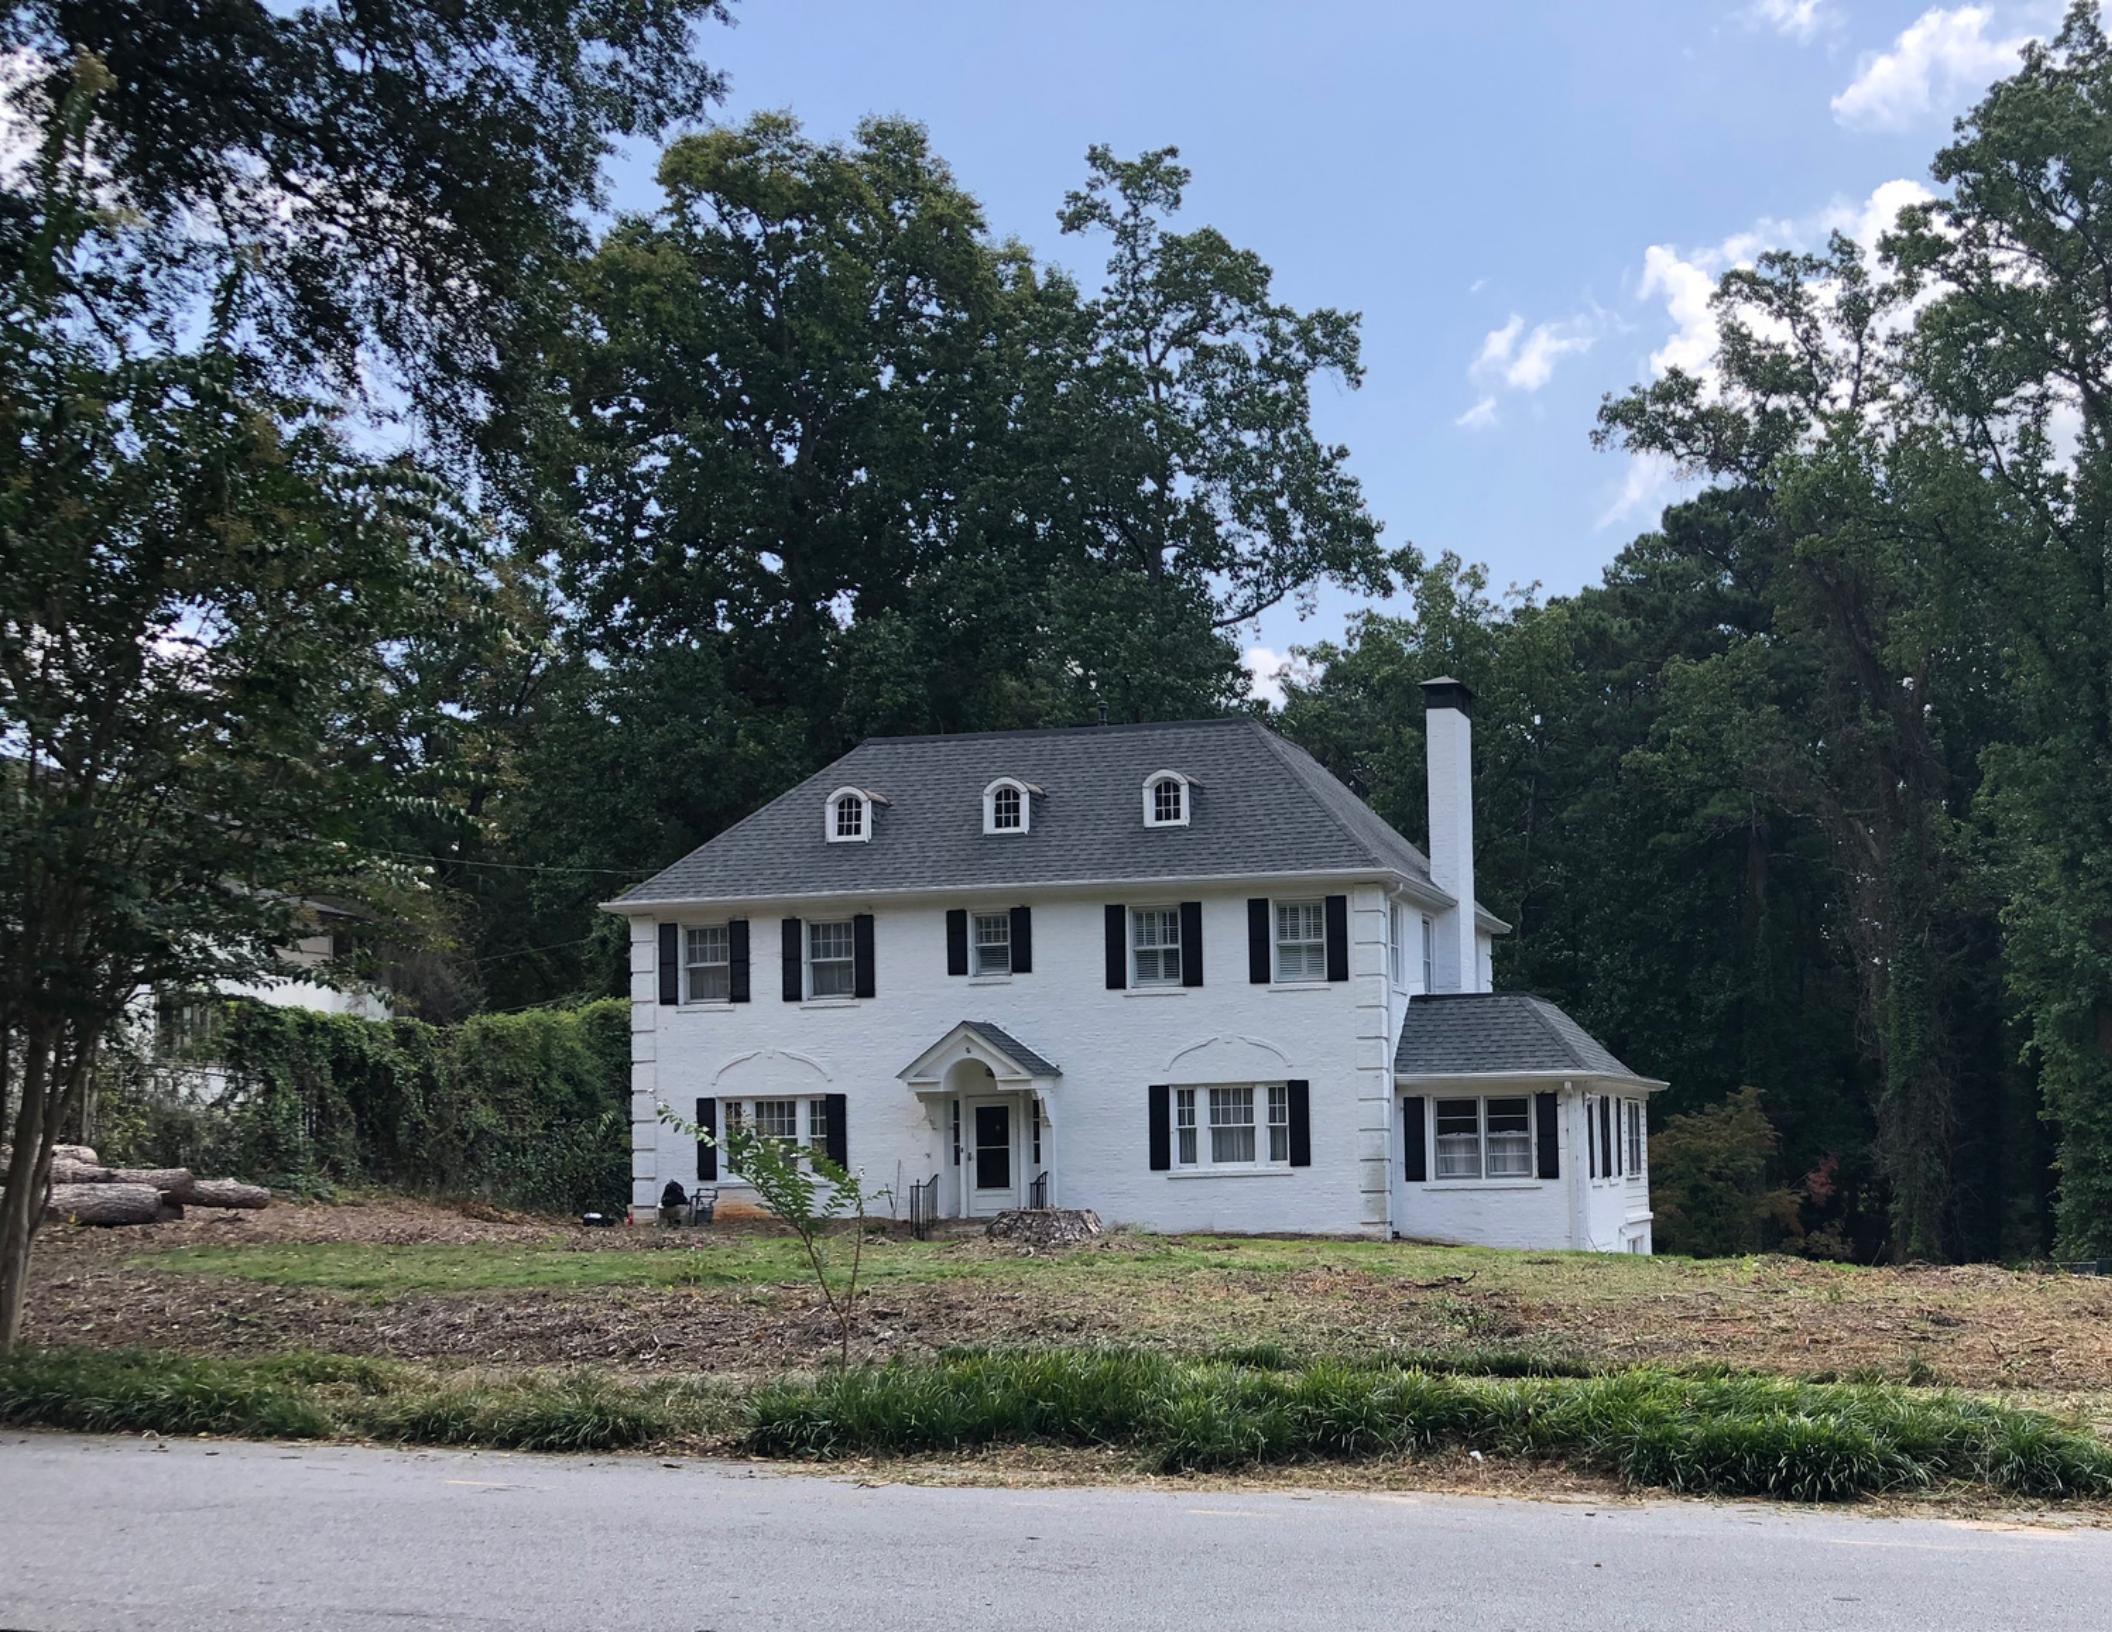
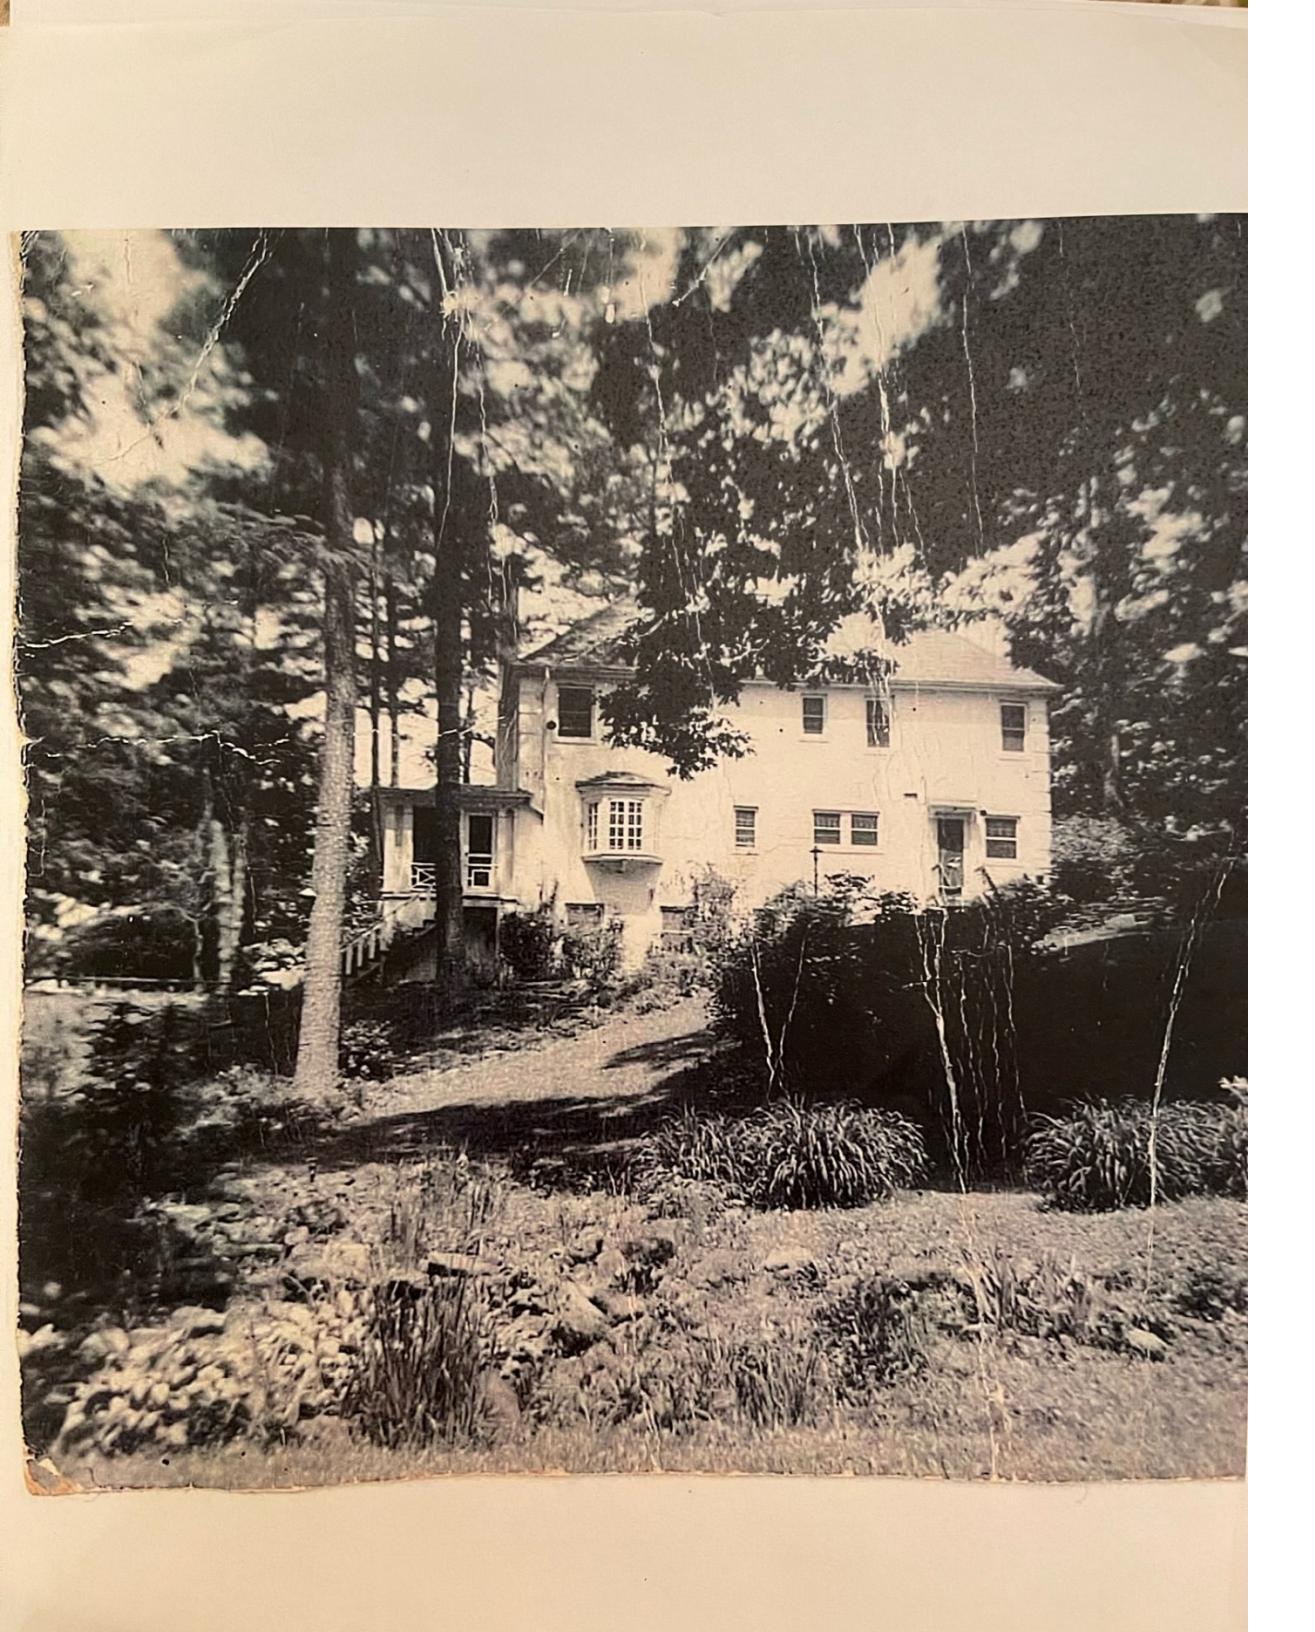
Please see some updated pics. **For the fireplace.** Restoration of stone and mantle will be the steps performed along with a pergola style wooden overhead to match where previous metal anchors are represented in the structure. We will utilize timber intended to be from that period.
