Application for Certificate of Appropriateness

Address of Subject Property: 1080 Clifton Road NE, Atlanta, GA 30307

STRUCTURAL ASSESSMENT

1080 Clifton Road, NE

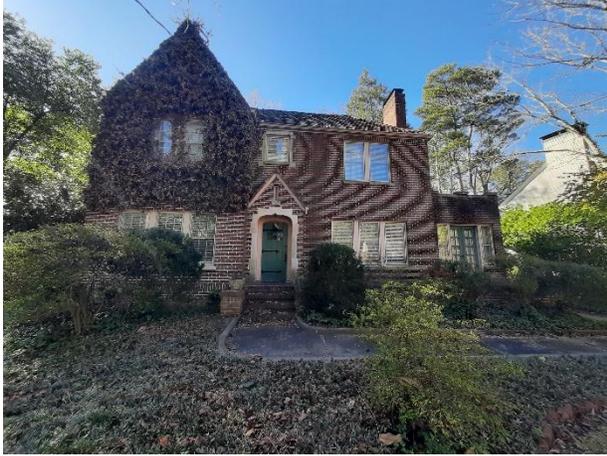
Photo 1
Front of House (East Façade)

- a. Brick pilasters in crawlspace at the east side
 - b. Ivy covering a portion of the east façade (Ivy had been trimmed back from the first floor at the time of our visit). See **Photo 1**.

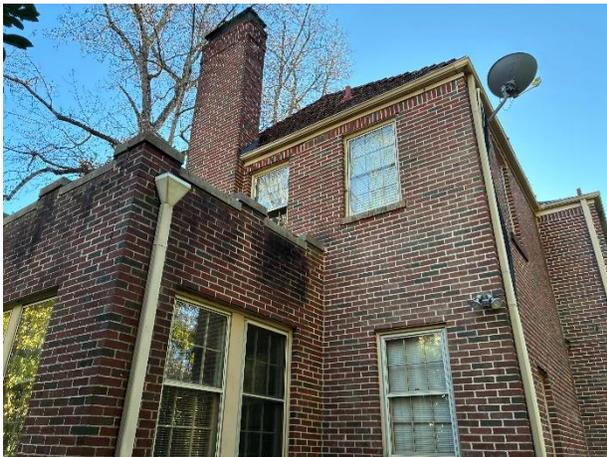
Photo 3
North Side of House

3. One chimney / fireplace. **See Photo 3**.
4. Wood stick framed roof
 - a. Clay tile roof over main house
 - i. Low slope portion of main roof over the private bathroom on the second floor does not appear to have clay tile

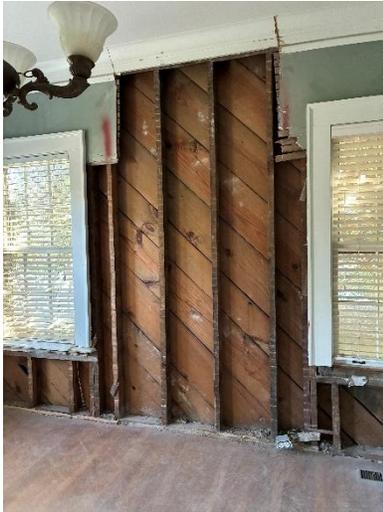
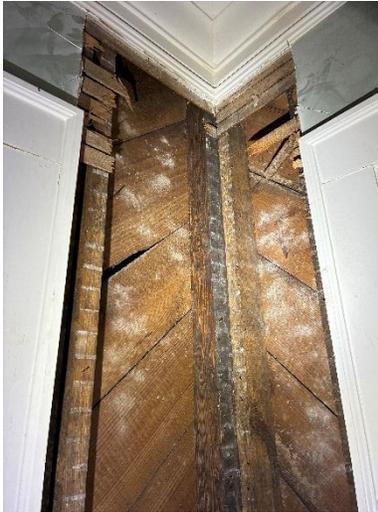
4. See **Photos 19 through 24.**

Dining Room Wall Framing

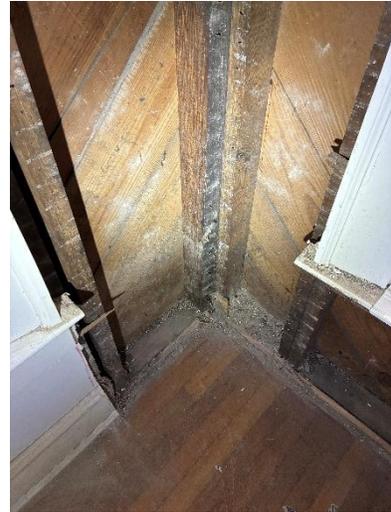
Photo 21

- a. **Photo 21** is in the same corner as the stairstep crack in **Photos 5 through 7.** A small ball placed on the floor of the dining room to test for floor slope did not roll toward this corner indicating a relatively level floor.

Dining Room Wall Framing

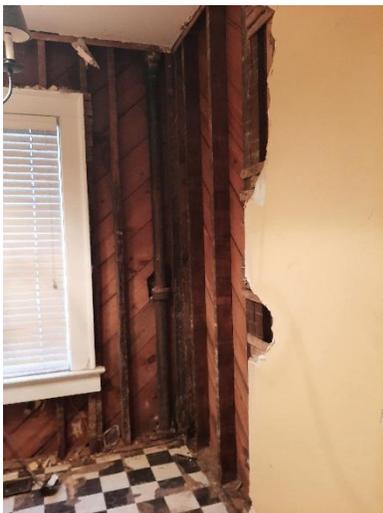
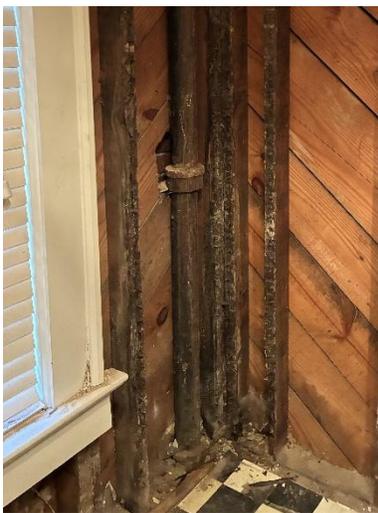
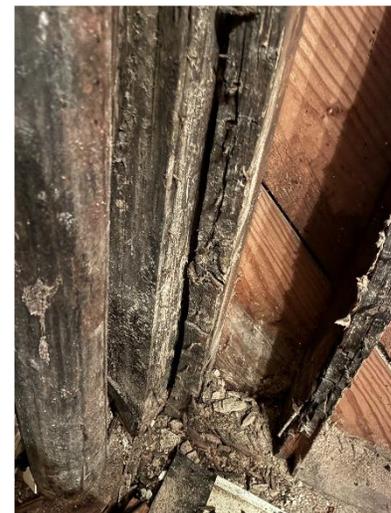
Breakfast Nook Wall Framing

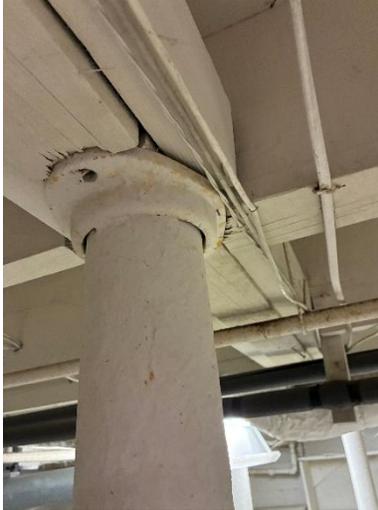
- ii. First floor framing was visible from the basement. See **Photo 25**.
 - 1. Floor joists are supported by wood ledgers. A few joists show cracking at the notch.
 - 2. The ledgers are nailed to beams / rim joists. Some ledgers have slight separation from the support member.
 - 3. There is floor damage directly below the northwest corner of the Breakfast Nook. See **Photo 26**. This damage extends from the roof to the basement in this location.
 - 4. Beams are supported by multiwythe brick or CMU walls, by other beams, or on columns.
 - a. No metal connectors were observed
 - b. The header beam at the stairs has been cut to allow for piping. See **Photo 27**.
 - c. Some beams at the columns show signs of crushing at the column caps. See **Photos 28 and 29**.

2. One column has an adjacent shoring post. The bottom of the beam is at least 1/2 inch above the column cap, so the column is no longer load bearing. A slight indentation is visible where bearing occurred indicating compression of the wood possibly due to inadequate bearing area. See **Photos 29 and 30**.

Photo 29
Top of Pipe Column

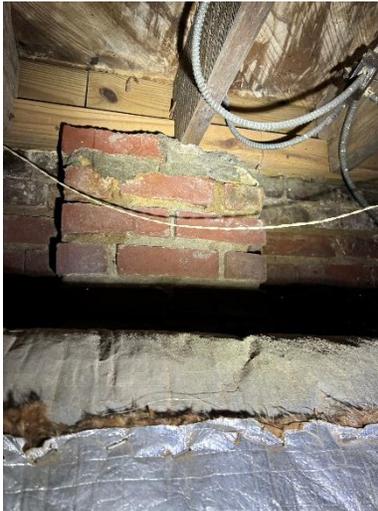
1. The accessible portion of the crawlspace (under the front patio) was dry at the time of Sykes' visit. Some localized water stains were observed on the exterior brick wall and the interior CMU wall. See **Photos 33 through 35**.

Photo 34
Brick Pilaster at Crawlspace

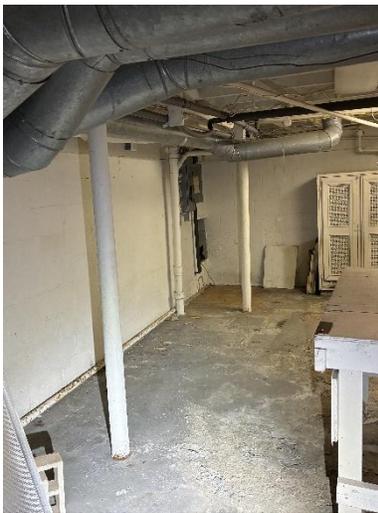
- v. Slab on Grade
 - 1. The thickness of the slab on grade is unknown.
 - 2. No standing water at the time of Sykes' site visit; however, there is damage to the slab on grade due to continuous water intrusion and prior patching. See **Photos 36 and 37**.
- vi. Exterior Entrance
 - 1. There is an exterior entrance to the basement that allows water to enter. See **Photo 38**.
- vii. A mold assessment is recommended. See **Public Safety Considerations** Section

Photo 37
Slab on Grade

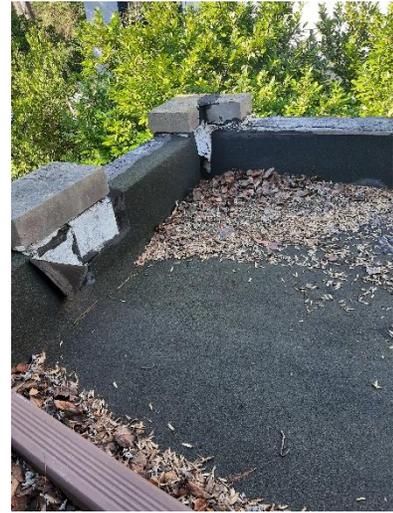
Photo 40

Roof of Sunroom / Enclosed Porch

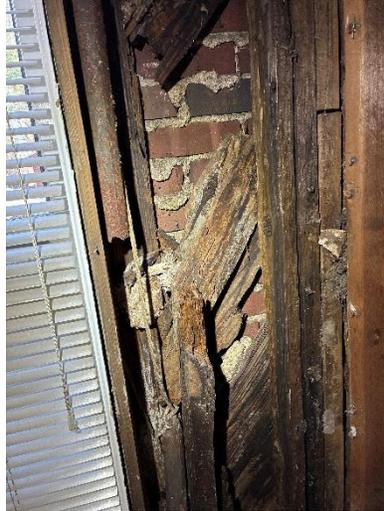
- iii. The wall in the northwest corner has extensive damage and rot. Some of the wall studs and exterior diagonal sheathing have partially rotted away and the exterior brick veneer is visible. See **Photos 43 through 45.**
- iv. The floor shows signs of water damage but most of the framing below appears sound. See **Photos 46 and 47.**

Photo 44
Northwest Corner Framing
At Sunroom / Enclosed Porch

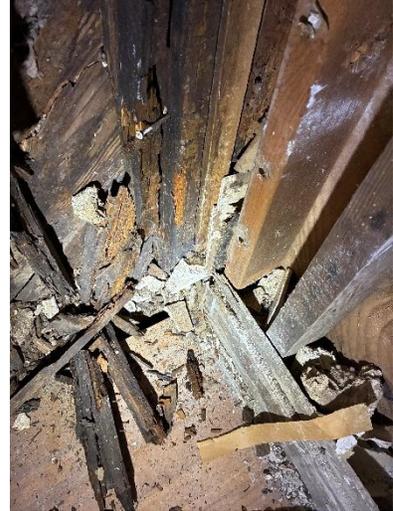
Photo 45
Northwest Corner Framing
At Sunroom / Enclosed Porch

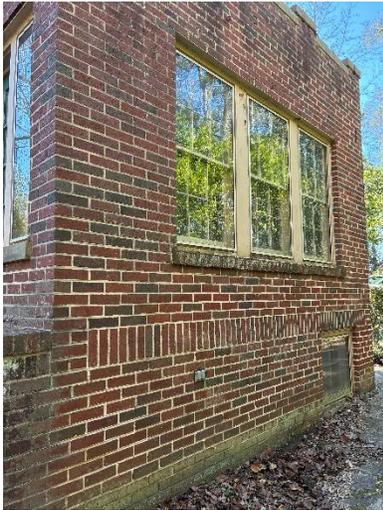
North Exterior Wall of Sunroom / Enclosed Porch

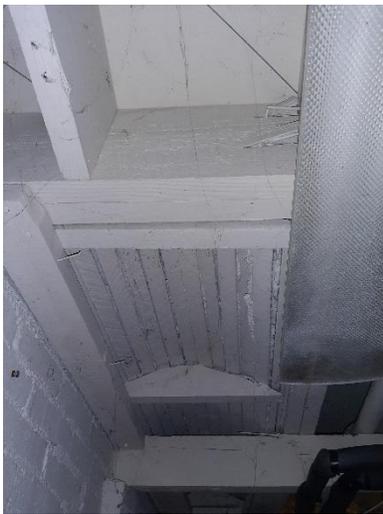
Framing Under Hearth

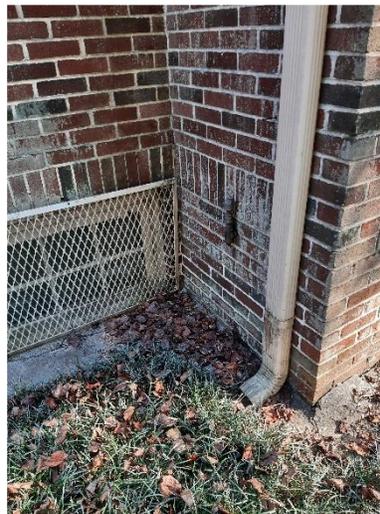
Downspout Near
Basement Window
