1750 Hummingbird Lane Existing House

Inspection Report

Property Address:
1750 Hummingbird Ln NE
Atlanta GA 30307

Home Sweet Home Inspections LLC

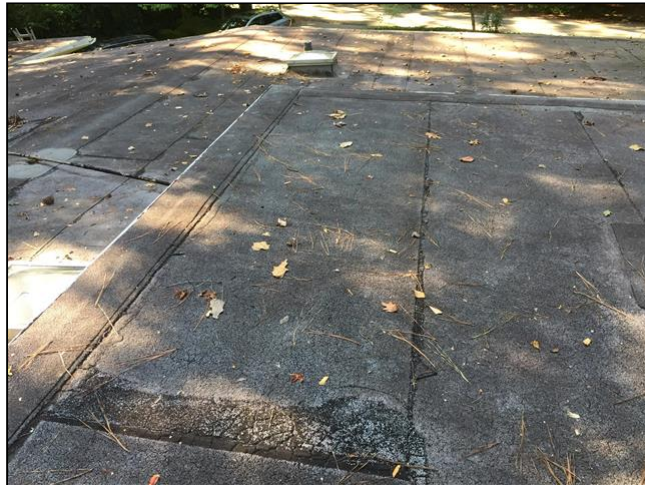
1.0 Item 1(Picture)

1.0 Due to the age and condition of the roof covering, it is recommended that the roof covering be replaced. There are many cracks and bulges in the covering. The average life expectancy of roll roofing is 5-10 years.

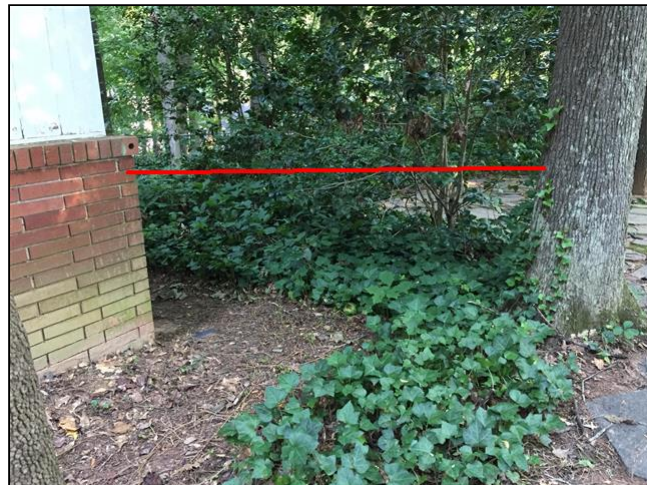
2.3 Item 3(Picture)

(2) Mature trees within 12' of the home can disrupt the foundation of the home. If any signs of structural movement occur in the future (in this area) I recommend further evaluation by a structural contractor. Due to the number and age of trees around the home, it is recommended that a qualified arborist diagnose the health of the trees.
