Application for Certificate of Appropriateness

Address of Subject Property: 1168 Clifton Road NE Atlanta GA 30307

Description of Work:

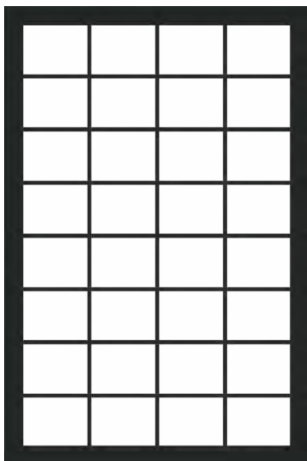
1. Replace all existing windows

- Existing windows are mismatched in size, style and materials. Existing window layout does not support new floor plan, some windows are broken and/or inoperative.

- i. 1- A-2 (Front elevation) windows sizes: 59"W by 89"H X 3
 - ii. 1-A-2A (Clifton/Oxford side) replacement windows to match existing design/size/location (39"X80" X 2 and 60"X80")

- iii. 2-A-2A Bedroom Windows (36" X 60")
 - iv. 2A-2 (Adjacent to 1478 Oxford Road) Install new windows according to the floor plan. Bedroom windows sizes 36" X 60", office 60"X 60".

- We can source desired look with aluminum windows if required by the Historic Board.

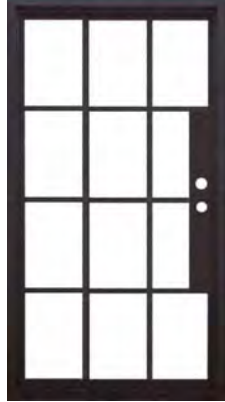
2. Install new front door (iron, black, colonial pattern grid 60" X 94", pivot)

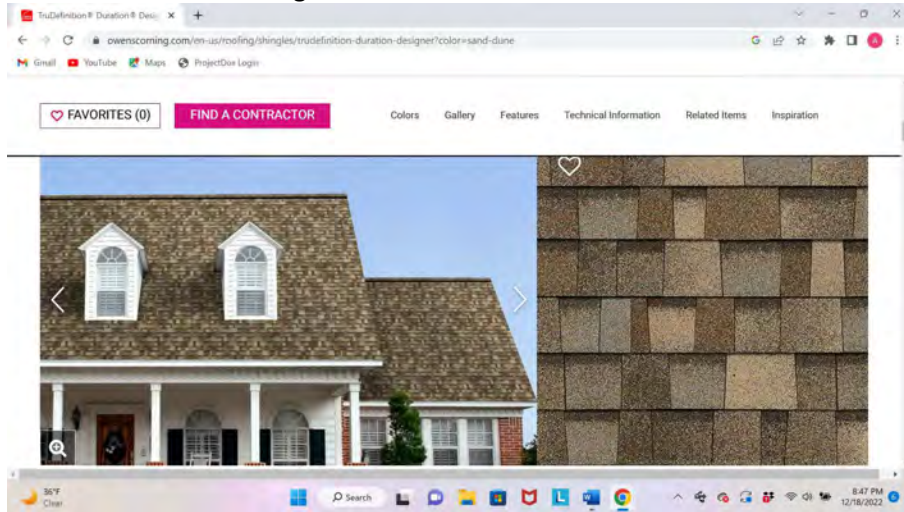
4. Replace roof. Roof is unrepairable, many shingles are worn, damaged or missing.

- Install architectural shingles

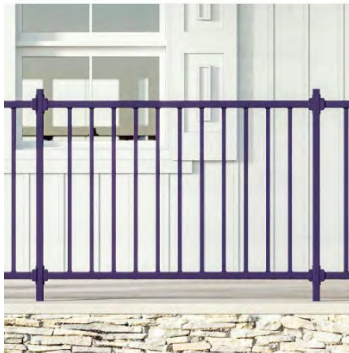
5. Railing:

- Iron, black

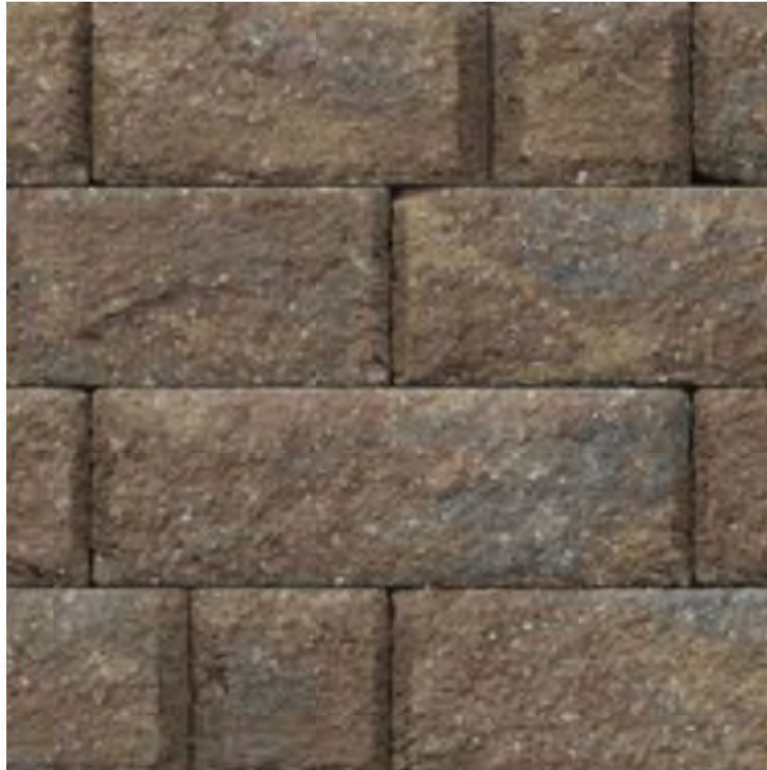
DIAMOND PRO

DETAILS: Size- 8 x 12 x 18 1 pallet minimum. 48 blocks per pallet The Diamond Pro retaining wall system is an ideal choice for large-scale projects. With a rough-hewn face style, it gives landscapes substance and stability.

Each block is 1 Sq. Ft.

48 square feet per pallet.

if allowed. I would like to replace existing timber wall with pre-cast stone block wall.

5) retention wall will be change to more appealing stacked stone retention wall

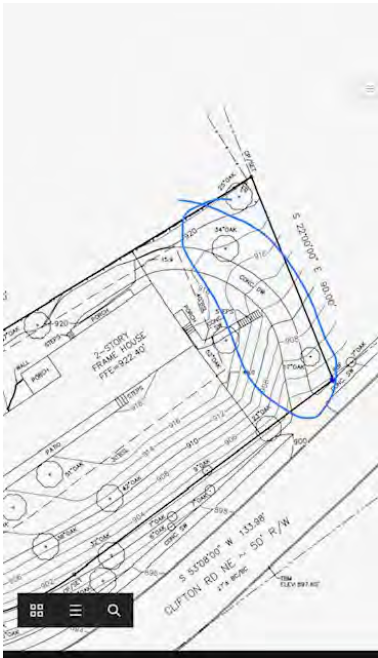
6) Existing apron is about 10 feet, we would like to widen to 12 feet if possible. We are only widening a portion of the driveway. I highlighted on site plan below:

How wide will the driveway apron be?

Will you widen the whole driveway?

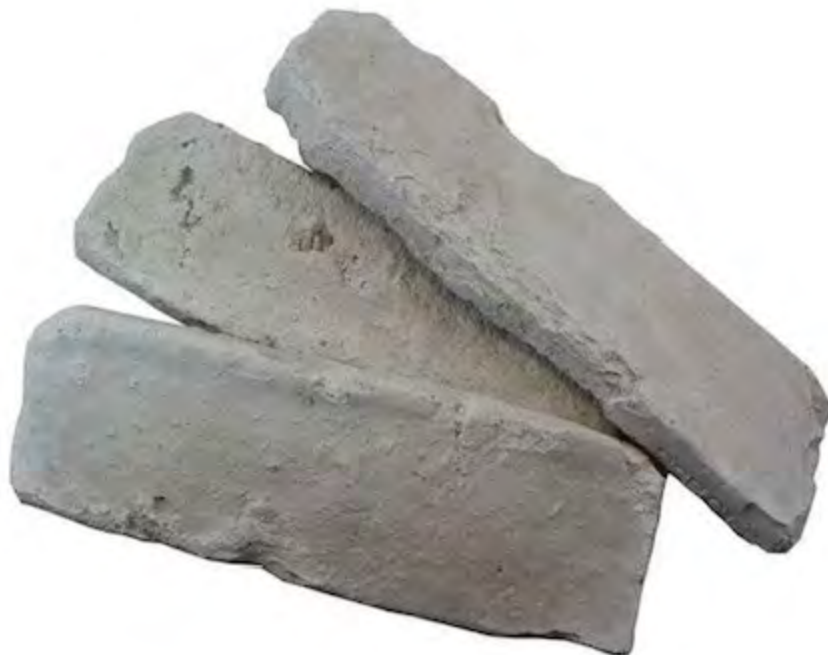
Good morning again :), faux brick is half the thickness of the regular brick.

- Thinner, lighter and easier to install
- Perfect for the DIYer
- Can be used with interior and exterior applications

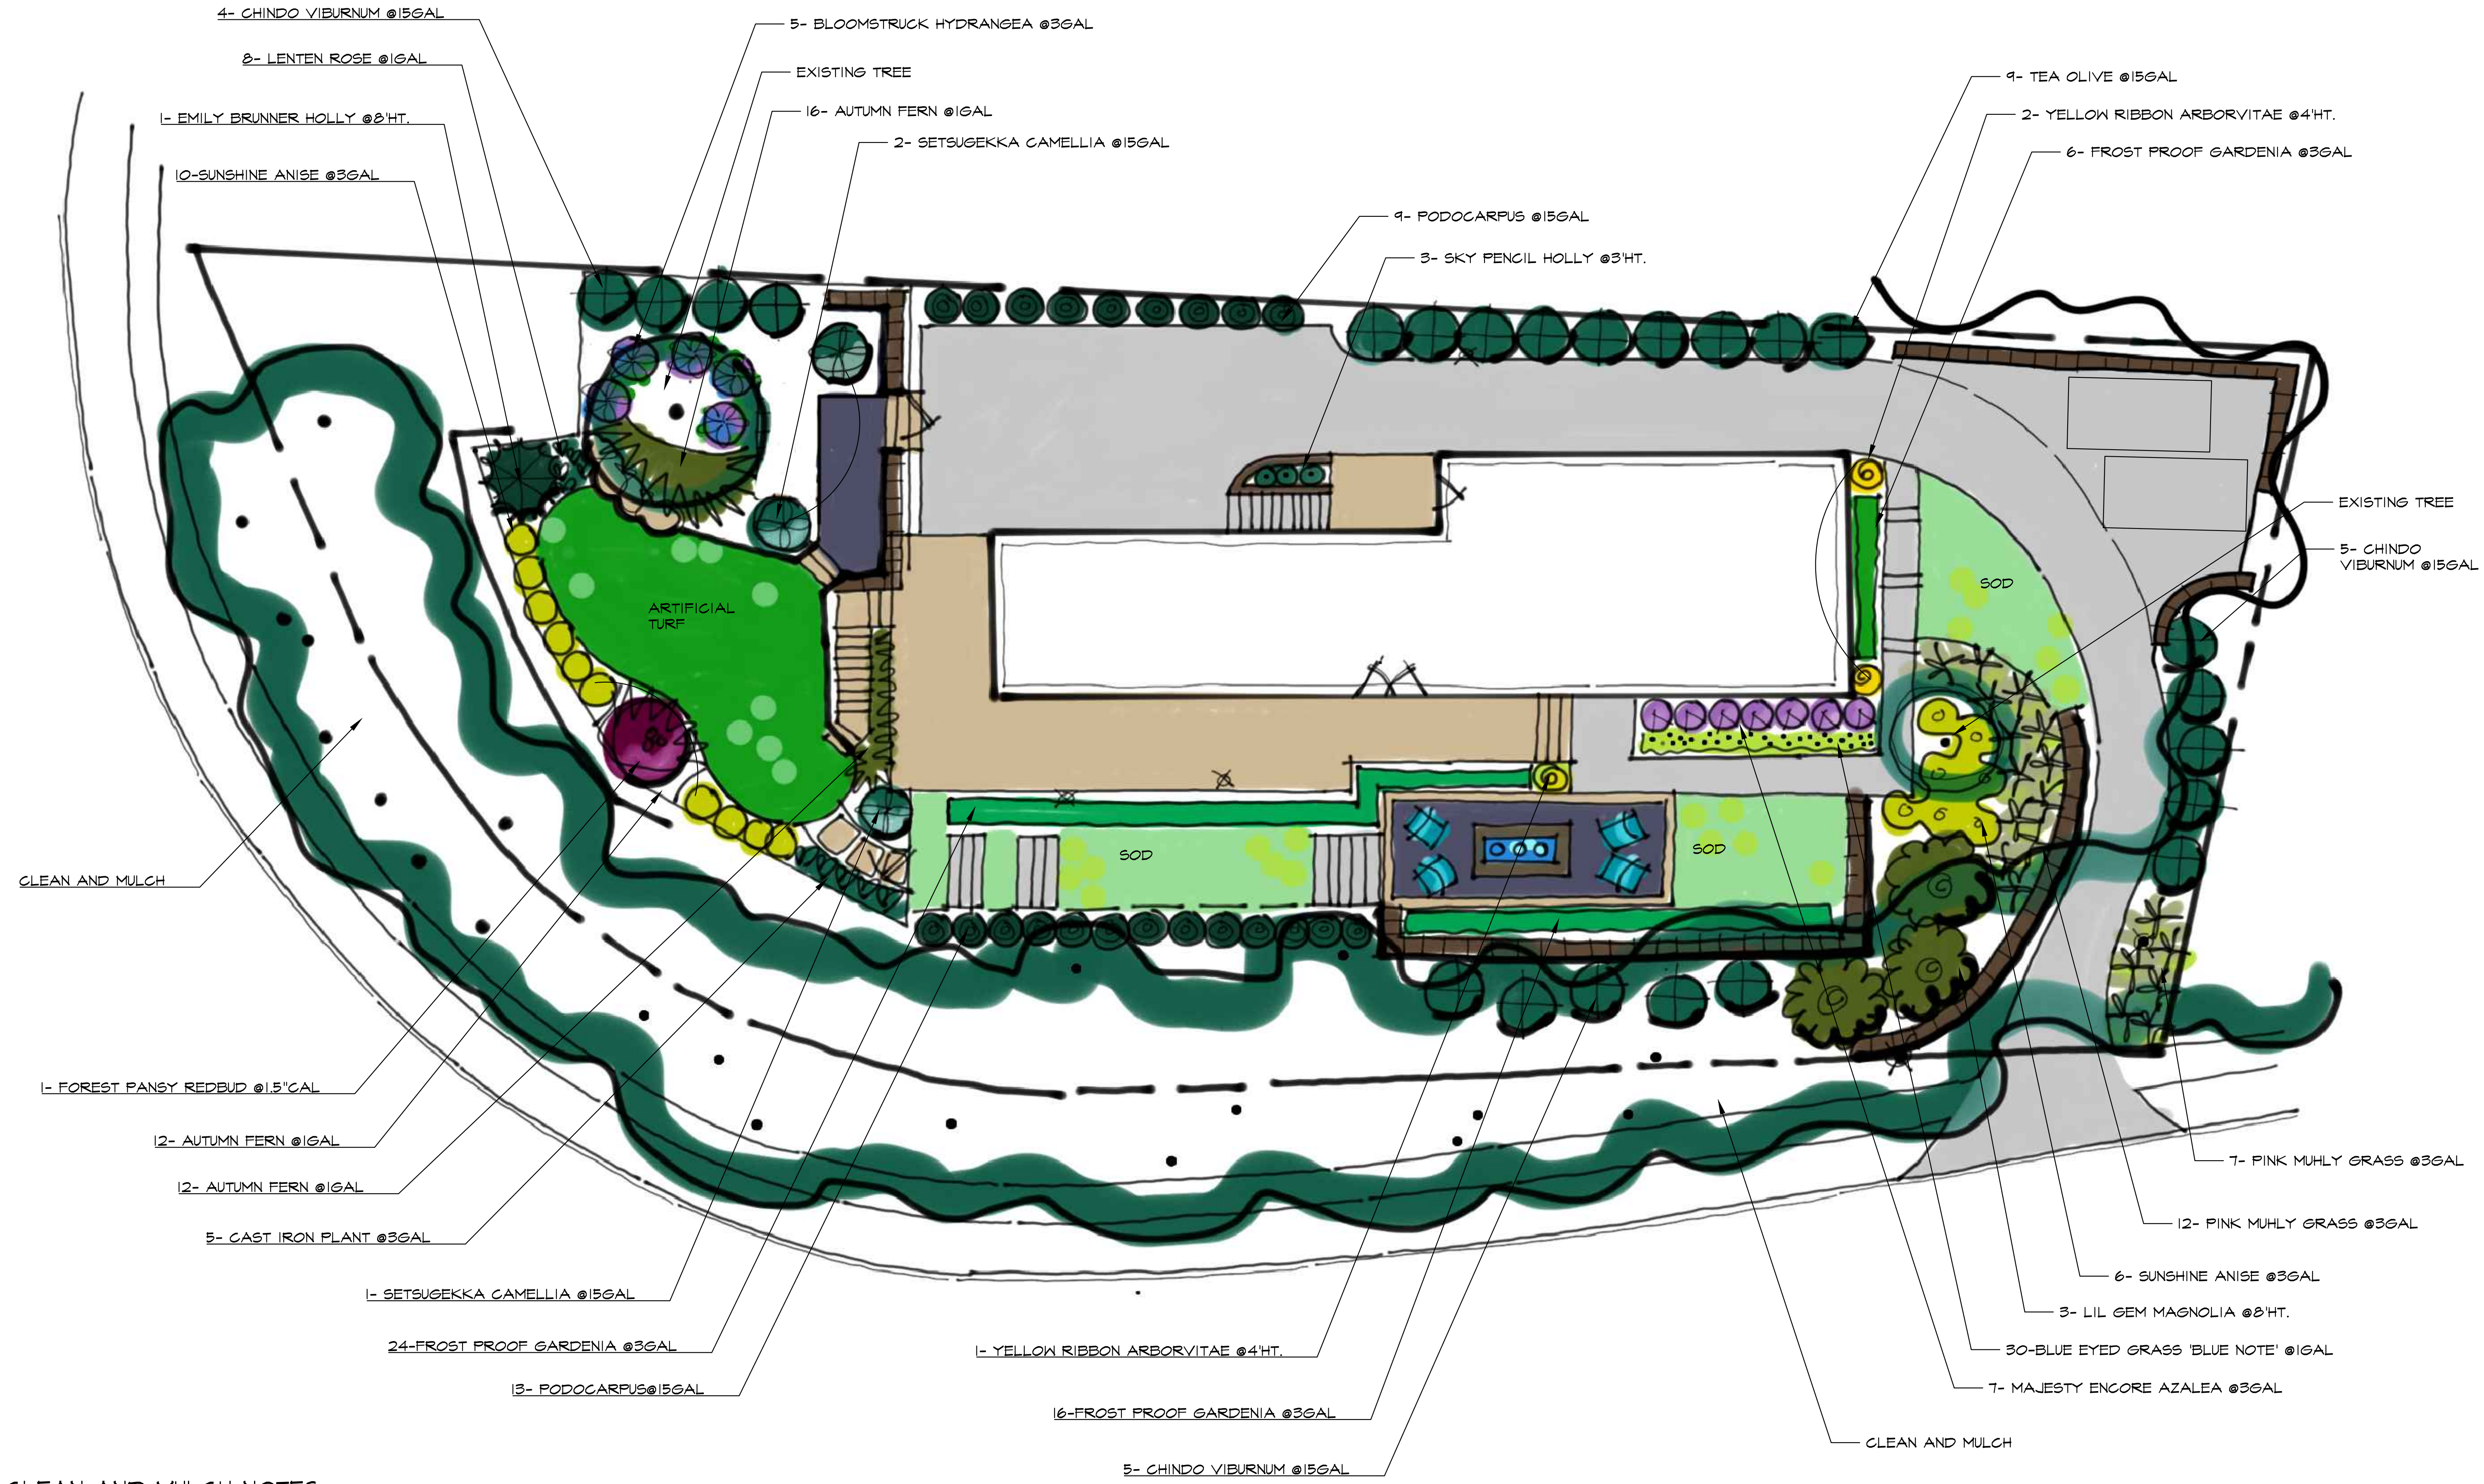
CLEAN AND MULCH NOTES:
THE CONTRACTOR SHALL CLEAR AND GRUB ALL WEEDS, DEAD TREES, TREES ONE (1) INCH CALIPER OR LESS AND OTHER SELECT TREES UP TO FOUR (4) INCH CALIPER AS DETERMINED IN THE FIELD IN THE TREE SAVE AREAS INDICATED ON THE DRAWINGS. A 3 INCH MINIMUM LAYER OF CYPRESS MULCH SHALL BE SPREAD OVER THE ENTIRE CLEARED AREA. THE CONTRACTOR WILL NOTIFY THE LANDSCAPE ARCHITECT PRIOR TO START OF CLEAN AND MULCH WORK. THE LANDSCAPE ARCHITECT WILL VERIFY SCOPE OF WORK IN FIELD WITH THE CONTRACTOR PRIOR TO START OF WORK. THE CONTRACTOR IS RESPONSIBLE FOR THE REMOVAL AND LEGAL DISPOSAL OF ALL DEBRIS FROM CLEAN-UP OPERATIONS FROM THE SITE.

Provide a legend for the landscape plan showing the plants.

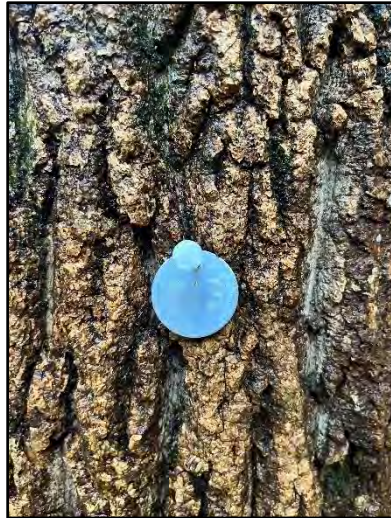
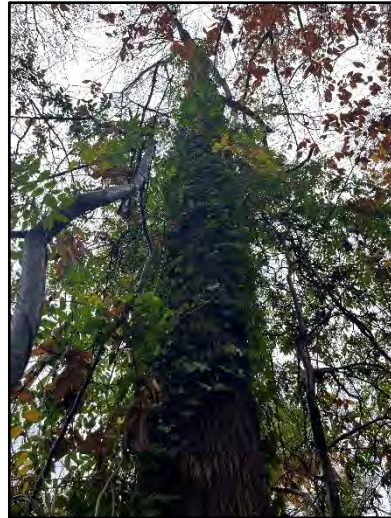
Tree #6 - 24" Poplar (Liriodendron tulipifera)

The subject tree is a 24-inch Poplar tree located along the front property line adjacent the existing driveway. During the visual inspection, a rubber mallet was used to check for the presence of a cavity. It was determined the subject tree contains a cavity; however, the extent of the cavity is unable to be determined.

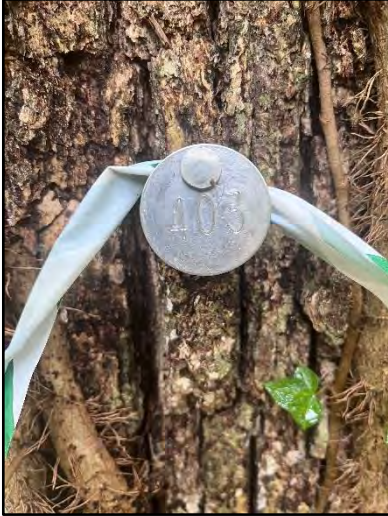
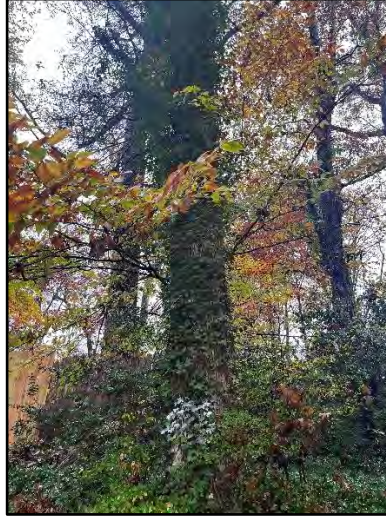
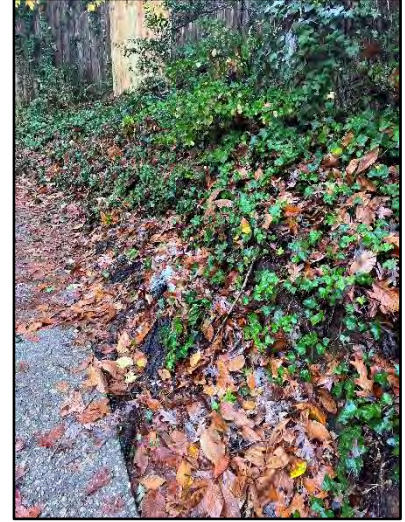
Tree #10 – 27” White Oak (Quercus alba)

The subject tree is a 27-inch White Oak located in the rear side yard adjacent the existing concrete driveway. As with trees number 8 and 2, the tree is suffering from root compaction caused by the existing concrete driveway. Tree roots are visible at the surface along the edge of the driveway and appear to have been damaged in the past by vehicles utilizing the driveway to access the property.
