Facility Inventory & Master Plan

Facilities Condition Assessments &
Real Estate Master Plan

Spring 2016

Jones Lang LaSalle
Incorporated
Houser Walker Architecture

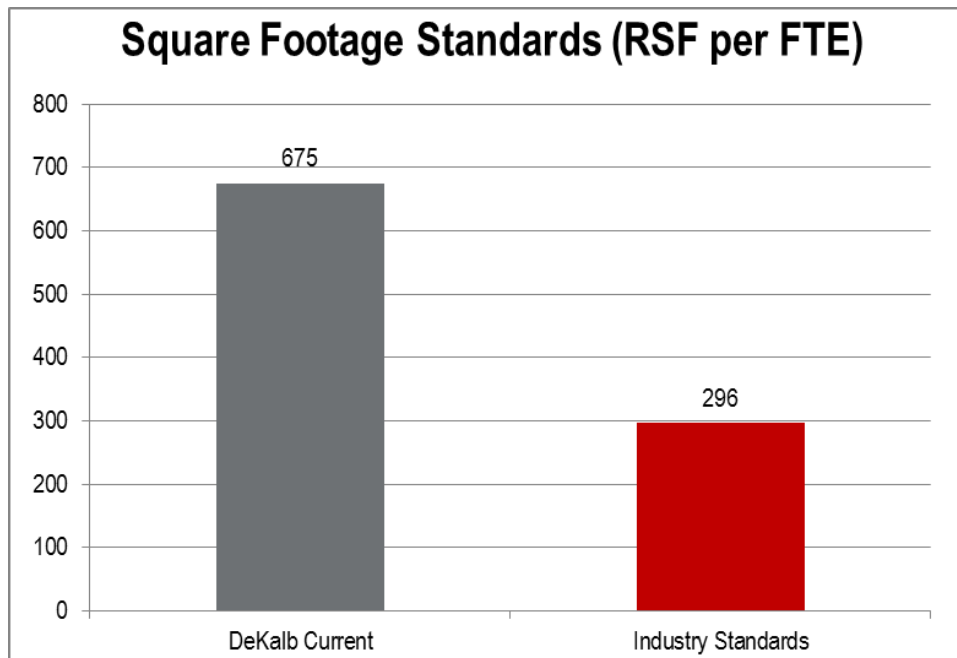
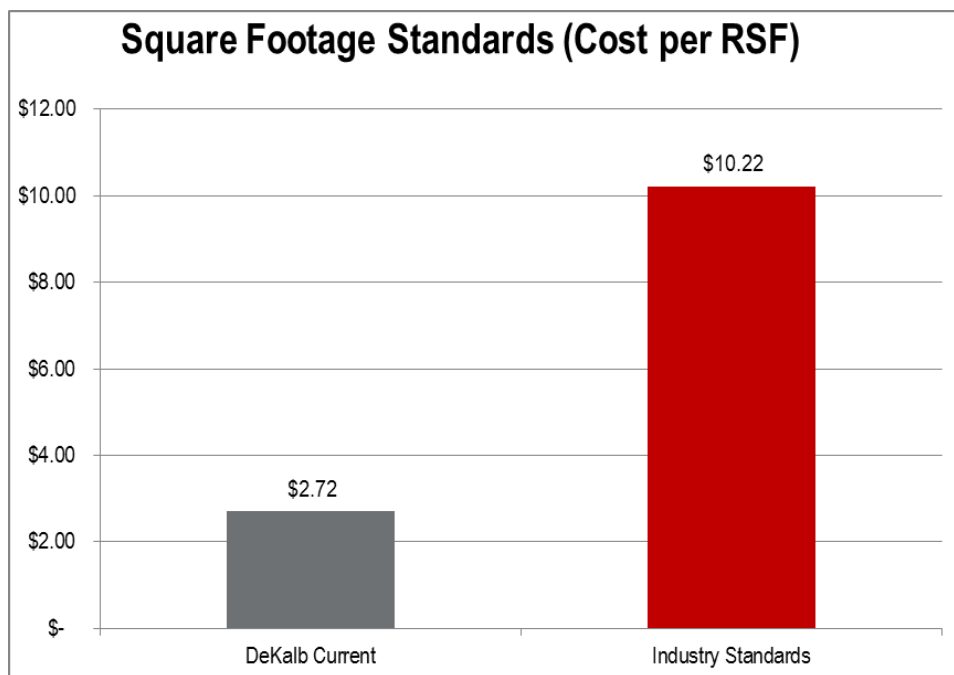
Figure 1a.

Figure 1b.

As figures 1a and 1b demonstrate, DeKalb County's current spatial allocation greatly exceeds the industry standard square footage (s.f.) per FTE amount. In its current state the average county employee has 675 s.f. of office space, while an average government employee in the Atlanta Metropolitan area is allocated an average of 296 s.f. Not only does this inefficiency contribute to wasted office space, but it also drives the County's occupancy costs up significantly. While the County's cost per s.f. amount is considerably lower than the industry standard, this number is not an accurate depiction of the true cost of excessive spatial allocation. In many cases government organizations do not necessarily overspend on facilities management, but rather greatly underestimate the amount needed to properly operate and maintain its real estate portfolio. In the case of DeKalb County, budget cuts, limited staff, and antiquated facilities management processes have led to a substantial amount of work order and maintenance backlog. During our interviews and conversations with County employees it quickly became apparent that preventative maintenance is minimal throughout the portfolio. Despite seemingly keeping facility management costs down the County is, in the long term, significantly reducing the usable life span of its buildings and perpetuating the subpar working conditions many employees currently experience.

Figure 1a & 1b: Square Footage Standards

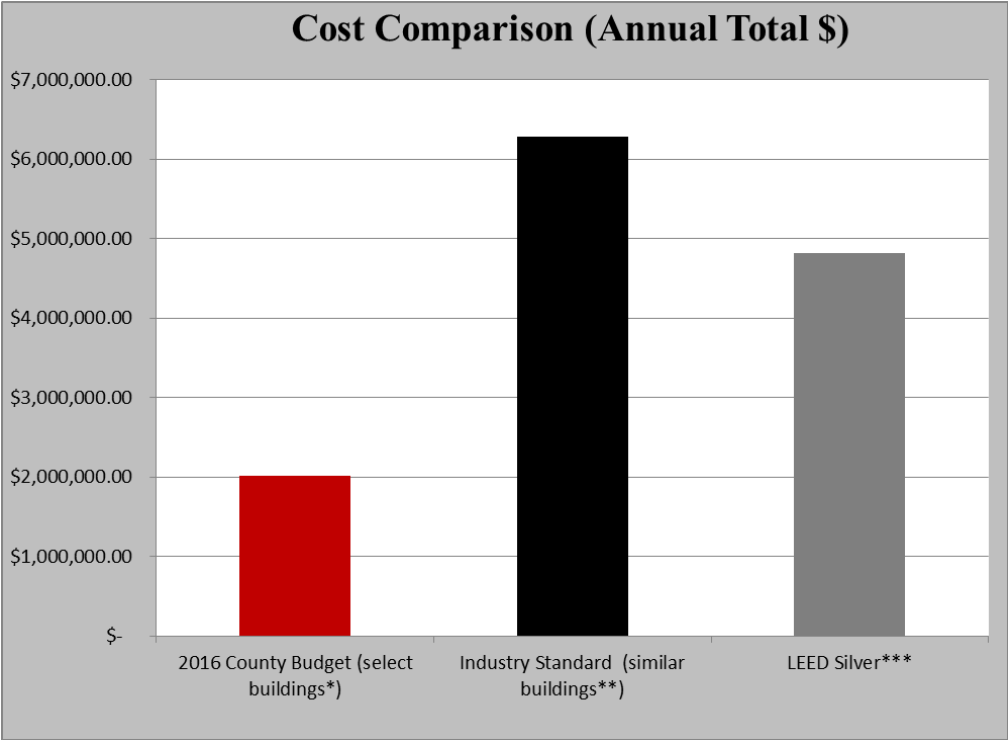
Figure 2.

Similarly, the County's current occupancy costs are well below industry standards. The overall cost of occupancy includes the full amount budgeted for each line item within the County's facilities management budget. As previously discussed, deferred maintenance combined with elimination of vital service contracts and limited staffing has driven the County's facilities management budget down. The two graphs below demonstrate the amount the County is currently allocating for the seven buildings our recommendation seeks to vacate and consolidate in the new government tower.

As can be seen, the consolidation of the County's government into a new, LEED certified government center would significantly reduce the County's annual O&M budget, while also allowing facility management staff to properly maintain the new facility and maximize its useable life. Through a combination of in-house management and outside maintenance contracts, the County can adopt new standards and procedures that will greatly improve facilities management efficiency, accountability, and as a result, employee morale.

Figure 2: Cost Comparison (Annual total \$)

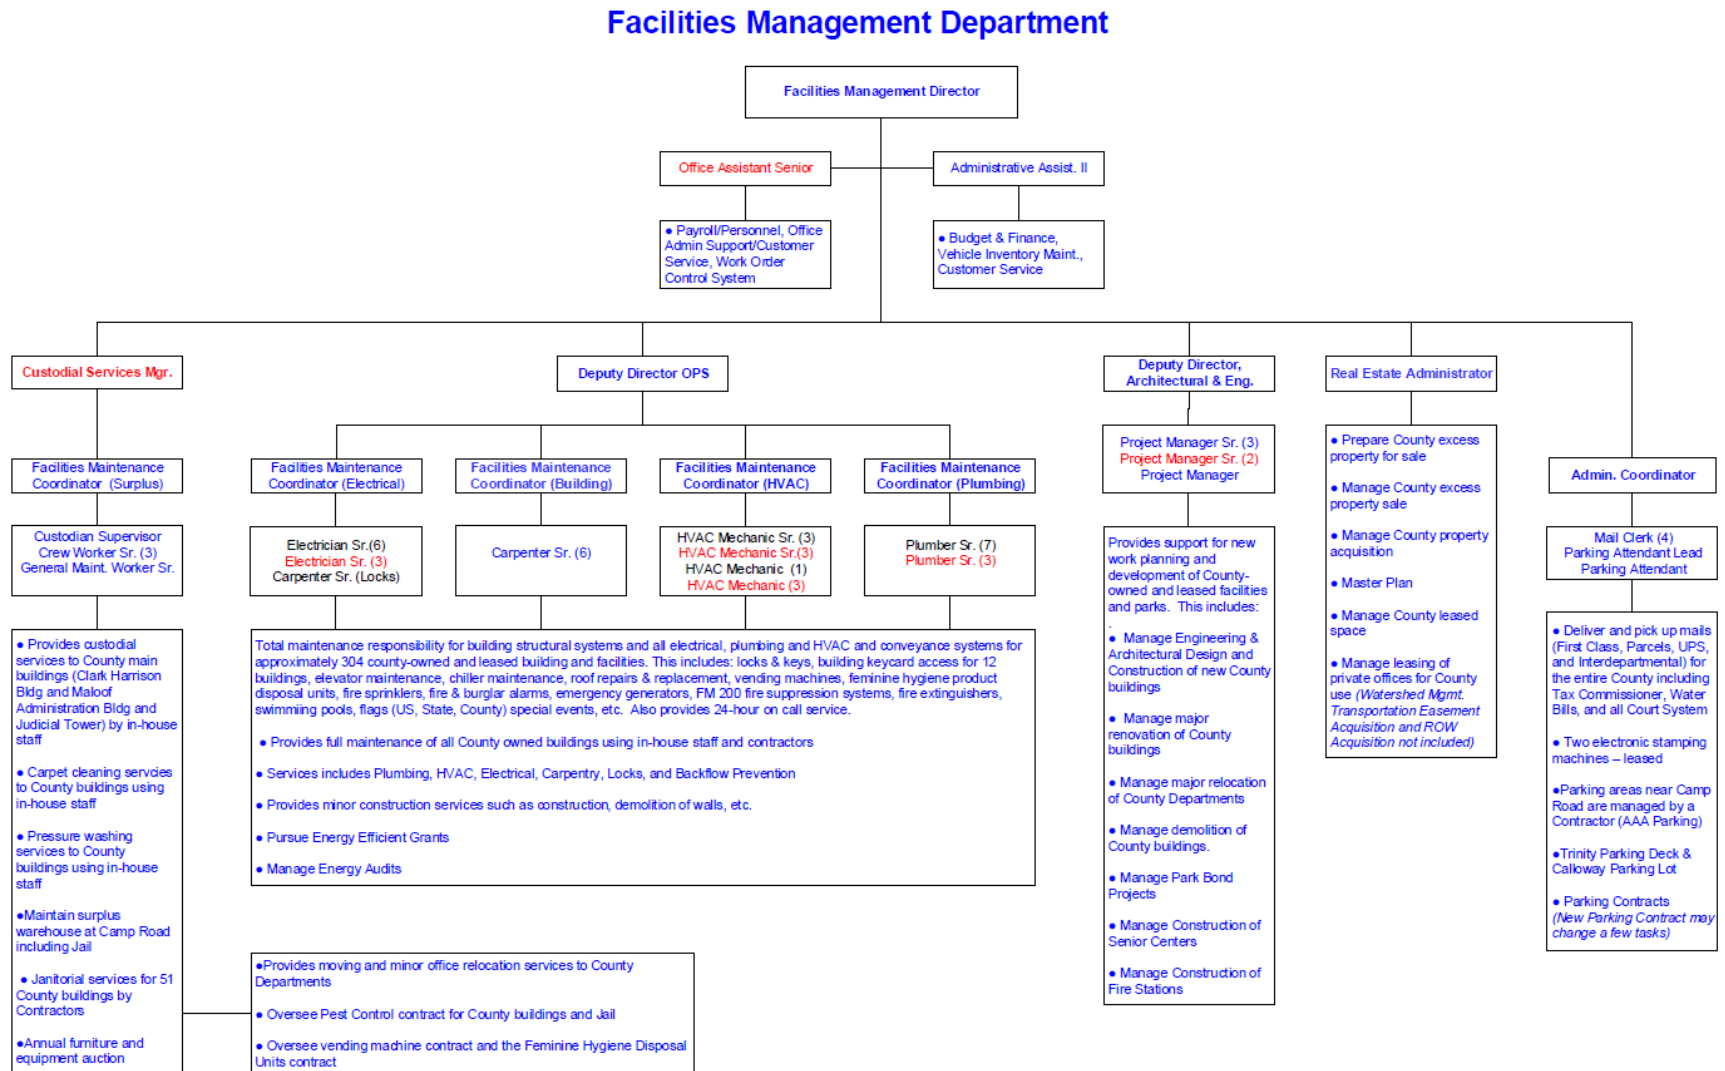
Trade	Headcount
HVAC	5
Carpentry	7 (includes a locksmith)
Electrical	7 (includes one new hire)
Plumbing	7 (includes swimming pool staff)

Figure 4. Facilities Management Organizational Chart

The internal staff is augmented with stand-by/on-call contractors for HVAC, Electrical and Plumbing. These on-call vendors are utilized primarily for large and/or complex projects that exceed the capabilities, equipment or manpower of the in-house staff.

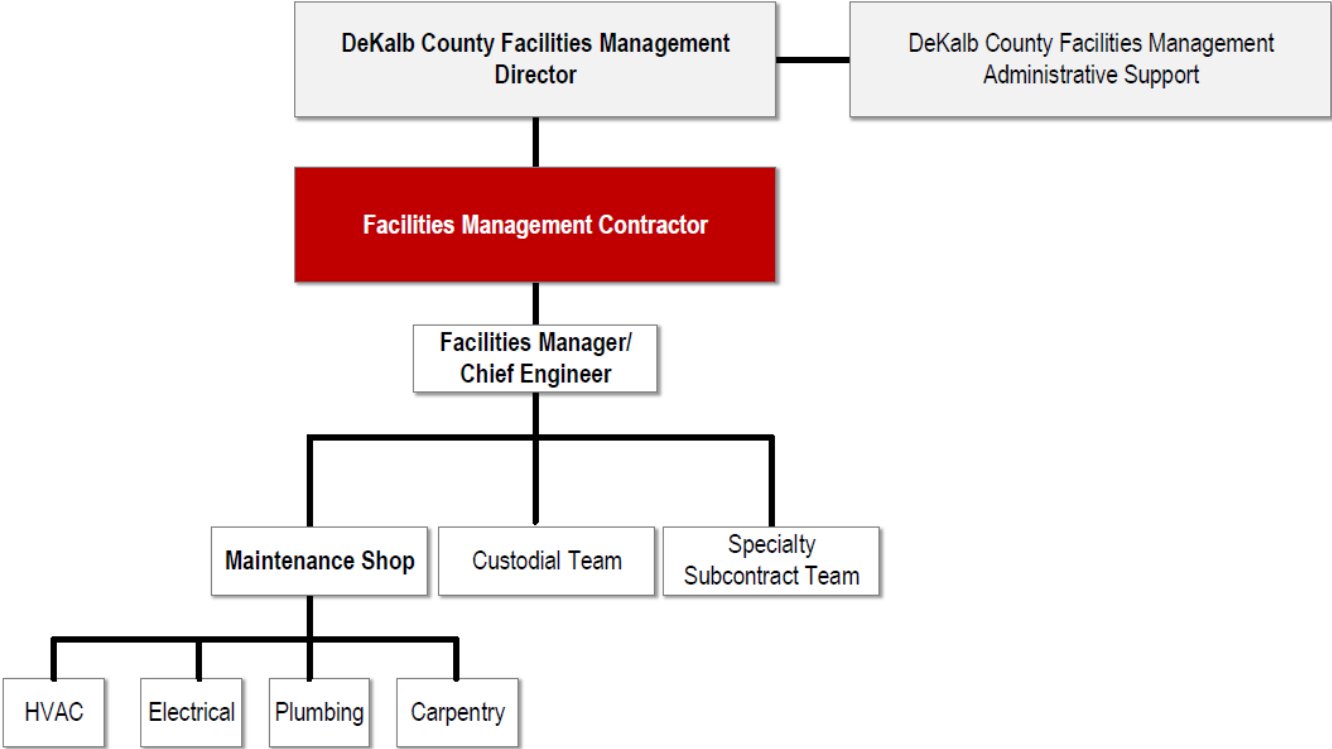
A comprehensive review should also consider a full range of outsourcing models from selective out-tasking to on-call contractors up to completely outsourcing all but the most mission critical of maintenance tasks. Consideration should be given to a hybrid model where an in-house management staff directs the activities of one or more private maintenance firms ensuring that costs, service times, meet or exceed the County's expectations. A sample organizational chart for this hybrid facilities management model can be seen on the following page.

Figure 5. Proposed Hybrid FM Organizational Chart

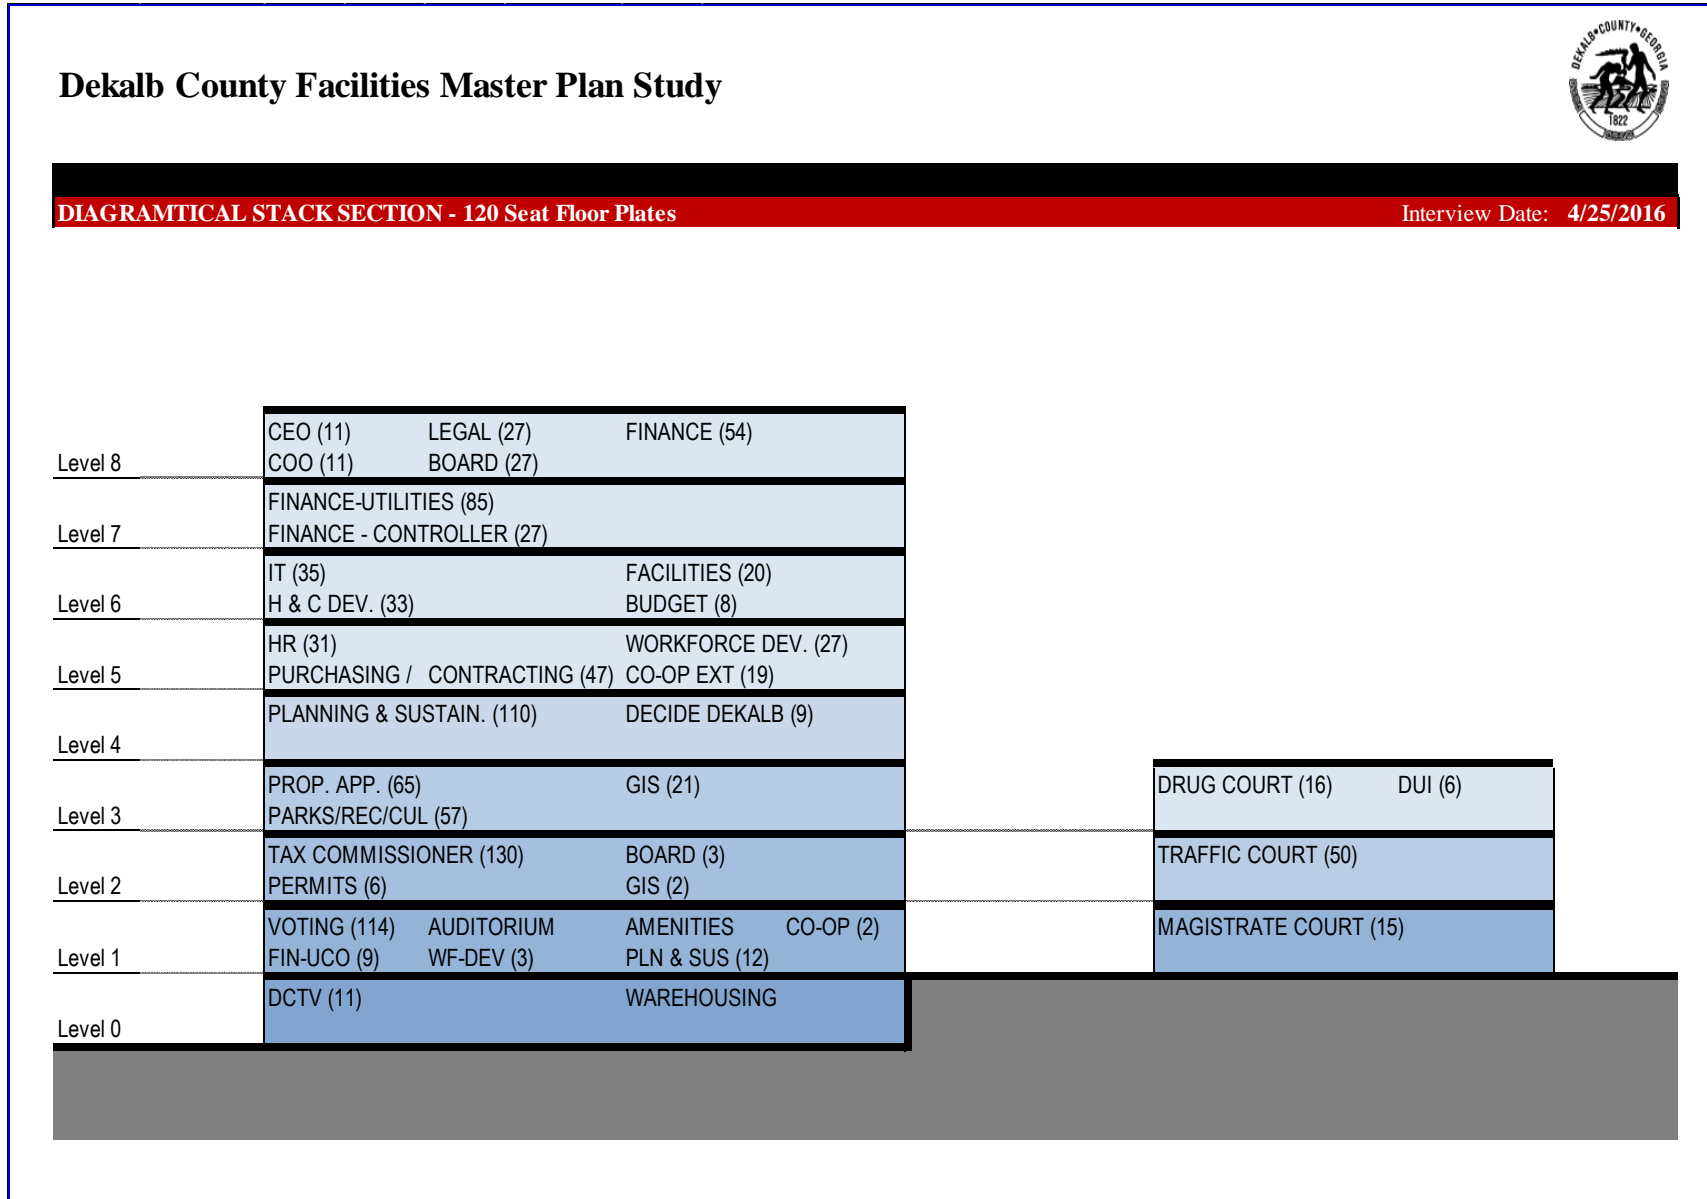
Figure 10.

The tenant stacking plan forms the foundation of the design for the new government center and was formulated in concert with County employees across all departments. Through the completion of a survey questionnaire as well as in-person conversations the JLL team created a concept for a new government tower that takes into account each department's relationships with other facets of the County government. The new stacking plan combined with spatial allocation standards and an open office concept with allow department's to work more efficiently and collaborate more effectively.

Figure 10: Tenant Stacking Plan

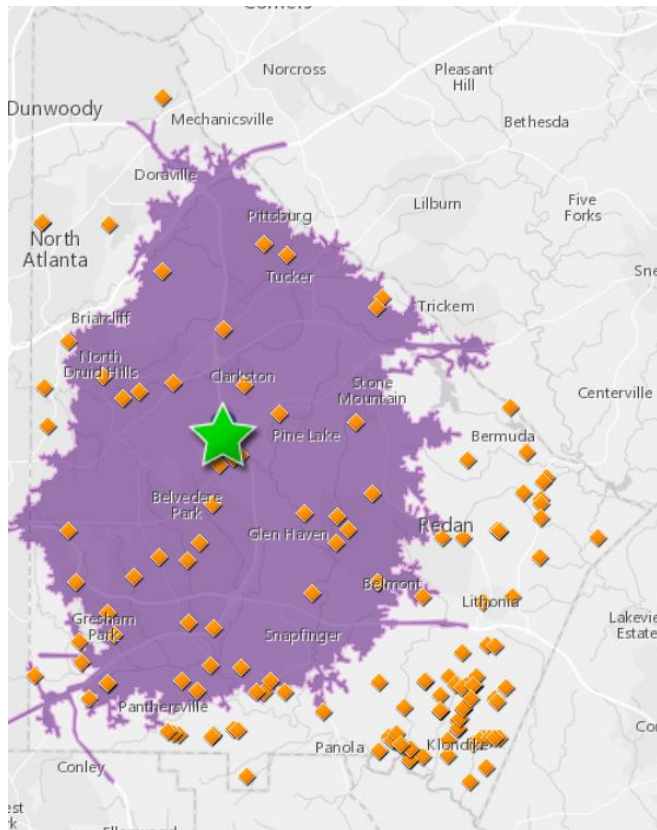
Figure 12.

After analyzing the County's portfolio of owned, undeveloped land JLL concurs with County administrators that the site at the corner of Kensington Road and Memorial Drive best fits the desired site characteristics. As can be seen on the map below the Kensington/Memorial site is centrally located within DeKalb County and allows easy access to Interstate 285, which runs adjacent to the site. **The central location of the site allows for a short fifteen minute drive from almost anywhere in DeKalb County, as demonstrated by the purple shading in the map below.**

Figure 12: Drive Time to Government Center Site Map

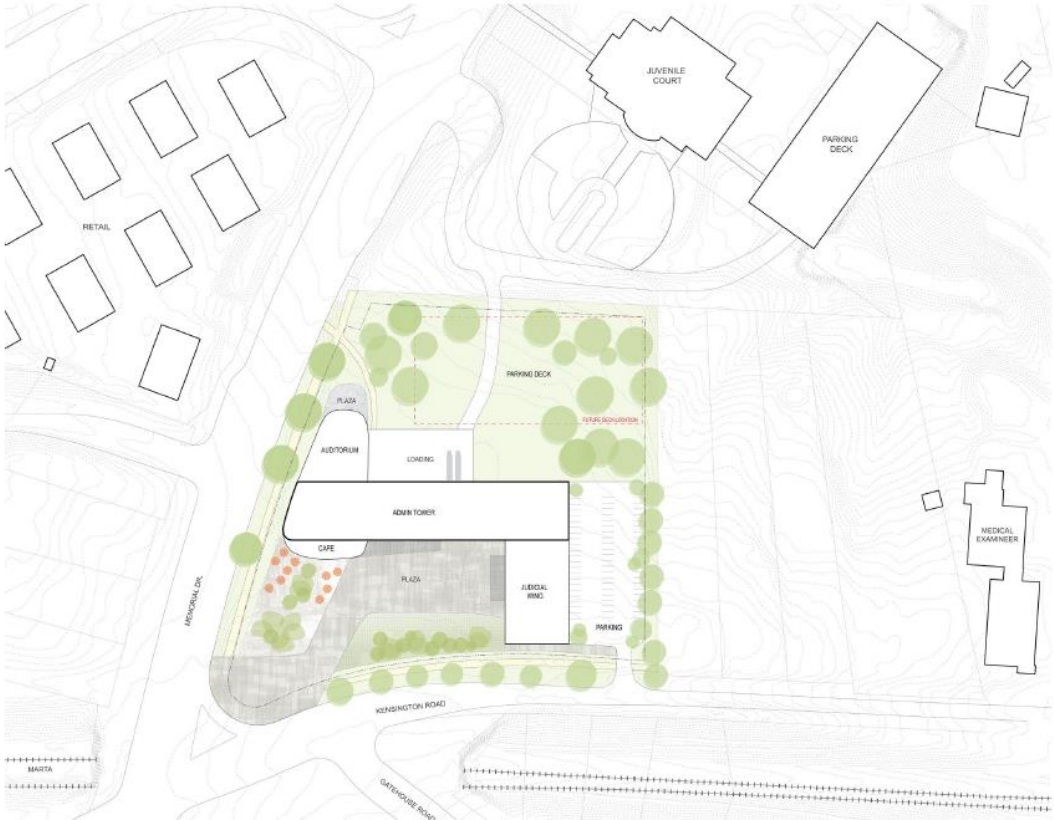
Figure 13.

Site Plan

Figure 13: Site Plan

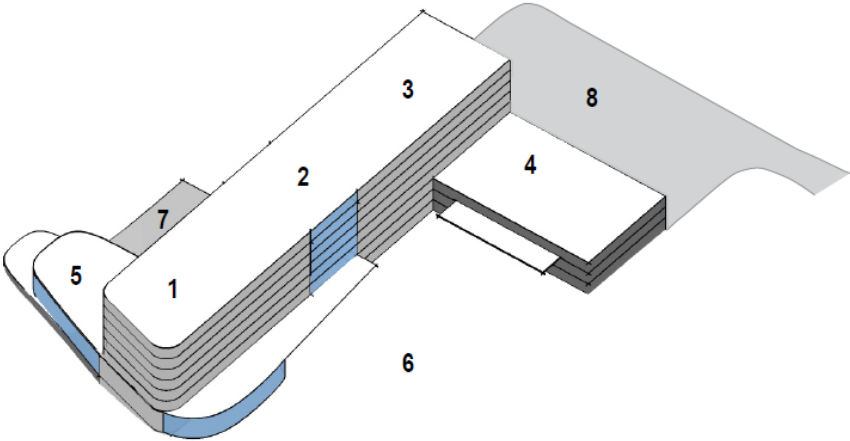
Figure 14.

Massing Strategy

- 1. Administration Wing
- 2. Open Atrium
- 3. Public Transaction Wing
- 4. Judicial Wing
- 5. Auditorium
- 6. Public Plaza
- 7. Loading Dock
- 8. Parking

Figure 14: Massing Strategy
