### **DeKalb County Historic Preservation Commission**

### Staff Report

R. 1256 Briarcliff Road, Karen Gravel for Galerie Living. Rehabilitate the Candler Mansion and carriage house. **1246710.**

**Condition Assessment & Schematic Design Proposal**

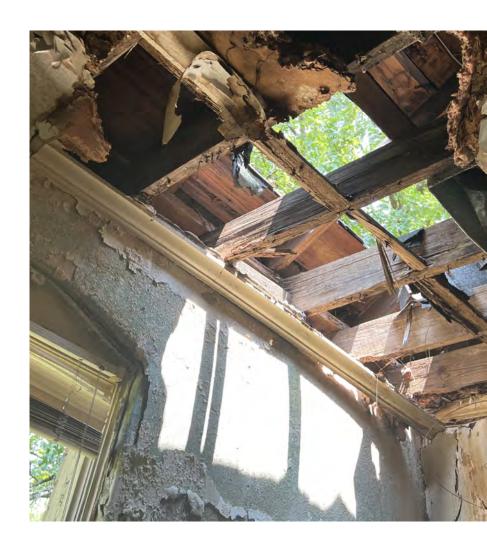
Masonry and Concrete Structure: No cracking, leaning, or other evidence of failures of the structure were observed. Investigative demolition thru damaged finishes and cores thru the structure at the locations of water damage should be performed to verify the integrity of these areas.

Wood Roof Structure: At the house, localized areas of damage caused by water infiltration exist and will need to be repaired. Extensive damage has occurred at the Carriage House Roof.

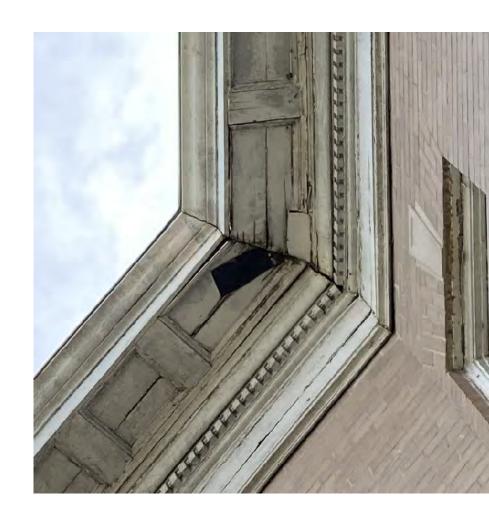
<u>Masonry</u>: Minor repointing and brick/stone replacement needed. At the tile porches & walkways much of the perimeter stone edge needs to be removed and reset.

<u>Woodwork:</u> Portions of all exposed woodwork have deteriorated. Substantial portions of the wood cornices have deteriorated. Removal and reconstruction with matching wood or composition materials will be needed. All exterior woodwork to remain should receive extensive paint preparation before repainting.

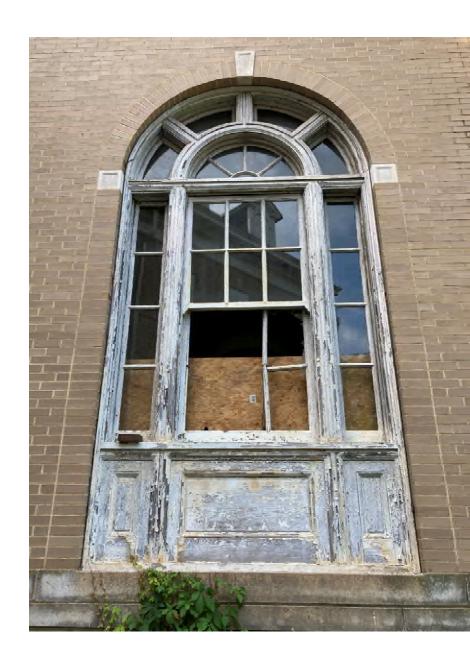
Original Wood Windows: Wood windows are largely intact with only minor areas of decay observed. Some openings have been damaged by vandalism and building stabilization measures. Approximately 75% of glass needs to be replaced.

Original Steel Windows: The steel window systems at the Summer Pavilion and Music Hall/Banquet Hall addition appear to be in good enough condition that they can be stripped, repaired and remain in place. Full glass replacement should be anticipated as part of the restoration of these windows.

Replacement Windows: Non-conforming replacement windows should be removed and replaced with historically accurate windows as part of the rehabilitation.

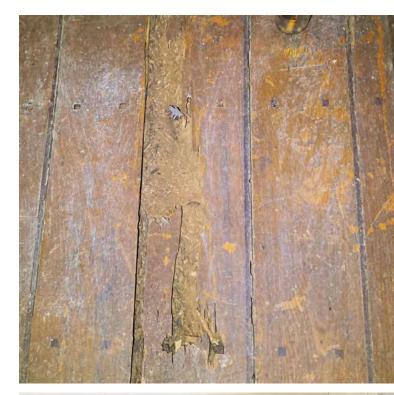
Wood Floors - First Level: 1 ½" tongue and groove oak floors at the main house and the 7" wide decorative plank floors at the Music Hall addition should be replaced, repaired and restored where damaged.

<u>Wood Floors – Second and Third Level:</u> Traffic Coatings and adhesives on the wood floors may be impractical to remove for refinishing original wood flooring.

<u>Tile Floors – All Levels</u>: Remove any coatings and restore.

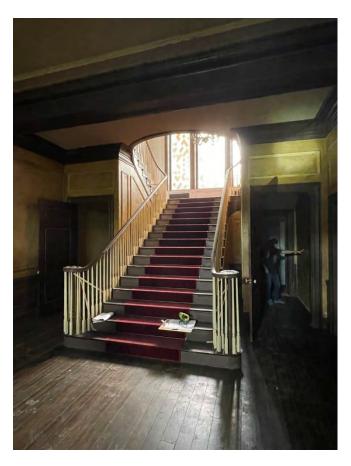
IMG 109-1: Entry Hall Main Stairs. Remove Non-Historic infill under 2<sup>nd</sup> stair runs. Remove/replace non-historic rail and balusters. Visible flooring is loose laid LVT plank over original 1 ½" T&G wood flooring.

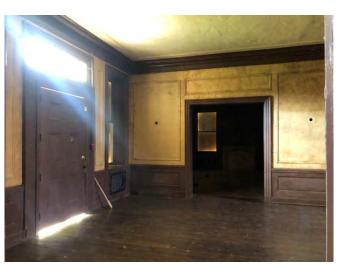
IMG 109-2: Front door and opening into wood paneled Library 104. Paint and textured plaster finish to be removed.

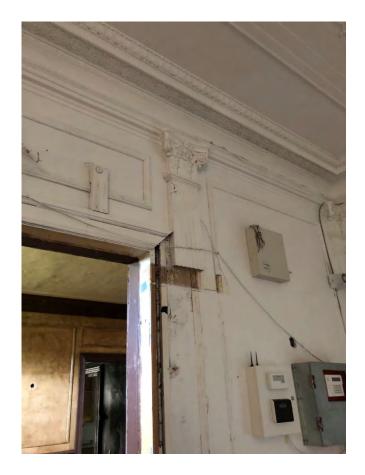
IMG 110-3: Damaged/Missing trim elements.

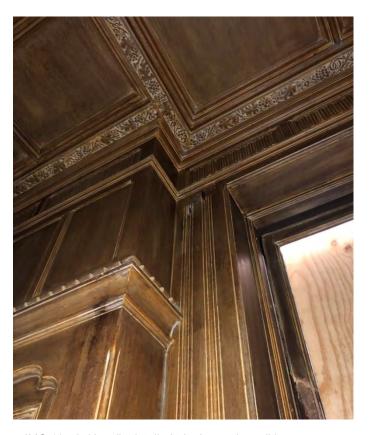
IMG 104-3: Heavily detailed trim in good condition.

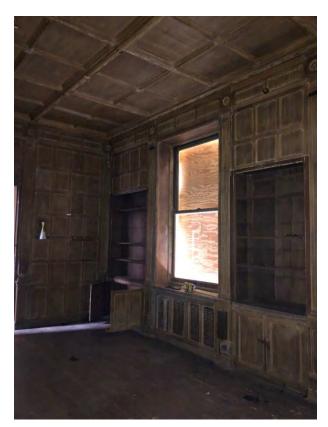
IMG 104-4: Built in shelves. Shelves at right in photo water damaged. Back of shelf to be replaced in-kind.

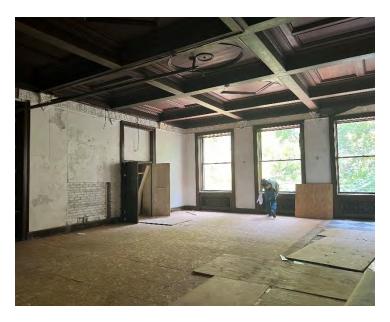
IMG 122-1: Banquet Hall – Original floors assumed lost. 6" ornamental plank similar to Music Hall.

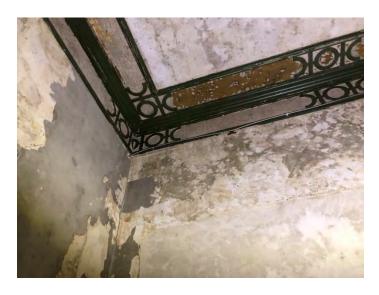
IMG 111-1: Family dining room original crown molding which depicts the garden lattice theme of the original space. Similar wall applied elements are missing but historic photographs are available.

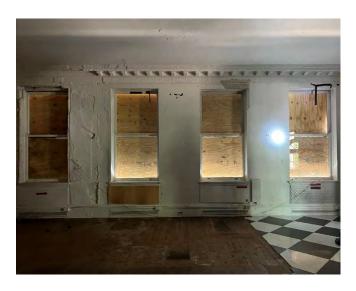
IMG 102-1: Family Living Room with water damage located on the left side of the image, effecting both the wall and ornate plaster crown molding with corbels. Tile floor section not original. 1 ½" T&G oak typical at Main House 1st Floor

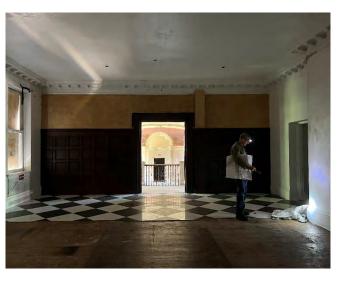
IMG 102-2: Family Living Room looking west towards Solarium. Black and white tile, paneling, and textured paint are non-historic movie set additions.

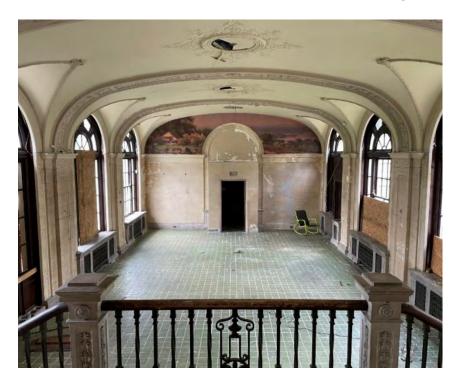
IMG 101-1: Solarium looking west from stair landing. Door and vestibule "box" leading to egress stair to be removed. Mirrored imitation of typical window to be installed in arched opening original arched opening.

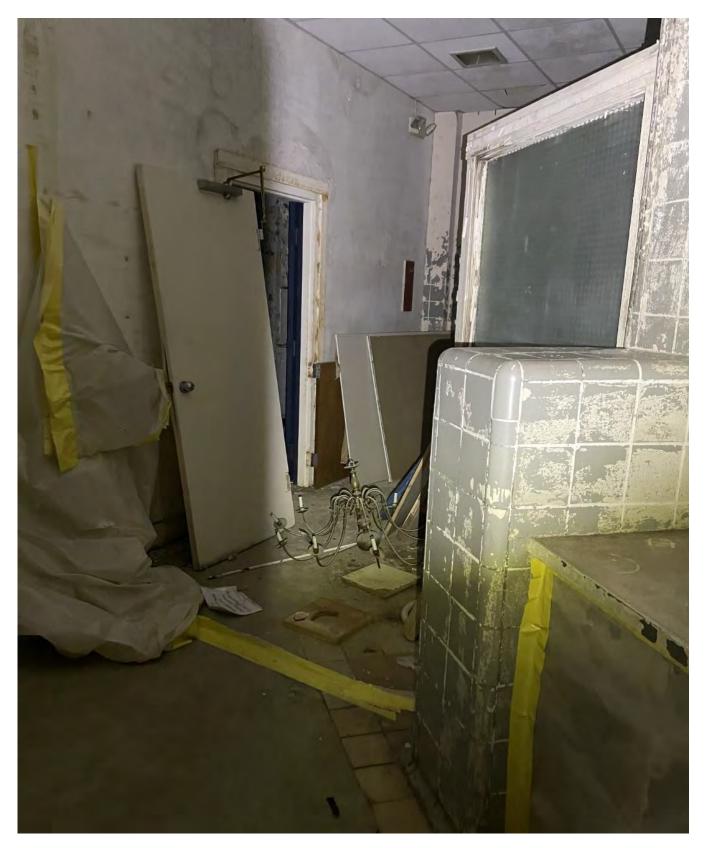
IMG 114-1: Original Kitchen was divided up into many rooms during the institution era. Tile @ floors, full height walls and even ceilings appear to be original materials. Area of mansion to contain new restrooms serving future event/assembly uses.

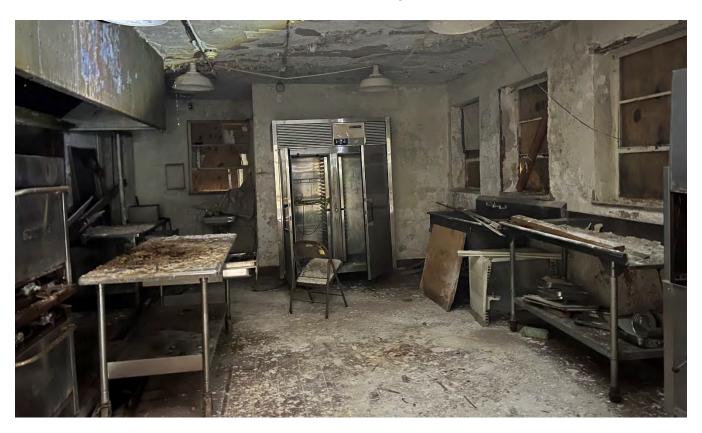
IMG 123-1: Institutional Kitchen addition off of the Banquet Hall in poor condition.

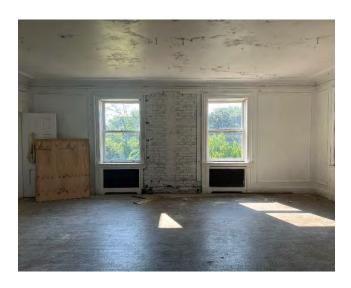
IMG 208-1: Candler's bedroom which showcases water damage on the front side of the mansion in between two windows.

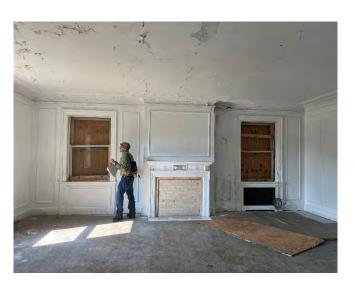
IMG 208-2: Directly above the Library, marble mantle at closed-up fireplace. (Original chimney at this location has been removed from structure).

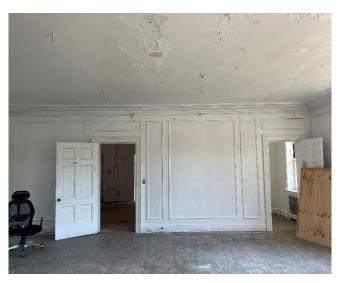
IMG 208-4: Typical smooth plaster walls with applied wood moulding creating panels. Looking north at doors leading to Stair Hall and Bath 4 & Closet. Typical ceiling damage visible after removal of ACT ceiling systems.

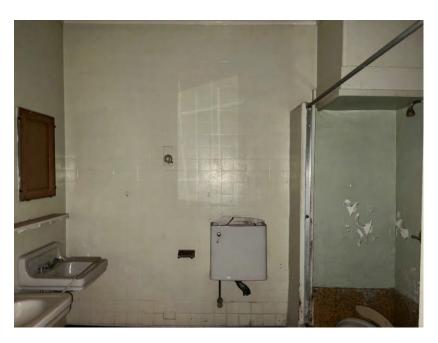
IMG 204-3: Tiles in a typical bathroom in good condition covering the walls. Existing plumbing fixtures to be removed and replaced.

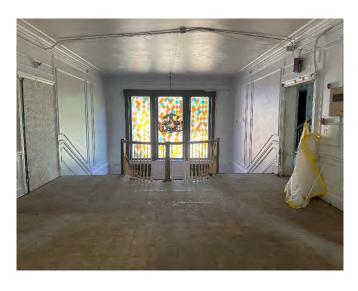
IMG 209-1: Stair Hall from first floor entry hall ascending to second floor. Non-historic faux stained-glass panels to be removed and replaced with new sashes. Fixed or double hung to-be-determined.

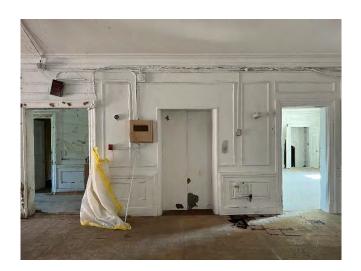
IMG 209-3: Elevator installed at former Bedroom closet location on this floor. Door on left leads into Back Stair Hall and North Hallway. Both with severe water damage to plaster and wood paneling finishes.

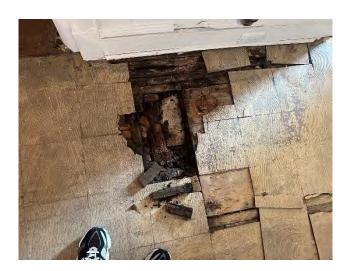
IMG 209-4: existing ACT flooring on plywood installed over original tongue and groove wood flooring. Areas of water damage revealing layers shown here.

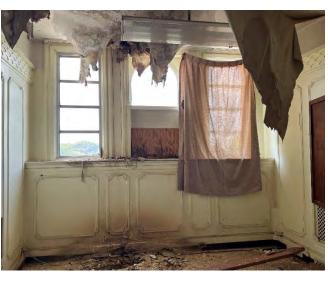
IMG 311-2: Water damaged plaster ceiling in South Alcove. Aluminum replacement windows to be removed and replaced with historically accurate wood sashes.

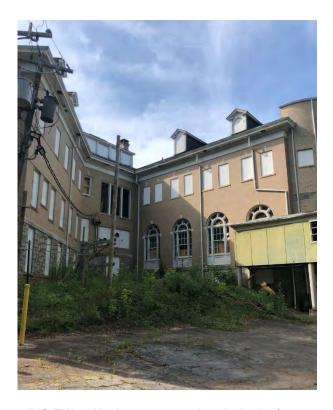
IMG EX2-1: Northwest courtyard on the back of house. Broken windows are to be fixed, and the bridge the carriage house is to be removed. This is the location of the new addition to the house which includes a new elevator.

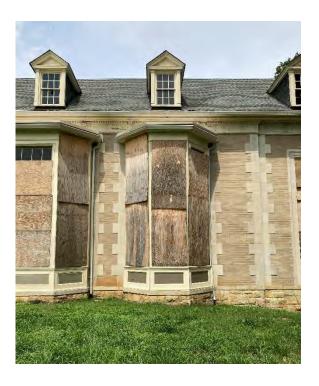
IMG EX4-2: Boarded up, damaged windows of the Music Room.

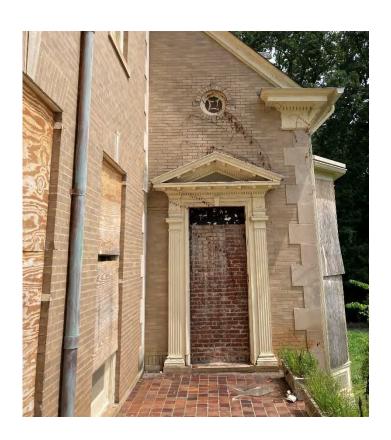
IMG EX4-3: Detailed trim of brick-filled door that leads to nothing on the interior side. Trim needs repair.

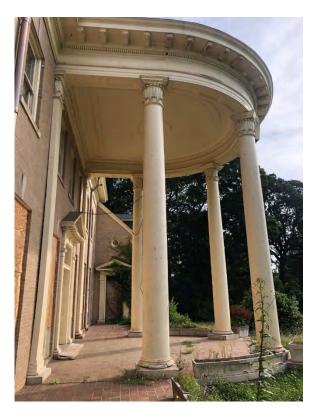
IMG EX4-4: Entry patio for main door. Column bases need to be addressed.

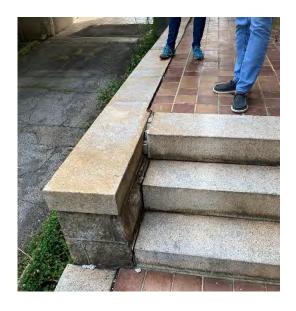
IMG EX6-6: Stone retaining wall breaking away from tile walkway; needs to be redone.

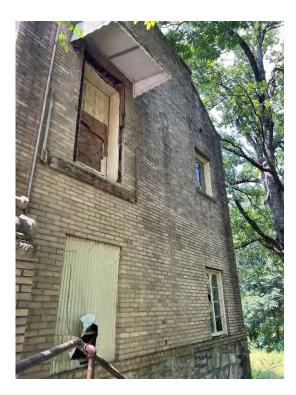
IMG CH1-2: North side with stairway down to back of Carriage House. Replace door with window matching adjacent.

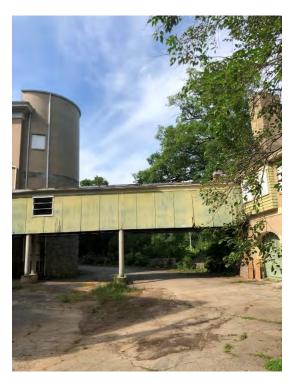
IMG CH1-5: Bridge connection from Main House to Carriage House which is to be demolished.

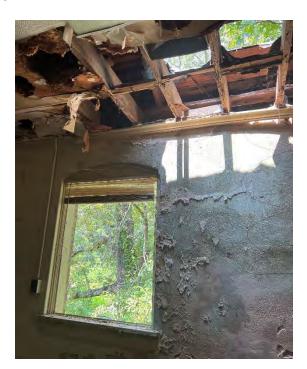
IMG CH3-2: Hole, one of two, in roof allowing structural deterioration. Framing repairs needed before roof replacement.

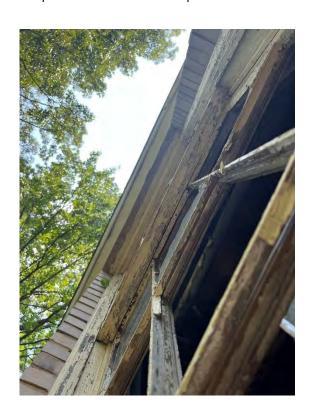
IMG CH3-5: Chipped paint and wood on widows. Window is missing windowpanes.
