# DeKalb County Historic Preservation Commission

## *Staff Report*

J. 1035 Oxford Road, Ben Darmer for Parkwood Living, LLC. Demolish a historic house and construct a new house. **1247316.**

## STRUCTURAL ENGINEER INSPECTION REPORT

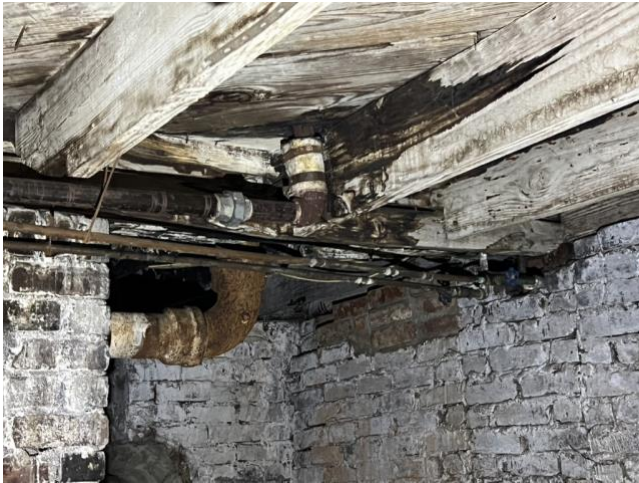
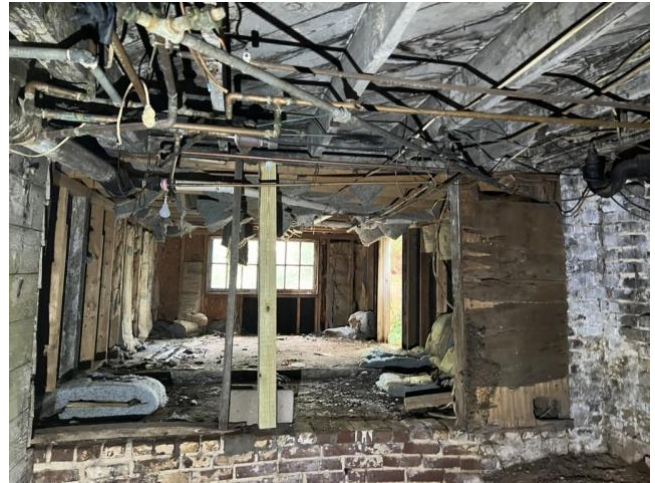
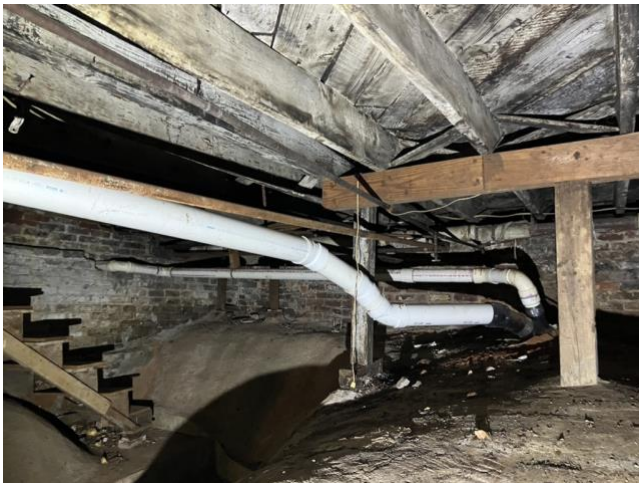
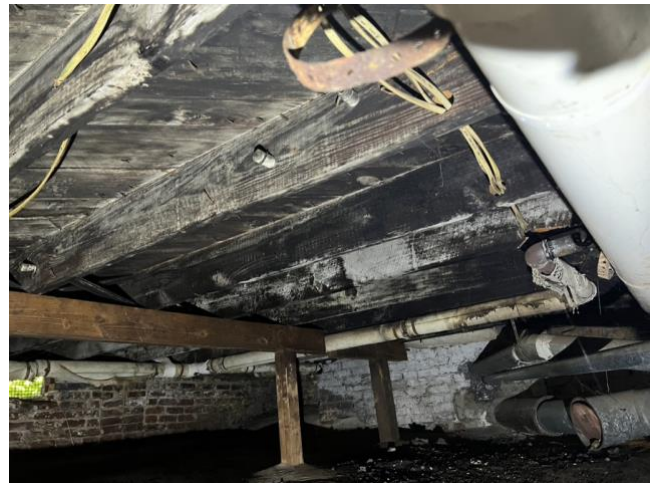
Exhibit 1:

**Observation #1:** Damaged floor joists and beams and uneven floor in different floor locations; see Exhibit 1.

**Conclusion:** The floor joists/beams and subfloor have been severely damaged for an extended period due to a leak or moisture condition. Any moisture problems contributed to decay and weakened the floor joists and subfloor. Also, there are noticeable deflections on the surface. This condition is called "creep" and is observed in buildings 40 years or older. This type of age deflection occurs when, after many years of continuous loading, the cells in the

wood change shape, and some of the fibers start to bend. Breakage and collapse seldom occur because the breaking strength of wood usually doubles its fiber bending strength. Accordingly, creeping floors tend to deflect and then set. Also, many Improper supplemental supports and beam/joists have been noticed.

**Recommendation:** We recommend replacing all the rotted beams/joists and adding more support in the form of new structural beams and columns, such as new wood/steel posts.

Assuming the joists are in good condition, reinforcing the floor can solve uneven floor problems. Beefing up the floor joists can diminish uneven floor issues. It is essential to demolish all the wooden structural elements of the house and build a new floor system and foundation.

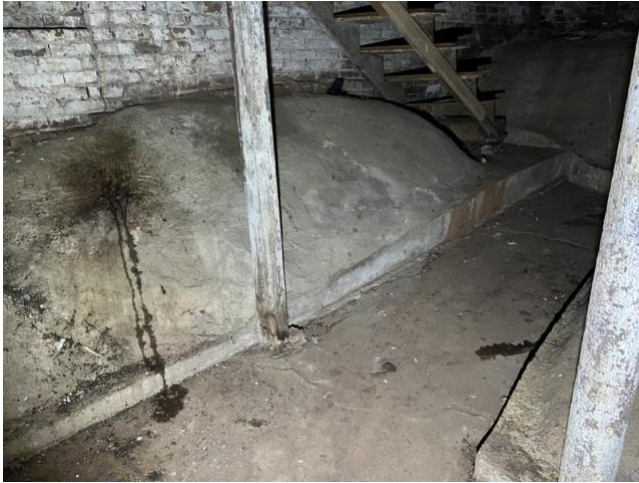
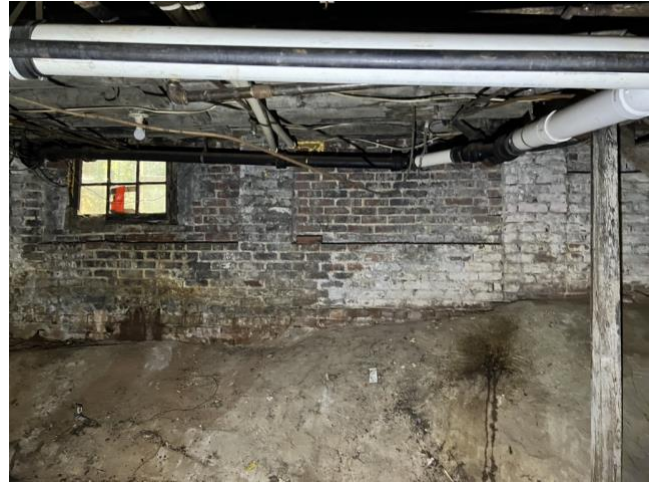
**Exhibit 2:**

**Conclusion:** When excavating to convert the low crawl space to a deeper level, the soil within the perimeter is excavated to the desired depth, usually done by hand. Once the footings have been exposed without adequate support or soil stabilization, the structural integrity of the home foundation will be compromised.

**Recommendation:** It is recommended to support the crawl space wall and middle piers foundation. This can be achieved by adding new supports such as steel posts and footings and stabilizing the soil with concrete flowable fill. Alternatively, creating a "bench ledge" by constructing a small retaining wall inside the perimeter of the foundation can help strengthen the structure and serve as a retaining wall for the soil outside the new foundation.

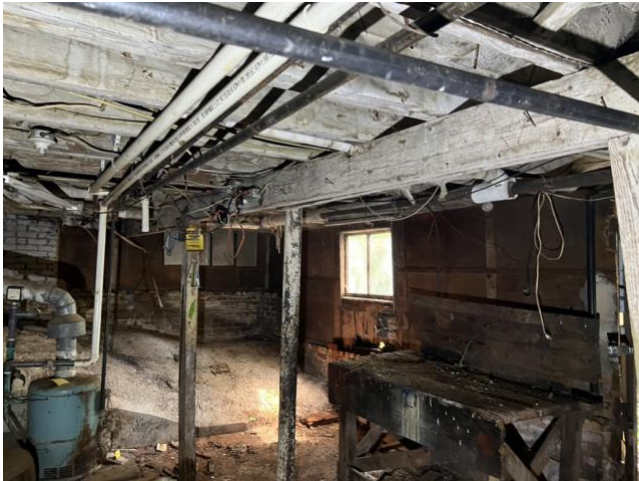
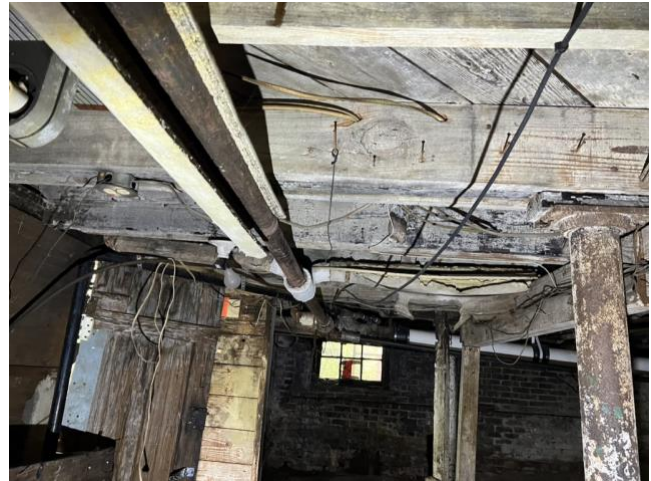
**Exhibit 3:**

**Observation #3:** The steel posts supporting the main beams display rust damage at the base; Exhibit 3.

**Conclusion:** Steel posts exposed to high humidity and moisture will eventually rust at various points. When these parts are subjected to flooding or repetitive wet conditions, they become corroded and lose their strength.

**Recommendation:** If the corrosion on the steel posts or base is not severe, they should be sanded down and coated with a zinc-rich primer. Subsequently, the steel should be covered with at least two coats of acrylic paint. If the rust damage is severe, it is best to replace the affected parts entirely. This can be accomplished by cutting out the severely rusted section, attaching an elevated base, or welding a new steel post to the bottom.

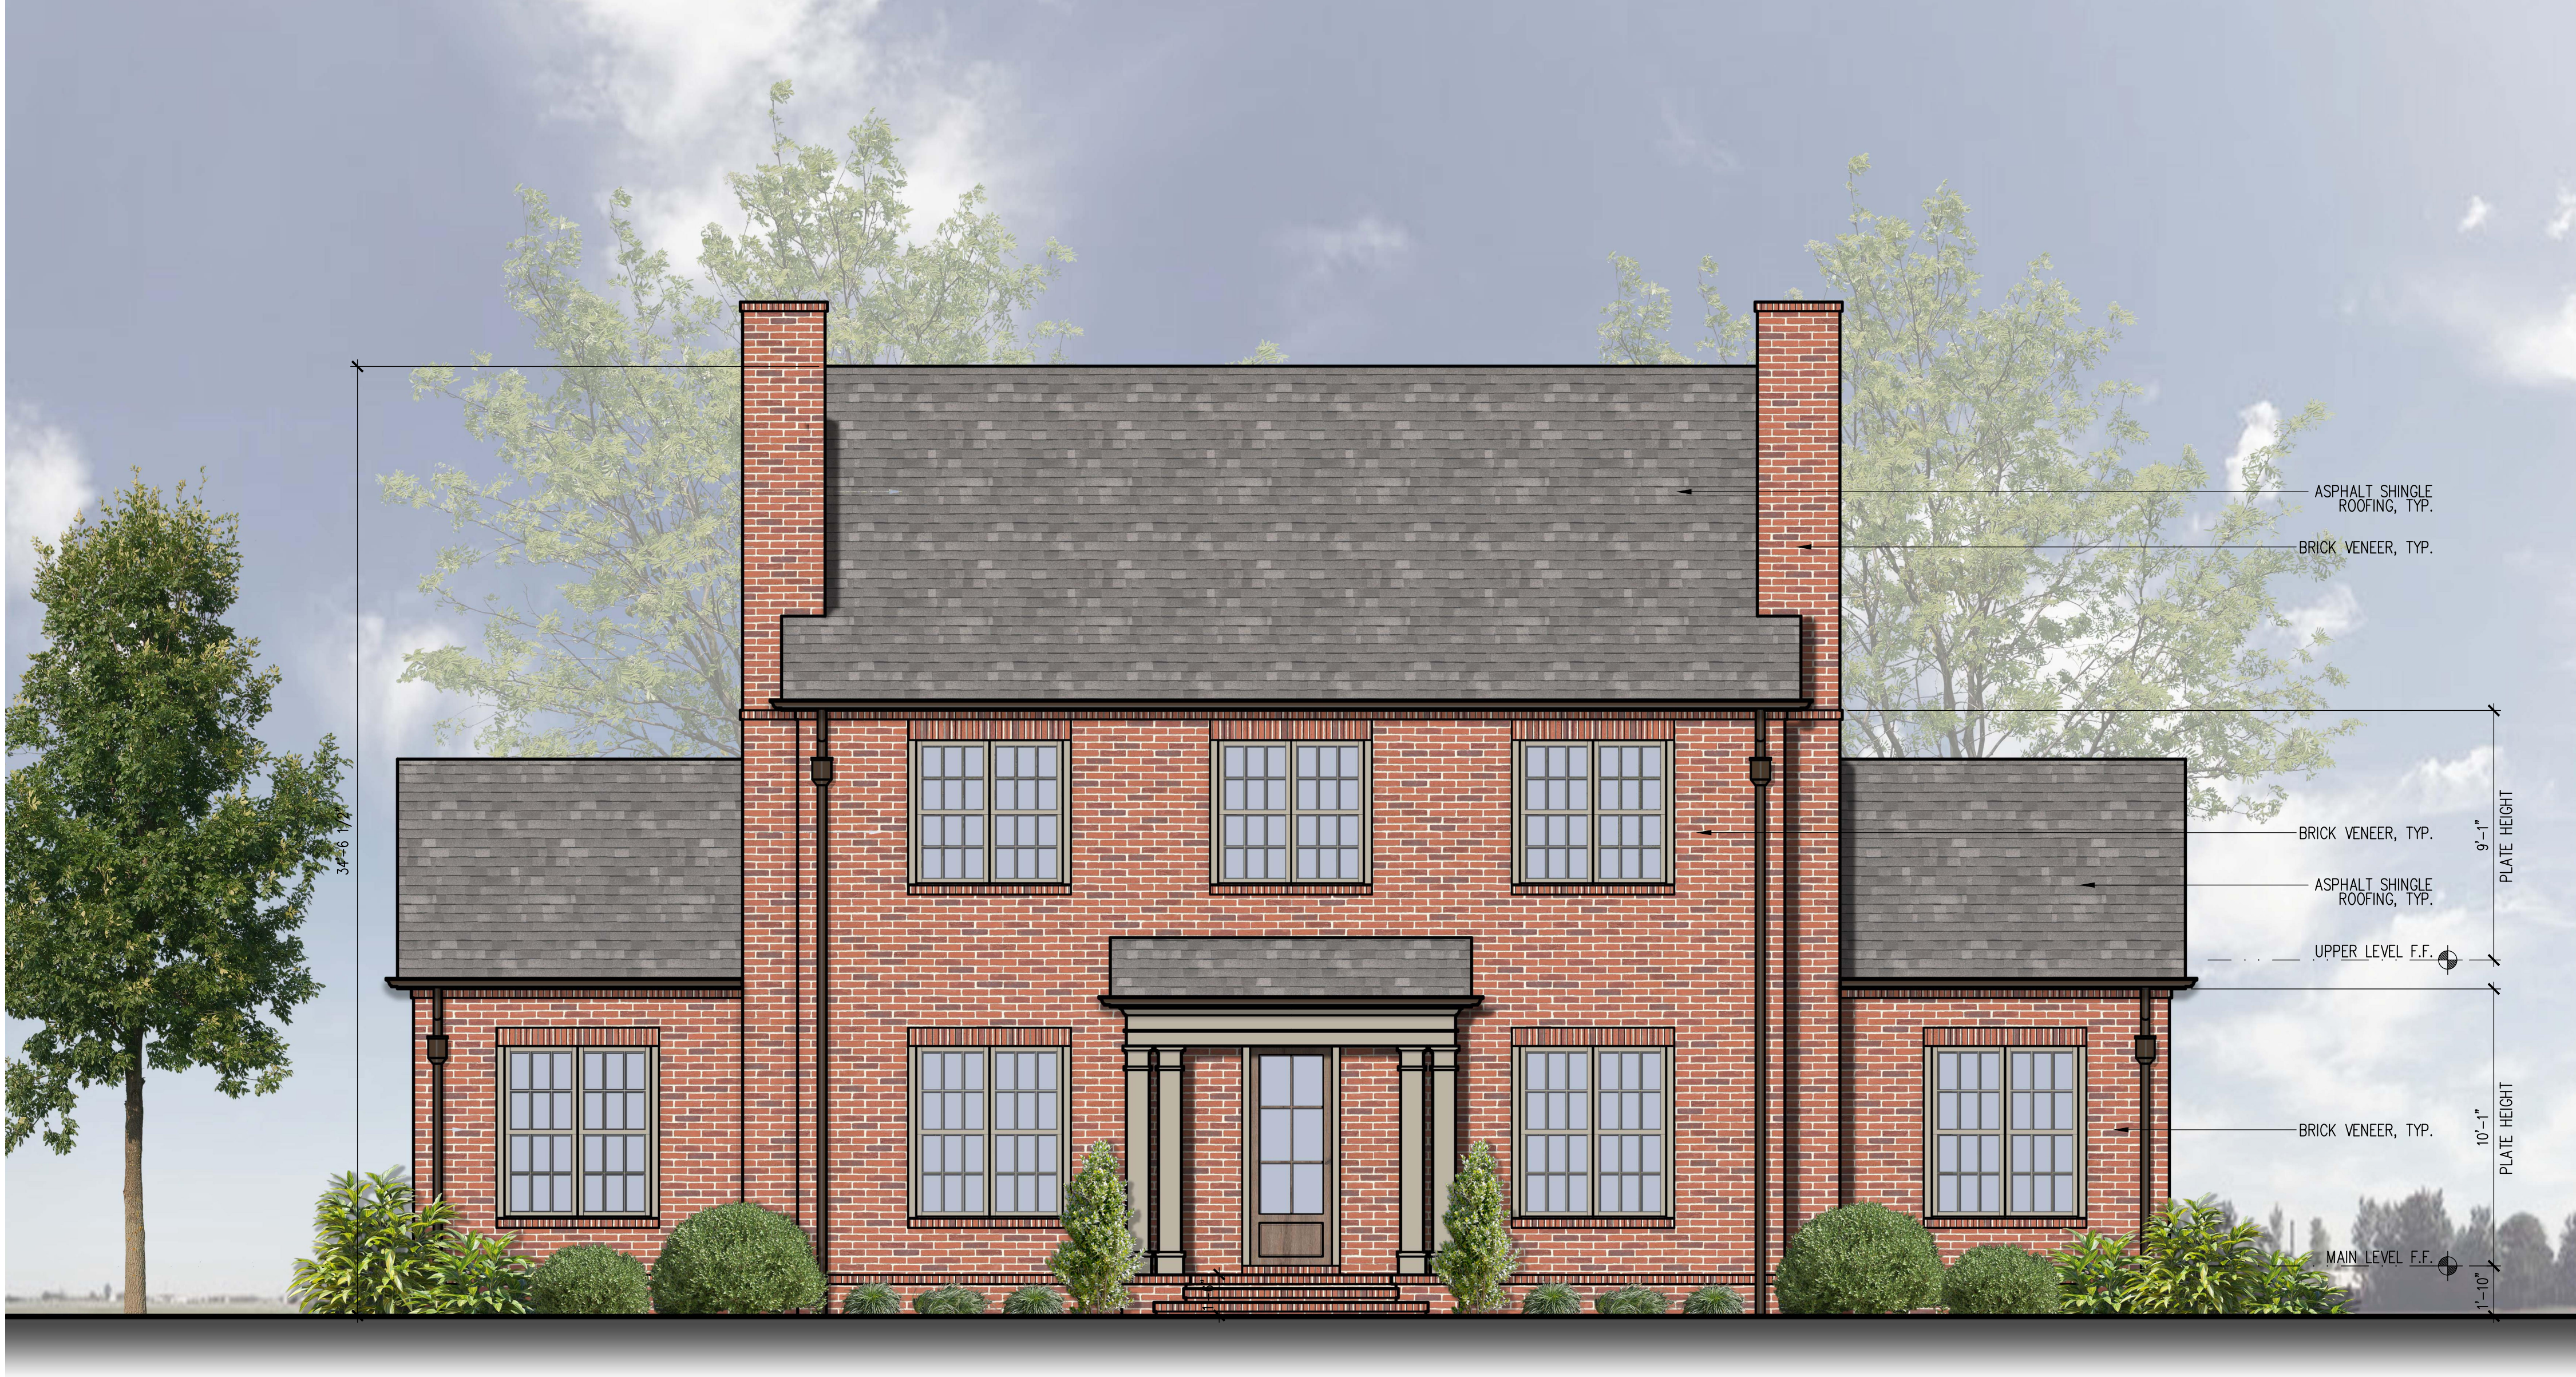
1 FRONT ELEVATION  
A201 1/4"=1'-0"

A two-story, brick house with Colonial Revival elements, including two chimneys on either side of the gabled roof, will be constructed in the footprint of the demolished house. The new house will be constructed with a basement, including a garage below grade, and a covered porch on the rear of the property with set of spiral stairs leading to the backyard.
