Application for Certificate of Appropriateness

Address of Subject Property: 1859 Ridgewood Drive Atlanta, GA 30307

1859 Ridgewood Dr NE
Atlanta, GA 30307
Project No: 22267

Residential Inspection and Construction Evaluation

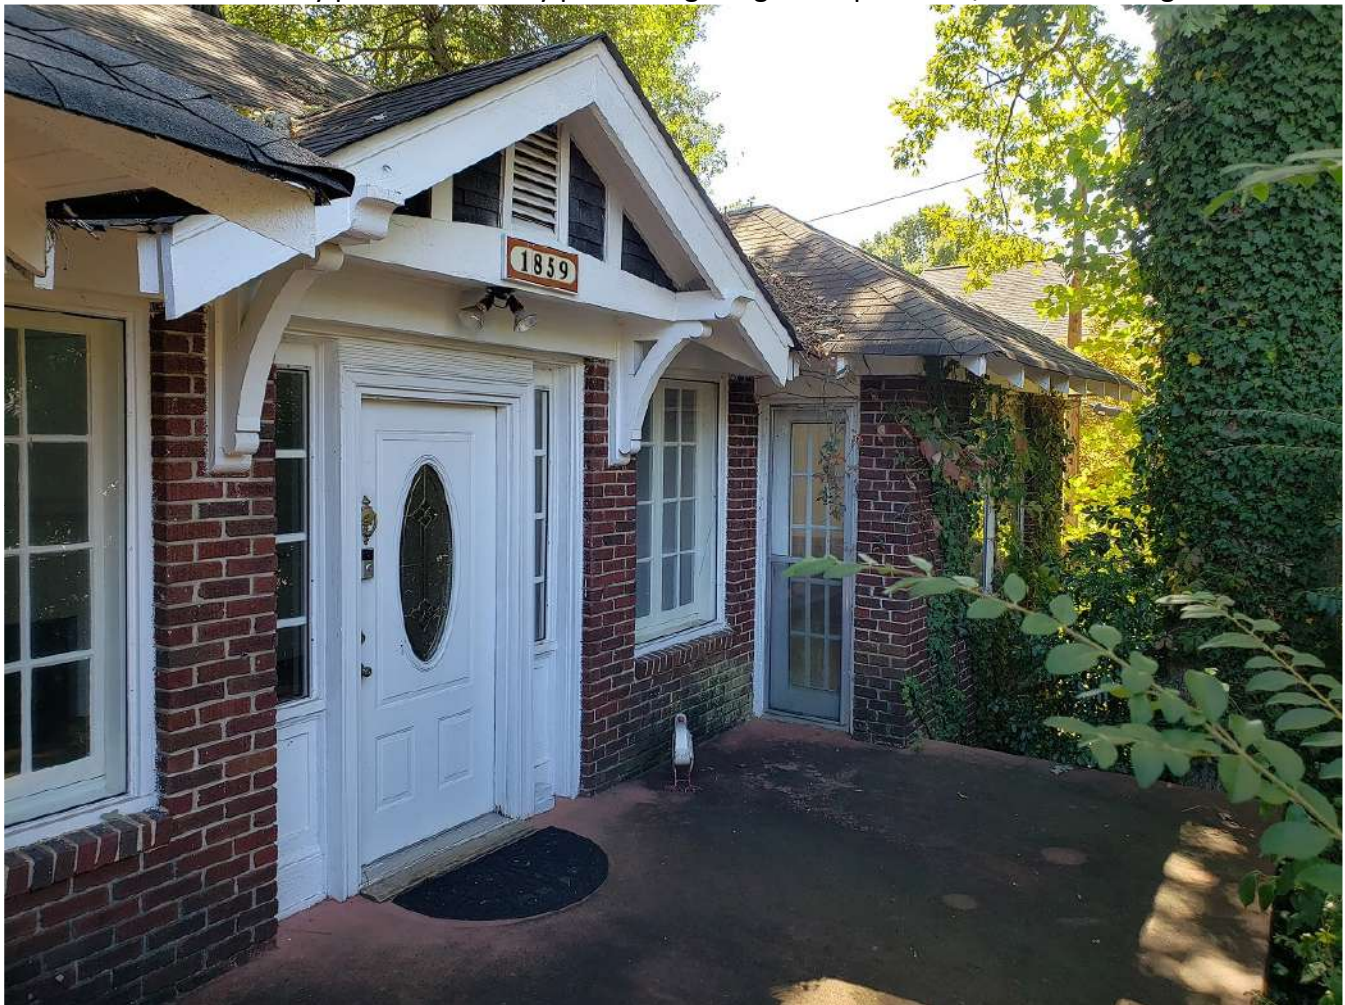
The front steps and terrace, showing the specimen tree slowly destroying the house in the background.

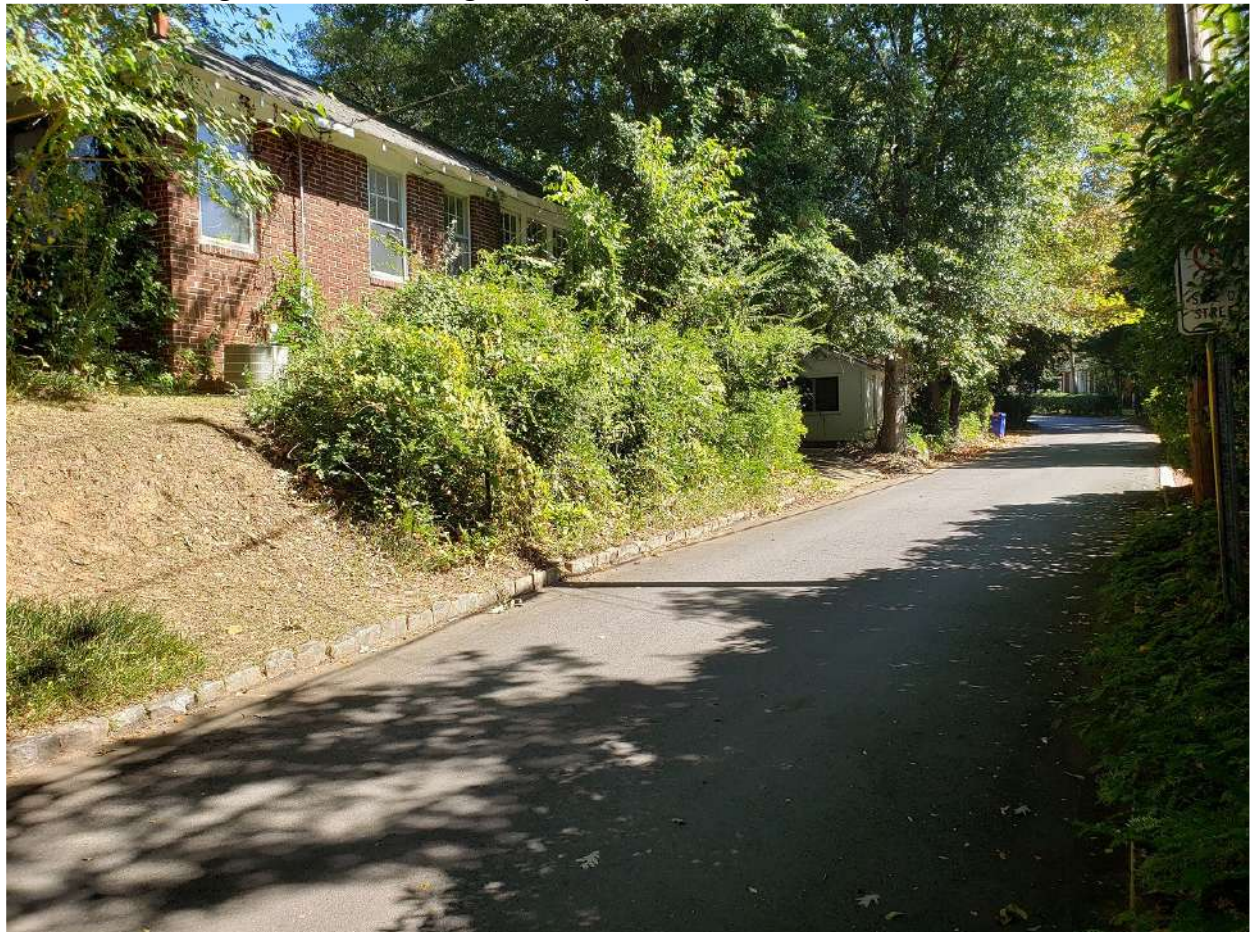
Rear corner of right side of home with damaging tree

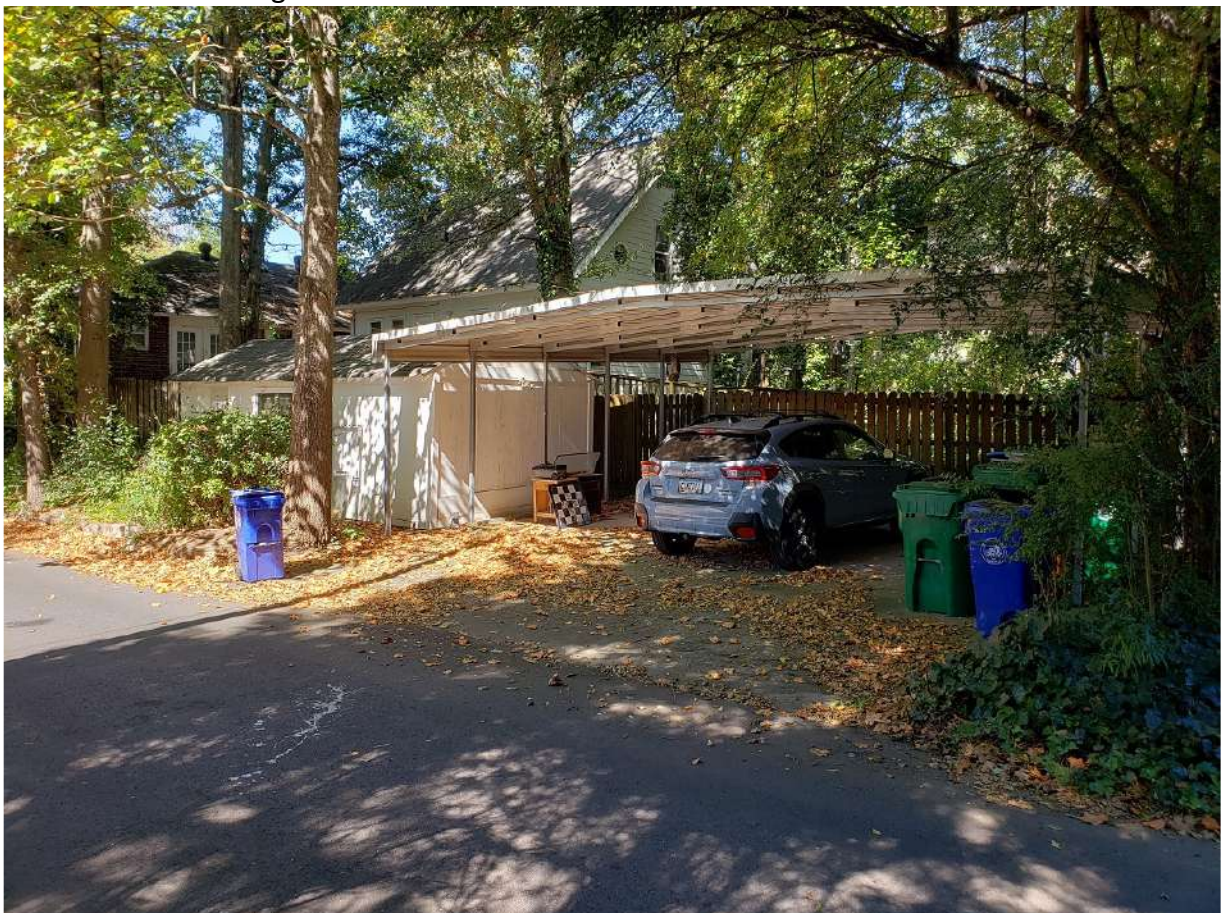
Non-historic shed to be demolished

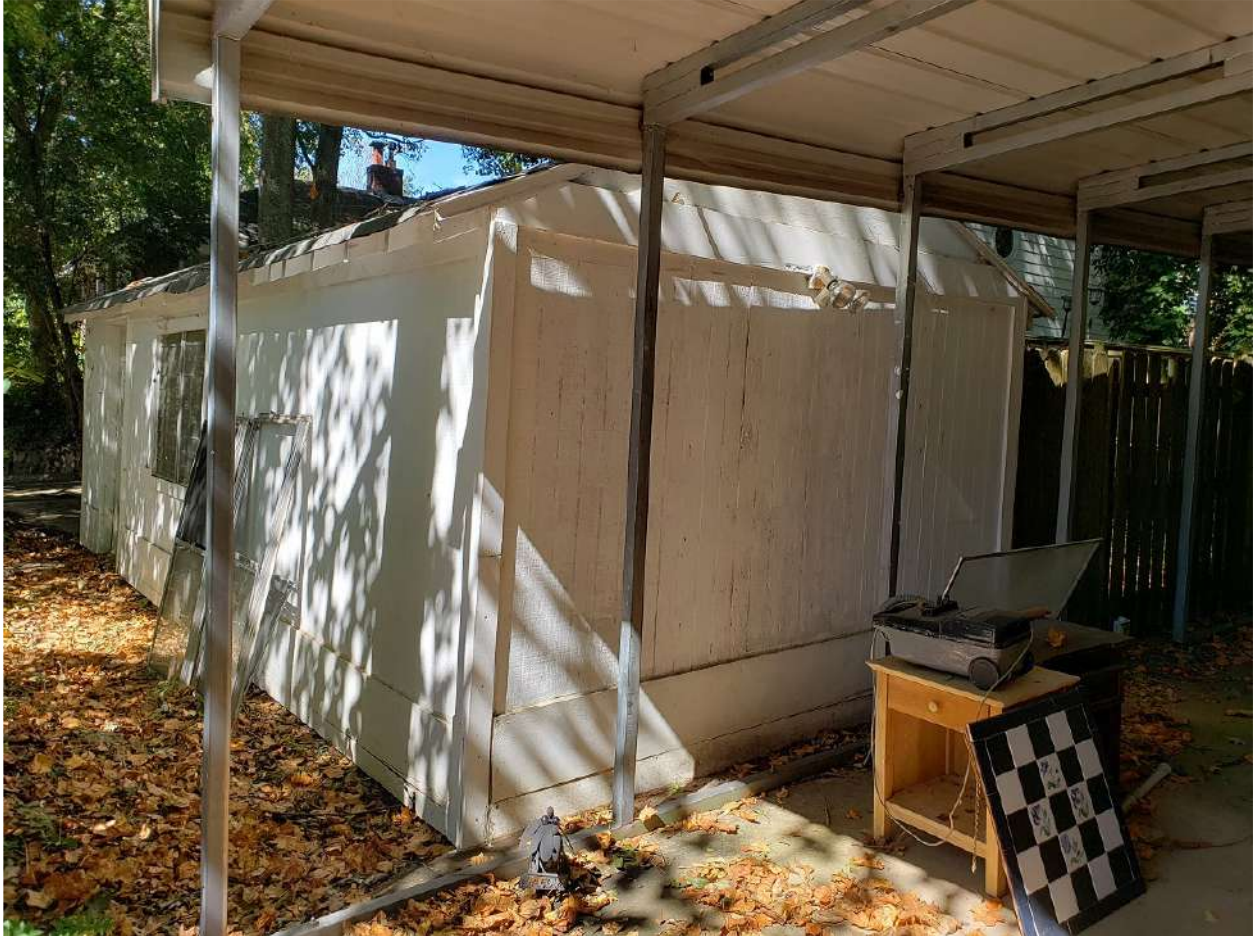
Huge addition to be removed
